Town Square Shopping Centre Stratford-upon-Avon Warwickshire

Programme of Archaeological Investigation

CA Project: 660623 CA Report: 16154 Site Code: TSQ15

October 2016

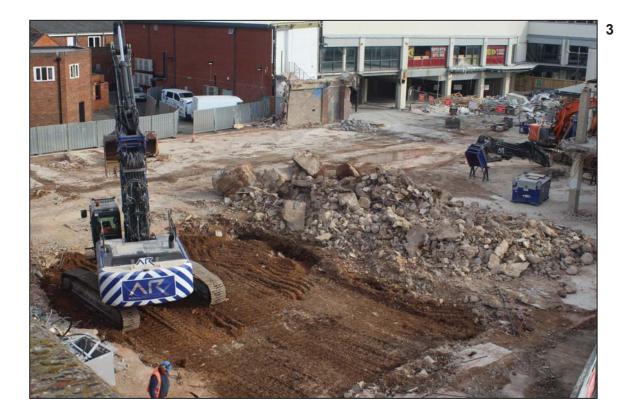
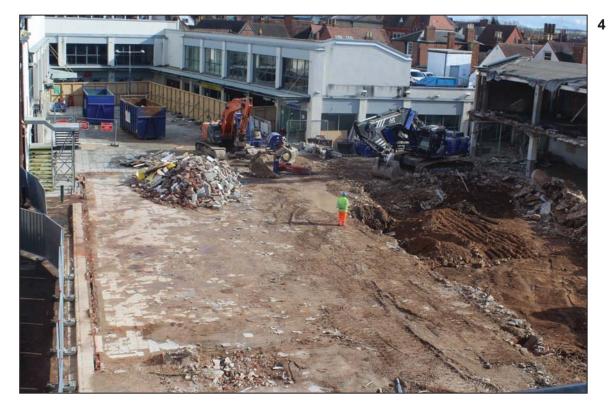
- 3 General view of the site, looking north-east
- 4 General view of the site, looking south-east

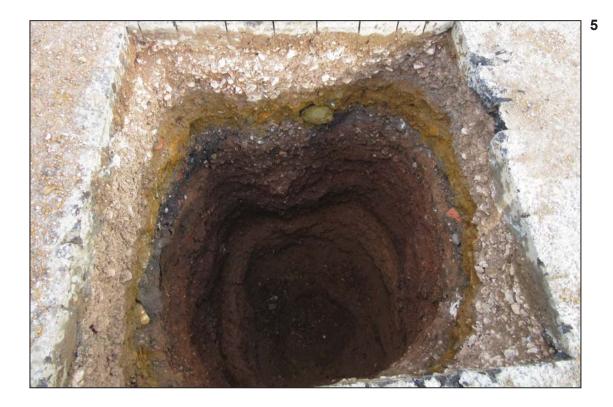
5.2 Test Pit 1 was excavated to a depth of *c*. 1.6m below present ground level (bpgl). The upper surface of the geological substrate (104), comprising mid reddish brown sandy clay, was encountered at a depth of 0.72m bpgl; this was sealed by a thin layer, *c*. 0.08m thick, of mid reddish brown sandy silt (105), which was tentatively interpreted as a silty lamination within the gravel terrace and also part of the geological substrate. Overlying these natural deposits was a 0.15m thick layer of mixed mid to dark greyish brown clayey silt (103), probably a former garden soil; its mixed appearance suggests that it was redeposited. This dark deposit was overlain by a compacted mid yellowish brown clayey silt (102) that formed the base for a levelling layer of Type 1 stone (101) and the tarmac surface of the access road (100).

- 5 Test Pit 1, looking west
- 6 Test Pit 2, looking, south-east (1m scale)

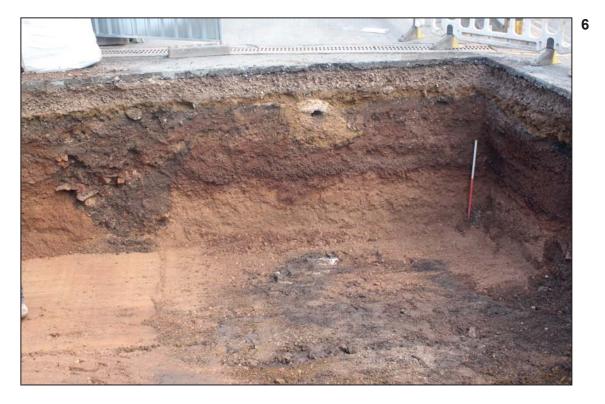
Test Pit 2, which was located immediately to the west of Test Pit 1, was excavated to a depth of 2.1m bpgl. The upper surface of the geological substrate (117), comprising light greyish orange silty gravel, was encountered at a depth of 1.5m bpgl. Overlying this was a redeposited layer of gravel in a mid brownish red sand matrix (116), measuring approximately 0.4m thick¹. This deposit was sealed by a 0.75m thick layer of made-ground (115), predominately consisting of brick rubble, which formed the base for the access road above (114 and 113).

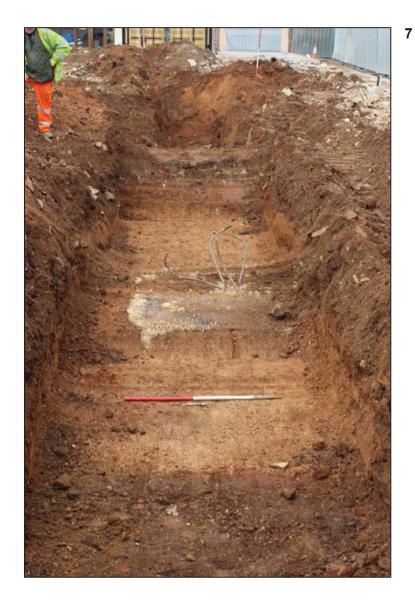
- 5.6 Within the footprint of the former retail unit on the north side of Fountain Way, an area was identified where the impact of the 1970s development was less extensive and offered the opportunity to investigate any deposits or features below the layers of made-ground. An exploratory trench, measuring 25m long by 2m wide, was therefore excavated in this area.
- 5.7 The geological substrate (110) was encountered at a depth of 1.15m–1.25m bpgl. This was overlain by a layer, *c*. 0.15m thick, of dark orangey brown clayey sand

(109). In the western half of the trench, this deposit was cut by a modern rubbish pit (108), the fill (107) of which contained a glass bottle bearing the stamp *'R. M. Bird & Co, Stratford-on-Avon'*, a local wine merchant in business in the town around 1900. The pit was sealed by an extensive layer of made-ground (106), approximately 1.0m thick, which extended over the general area.

7 Trench 1, looking west (1m scale)	Andover 01264 347630 Cirencester 01286 771022 Exeter 01392 826185 Milton Keynes 01908 564660 w www.cotswoldarchaeology.co.uk e enquiries@cotswoldarchaeology.co.uk
	PROJECT TITLE Town Square, Stratford-upon-Avon Warwickshire
	FIGURE TITLE Photograph
	DRAWN BY LJHIAO PROJECT NO. 660623 FIGURE NO. CHECKED BY DJB DATE 13/10/16 APPROVED BY SCC SCALE@A4 NA 7

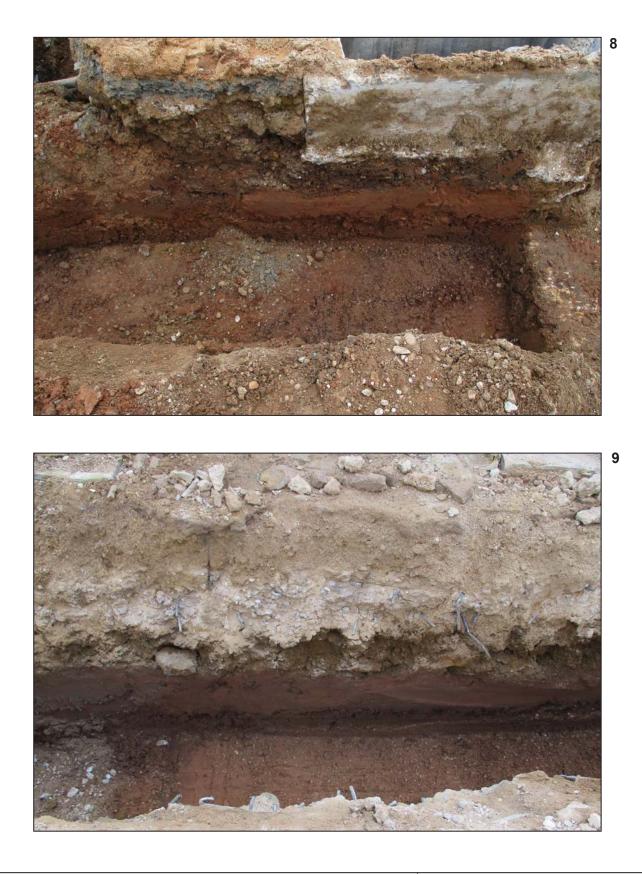
- 5.9 In the western half of the trench, the geological substrate (110), consisting of mid yellowish orange sandy gravel, was encountered between 0.9m and 1.1m bpgl. This was sealed by a reddish orange layer of sandy gravel (111) with an average thickness of 0.25m. Overlying this was a deposit of made-ground (equivalent to 106) which consisted of demolition rubble and redeposited sand and gravel. At the centre of the site the degree of truncation was extensive, with concrete pile bases, brick inspection chambers and service trenches associated with a large sewer cutting deep into the geological substrate.

- 5.10 The eastern length of the pipe trench extended across a paved square to the east of the demolition area. The geological substrate was encountered at an average depth of 1.0m bpgl and consisted of light orangey brown sand and gravel. The upper surface of the geological substrate had been truncated by the 1970s development of the site and the ground made-up with a compact layer of red sand (112), measuring 0.45m–0.55m thick. This was overlain by a layer of reinforced concrete and the subbase and slabs of the paved surface.

- 8 Pipe trench section (west), looking north
- 9 Pipe trench section (east), looking south

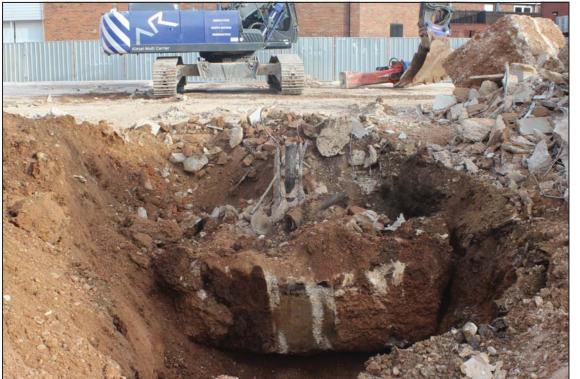
- 5.4 The removal of the concrete floor slab was carried out using a breaker mounted on a 360-tracked excavator, followed by the mechanical removal of the resultant rubble. The underlying concrete foundation pads and ring beams were then removed and broken up and the surface was levelled off in preparation for the construction of the new building. The concrete foundations of the former buildings were substantial and had caused extensive truncation to underlying deposits, in places to a depth of *c*. 3.5m bpgl. However, the underlying deposits only comprised made-ground directly overlying the geological substrate, indicating that the site had been reduced previously as part of the 1970s development.

- 5.5 The geological substrate, which was extensively truncated by concrete foundations and service trenches, was encountered at a depth of 0.9m–1.1m bpgl and comprised compact mid brownish red silty sand (118). At the western end of the site this was overlain by a 0.25m thick layer of dark orangey brown clayey sand containing fragments of brick (112). This was sealed by a layer of made-ground, 0.9m–1.1m thick, consisting of redeposited sandy gravel and demolition rubble (111). This deposit was capped with a layer of crushed stone that formed the base for the reinforced concrete floor of the supermarket and the paving stones on Fountain Way.

10 Removal of a foundation block, looking north	Andover 01264 347630 Cirencester 01265 771022 Exeter 01392 826185 Milton Keynes 01908 564660 w www.cotswoldarchaeology.co.uk e enquiries@cotswoldarchaeology.co.uk
	Town Square, Stratford-upon-Avon Warwickshire
	FIGURE TITLE Photographs
	DRAWN BY AO PROJECT NO. 660623 FIGURE NO. CHECKED BY LM DATE 28/04/16
	APPROVED BY SCC SCALE@A4 NA 10

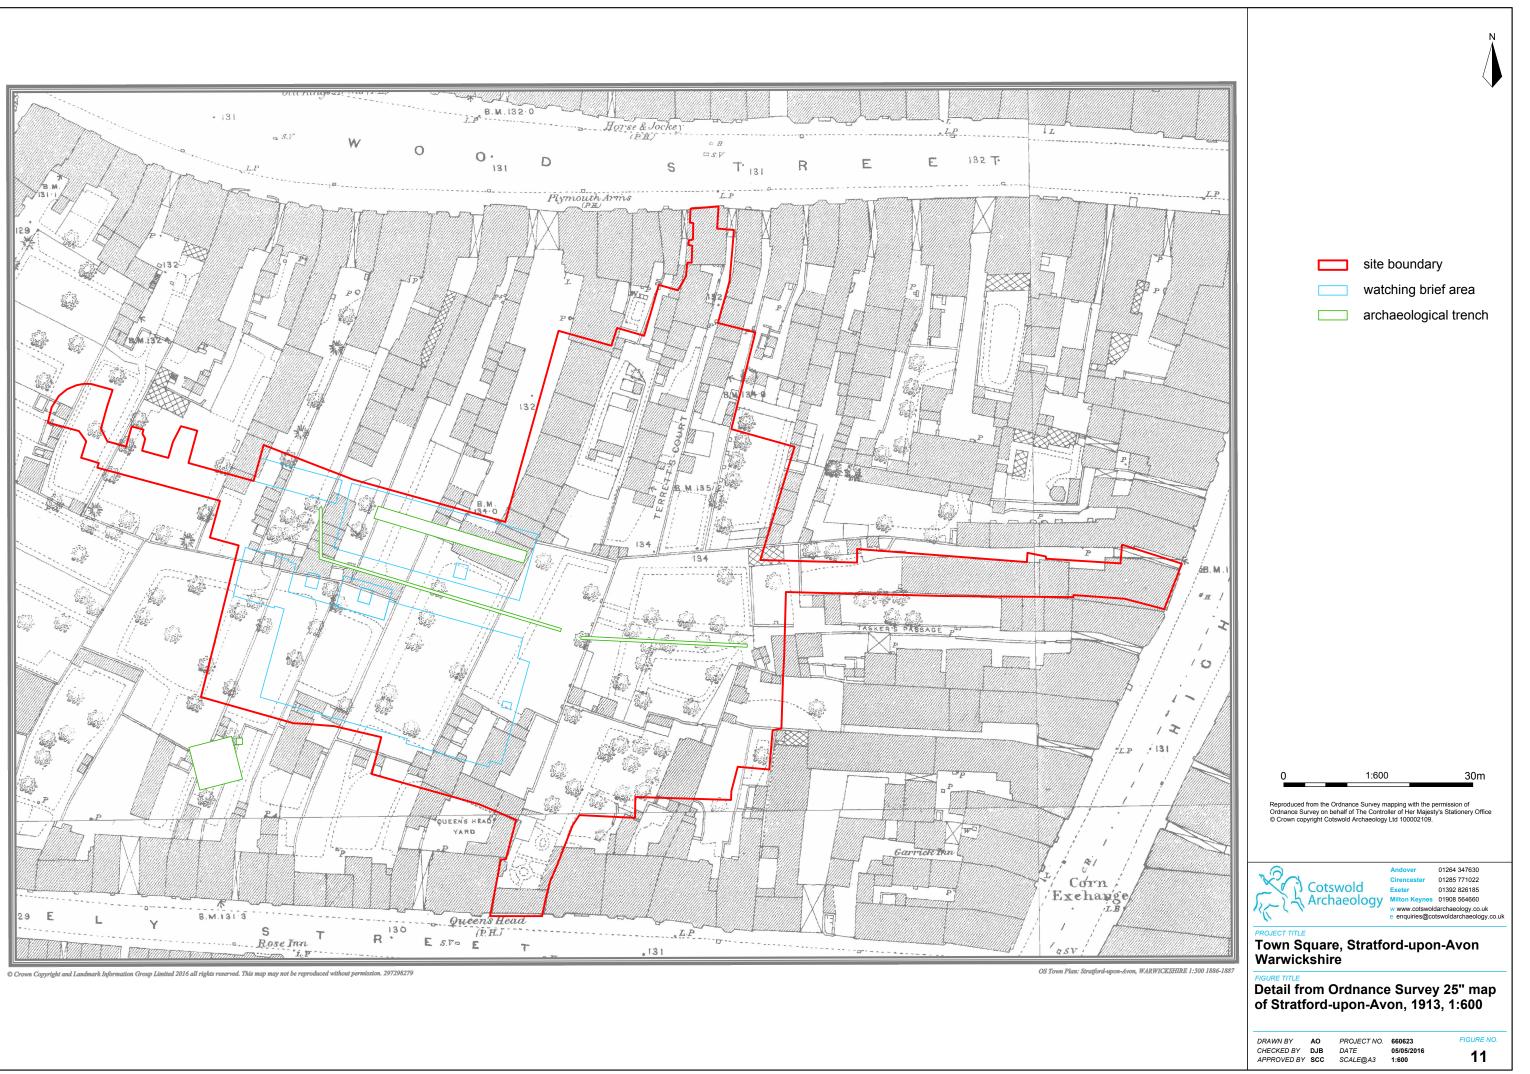
- 6.5 The Ordnance Survey's 25" map of the town, published in 1913, shows that the southern range of buildings behind the Plymouth Arms had been extended by a range of buildings into the garden shown on the earlier map (Fig. 11). The construction of these buildings in the central part of the site is likely to have had a

localised impact on any archaeological remains in this area, prior to the more widespread truncation caused by the construction of the 1970s shopping centre.
