Home Guard Club Tiddington Warwickshire

Archaeological Evaluation

CA Project: 5660
CA Report: 16156

May 2016

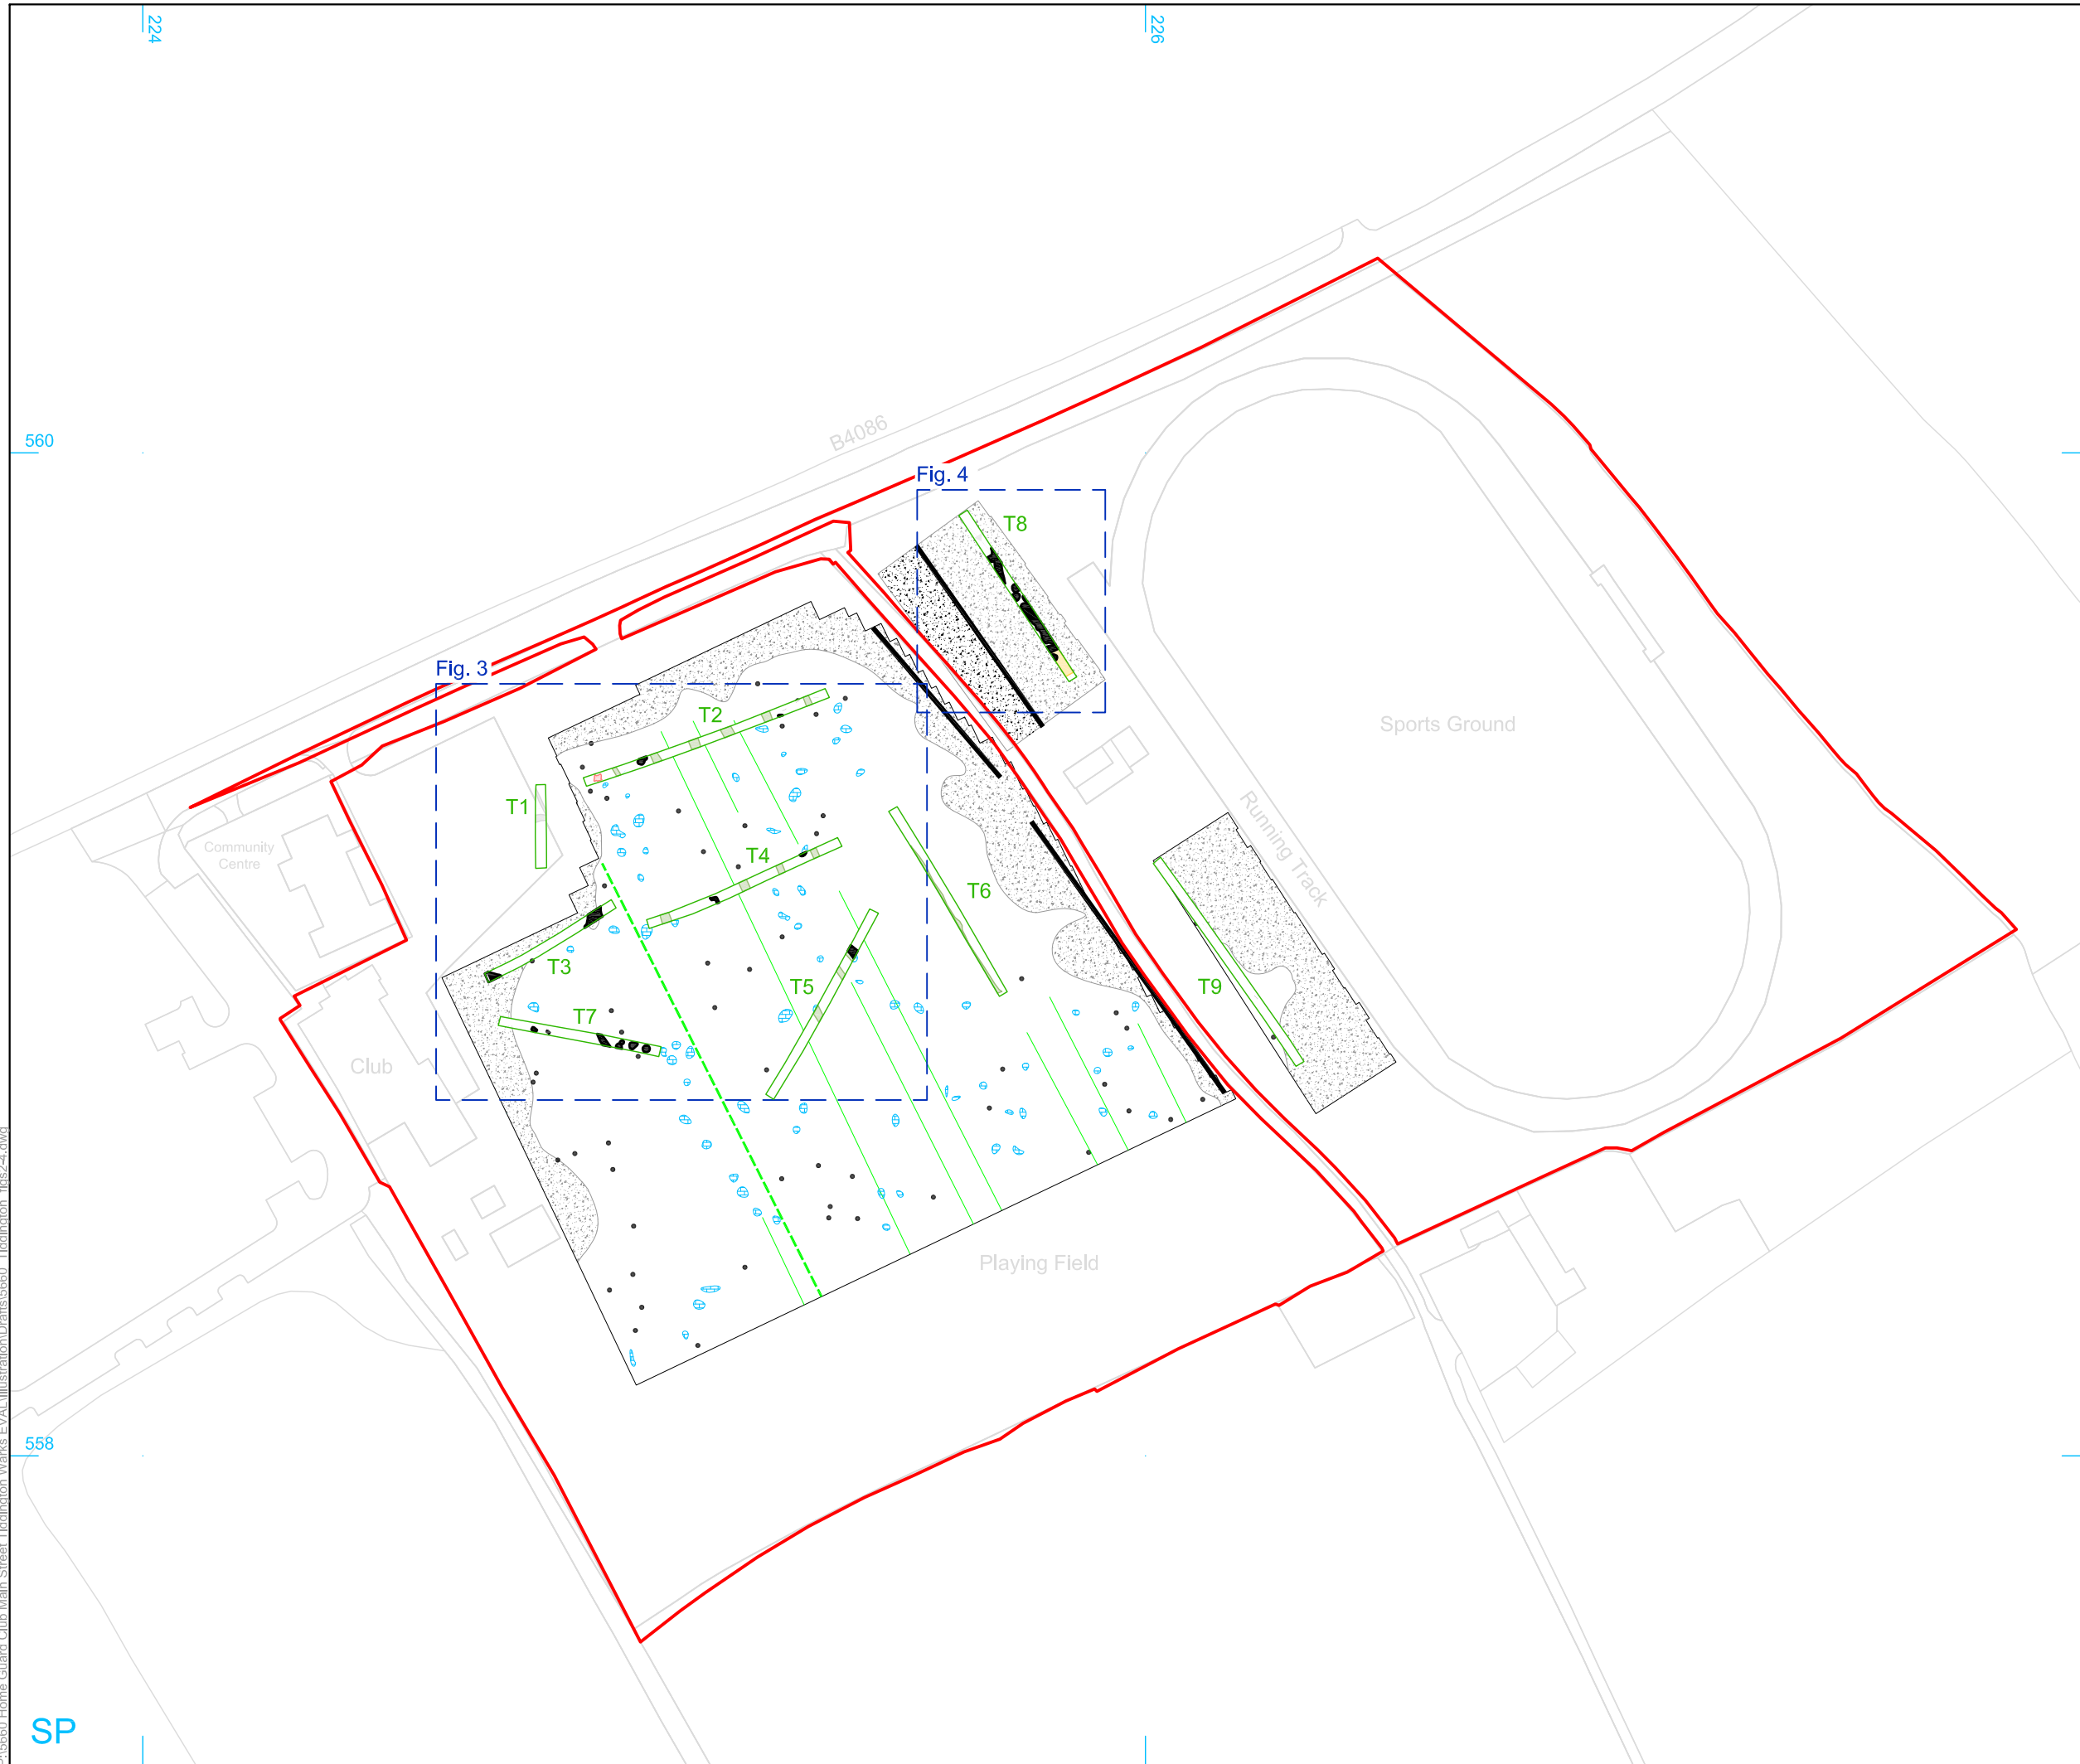
FIGURE TITLE
 Trench location plan showing
 archaeological features and
 geophysical survey results

- 4.1 The fieldwork comprised the excavation of nine, 2m wide trenches, in the locations shown on the attached plan (Fig. 2). Trench 1 measured 18.6m in length, Trenches 3 and 7 were 30m in length, Trenches 4, 5, 6, and 8 were 40m in length and Trenches 2 and 9 were 50m in length. The trenches were positioned according to the layout in the WSI, taking into account both areas of development and possible archaeological features indicated by the preceding geophysical survey (CA 2015). Trench 1 was shortened due to a live service and small tree, Trench 8 was shortened to 31m and moved to the east to avoid modern buildings and underground services. All changes were approved by Anna Stocks. Trenches were set out on OS National Grid (NGR) co-ordinates using Leica GPS and surveyed in accordance with CA Technical Manual 4 *Survey Manual*.

- 5.3 With the exception of ditch 4006 in Trench 4 and quarry pit 8006 in Trench 8, all features described below cut the natural substrate and were sealed by the lower relict plough soil. Trench 6 contained a furrow and Trenches 1 and 9 contained no archaeological features. There was a poor correlation between the geophysical anomalies from the preceding survey (ASWYAS 2014).

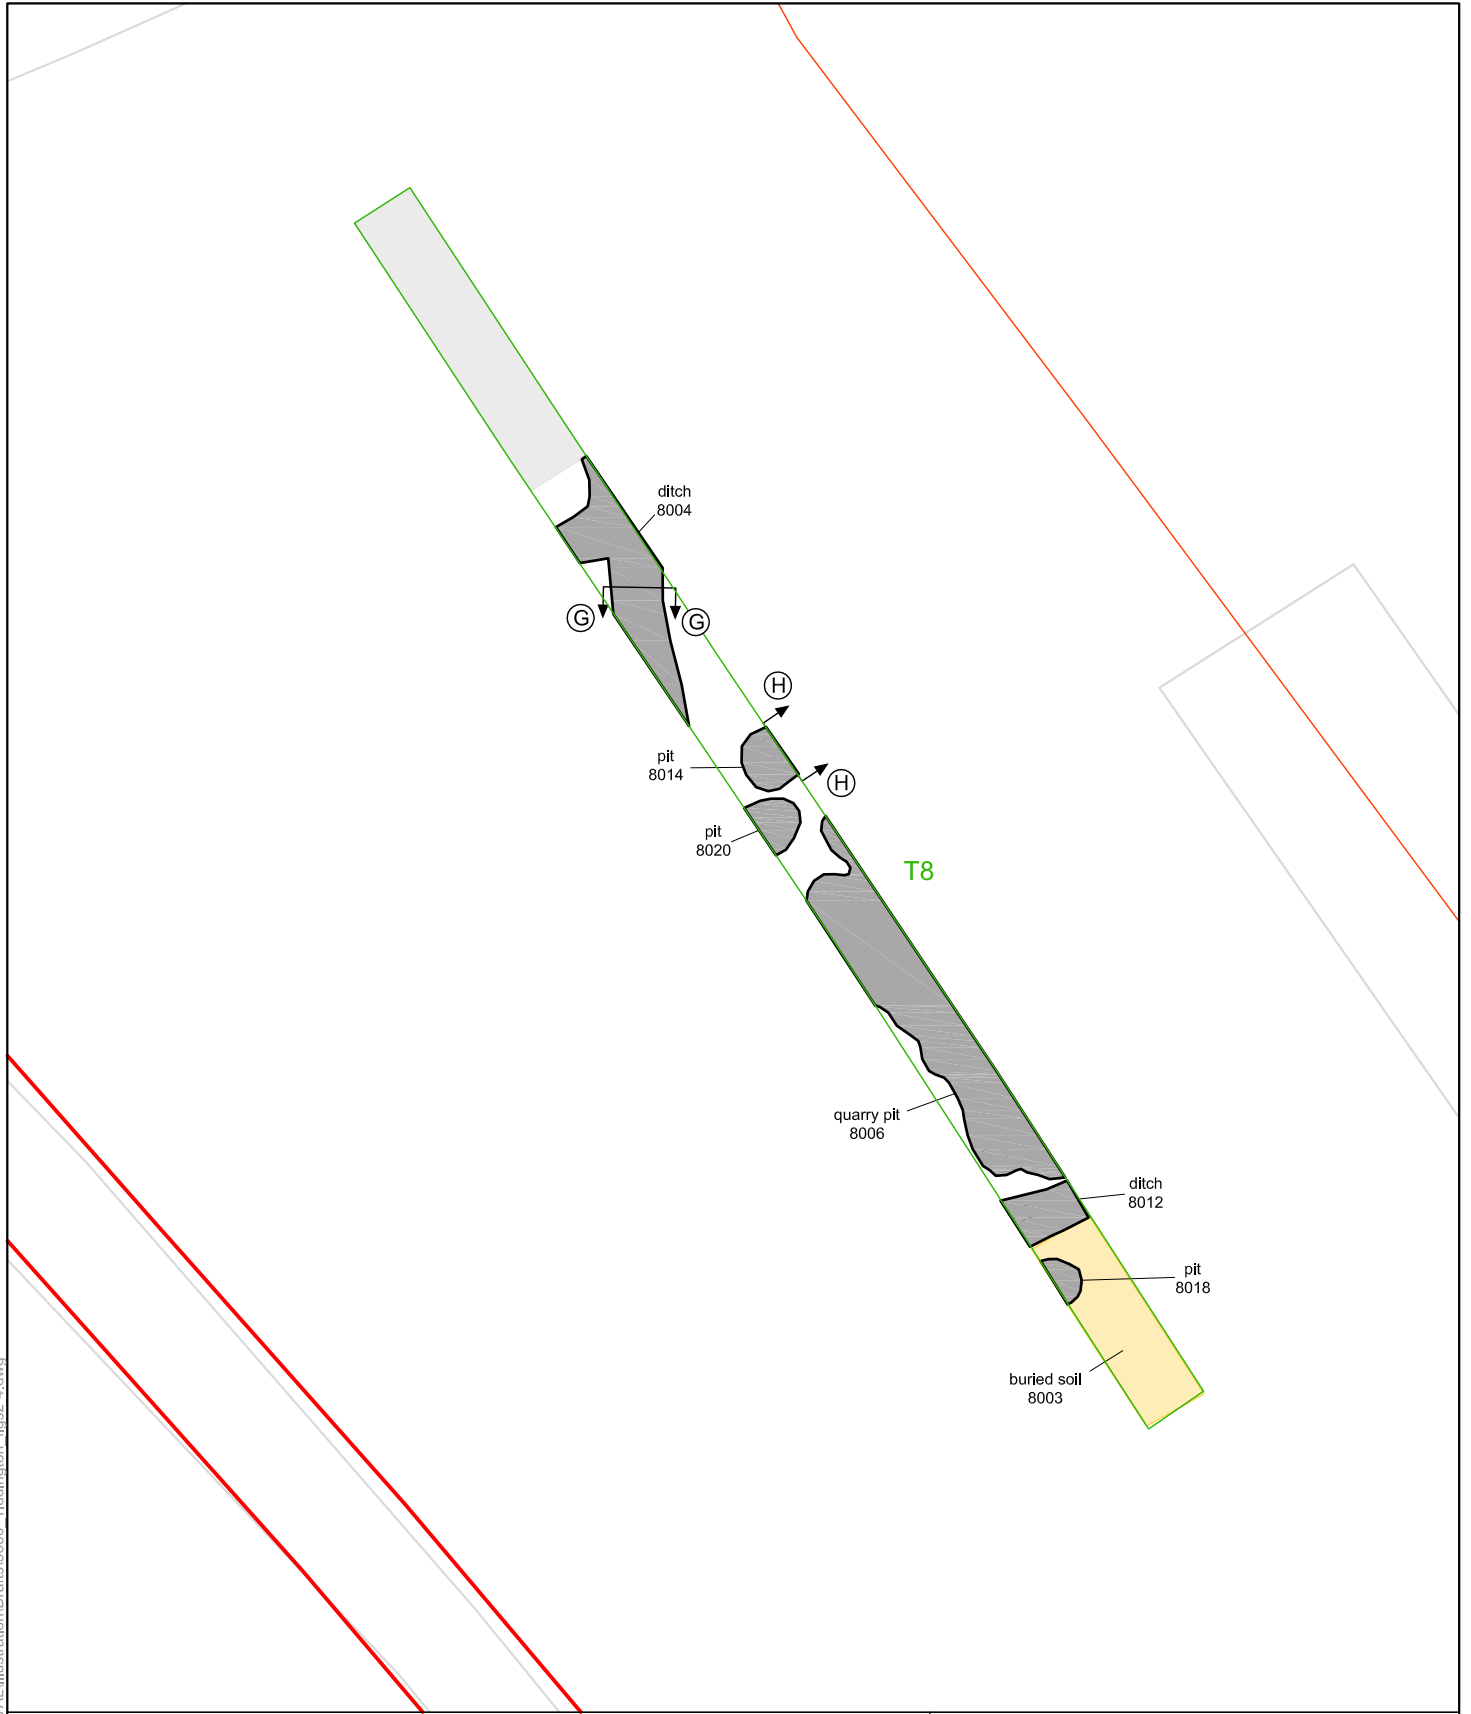
FIGURE TITLE
Trench 8 showing archaeological features

- 5.15 In Trench 8, two ditches and four pits were identified, in addition to a buried soil at the southern end of the trench.
- 5.16 Circular pit 8018 was revealed at the southern end of the trench. It measured 1.5m in diameter. It was not excavated, but was observed to contain silty sand fill 8019. This deposit was sealed by grey brown silty sand buried soil 8003 which measured c.0.2m in thickness. It was noted to be present only at the southern end of the trench, to the south of ditch 8012.

- 5.17 Ditch 8012 was orientated east/west and corresponded with the southern boundary of a rectangular enclosure depicted on the 1886 and 1914 ordnance survey maps. Cut through buried soil 8003, ditch 8008 measured 1.35m in width by 0.6m in depth and contained silty sand/gravel fill 8013 from which four sherds of Iron Age pottery were recovered.

- 5.18 Cutting the fill of northern edge of ditch 8012 pit 8006. The pit measured 11.6m in length, >2m in width by >0.7m in depth, with irregular sides. It contained a succession of silty fills (8007-8010). Its size and irregular nature strongly suggests it

functioned as a quarry pit, located in the south of the rectangular enclosure depicted on the 1886 and 1914 ordnance survey maps.

- 5.19 To the north of the quarrying two circular pits, 8014 and 8020, were identified. Pit 8014 measured 1.2m in diameter by 0.7m in depth with steep sides and round base, and contained silty sand fill 8015 (Fig. 5, section HH and Fig. 6 photograph). Pit 8020 measured 1.2m in diameter and contained sandy fill 8021.
- 5.20 To the north of pits 8014 and 8020 an undated north/south orientated ditch, 8004 was identified. The ditch measured in excess of 4.9m in length, 1.4m in width and 0.4m in depth, containing silty sand/gravel fill, 8005 (Fig. 5, section GG).
- 5.21 Modern services were revealed at the northern end of the trench and in the centre of the trench a crushed rock foundation of a north-west/south-east orientated modern road was observed.

- 8.3 The pits in Trench 8 appear to be confined within an area defined by undated ditch 8004 and Iron Age ditch 8012. It is probable that these features represent the western and southern sides of a rectilinear enclosure. Undated ditch 7012 in Trench 7 may define the western side of a similar enclosure.

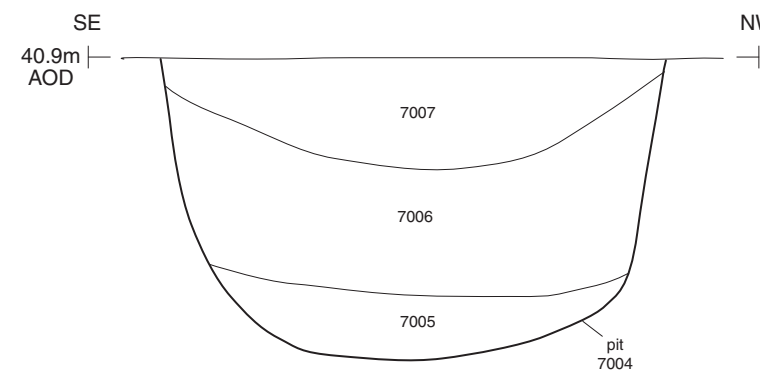
Section EE

- 5.10 Pit 7004 was circular in plan, measured 1.35m in diameter by 0.79m in depth, with vertical sides to a concave base. The lower undated, silty sand gravel fill 7005 likely contained material eroded from the sides of the cut. This deposit was sealed by silty sand fill 7006. A very sharp boundary between these two fill was noted, as well as their matrices being homogenous. This was in turn sealed by silty sand fill 7007 (Fig. 5, section EE and Fig. 6 photograph).

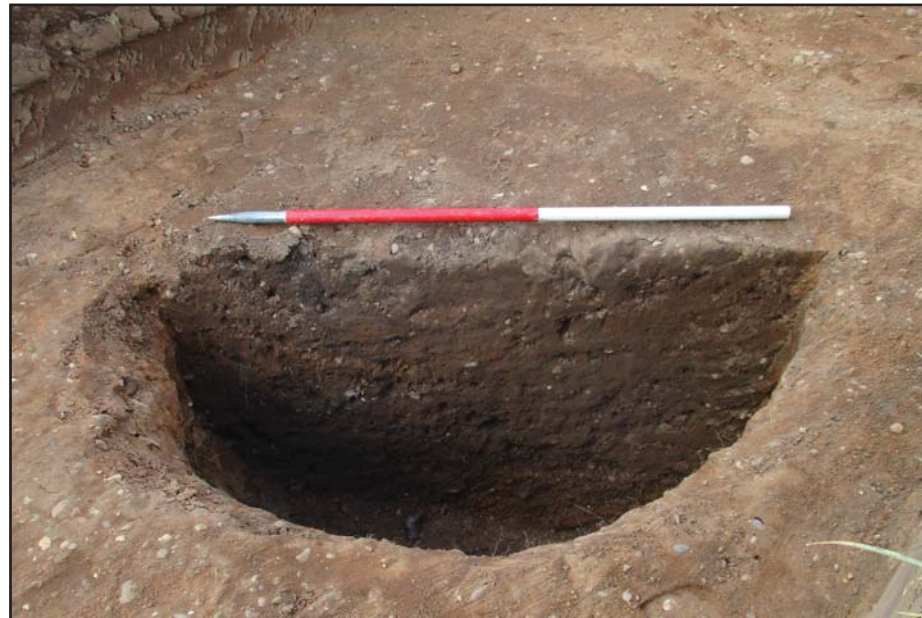
Pit 7004 looking west. 1m scale

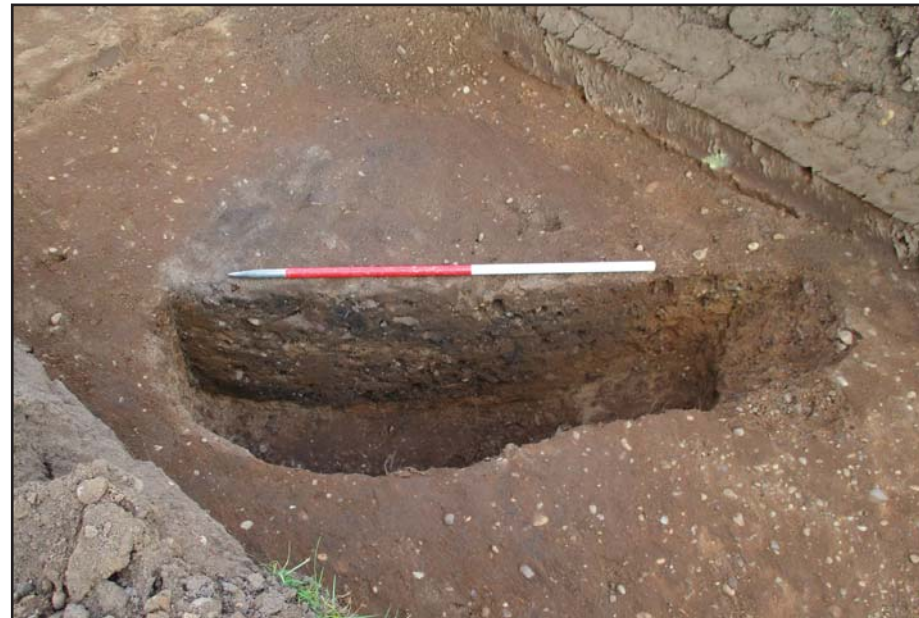
- 5.11 Pit 7008 was oval in plan, measured 1.18m in width by 0.54m in depth, with vertical/steep sides and slightly concave base. It contained a similar sequence of fills to pit 7004. Undated gravelly fill 7009 was sealed by silty sand/gravel fill 7010. Two sherds of Iron Age pottery, in addition to a perforated whetstone, were recovered from this fill. This in turn was sealed by silty sand/gravel fill 7011 (Fig. 6 photograph).

Pit 7008 looking north-west. 1m scale

- 6.5 A single worked stone object, a perforated whetstone, was recorded from fill 7010 of pit 7008. This object is well made from a very fine grained sandstone, possibly an erratic and sourced locally. It is of sub-rectangular form (measuring 88mm x 35mm x 22mm), with a rounded upper end. The perforation, which is set close to the rounded end of the whetstone, is of hourglass profile, having been bored from both sides. All faces are well smoothed from use or handling and there is a shallow groove to one edge possibly from utilisation as a point sharpener. The edges of a small portion absent from the lower edge are well smoothed, suggesting use after breakage. The Iron Age dating suggested for this item by the associated pottery would be consistent with its form and other characteristics, although a Bronze Age date is also possible.

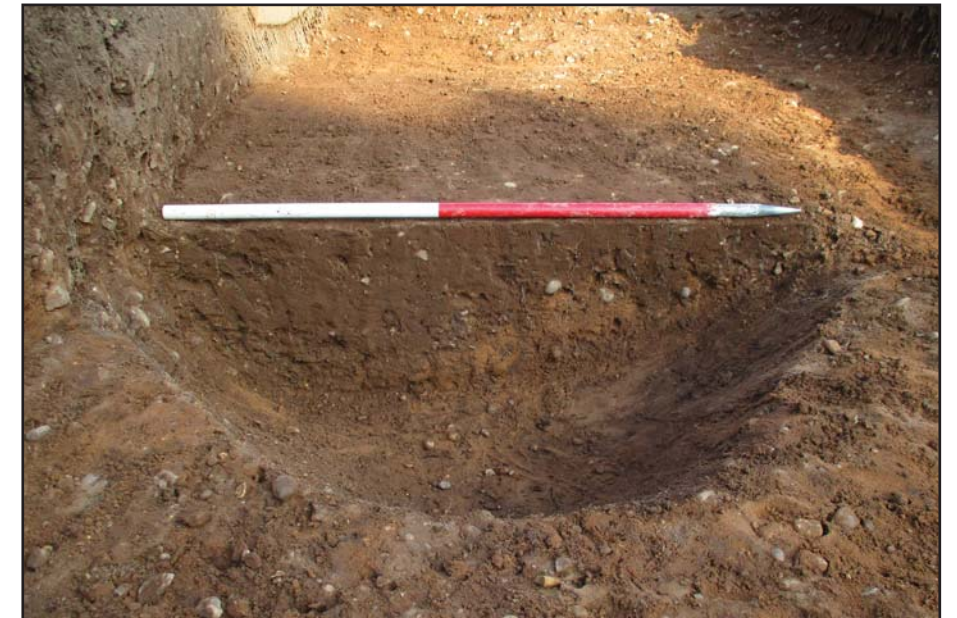
- 5.4 There were two undated pits identified in Trench 2. The western pit, 2004, was irregular in plan with moderately sloping sides and a rounded base, containing gravelly fill 2005 (Fig. 5, section AA and Fig. 6 photograph). Its irregular shape and sloping sides suggests it may be small gravel borrow pit. Approximately 28m to the east, unexcavated pit 2007 was partially visible against the southern bulk of the trench.

Pit 2004 looking east. 1m scale

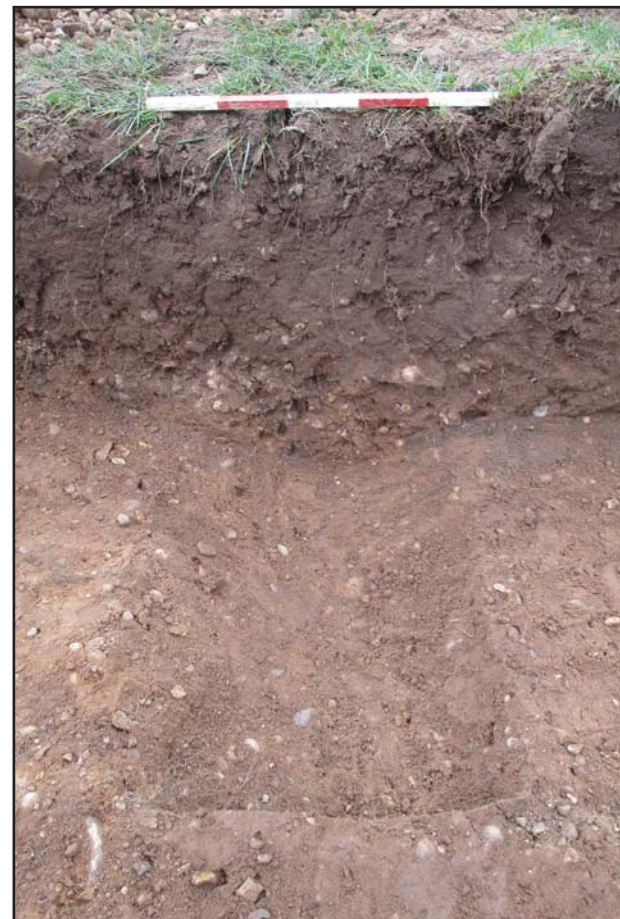
- 5.6 Undated ditch 4006 was located in the middle of Trench 4. It initially ran north/south to the middle of the trench before turning sharply to the west. It measured 0.41m in width and 0.19m in depth and contained silty sand/gravel fill 4007, which was gravelly towards its base (Fig. 5, section CC and Fig. 6 photograph). A single fragment of undated ceramic building material was recovered.
- 5.7 At the eastern end of the trench, presumed circular pit 4004 continued beneath the northern bulk section. The visible portion of the pit measured 1.15m in width by 0.14m in depth with moderately sloping sides and concave base. Its silty sand fill 4005 contained no inclusions, and was undated.

Ditch 4006 looking south-east. 0.5m scale

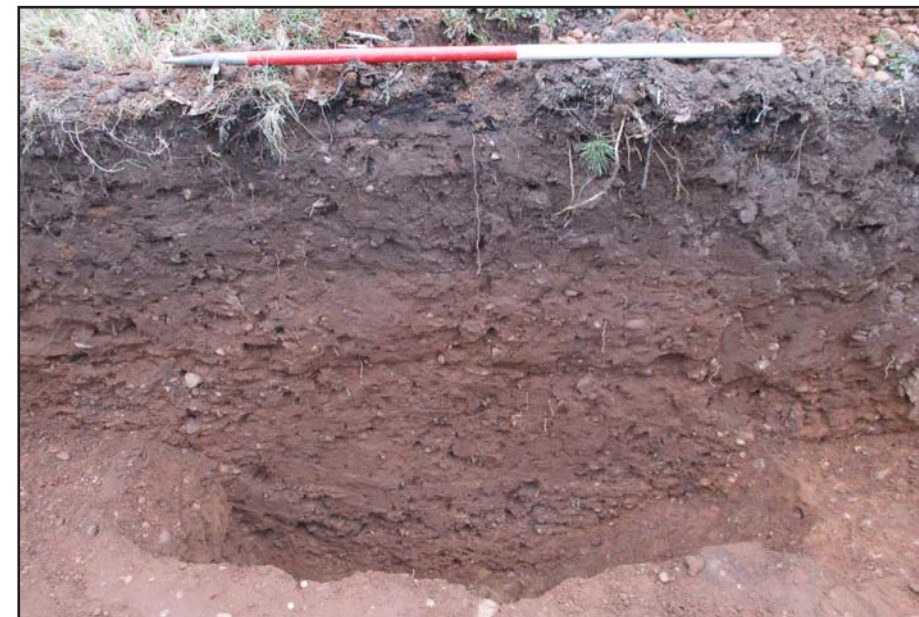
Pit 8014 looking north-east. 1m scale
