# Former HMP Gloucester Gloucester Gloucestershire: SI Works

*Programme of Archaeological Works*

CA Project: 5580  
CA Report: 17021

February 2017

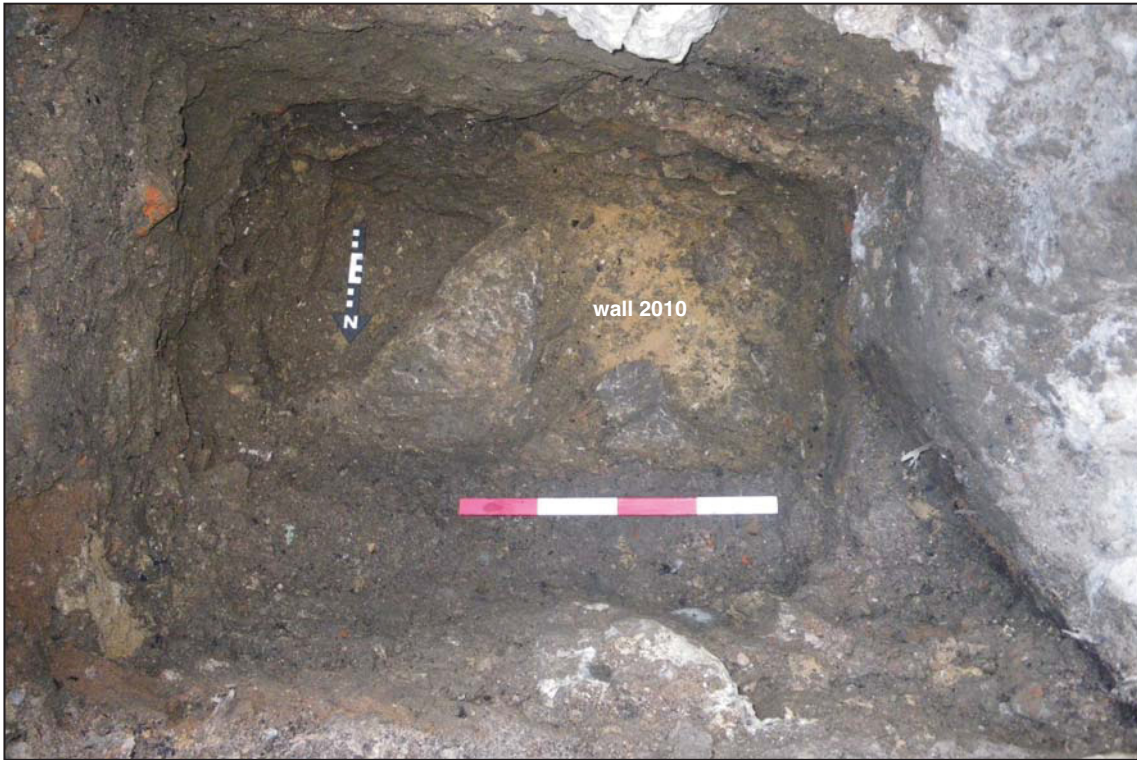
- 5.4 Within the associated hand-excavated test-pit, wall 2010 was identified at a depth of 0.8m bpgl. Although little of the wall was visible due to the limited size of the test-pit (see Fig. 3) it could be discerned that it was aligned approximately NE/SW, with part of its south-eastern elevation exposed within the trench. It was constructed from sandstone blocks that were bonded with light grey sandy mortar, and contained a soft orangey mortar core presumably between its two faces. The wall was abutted by dark grey silty clay deposit 2011 which, like wall 2010, extended below the limit of the test-pit.

Figure 3: Wall 2010 in base of test-pit for borehole B, looking south (0.4m scale)

- 7.5 The construction of wall 2010 within the hand-excavated test-pit associated with borehole B was similar to that of the inner face of the keep wall identified during the previous evaluation. Its location, together with its north-east/south-west alignment, correlates closely with that suggested by Hurst (1984) for the northern wall of the inner enclosure which contained the castle keep. A wall in a similar location and on the same alignment was also identified during a watching brief in 1985 (Garrod 1986). Drilling of the borehole adjacent to wall 2010 indicated that archaeological deposits here may extend to at least 3.2m bpgl (7.84m AOD).

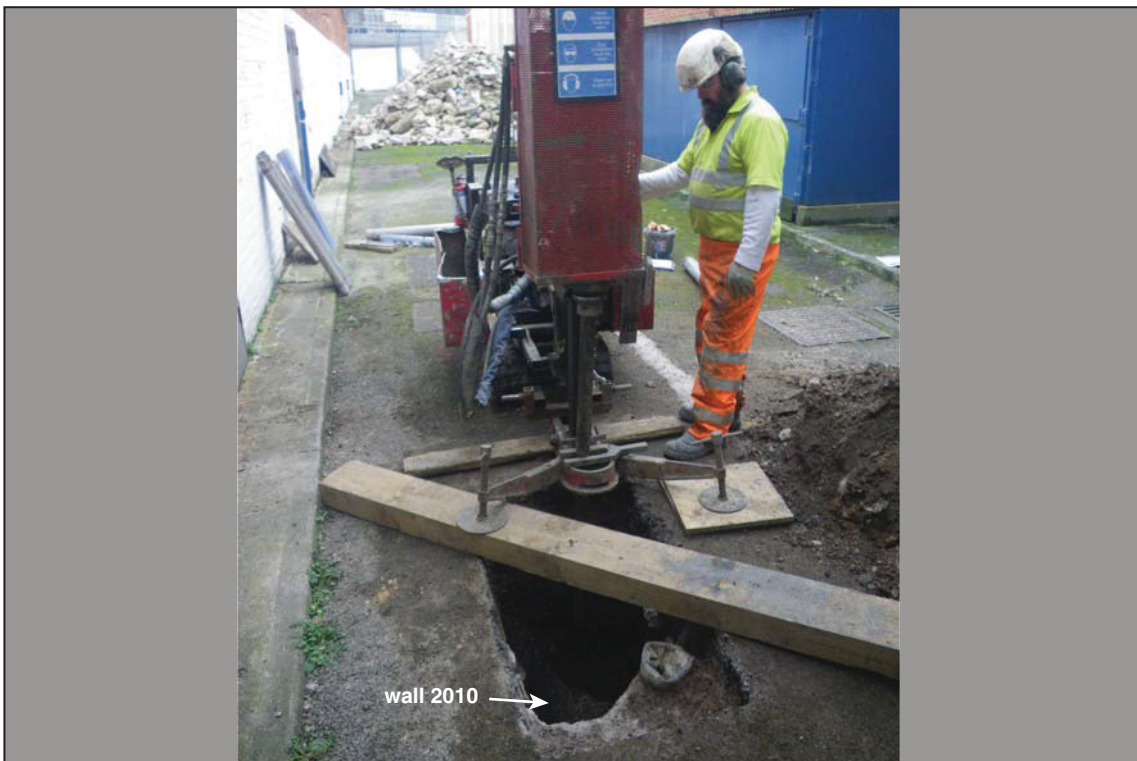
- 5.3 Borehole B was drilled to a depth of 5m bpgl, where a very loose, wet deposit of mid brown silty sand, 2603, most probably Holocene Elmore Member alluvium, was encountered. This contained gravel and occasional charcoal, as well as an oyster shell, and extended up to a depth of 3.2m bpgl. Overlying this was a band of dark greenish grey, gritty clay, 2602, which was approximately 0.15m thick. This was covered by deposit 2601, comprising mid brown sandy, clayey silt containing frequent charcoal flecks, occasional ceramic building material and within which a small animal (mouse/shrew) skull was identified, however none of the artefactual or ecofactual material was removed from the borehole core. This deposit was approximately 1.1m thick, extending upwards to a depth of 1.95m bpgl. Above this was a deposit of soft, dark greyish brown sandy, clayey silt, 2600, which contained abundant flecks of charcoal, as well as frequent gravel and lumps of lime mortar. This material was at least 0.25m thick, extending up to a depth of 1.7m bpgl. Above this, the drill failed to retrieve a core between a depth of 1.2m and 1.7m bpgl.

Figure 4: Drilling borehole B adjacent to wall 2010, looking east

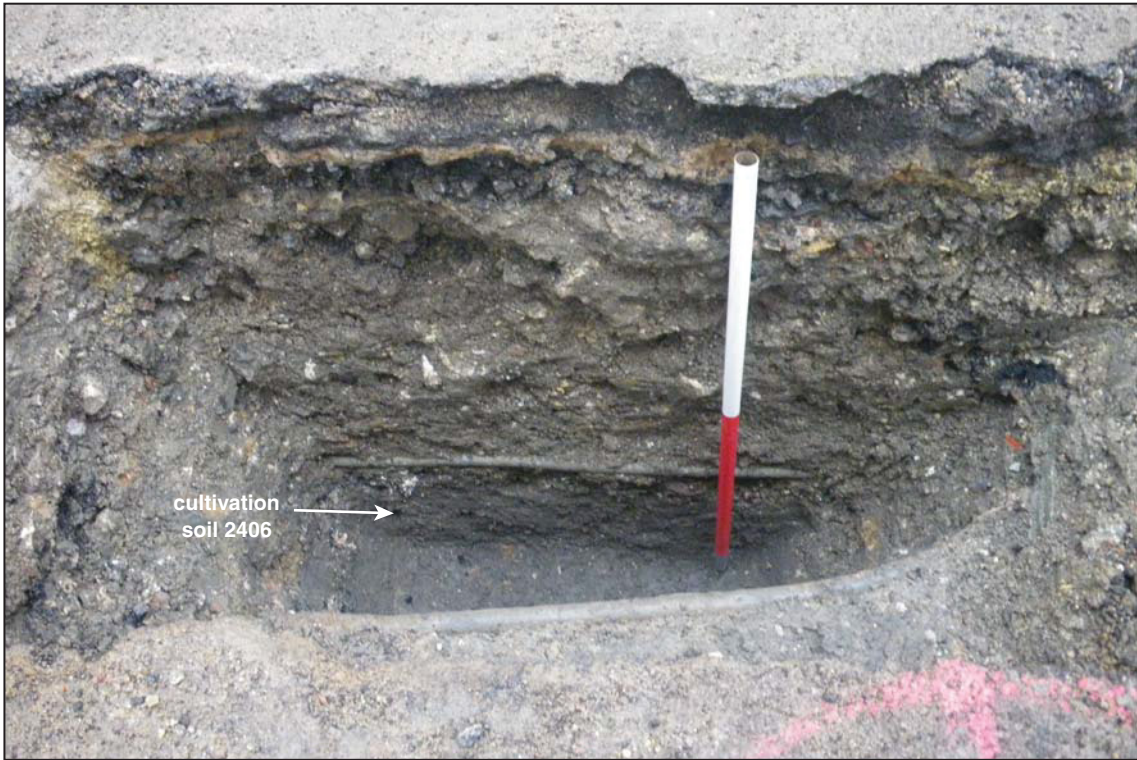
- 5.12 Borehole F was terminated at a depth of 3.2m bpgl. Between this depth and approximately 3.05m bpgl was a deposit of very loose, wet, brownish orange sand and gravel, 3051, most probably Late Devensian Power House Member Gravels. Above this, to a depth of 1.2m bpgl, was dark brown silty sand 3050 containing pebbles, grit, frequent charcoal and very occasional ceramic building material of presumed later medieval/early post-medieval date, however none of this material was recovered from the borehole core.

- 5.13 Within the test-pit, the earliest deposit encountered was context 2406, which is presumably the same as deposit 3050 recorded within the borehole. Here, the surface of this deposit was identified at 0.9m bpgl. It was cut by trench 2405 for metal pipe 2403 which extended along the western section of the test-pit. The pipe trench also contained a further metal pipe at a slightly higher level, again running approximately north/south through the centre of the test-pit. The pipe trench was backfilled by deposit 2402, comprising mixed light and mid brownish grey silty clay with inclusions of mortar, brick, ash, charcoal and sandstone.

Figure 5: Test-pit for borehole F, looking west (1m scale)

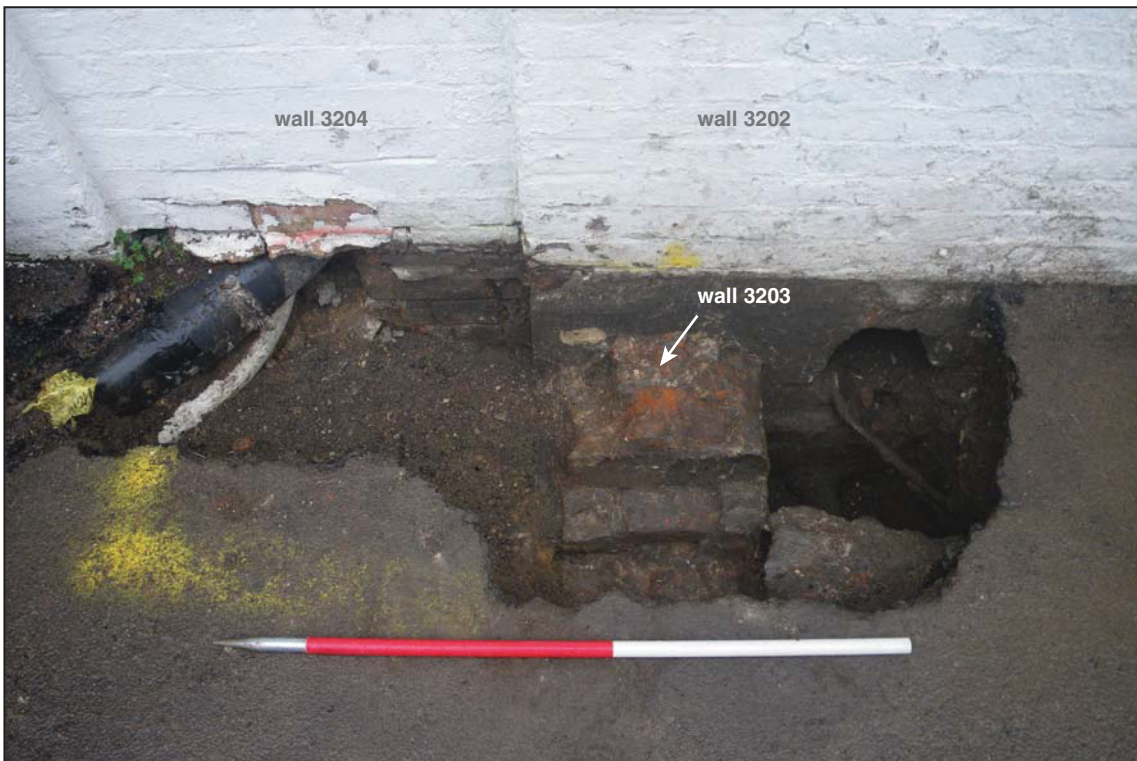
- 5.15 Test-pit SI1 was excavated against the southern wall of the western part of the 'new' gatehouse constructed in 1826. Due to the discovery of unknown shallow services, the test-pit was extended eastwards from its original location and had an overall final length of 1.85m and a maximum width of 0.8m. The test-pit was terminated at a depth of 0.9m following the discovery of a number of further services.

- 5.16 Excavation of test-pit SI1 exposed part of the gatehouse foundations and demonstrates that these comprise both brick and stone courses, punctuated by a number of services running into the gatehouse in this location. From the limit of excavation to a depth of 0.5m bpgl, the foundations are of brick. Above this is a single course of stonework comprising substantial blocks, individually measuring 0.9m deep and at least 1m long. Above this was the brickwork of extant gatehouse wall 3202.

- 5.17 Investigation demonstrated that wall 3202 represents the presumed original construction, against the western side of which wall 3204 has been added. Although similar in construction to the original wall above ground, the foundations of the later structure solely comprised brick.

- 5.18 Abutting the south-western corner of wall 3202, brick structure 3203 extended southwards beyond the limit of excavation. It was at least 0.75m long, 0.46m wide and extended to a depth of at least 0.6m, beyond the base of the test-pit.

Figure 6: Test pit SI1, looking north (1m scale)

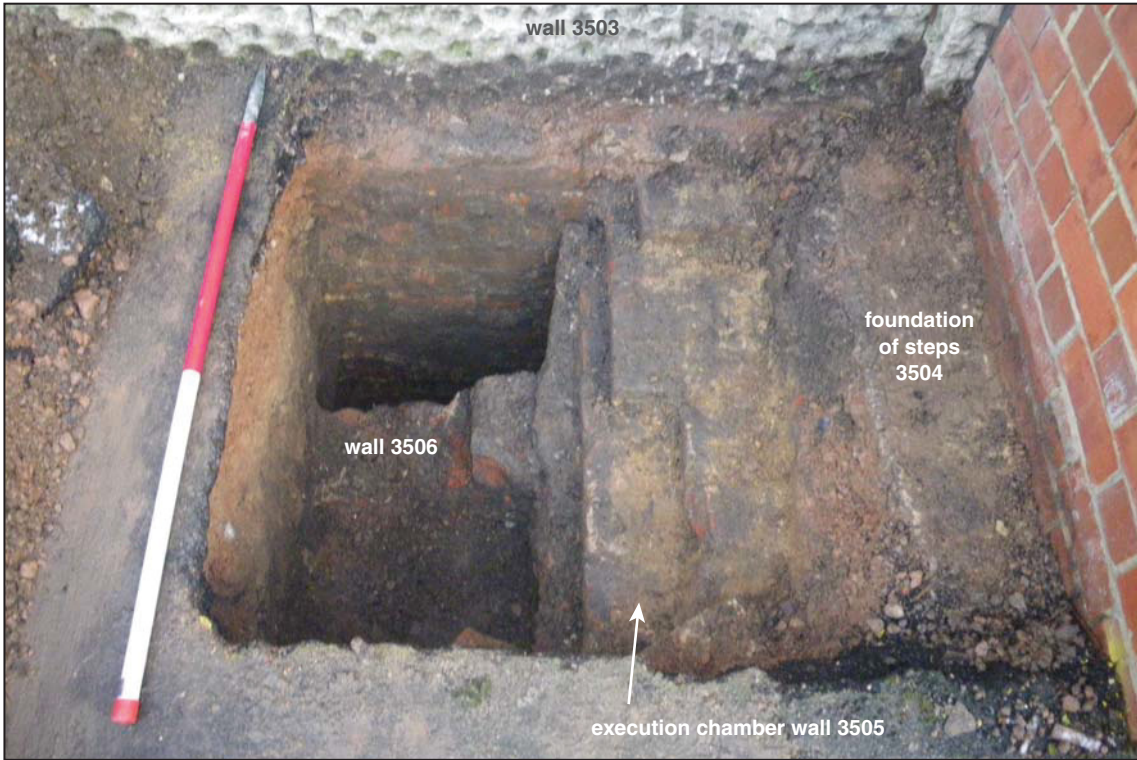
- 5.20 Test-pit SI2 was excavated against the southern wall, 3503, of A Wing and measured approximately 1m square. Brick wall 3506 was identified at a depth of 0.65m bpgl and lay on a parallel alignment and 0.5m south of the extant building. Wall 3506 was approximately 0.27m wide and at least 0.75m deep. It was sealed by,

- 5.21 An attempt to excavate to the base of the foundations of A Wing wall 3503, in the gap between it and wall 3506, was abandoned at a depth of 1.35m bpgl due to physical restrictions.

- 5.22 The construction trench for north/south aligned, stepped brick foundations 3505 cut across wall 3506. These foundations had a combined depth of at least 1.3m and were at least 0.7m wide, extending beyond the eastern limit of the test-pit. They are evidently associated with the western wall of the former execution chamber, which was built in 1912 and removed in 1966. The eastern and southern foundations of this structure were recorded within adjacent Trench 4 during the preceding evaluation. Foundations 3505 were overlain by rough concrete foundations 3504 for the extant flight of external steps constructed against the southern wall of A Wing.

Figure 7: Test-pit SI2, looking north (1m scale)

- 7.15 Walls 3506 and 3403, identified within test-pits SI2 and SI3 respectively, were offset from the main walls of A and B wings by a similar distance of 0.5m and presumably formed a duct or similar type of feature, however further interpretation was not possible due to the restrictive nature of the observed works.

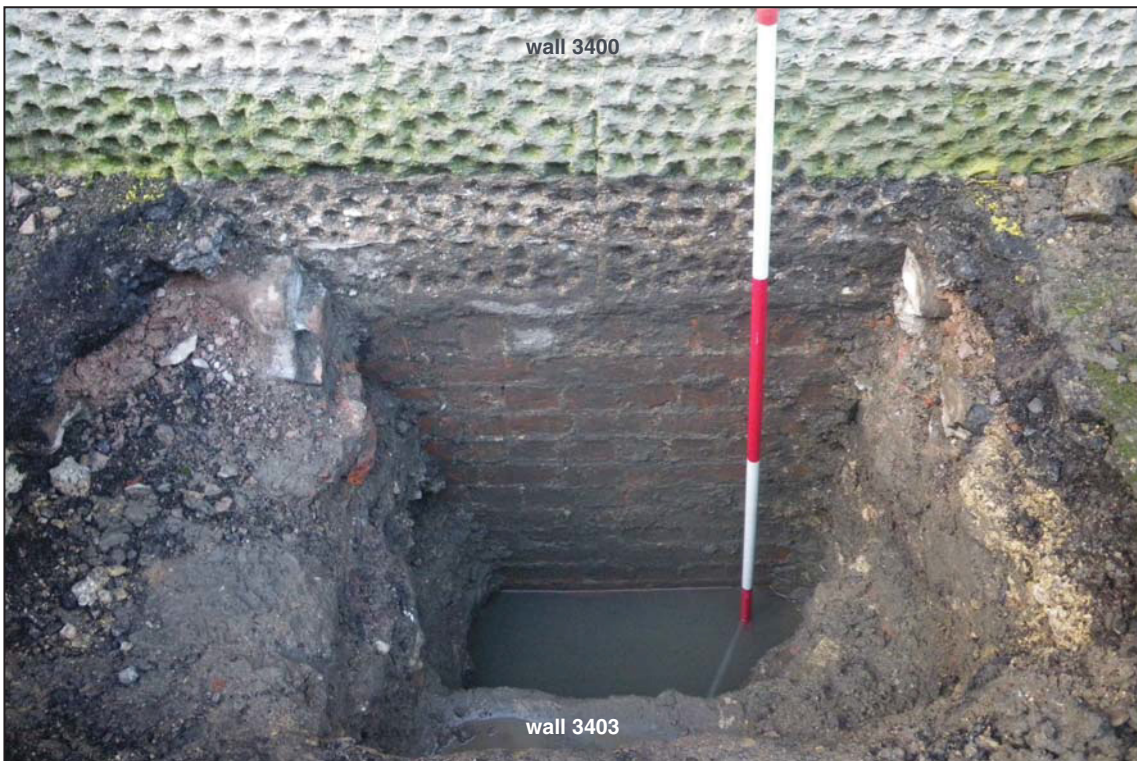
- 5.24 Test-pit SI3, excavated to investigate the foundations of eastern wall 3400 associated with B Wing, measured 1.4m north to south and 1m east to west. Brick wall 3403 was identified at a depth of 0.8m bpgl and lay on a parallel alignment and approximately 0.5m east of the extant building. Wall 3403 was at least 0.3m wide, extending beyond the eastern limit of excavation and it was at least 0.8m deep. It was sealed by, and the gap between it and wall 3400 infilled with, deposit 3402 comprising brown sandy silt with abundant inclusions of mortar, charcoal, ceramic building material, animal bone, pottery and stone, presumably representing backfill associated with the construction of B Wing. It also contained evidently dumped layers of limestone and brick rubble.

- 5.25 The attempt to excavate to the base of the foundations of wall 3400 in the gap between it and wall 3403 was abandoned at a depth of 1.8m bpgl due to physical restrictions and the ingress of water. Although the base of the test-pit was under water, probing identified that the foundations of the eastern wall of B Wing, 3400, were stepped, with narrow offsets of approximately 0.1m at depths of 1.45m and

- 5.26 Abutting wall 3400, above deposit 3402, was a ceramic glazed drain, with a central channel, laid in sections and presumably originally covered with a grate. This was evidently held in place by concrete laid along its eastern side. Above this was the modern tarmac footpath surface, 3401, which was 0.15m thick.

Figure 8: Test-pit SI3, looking west (2m scale)

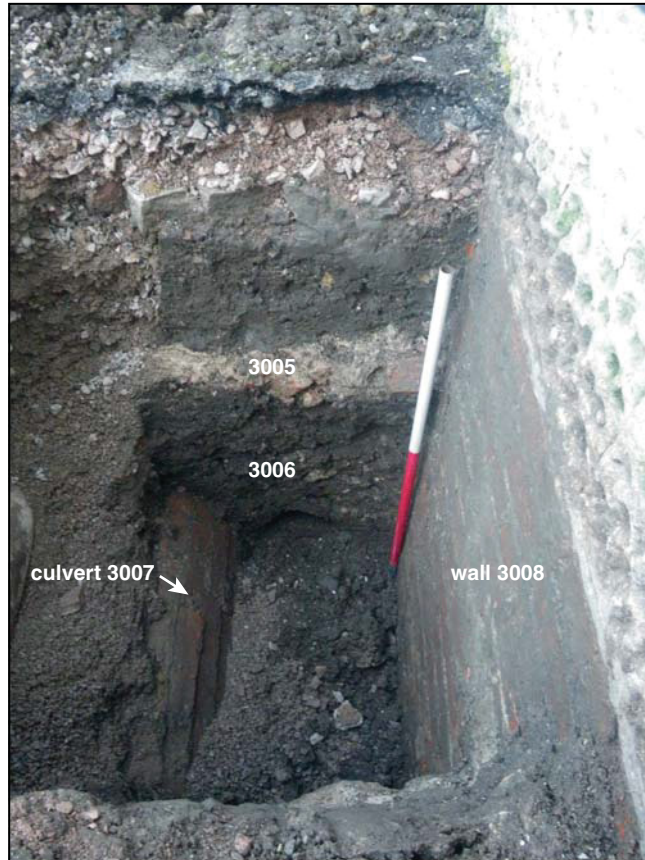
- 5.27 Test-pit SI5 was excavated against the western wall, 3008, of A Wing and measured approximately 1m square. The earliest feature encountered here was truncated brick culvert 3007, which was aligned north/south, running parallel to the A Wing wall, with a gap of 0.6m between the two. The culvert was at least 0.4m wide and extended beyond the western limit of excavation. It survived to a depth of at least 0.25m and was sealed by deposit 3006, comprising brownish grey silty clay with mortar inclusions, measuring at least 0.5m thick and extending below the base of the test-pit. This deposit evidently represents backfill associated with the construction of A Wing.

- 5.28 Deposit 3006 was in turn sealed by a layer of demolition debris, 3005, comprising mainly brick rubble and mortar fragments, which was 0.1m thick. This was overlain by deposit 3004, comprising greyish brown silty clay with frequent stone inclusions. This material was 0.45m thick. North/south aligned trench 3002 cut through contexts 3004, 3005 and 3006, and had evidently removed the top part of culvert 3007. It was at least 0.4m wide and 0.75m deep and contained a large ceramic sewer pipe. It was backfilled by loose gravel, 3501.

- 5.29 Efforts to excavate to the base of the foundations of the western wall of A Wing, in the gap between it and culvert 3007, ceased at a depth of 1.3m bpgl due to physical restrictions.

Figure 9: Test-pit SI5, looking north (1m scale)

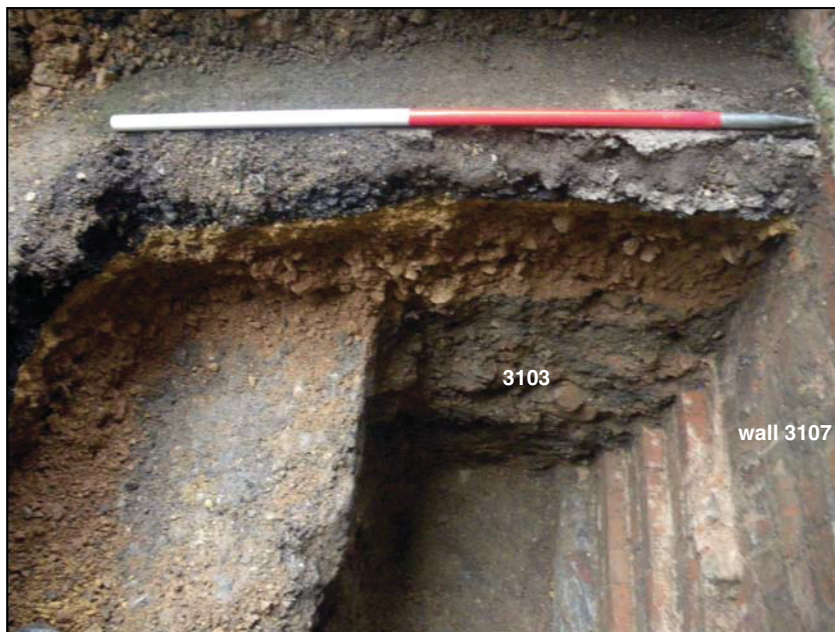
- 5.30 Test-pit SI8, measuring approximately 1.2m square, was excavated to investigate the foundations within the angle at the north-western corner of the Debtors Prison. A stone course was identified at the base of the western wall, 3107, at a depth of 1.1m bpgl. It appeared to comprise Pennant sandstone slabs, protruding 0.35m from the face of the upper wall. This course was at least 0.1m thick and presumably formed

the base of the foundations. Above it were three offsets of stepped brick foundations, with a combined depth of approximately 0.45m.

- 5.31 The foundations of the western wall were abutted by those of the northern wall of the projecting rear, western part of the building, 3105. These comprised a rough concrete containing brick rubble and mortar, 0.6m thick.
- 5.32 The two sets of foundations were abutted by construction backfill deposits 3104 and 3103. Deposit 3104 was the earliest of these and comprised dark grey silty clay, 0.35m thick. Overlying deposit 3103 consisted of brownish grey silty clay with brick, stone and mortar inclusions and was up to 0.55m thick. Above this were two layers of gravel, 3102 and 3101, with a combined thickness of 0.35m, laid as levelling/make-up for the current tarmac surface, 3100.

Figure 10: Test-pit SI8, looking north (1m scale)
