**Aldi Site, Park Farm,
Gillingham
Dorset**

Archaeological Watching Brief

CA Project: 770432
CA Report: 16432

July 2016

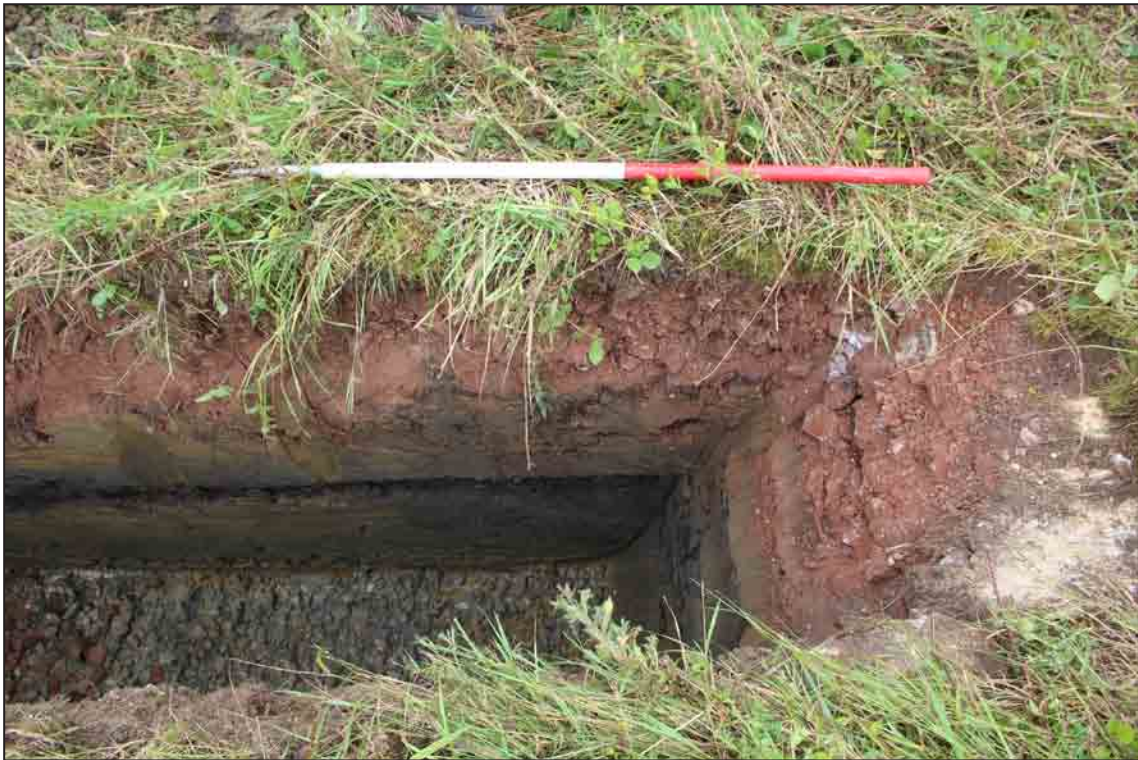
5.1 The natural geological substrate consisting of firm fine blueish grey clay, becoming brown at greater depths, was revealed within all of the test pits at depths varying between 0.6m–1.7m below the present ground level. This was overlain by a deposit of dark brown organic rich buried soil horizon averaging c.0.2m in thickness, which was in turn sealed by a 0.3m–1m thick layer of redeposited natural clay. Across parts of the site this redeposited clay was sealed by modern waste building material and areas of imported crushed material, formally used for hardstanding. This meant that the present ground surface of the site was very uneven, with large piles and spreads of dumped material. These deposits were covered with a thin layer of topsoil, mainly consisting of matted roots with very little soil present.

- i Aldi Site, Park Farm, Gillingham, Dorset
- ii Trench 4, clearly showing the dark buried soil horizon that extended across the site. With modern made ground above. Facing east. (1m scale)

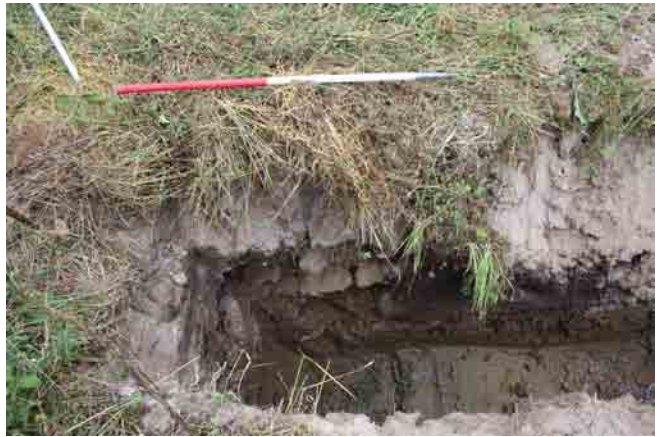
Plan 4.1

5.5 To the northern extent of this test pit was an east/west aligned wall 302. The wall was 0.9m wide by 1.05m high and set within a 0.55m deep vertically side cut 303. The wall was constructed from roughly hewn sandstone blocks. The top of the wall was at 77.53m aOD. No artefactual material was recovered.

Trench 3: Wall 302 to left of trench. Facing east. (1m scale)

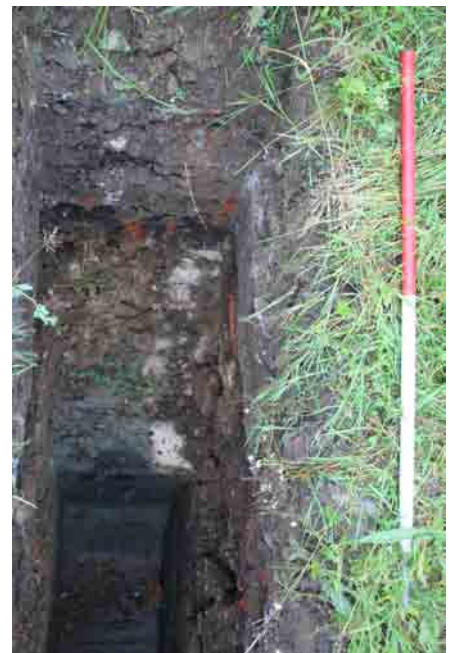
Plan 4.2

- 5.8 Another sandstone wall 1102, similar to that seen in Test Pit 3, was recorded to the eastern part of this test pit. This wall was also constructed from roughly hewn sandstone blocks and was at least 0.25 wide by 0.8m high. The wall was aligned east/west and either terminated or turned south roughly 1.5m from the eastern end of the test pit. The wall extended eastwards beyond the limit of the test pit. The top of the wall was at 79.44m aOD.
- 5.9 Apart from the two undated sandstone walls, no features of archaeological interest were observed during groundworks and, despite visual scanning of spoil, no artefactual material pre-dating the modern period was recovered.

Trench 11: Partially exposed sandstone wall 1102 in southeast corner of trench. Facing east. (1m scale)

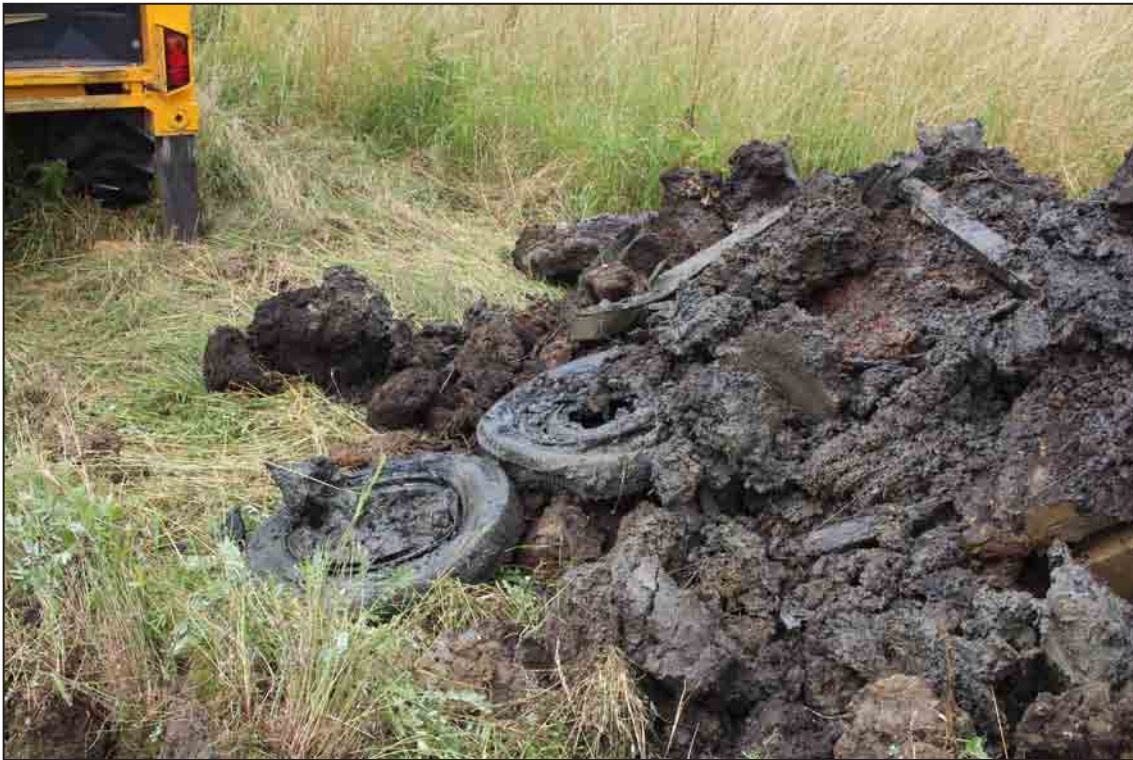
Photo of modern material from pond

- 5.6 This test pit was located in the vicinity of a former pond. Below the topsoil was a 1.4m thick deposit 501 of dark peaty organic rich material. This overlain a thinner, darker, but similarly organic rich layer 502. Both these deposits are likely to have been fills of the now in-filled pond. The material recovered from these deposits clearly show that the pond was in-filled recently, these included barbed wire and car tyres.

Trench 5: Modern material 501 from the in-filling of the pond
