**ASDA PFS  
Belmont Road  
Hereford  
Herefordshire**

*Archaeological Watching Brief*

CA Project: 5951  
CA Report: 16499

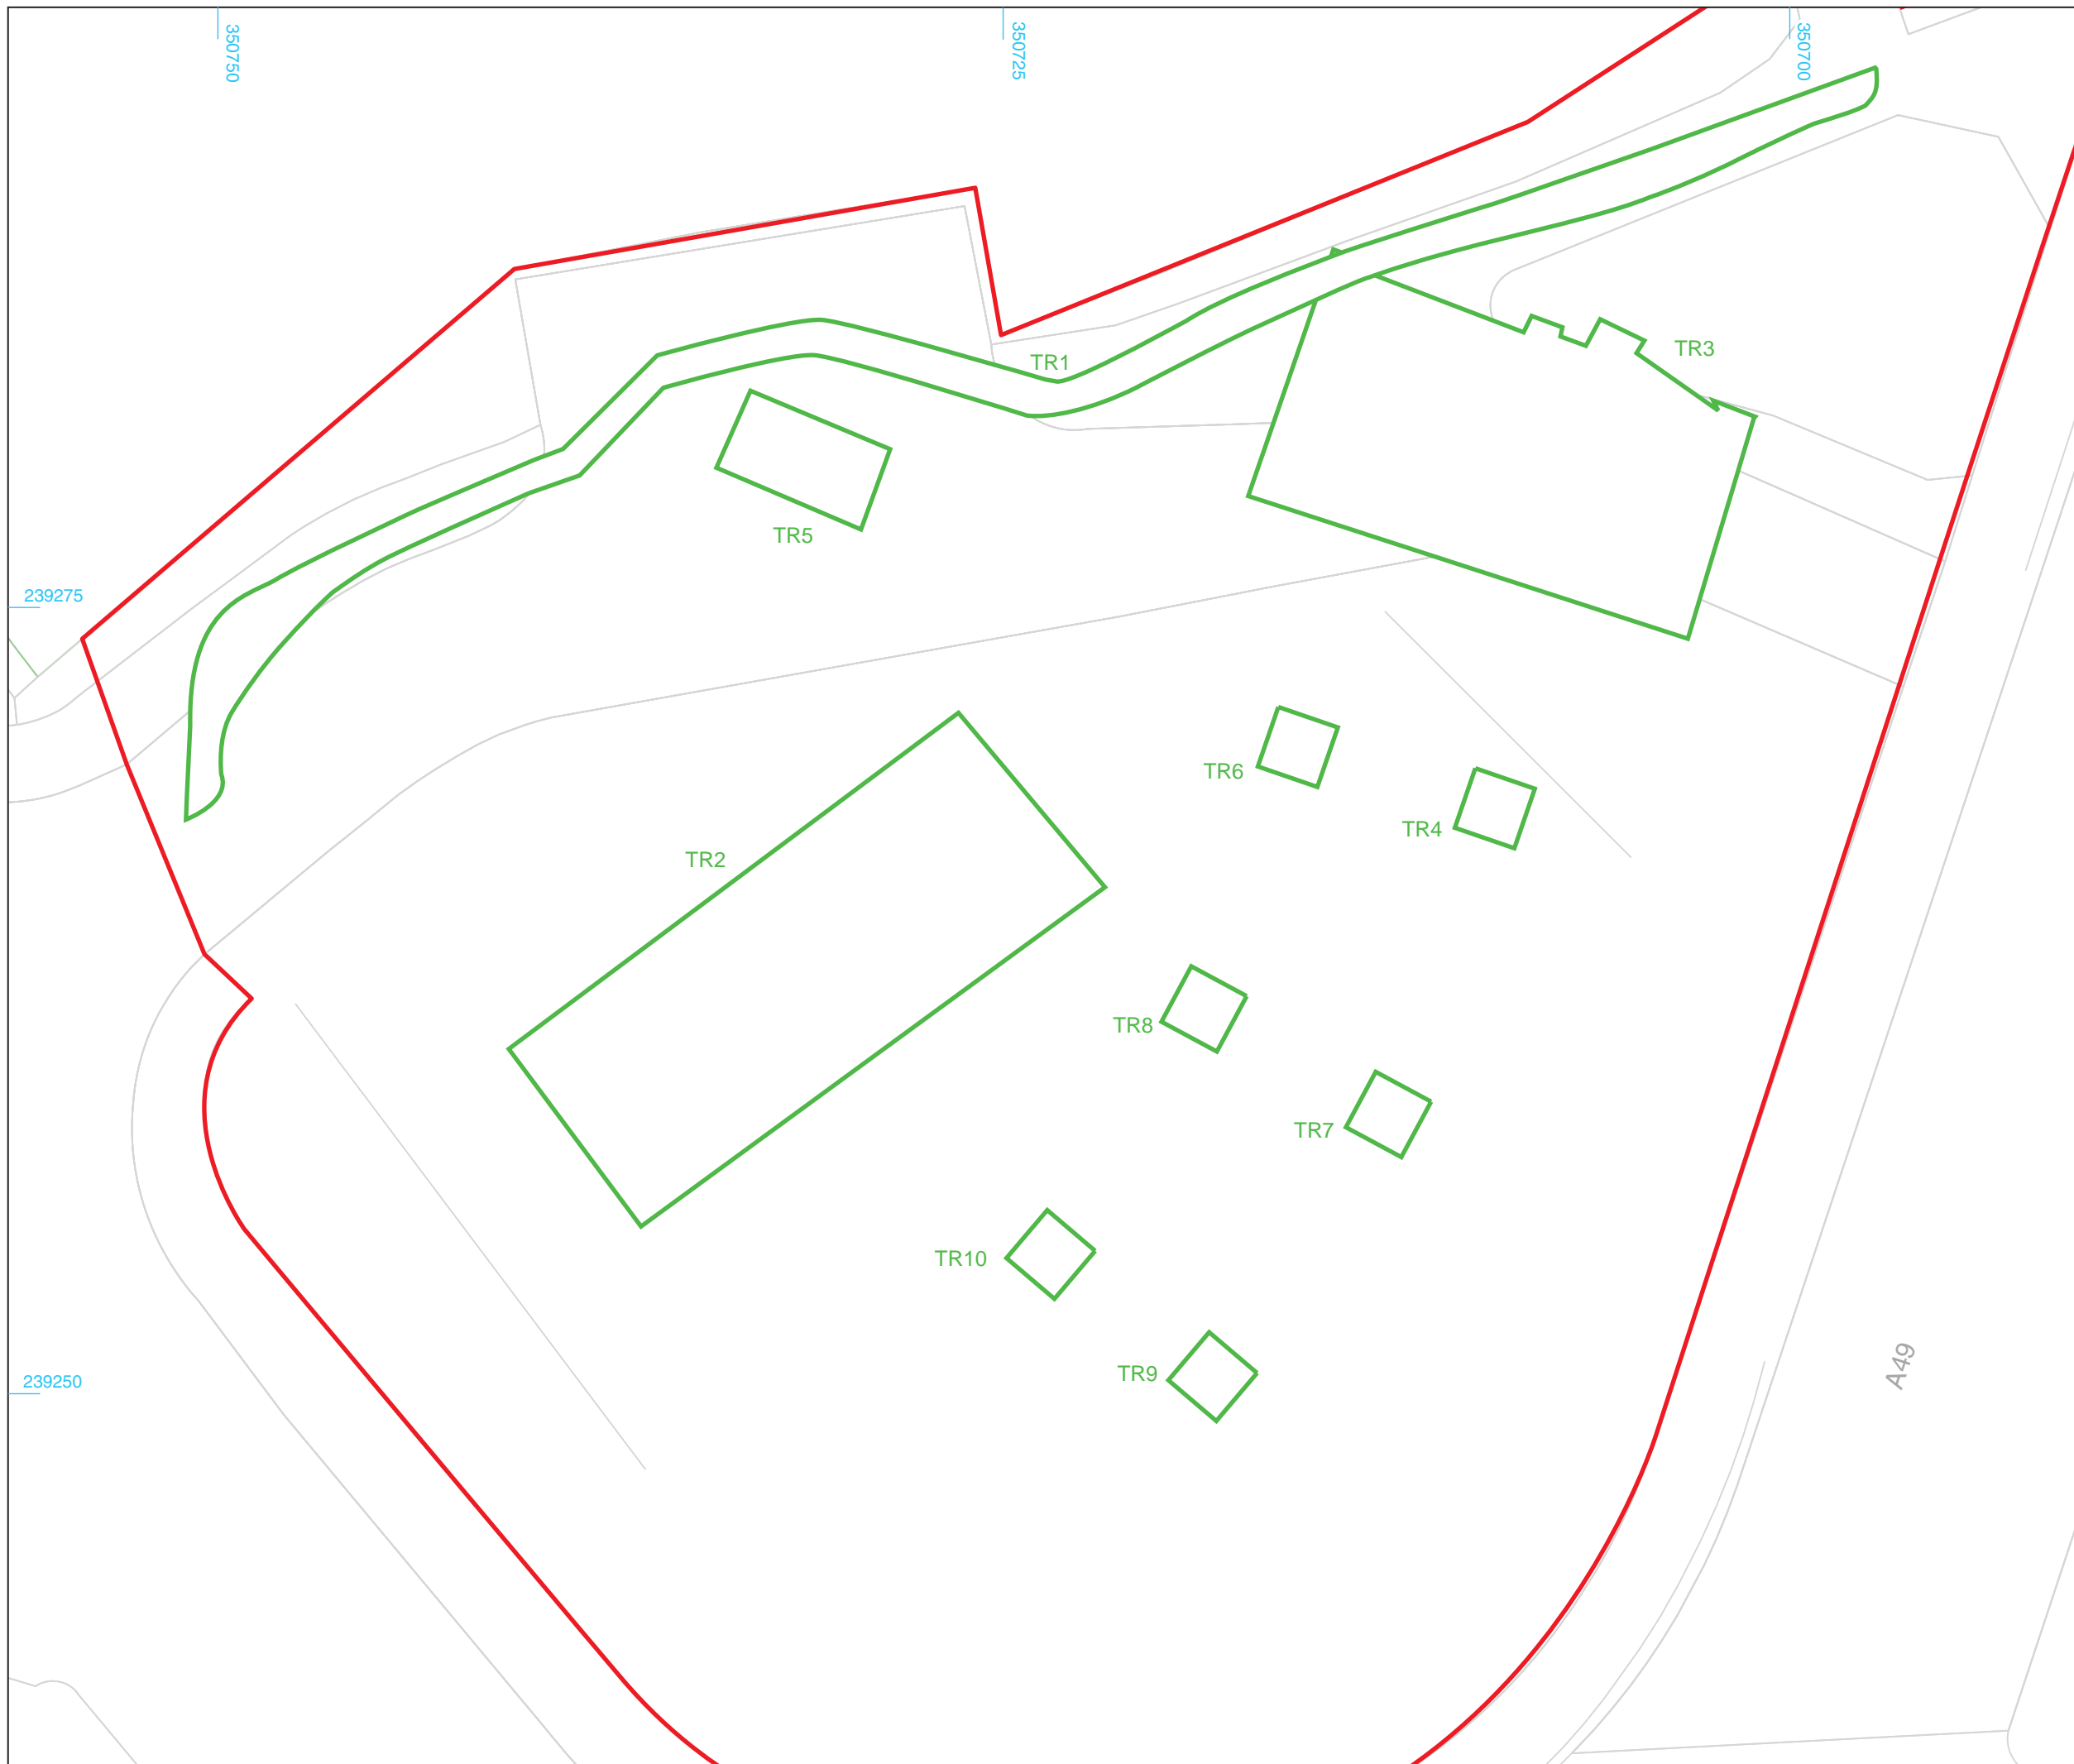
**FIGURE TITLE**  
 The site, showing location of  
 groundworks

- 4.1 The fieldwork followed the methodology set out within the WSI (CA 2016). An archaeologist was present during the excavation of foundation trenches (Trenches 3, 4 and 6-10), fuel storage tanks (Trenches 2 and 5) and a cable trench (Trench 1) (see Fig. 2 for locations and extent). Non-archaeologically significant deposits were removed by the contractors under archaeological supervision. Where mechanical excavators are used, they were equipped with a toothless bucket.

- 5.1 Trench 1 comprised the excavation of a cable diversion trench located along the northern boundary of the site. The natural substrate, 104, was revealed at a typical depth of 0.75m below the present ground level (bpgl). It was overlain by subsoil, 103, typically measuring 0.13m in thickness, which was in turn overlain by modern make-up/levelling deposit, 102, typically measuring 0.2m in thickness. This was in turn sealed by modern sub-base, 101, for overlying tarmac road 100.

- 5.2 Trenches 2 and 5 comprised excavations for fuel tanks. The natural substrate was typically revealed at 1.15m bpgl in Trench 2 and at 1.25m bpgl in Trench 5. In both trenches the surface of the natural substrate showed signs of being heavily disturbed by modern activity. The natural substrate was directly sealed by modern make-up/levelling deposits, containing concrete, tarmac and red brick fragments and

measuring up to 1m in thickness. These deposits were, in turn, sealed by topsoil or modern tarmac road surface.

- 5.3 Trench 3 comprised the excavation of foundations for the PFS kiosk and shop. Trenches 4 and 6-10 comprised the excavation of foundation pads for the forecourt canopy. In Trench 3, the natural substrate was revealed at a typical depth of 0.85m bpgl. In Trenches 4 and 6-10 the natural substrate was typically revealed at a depth of 1.05m BPGL. In all of the excavated foundation trenches, the surface of the natural substrate showed signs of being heavily disturbed by modern activity. The natural substrate was directly sealed by modern make-up/levelling deposits containing concrete, tarmac and red brick fragments and measuring up to 0.9m in thickness. These deposits were, in turn, sealed by topsoil or tarmac road surface.
- 5.4 No features or deposits of archaeological interest were observed during groundworks and, despite visual scanning of spoil, no artefactual material was recovered.
