Warren Farm North Baddesley Hampshire

Archaeological Watching Brief

CA Project: 770255 CA Report: 16482

October 2016

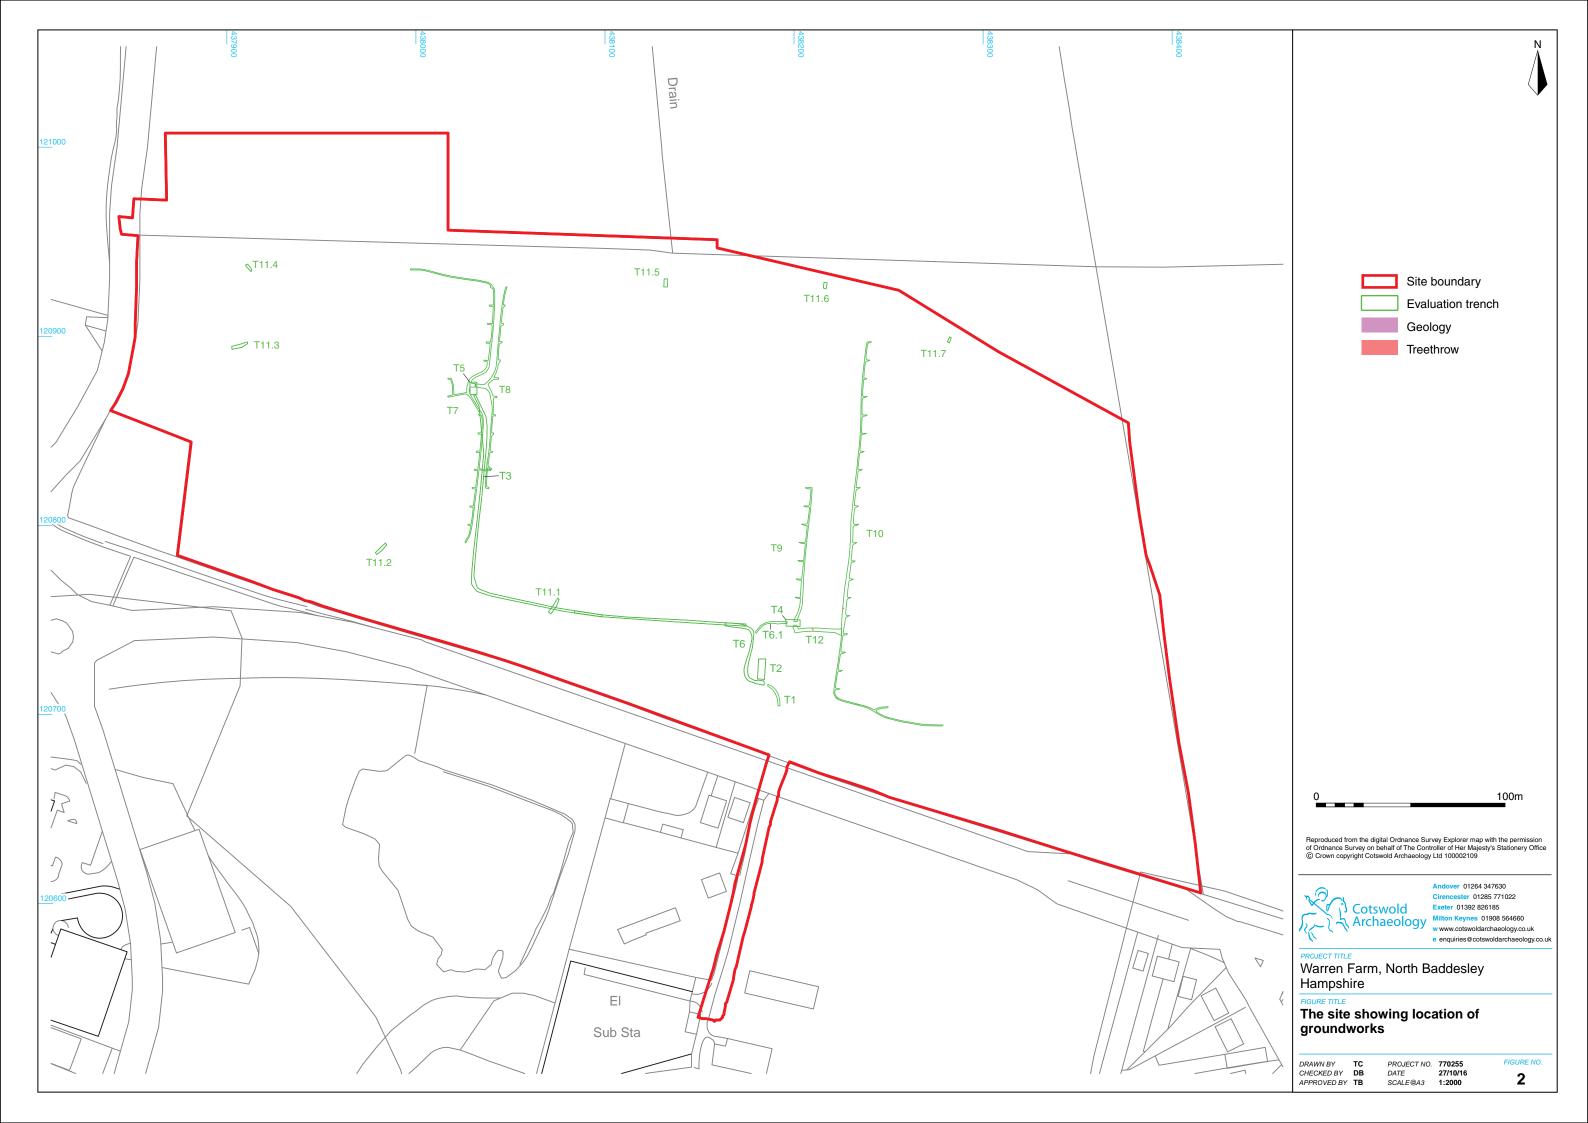
- 4.1 The fieldwork followed the methodology set out within the WSI (CA 2015). An archaeologist was present during intrusive groundworks comprising trenches for cables and transformer bases, and a later drainage ditch and pond (Figure 2).

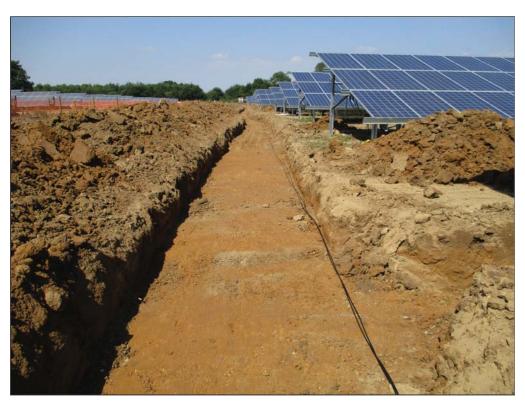
- 5.3 **Trench 10** (Figure 3) produced a small, sub-rounded possible geological anomaly or feature **1003** (Figure 4) protruding from beneath the baulk, towards the southern end of the trench. No finds or other cultural material were recovered from the investigation slot. Further anomalies of similar form and composition appeared slightly further to the south, in the same trench, and slightly to the west in **Trench 12** (Figure 5).

3 Trench 10, looking north

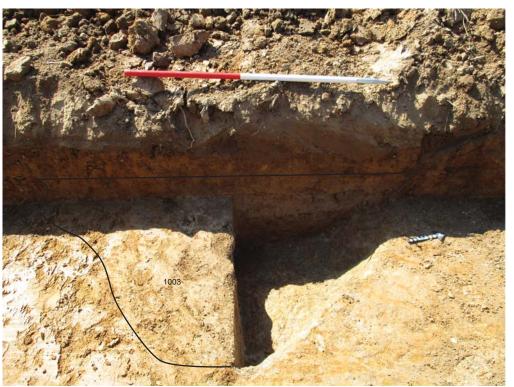
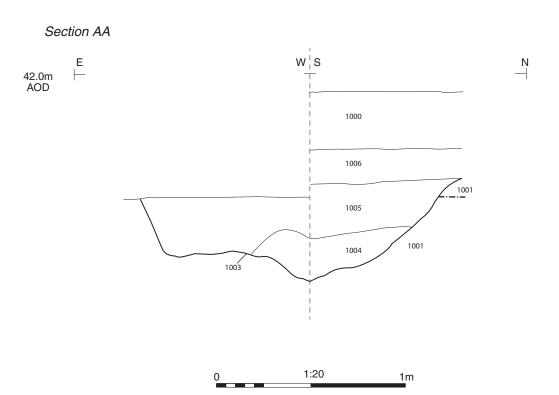
FIGURE NO. 4

Treethrow 1003 looking west (1m scale)

Treethrow 1003: section and photograph

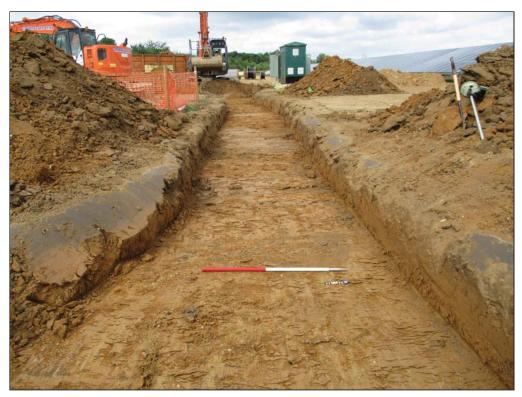
5 Trench 12, looking west (1m scale)

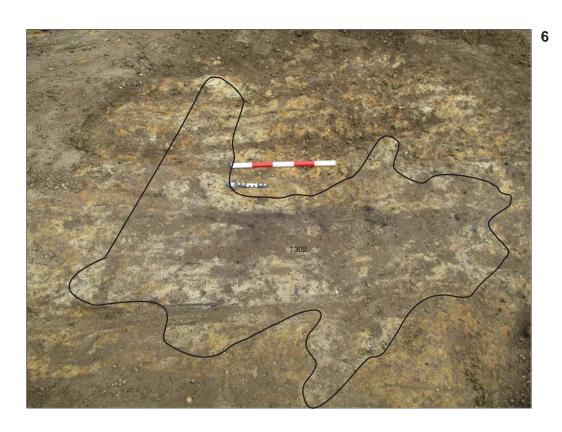
- A very irregularly formed anomaly **1302** was discovered in **Trench 13**, showing up as ash-coloured sand and abundant charcoal (Figure 6).

The charcoal-rich anomaly **1302** in **Trench 13** has been interpreted as a burnt out tree stump/throw, given its highly irregular form. Ploughing may have further contributed to the irregular form of this tree throw.

6 Treethrow 1302, looking east (0.5m scale)
