Farleigh Hungerford Castle Norton St Philip Somerset

Archaeological Watching Brief

CA Project: 5993
CA Report: 16671
SMC Reference: S00140870

December 2016

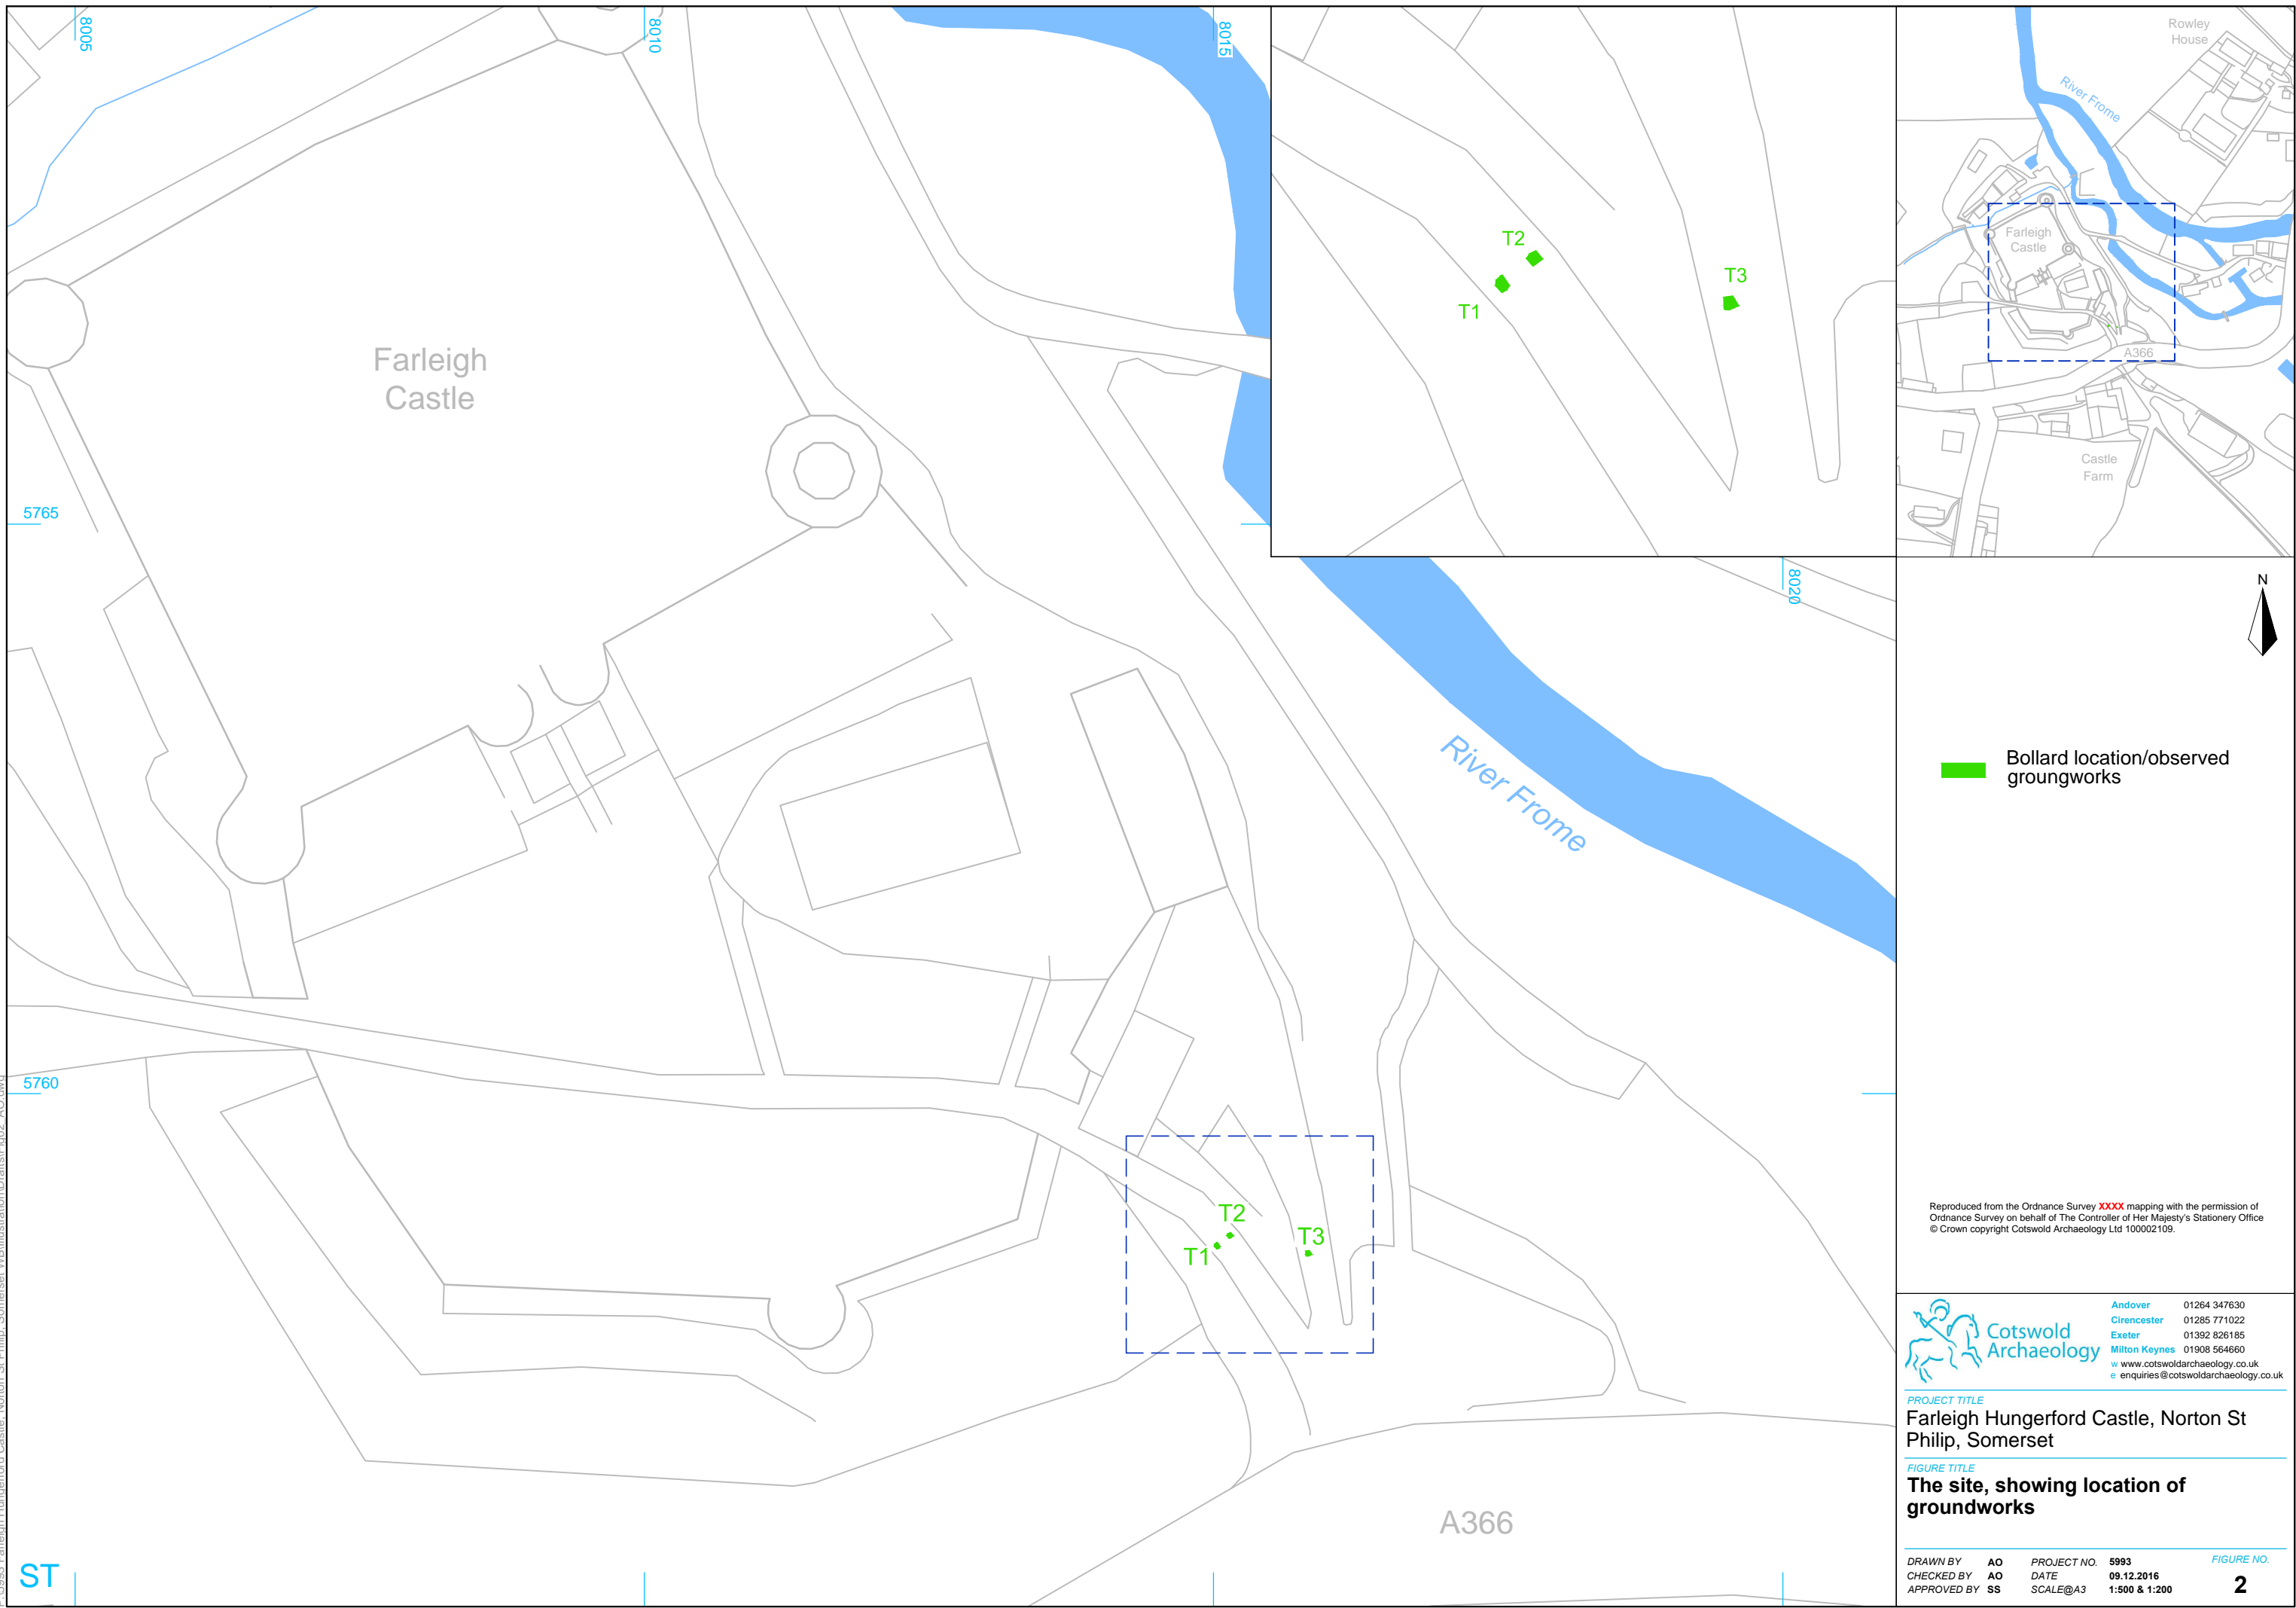
FIGURE TITLE
 The site, showing location of groundworks

4.1 The fieldwork followed the methodology set out within the WSI (CA 2016). An archaeologist was present during intrusive groundworks comprising the excavation and removal of existing bollards and the installation of new lift assist bollards in the same excavations (Trenches 1-3; see Fig. 2 for location and extent).

Bollard location/observed groundworks

5.1 Trenches 1-3 were excavated to a maximum depth of 1.2m below the present ground level (bpgl) and were entirely contained within the previous excavations for the existing bollards. The earliest deposits identified in these trenches related to the backfilling of these excavations. These deposits were overlain by modern bedding/levelling deposits, typically measuring 0.2m in thickness, for the modern tarmac driveway surfaces.

5.2 No features or deposits of archaeological interest were observed during groundworks and, despite visual scanning of spoil, no artefactual material was recovered.
