Dove Lane St Paul's Bristol

Archaeological Evaluation and Excavation Report

CA Project: 9261 CA Report: 18336

September 2018

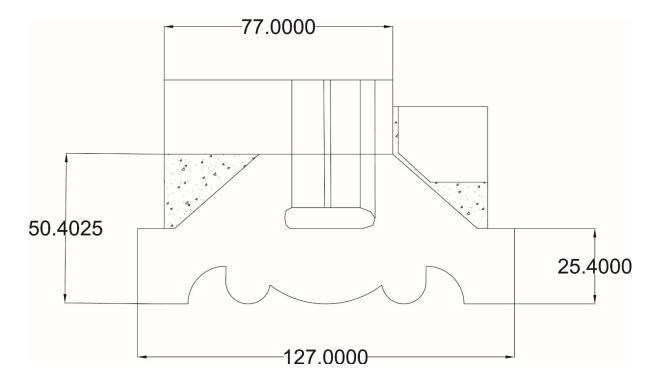
3) A reeded slab of stone with an integral block with recessed chamfered sides at the back (see section). The strip is 5" wide and the front section is 9/ 16" thick. The rear block projects a further 2" and reduces to 1¾" in width. The angle is squared up and the depth increased to 2½" with two strips of sawn stone mortared together with white fire cement. The slab is 250mm long but broken at each end. Half of the rear projection, including the additions, has been chiselled away from one end. A slot for a staple is evident cutting across all these elements. Context (5000).

The block is a composite construction and formed the jamb of a late 18th to mid 19th-century fireplace surround.

Cross section of catalogue no. 3

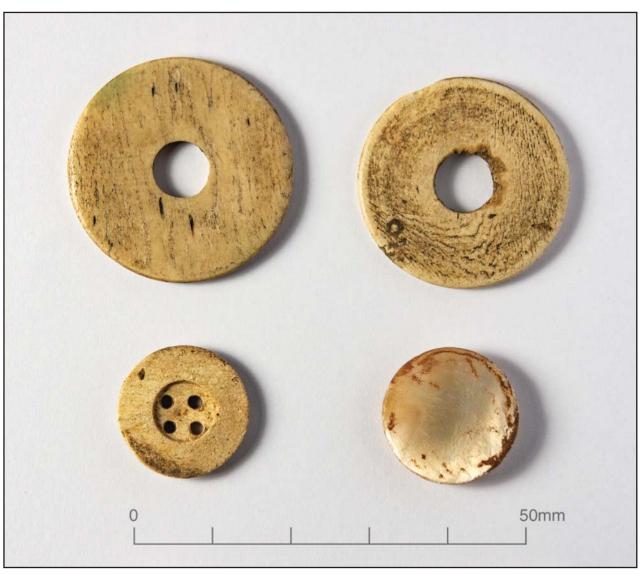
19

Top: thread spool fragments. Demolition deposit 5000; Bottom left: bone button. Box-drain fill 2035; Bottom right: mother of pearl button. Cultivation soil 233.

Four items relating to textile manufacture or working were recovered from three deposits within Areas 3 and 5, and as an unstratified item from Area 3. Two thread spools fragments, perforated bone discs used to keep thread bobbins on a spool, were recovered from Period 4 demolition deposit 5000 and between the stones of Period 2 stone path 3012 (Fig.19). A tattle shuttle, from Period 2 heater 5010 and a bobbin from Area 3 (unstratified) are both used in the production of lace (Fig. 20). Lace production in Britain is known from the late 15th century and continued until largely replaced by machine production at the turn of the 20th century (The Lace Guild 2018). The group is likely to date from the 19th century, although a date range extending into the early 20th century is possible in the form of personal hobby manufacture.

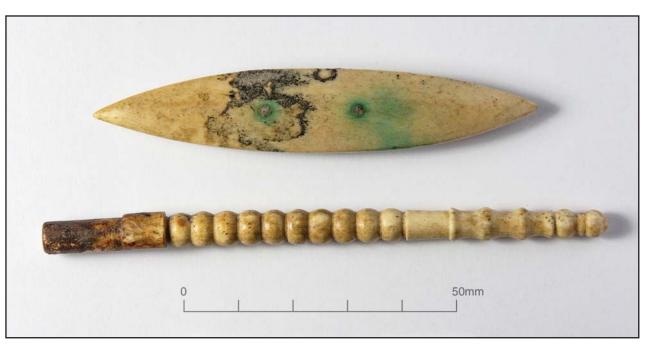
20

Top: tattle shuttle, from Period 2 heater 5010; Bottom: bobbin from Area 3, unstratified

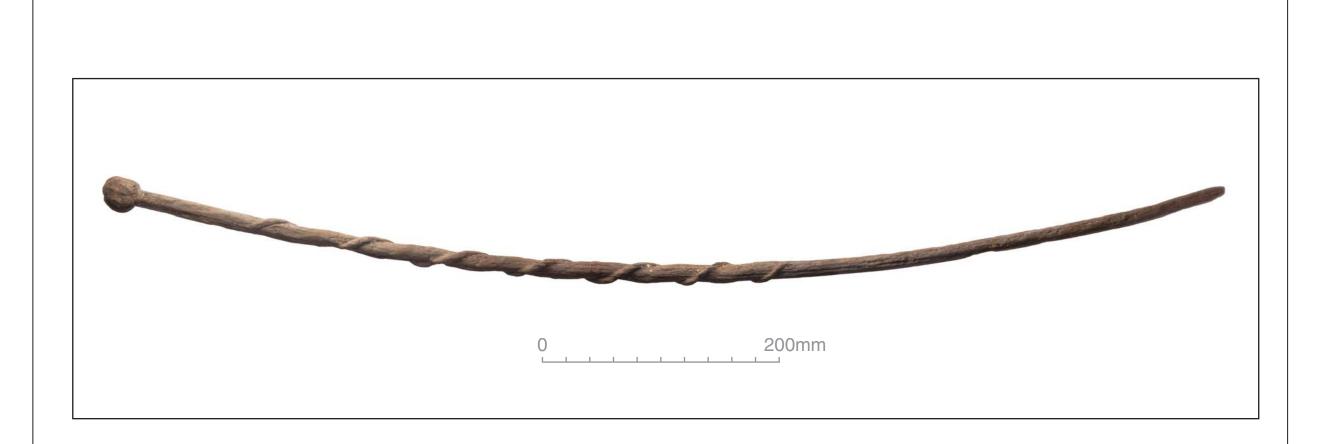
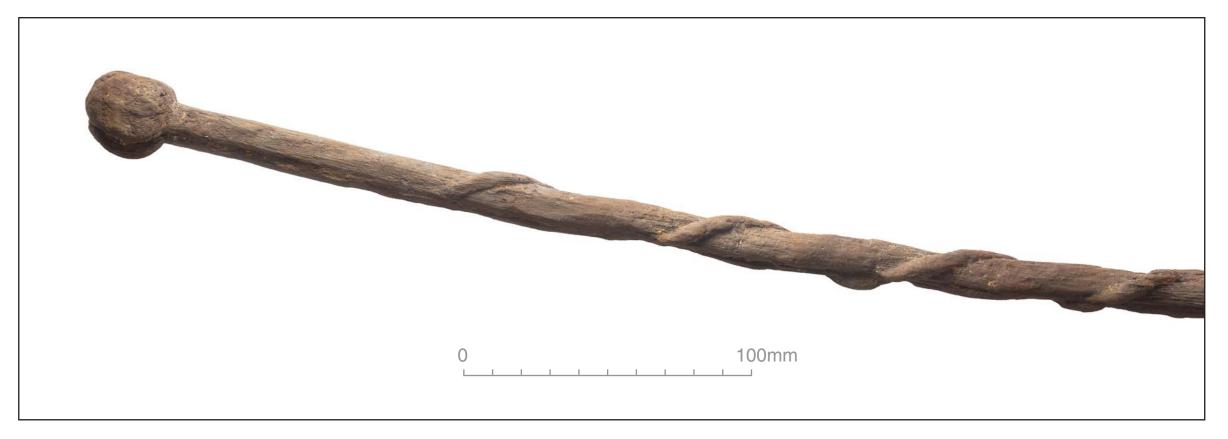
- Fig. 19 Worked bone and mother of pearl objects (not to scale)
- Fig. 20 Worked bone objects (not to scale)
- Fig. 21 Wooden walking stick (not to scale)

"It is obviously a fairly crude folk art piece –. If a 'local' craftsman made a cane like this, he would have first found a straight branch to carve (or use hot sand technique) to straighten it out. – The naïve carving of the 'ball'-shaped handle and shaft lead me to believe this was done by a sheep or goat herder for a tool made to help guide his herd --- (the) shape (is) not particularly effective as a support cane. The maker of this cane probably applied something like pitch to darken its surface." (Peter Robinson, Senior Director, International Society of Cane Collectors, pers. comm. http://www.internationalsocietyofcanecollectors.com/).
