Former HMP Gloucester Gloucester Gloucestershire

Archaeological Evaluation

CA Project: 5580
CA Report: 15811

November 2016

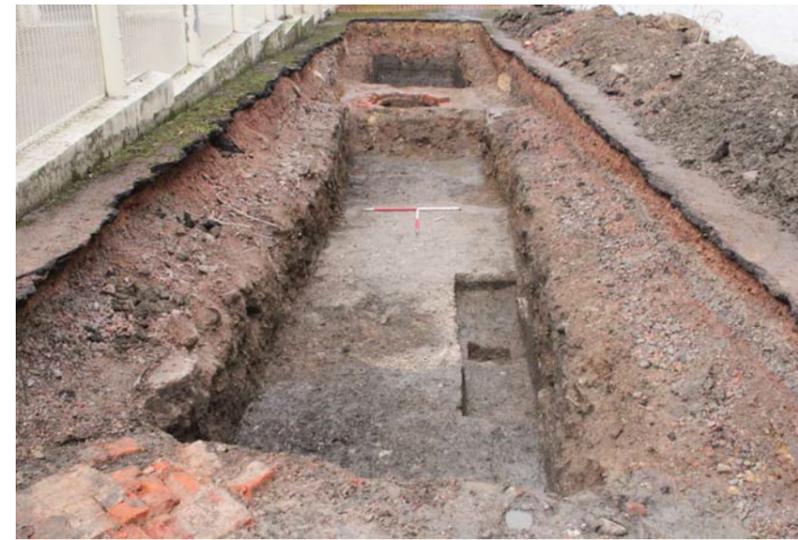
Trench 1, looking north-west (1m scales)

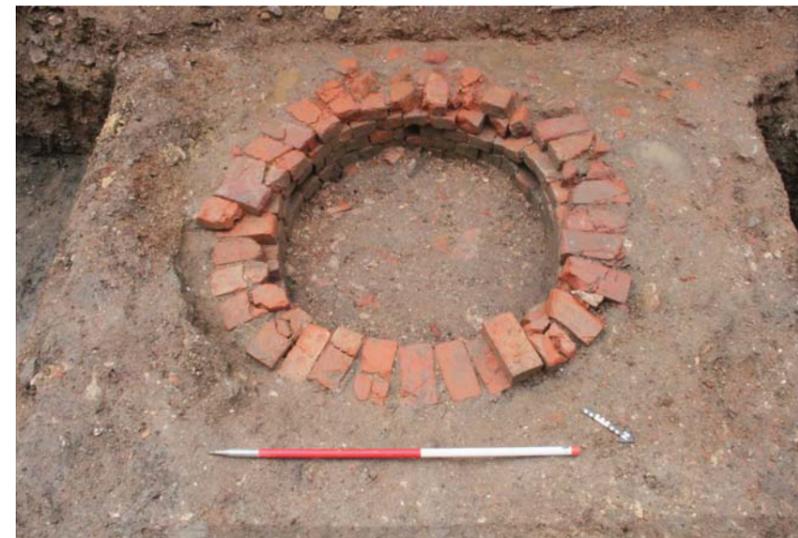
Well 107, looking south-west (1m scale)

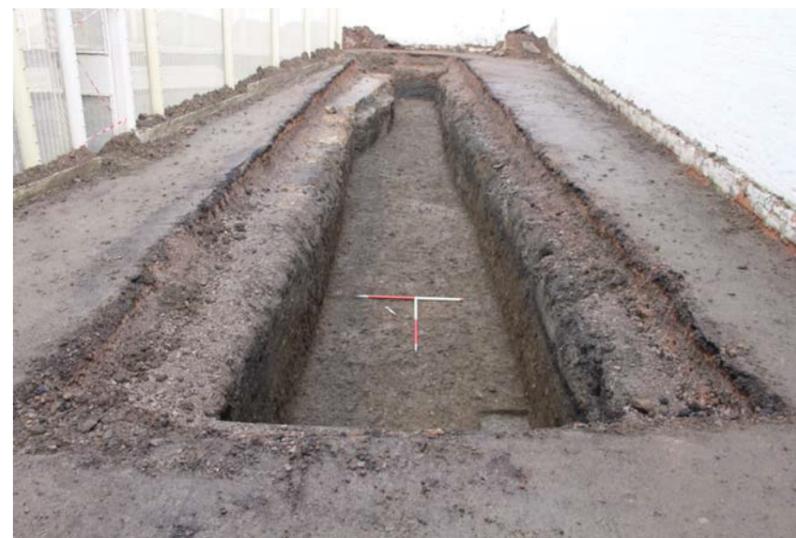
Trench 2, looking north-east (1m scales)

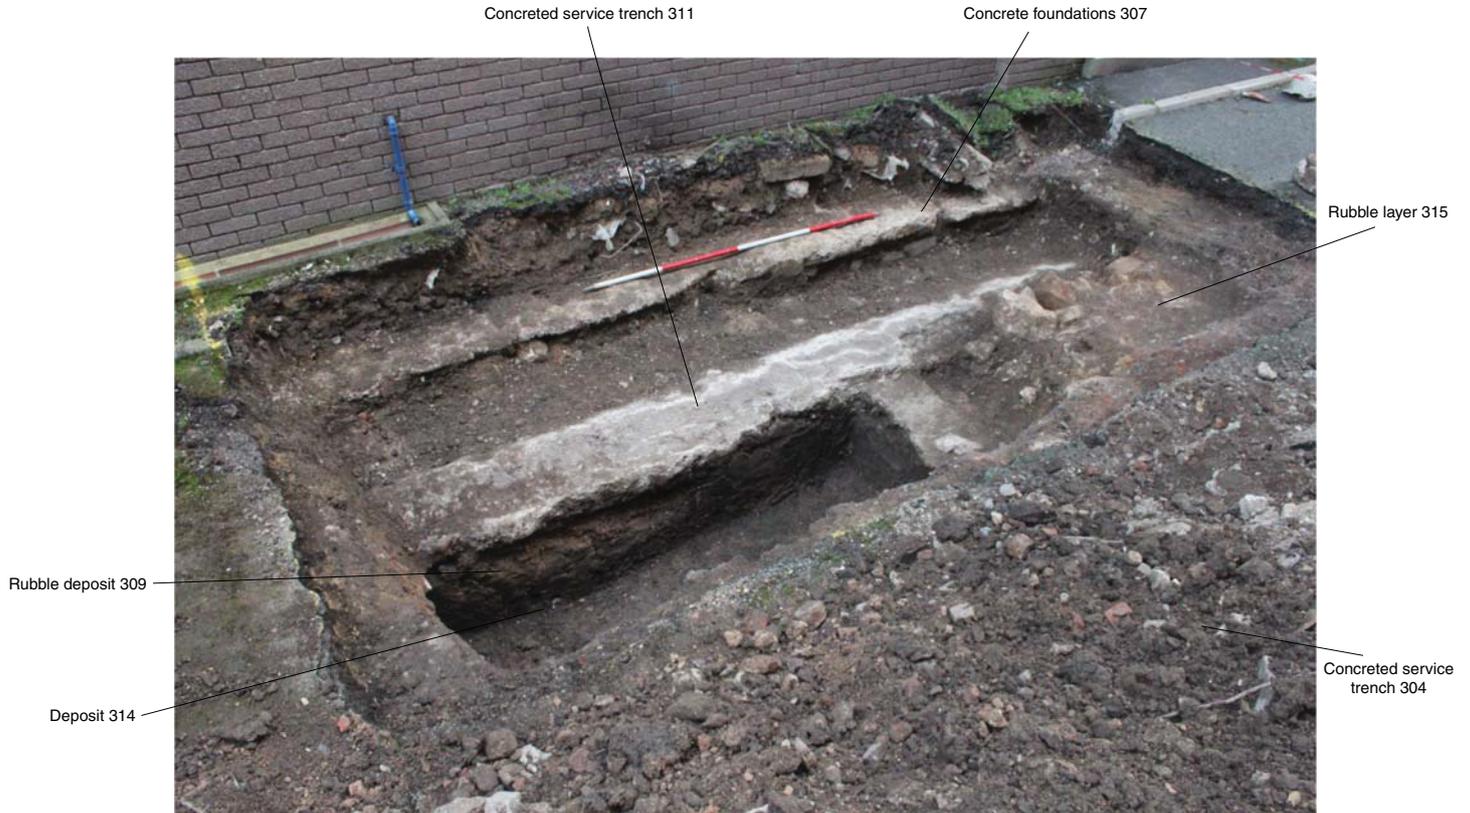
- 5.12 Layer 315 and deposits 309 and 313/314 were cut by a series of modern service trenches and the foundation trench for the extant C-Wing, built between the late 1950s and early 1960s. The sequence was sealed by layers of levelling/make-up and the existing tarmac surface.

Trench 3, looking south-east, showing foundations and services associated with C wing (2m scale)

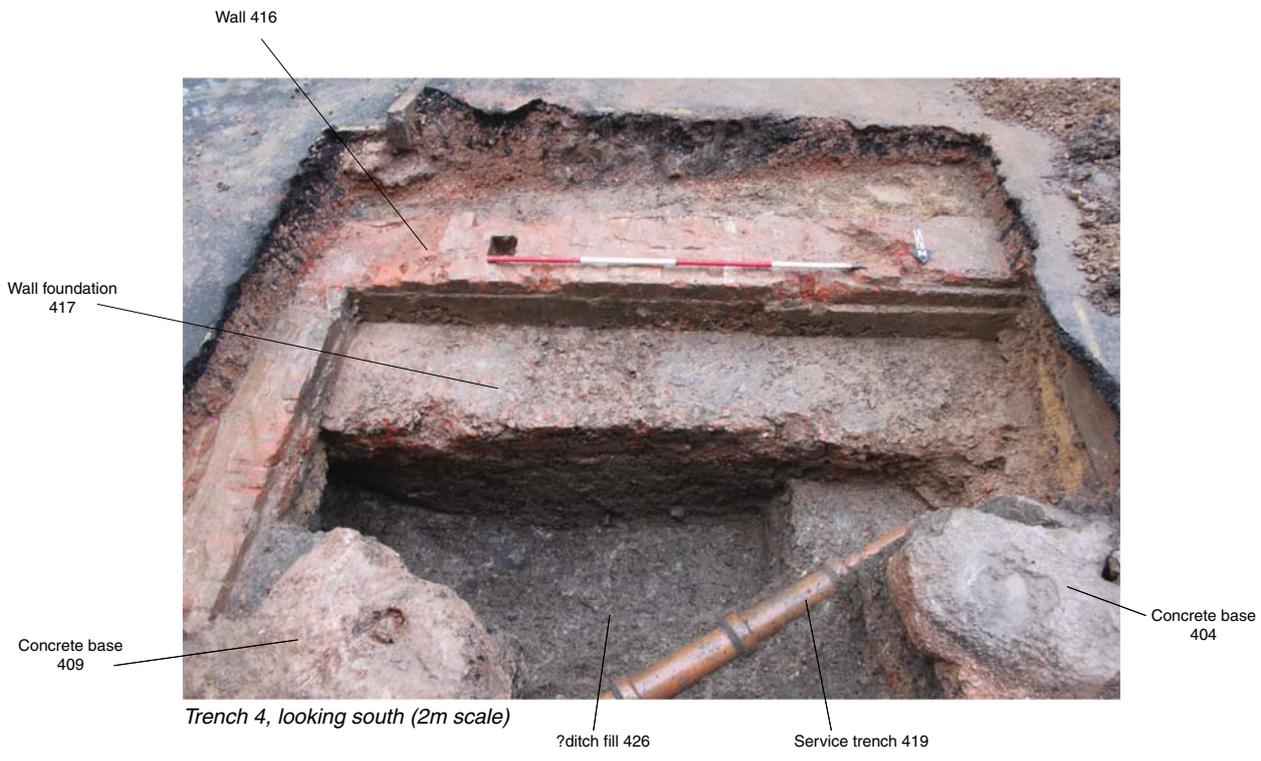
Trench 4, looking south (2m scale)

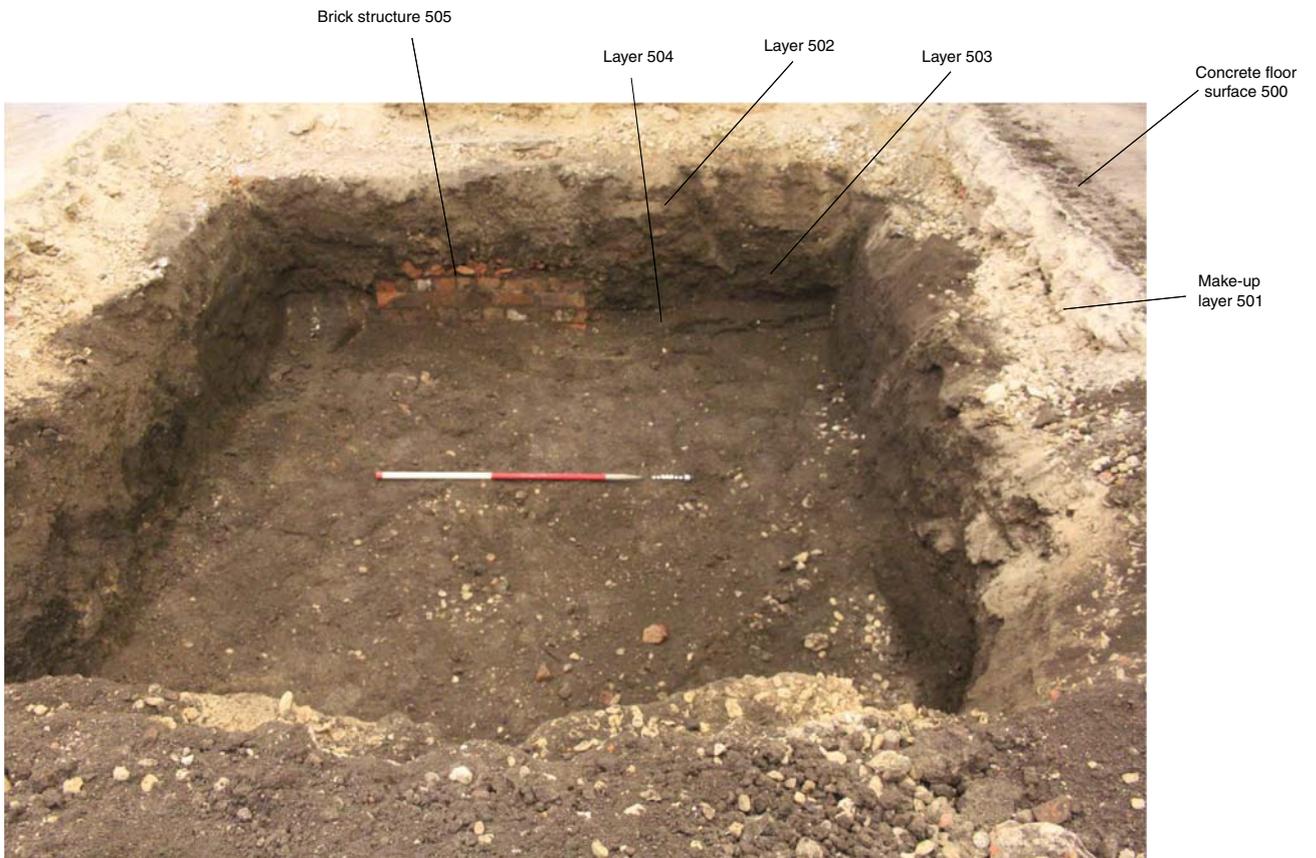
Trench 5, looking west, showing 19th-century garden soils (1m scale)

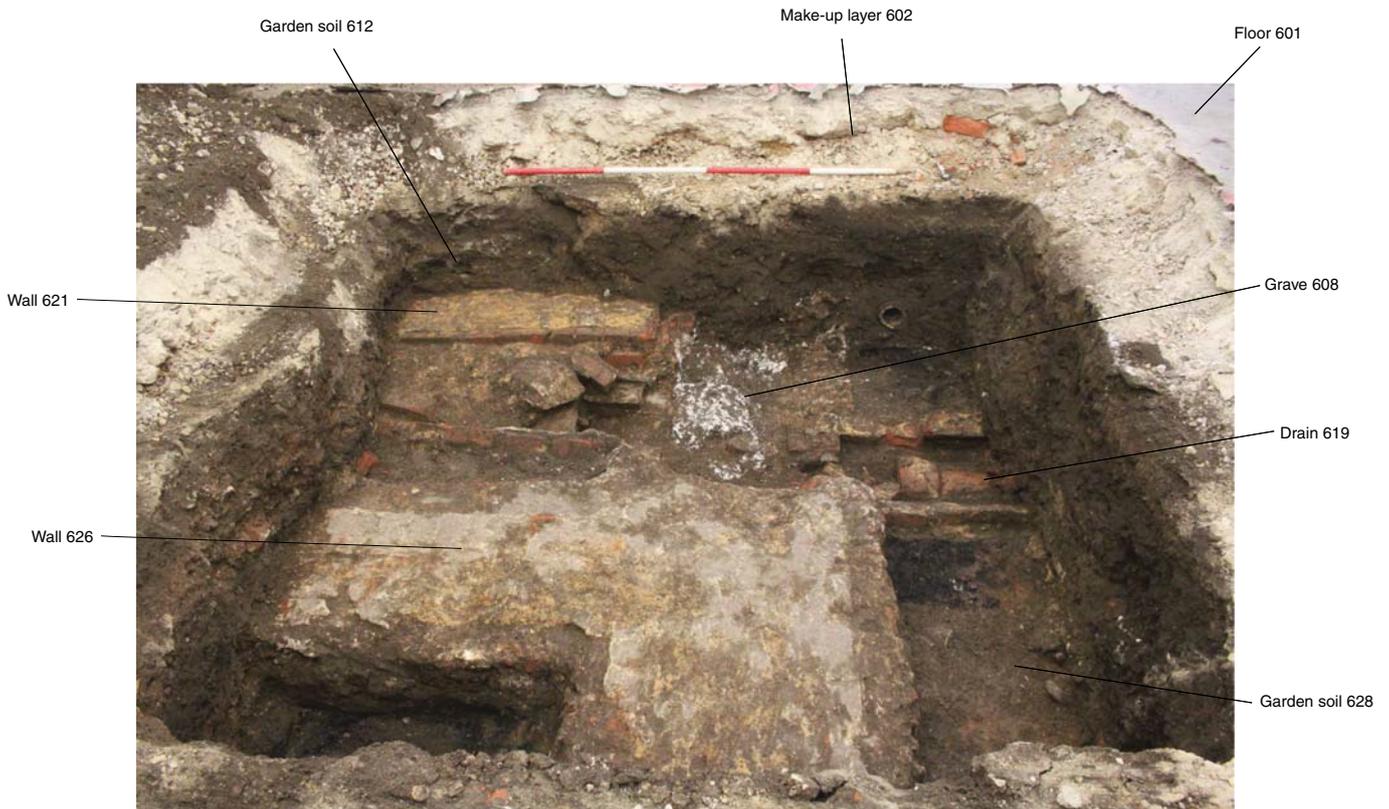
- 5.19 The construction backfill of the culvert, 630, was cut by the foundation trench for concrete and brick wall foundation 626. This formed the south-western corner of a structure, with walls just over 0.8m thick. The sandy silt fill of the brick culvert, 616, which probably accumulated during the use of the feature, was in turn cut for the insertion of ceramic pipe 614. This appears to have been followed by the construction of a further east/west aligned brick and concrete wall, 621, which abutted the partially demolished southern side of culvert 617/619.

Trench 6, looking south, showing 19th-century walls, culvert and 20th-century grave (2m scale)

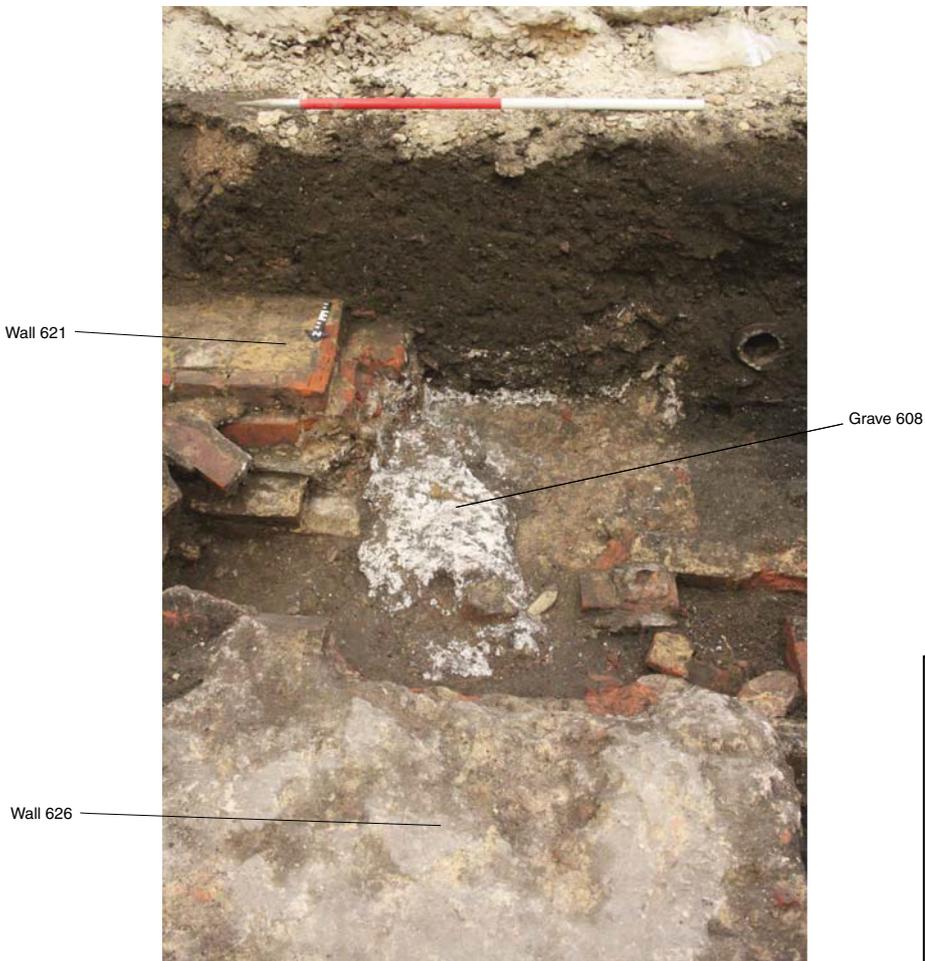
Grave 608, looking south (1m scale)

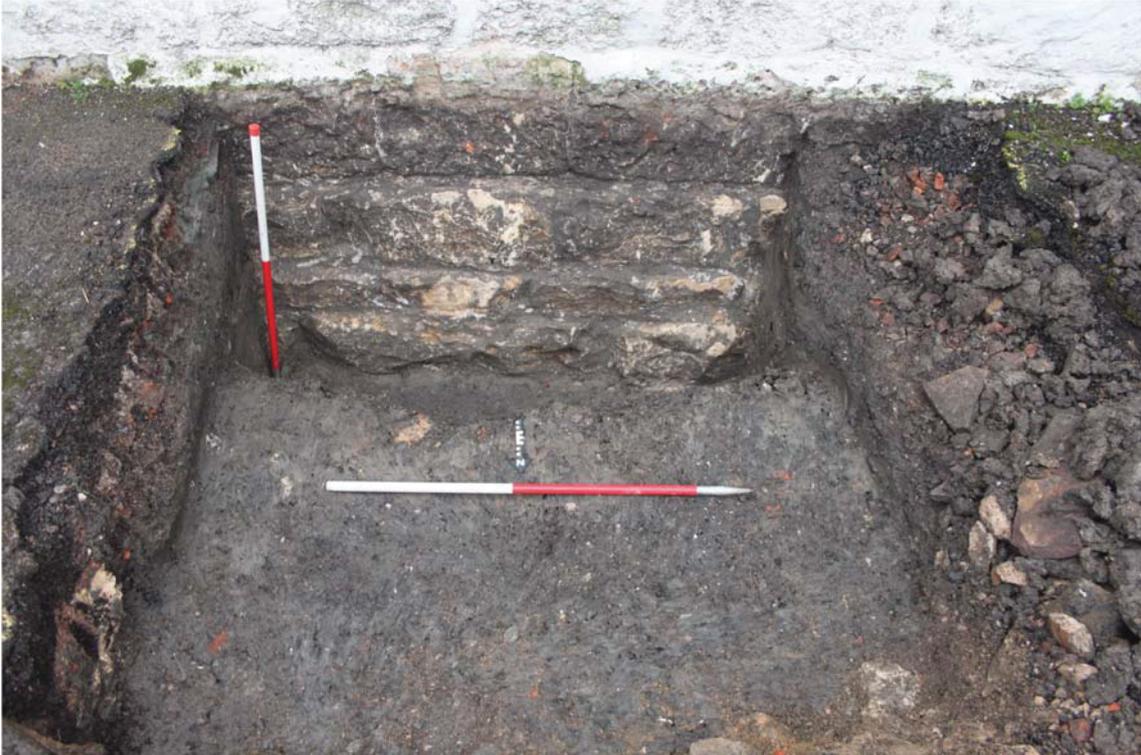
- 5.23 The excavation of Trench 7, to a depth of 1.1m bpgl, revealed the foundations of the perimeter wall of the prison, close to the south-western corner of the site.

- 5.24 Wall foundations 707 comprised large, roughly dressed limestone blocks, each up to 1.05m long and 0.45m high, bonded with light greyish white lime mortar (see Fig. 11). The blocks were laid in regular, even courses, each of which stepped out so that the lowest exposed course extended northwards into the trench by 0.2m from the inner face of the wall above ground level. The foundations extended beyond the base of the trench.

Trench 7, looking south, showing 19th-century rebuild of prison perimeter wall (1m scales)

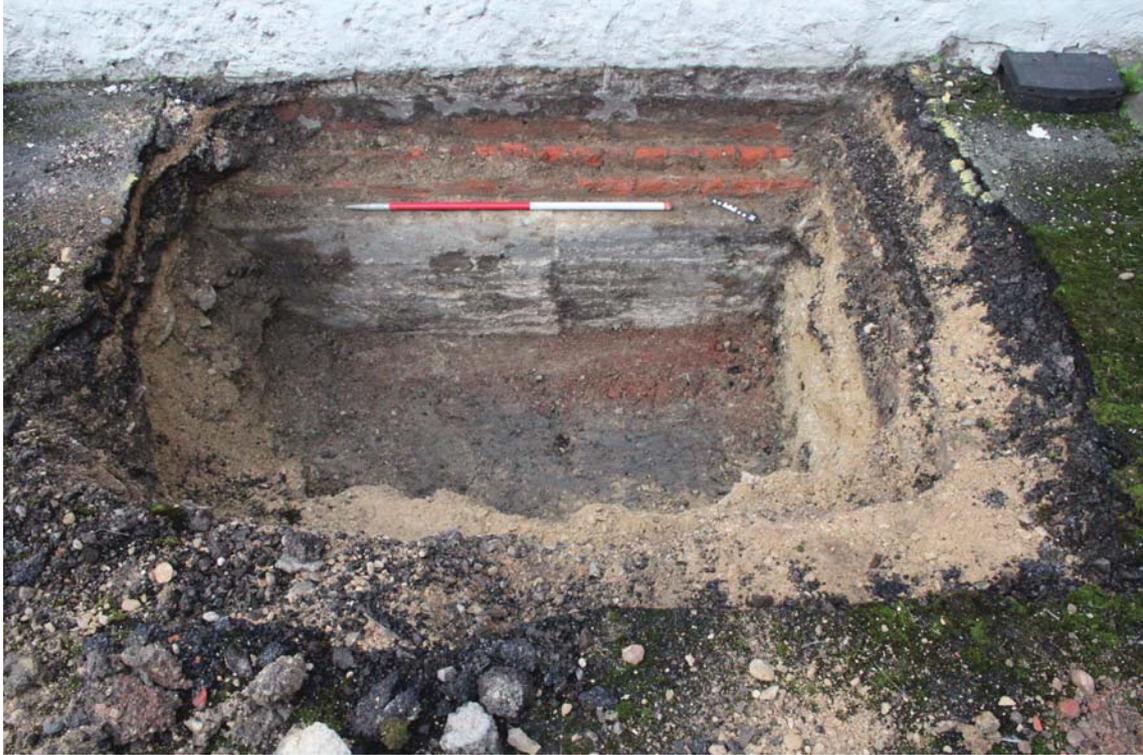
- 5.26 Trench 8 was excavated against the perimeter wall of the prison, approximately 10m north-west of Trench 7. It exposed the brick and concrete foundations of the wall, as rebuilt in the third quarter of the 20th century. Only modern deposits associated with this rebuild, service trenches and the existing tarmac road surface were encountered within this trench.

Trench 8, looking south-west, showing modern foundations of prison perimeter wall (1m scale)

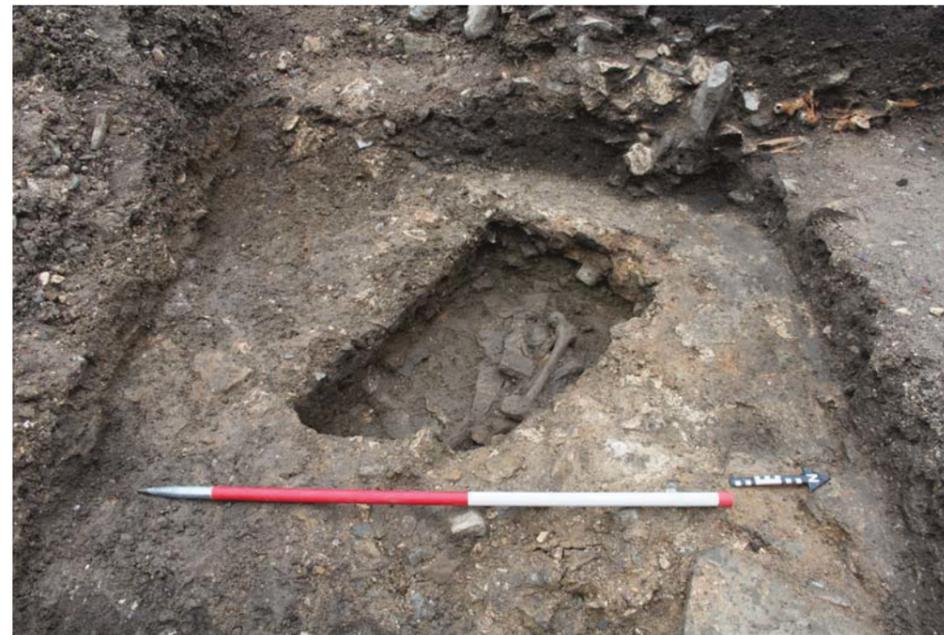
- 5.32 The exposed top of wall 944, which presumably represents the level to which it had been deliberately robbed in the late medieval/early post-medieval period, was cut by pit 951. The pit was partially exposed within the trench and appeared to be an elongated rectangular shape, following the alignment of the wall. It was at least 1.3m long, 0.9m wide with vertical sides and a slightly convex base. It contained a single fill, 950, within which a number of disarticulated human bone fragments were observed, including the upper part of a femur. The pit fill also contained a number of presumed residual finds of 13th-century date (see Fig. 14).

Graves 940 and 942 (in section, top right of photograph), with burial pit 951 cutting inner bailey wall 944 in foreground; 1m scale)

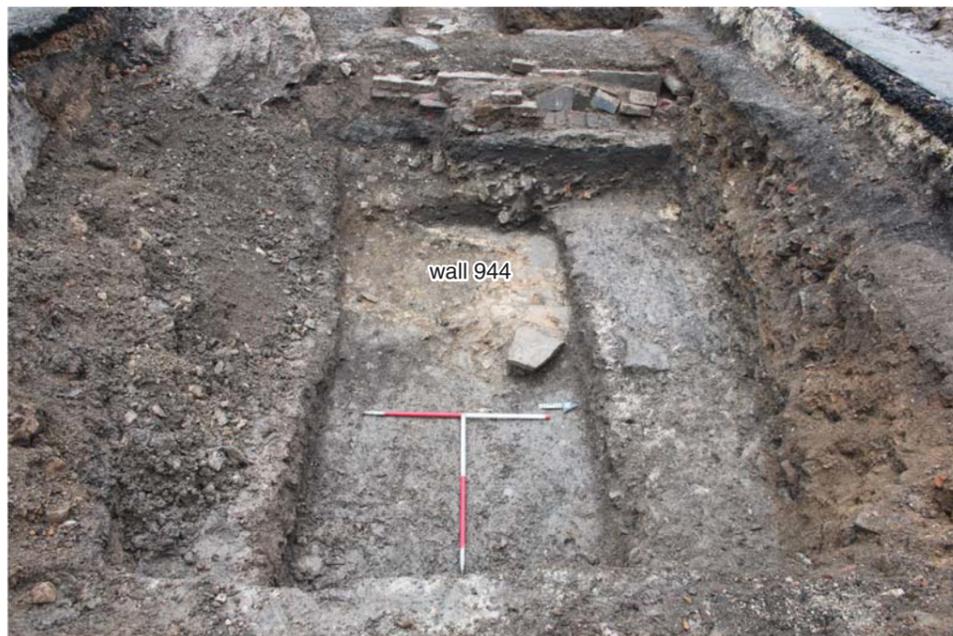
- 5.31 Substantial wall 944 extended north-east/south-west through the eastern extent of the trench. It was at least 1.7m wide and constructed from sandstone blocks bonded with lime mortar and it was evident that the facing stonework from the south-eastern elevation had been robbed. The wall would have been abutted to the east by stone surface 943, the latter presumably representing an external yard. Within the northern part of the trench, stone surface 925 was identified between, and cut by, two lengths of foundation associated with the late 18th-century prison. This layer was similar in construction to surface 943 and may be broadly contemporary.

Eastern end of Trench 9, showing inner bailey wall 944 (1m scales)

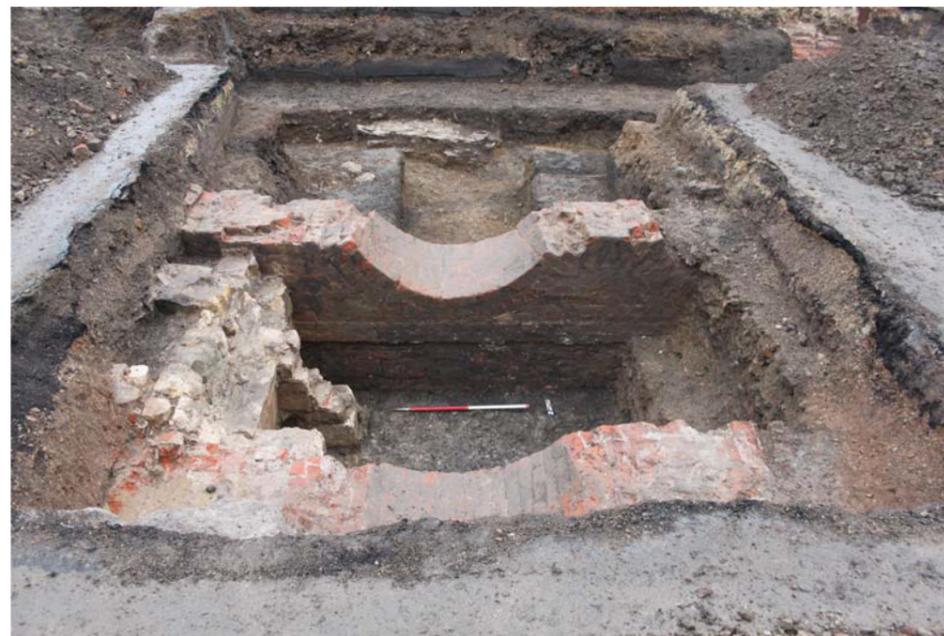
- 5.38 Cutting layer 903 into some of the earlier deposits below were brick walls 904, 905 and 907 which correlate closely with the foundations of the south-western wing and southern principal building of Blackburn's prison as depicted on an architectural plan dated 1785 (see Fig. 4). The exposed foundations survived up to 17 courses (1.55m) deep and continued beyond the base of the trench. They were 0.8m to 0.95m wide and each contained a series of inverted arches. Later structure 906 had been inserted between walls 904 and 905. It was principally constructed in limestone and incorporated ashlar blocks as well as some brick. It comprised a central north/south aligned wall with two short east/west stubs on either side.

Trench 9 looking south, showing brick 18th-century prison walls and medieval surface 925 between (1m scale)

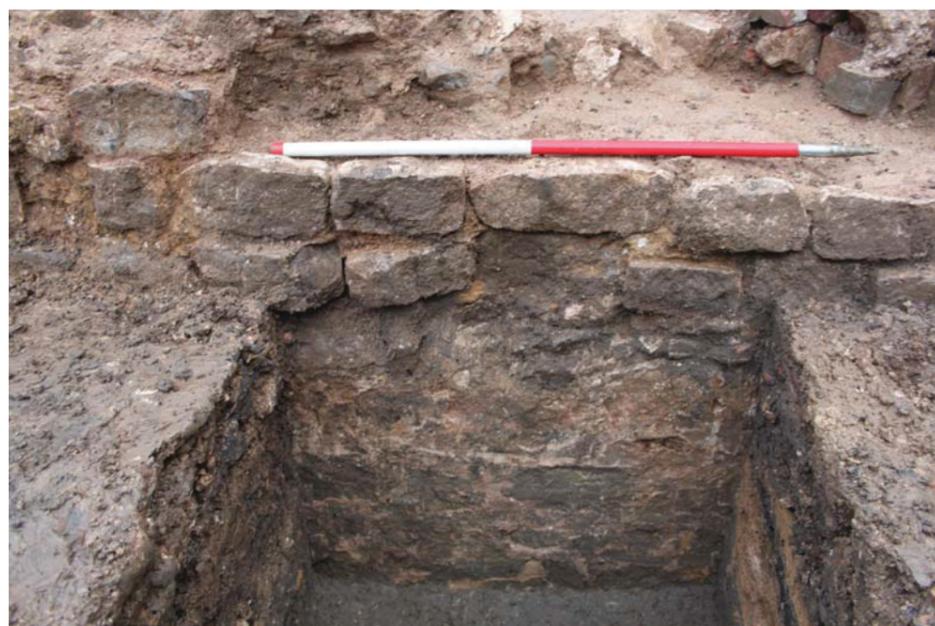
- 5.54 The earliest features encountered in Trench 11 comprised walls 1108 and 1110. Wall 1110 was aligned approximately north-west/south-east and extended throughout a large part of the trench. It was found to be at least 4.4m wide and was soon identified as the north-eastern wall of the medieval castle keep. Only the internal face of the wall was exposed within the trench, with the external face lying beyond the northern edge of the trench or obscured by later structures. The wall comprised a randomly coursed rubble core of limestone and sandstone blocks within a very sandy yellow mortar, faced with dressed blocks, typically up to 0.3m in dimension. Many of the facing stones were loose and it was evident that they were bonded with a different mortar to that of the core, suggesting that they may represent later repair work.

South-western face of keep wall 1110 (1m scale)

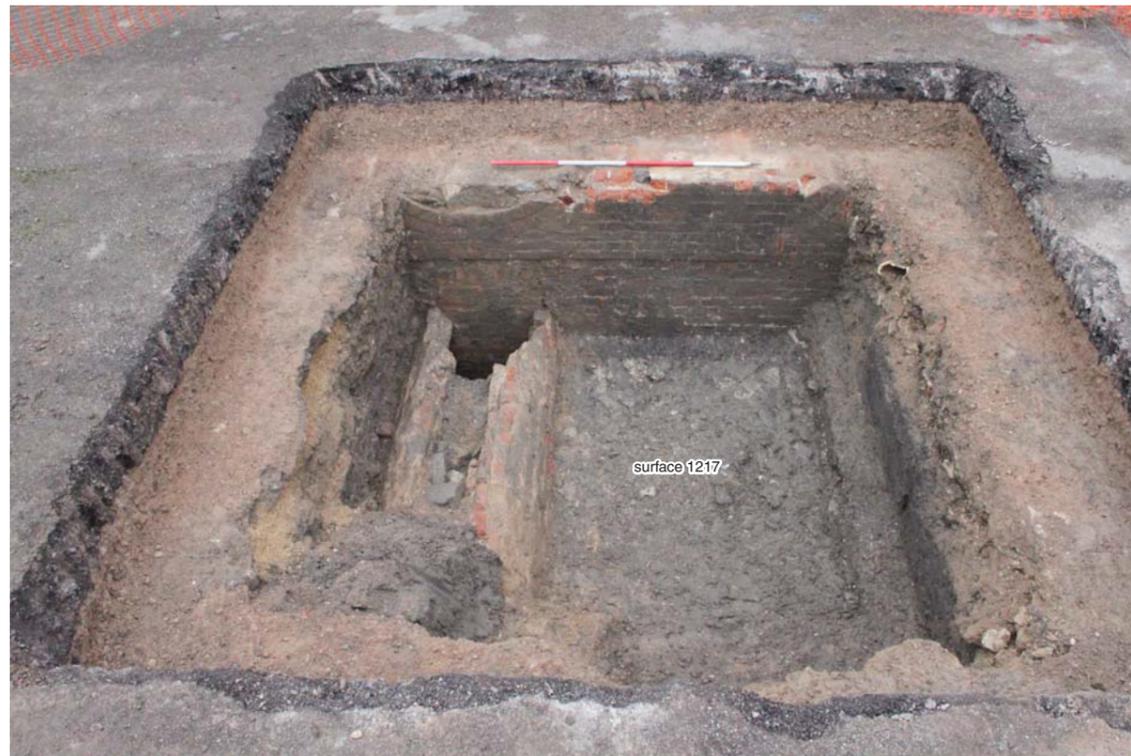
- 5.66 Surface 1217 and layers 1213 and 1212 were cut by construction trench 1216 for north/south aligned brick foundation 1215. This structure was exposed within the western edge of the trench and correlates well with the eastern elevation of the western block of the main quadrangular range of Blackburn's prison, adjacent to the central 'keeper's court' (see Fig. 4) . In common with similar foundations within other trenches, it comprised unfrogged red bricks bonded with light grey lime and sand mortar in English Cross coursing. It incorporated the remains of the bases of two inverted arches and survived to a width of at least 0.6m and to a depth of at least 1.45m, extending below the base of the trench.

- 5.67 The construction backfill associated with wall foundation 1215 was in turn cut by construction trench 1210 for brick culvert 1209. This feature was arched and constructed with similar materials to foundation 1215. It was aligned east/west and measured 1.1m in width and at least 1.35m in depth. It appeared to have originally extended through foundation 1215 but had subsequently been blocked by brick wall 1221, constructed inside the culvert, and by brick repair 1218 within wall 1215. Following the final blocking of the culvert, it was backfilled and covered by rubble deposit 1219, which was up to 1m thick and which contained a lead-alloy disc and a sherd of pottery of late 17th to 18th century date.

Trench 12, looking west, showing medieval surface 1217 and 18th-century prison wall and culvert (2m scale)

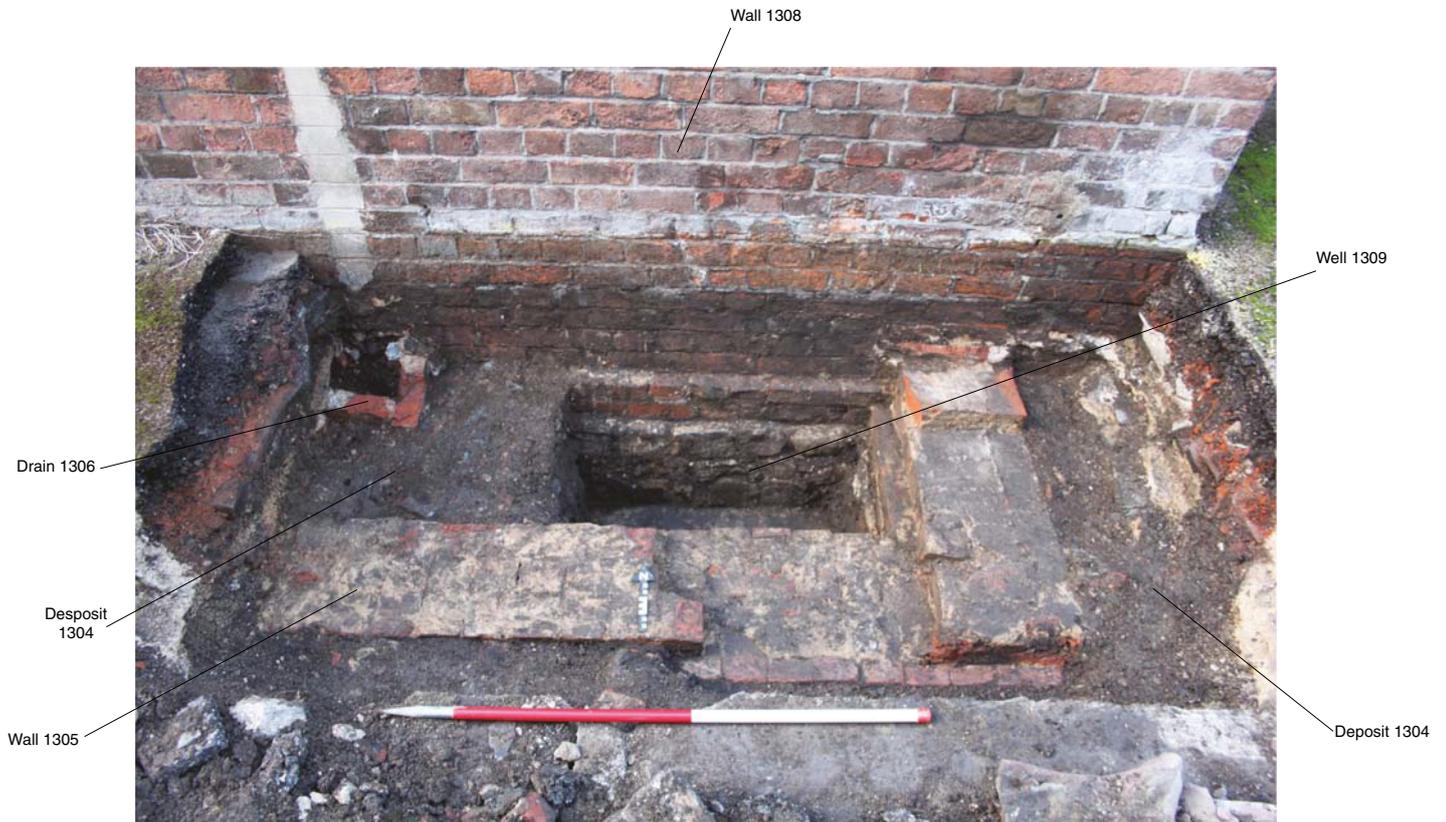
- 5.71 Surface 1313 was in turn overlain by deposit 1312, comprising demolition rubble, 0.2m thick. This was subsequently cut by a vertically-sided trench, 1311, for stepped stone foundations 1309, which were at least 0.6m deep, extending below the base of the trench. The foundations comprised roughly dressed limestone blocks and slabs, up to 0.5m in length and 0.15m in depth, arranged in regular courses and bonded with a sandy mortar. The three uppermost courses comprised visibly smaller stones than the lowest two courses. The construction cut for these foundations was backfilled with mixed deposit 1310, from which a lead alloy buckle and three sherds of pottery of mid to late 18th-century date were recovered.

- 5.72 Brick wall 1308, which forms the central southern wall of the extant former prison workshop, was constructed onto stone foundations 1309. The lowest two courses of brickwork were offset from the top of the stonework and then the face of the present wall was itself further offset from these two courses. The wall was constructed in English Bond style with evidence for the use of various types of mortar, presumably as a result of repairs, alterations or repointing.

Trench 13, looking north, showing foundations of 19th-century treadmill and later rebuilds (1m scale)

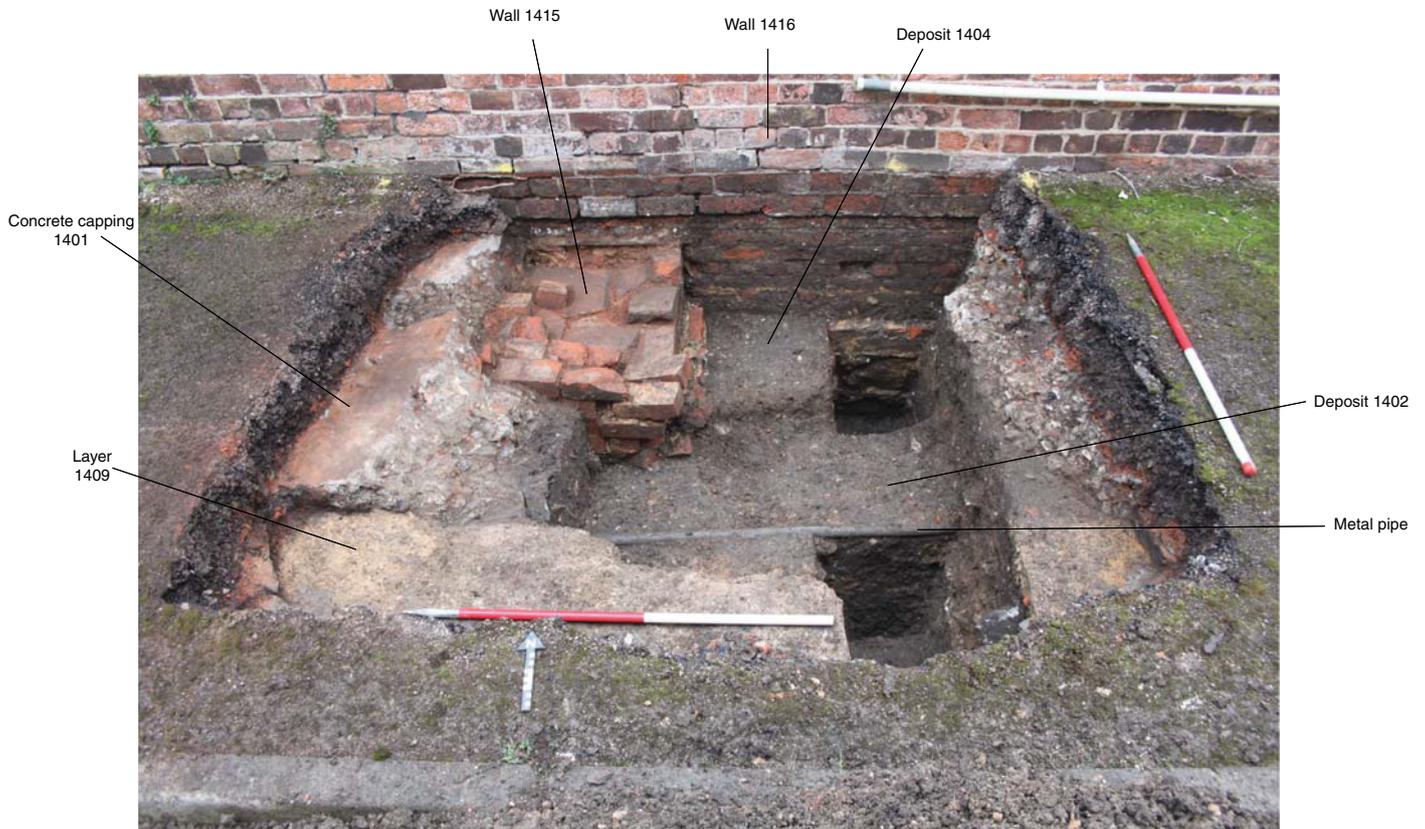
- 5.76 Deposit 1419 was cut by foundation trench 1407 for the extant former workshop wall 1406. The lower foundation courses of this wall were built in stone and were similar in size and material to the upper courses of foundations 1309 in Trench 13. The stonework was overlaid by a single course of brickwork before an offset for the main wall elevation. It was evident that from the eighth course of brickwork above the single brick foundation course, the wall overhung the lower courses slightly and it was observed that in this location the wall itself contained bricks of different sizes suggesting the re-use of readily available material.

Trench 14, looking north, showing foundations of 19th-century treadmill and later rebuilds (1m scales)

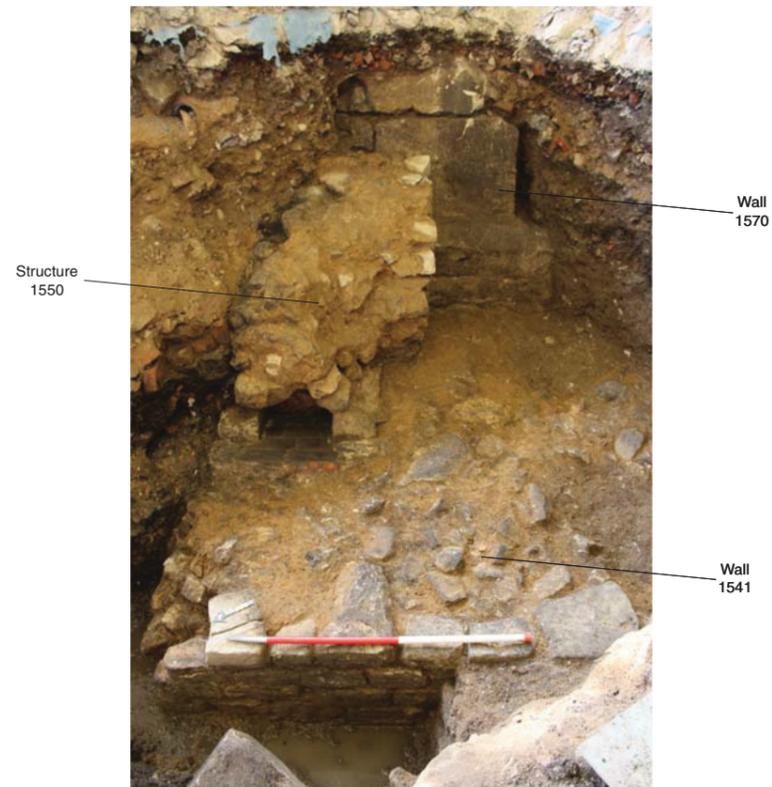
- 5.81 Wall 1541 measured at least 2.5m wide and a sondage excavated against its external (western) face demonstrated that it survived to a depth of at least 0.7m, extending below the limit of excavation. The visible face comprised dressed limestone blocks, up to 0.4m long, 0.3m wide and 0.15m deep, constructed in regular, even courses. Unlike the internal face exposed within Trench 11, there were no obvious signs of repair, such as the use of different mortar, in this elevation. Within the sondage, wall 1541 was abutted by sterile, gritty silty sand deposit 1592, from which no finds were recovered.

- 5.82 Foundation trench 1593 cut into the top of the surviving masonry of wall 1541, on the same north-east/south-west alignment. It contained a further wall, 1570, that was partially exposed within the south-easternmost corner of the trench. This later wall comprised large limestone ashlar blocks rising vertically for approximately 0.5m from the lowest visible extent, where there was then a chamfer of approximately 0.12m at an angle of c. 45°. Above this, the face of the wall sloped upwards at an angle of approximately 75°. The blocks within wall 1570 generally exhibited a uniform pattern of diagonal chisel marks.

Walls 1541, 1570 and structure 1550, looking south-east (1m scale)

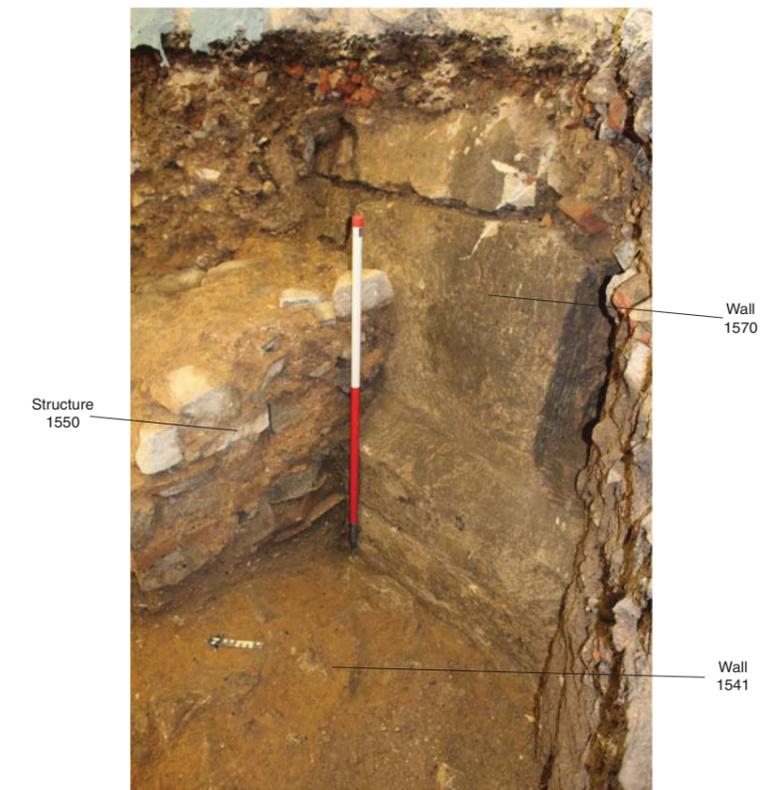
Western face of keep wall 1570 abutted by structure 1550, looking east (1m scale)

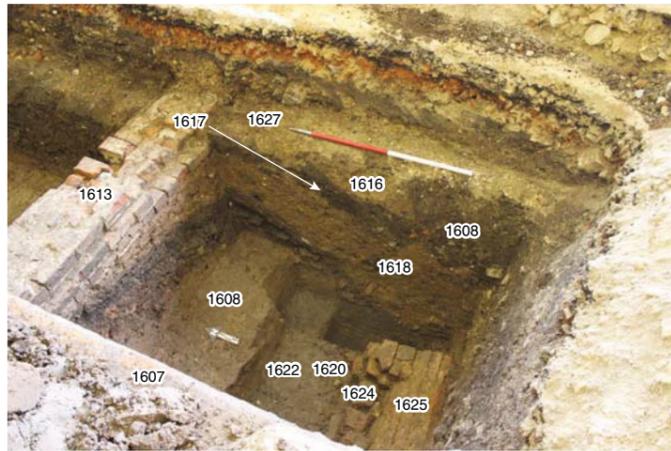
- 5.111 In the southern extent of the trench, uppermost deposit/ditch fill 1611 was cut by construction, or possibly robber cut, 1621 for east/west aligned culvert 1625. The culvert was constructed in unfrosted red brick bonded with yellow brown sandy mortar and was of arched construction. This culvert bears comparison with those identified in Trenches 12 and 15 and is therefore considered to be contemporary with Blackburn's prison.

- 5.112 Truncating the culvert construction/robber backfill deposits was a shallow construction trench for east/west aligned wall foundation 1613 and also north/south aligned wall 1607. The walls were contemporary and were constructed with unfrosted orange-red brick that were bonded by hard grey cement. Wall 1607 correlated closely with a boundary to the washing and drying ground depicted on the 1852 Board of Health map.

Southern end of Trench 16, showing wall 1613 and culvert 1625, looking north-east (1m scale)

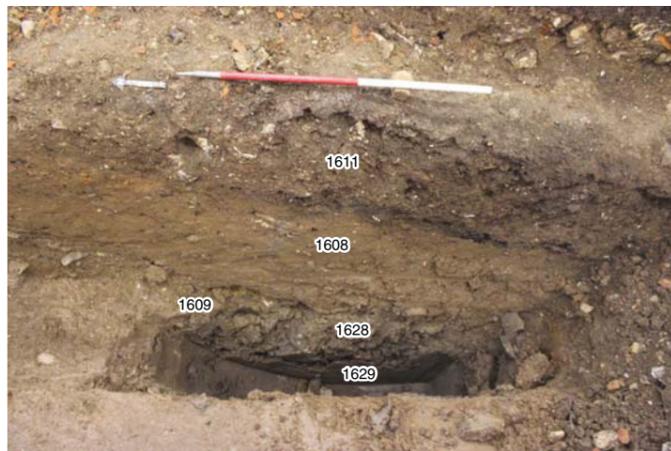
Trench 16 machine-excavated sondage, showing tipped deposits 1608, 1609, 1611, 1628 and 1629 looking east (1m scale)
