Devon County Council Historic Environment Record

Civil Parish & District: Sidford High Street, Sidmouth, Devon	National Grid Reference (between SY 31298 89731 and SY 313754 89953)		Number: (Leave blank for HES to fill in)		
Subject: Archaeological monitoring of the exreplacement trenches and insertion pits in Si		Photo attached? Yes			
Planning Application no: Non Applicable		Recipient museum: Royal Albert Memorial Museum			
OASIS ID: cotswold2-125759		Museum Accession no: 11/56			
Contractor's reference number/code: CA project number 3563		Dates fieldwork undertaken: 8 th September 2011 – 26 th March 2012

PROJECT TITLE
Gas Main Replacement, Sidford, Devon

Photographs

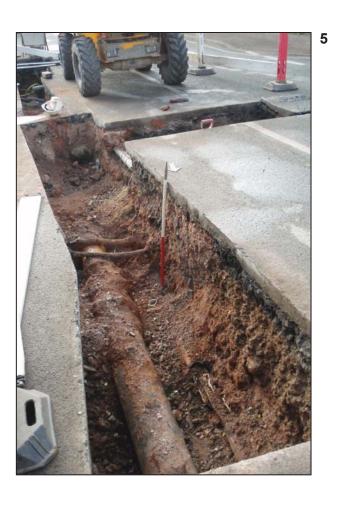
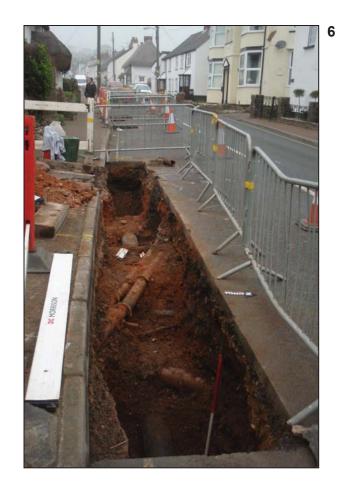
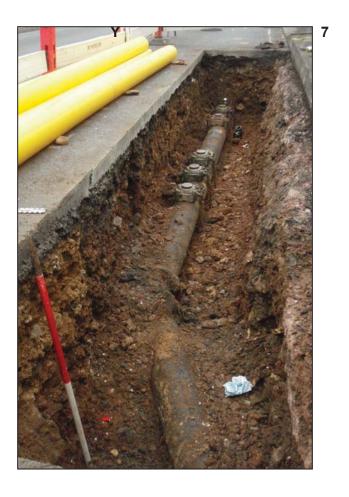
5 to 7

- Insertion pit 104, Church St looking south 5
- Insertion pit 221, near St. Peter's Church on Sidford High Street, looking west
- Insertion pit 222, outside St. Peter's Church on Sidford High Street, looking easrt
