# Exeter City Council Historic Environment Record

Civil Parish & District: Exeter	National Grid Reference: SX 9156 9283	Number:
Subject: Archaeological monitoring on the Exeter scheme, St David's Terrace, Exeter.	gas main replacement	Photo attached: Y
<b>Planning Application no:</b> n/a	Recipient mus Royal Albert M	eum: Iemorial Museum
OASIS ID: n/a	Museum Acces	ssion no:
<b>Contractor's reference number/code:</b> EGS13	<b>Dates fieldwor</b> 29/4, 8/5, 10/5, 29/5/13

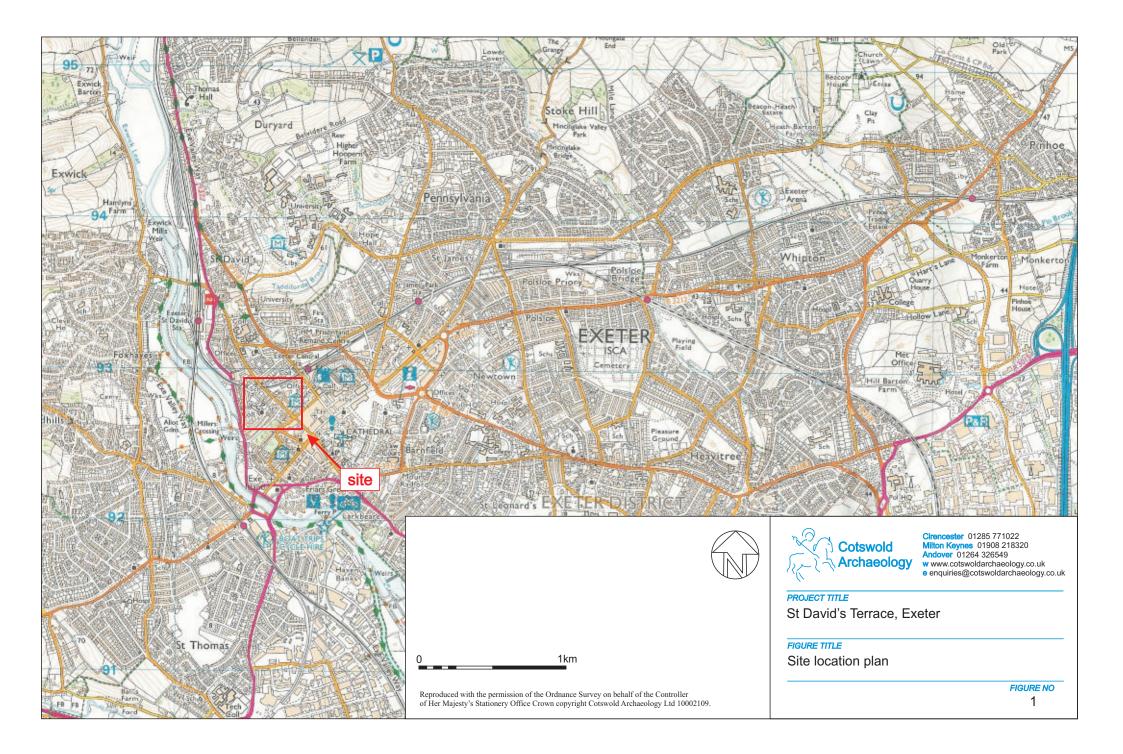
A watching brief was maintained by Cotswold Archaeology during groundworks associated with gas main replacement in St David's Terrace and Dinham Road, Exeter (Fig. 1). The proposed works are located to the north of an excavation undertaken by Exeter Archaeology in 2008 which produced evidence for post-trench timber buildings and a cremation burial of the Roman military period (c. A.D. 55-75). It was therefore considered possible that significant remains or deposits of Roman or later date might survive within the proposed works area and may be exposed during trenching.

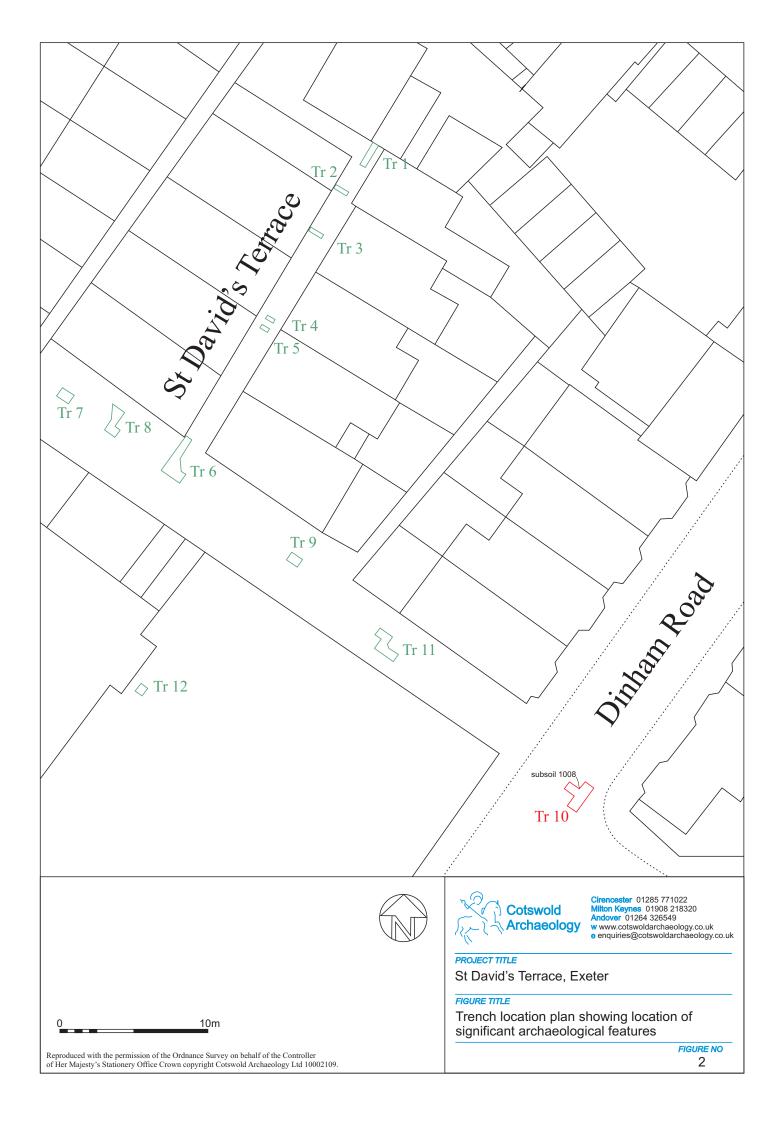
The works comprised the excavation of 12 trenches, for insertion of a replacement gas main (Fig. 2). All of the works exposed ground heavily disturbed by modern services to an average depth of between 600-850mm below current ground level. Trench 10 exposed archaeological deposits. Although none were of archaeological importance:

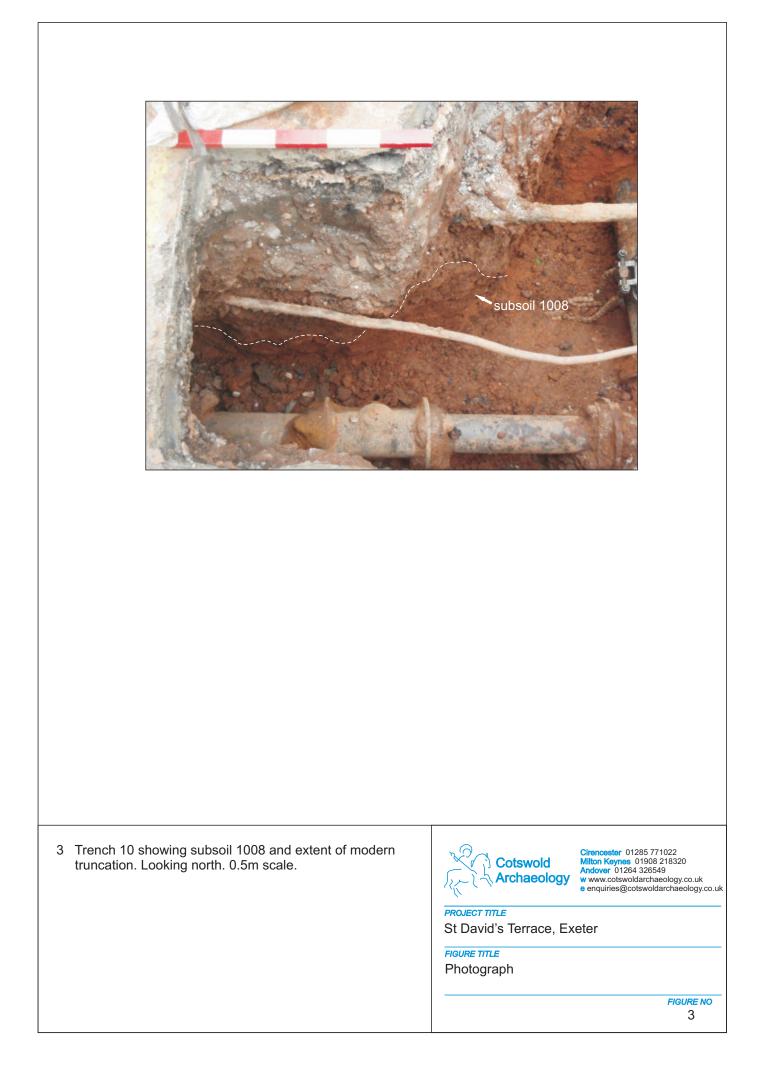
Trench 1 (Fig. 3):

1000 0-0.1m tarmac

1001 0.1-0.5m service trench

1002 0.1-0.5m mid reddish brown silty clay (service trench fill)

1003 0.1-0.6m service trench

1004 0.1-0.6m mid reddish brown silty clay and red sand (service trench fill)

1005 0.1-1.1m service trench

1006 0.1-1.1m mid reddish brown silty clay (service trench fill)

1007 0.1-0.7m mid to dark reddish-brown silty clay (disturbed ground)

- 1008 0.7-0.9m mid reddish brown silty clay (subsoil)
- 1009 0.9m+ mid orangey red clay (natural subsoil)

Deposit 1008 was identified at the base of Trench 10, overlying natural subsoil, and consisting of a clean mid reddish brown silty clay with occasional gravel inclusions (Fig. 3). Two fragments of probably Iron Age pottery, consisting of small body sherds, were recovered from 1008. This deposit has been interpreted as a surviving subsoil. The deposit was truncated by modern services to the east, south and north, and was overlain by mid to dark reddish brown silty clay 1007, interpreted as modern disturbed ground.
