Gloucester Bus Station Station Road Gloucester, Gloucestershire

Programme of Archaeological Recording

CA Project: 6407
CA Report: 17691

July 2018

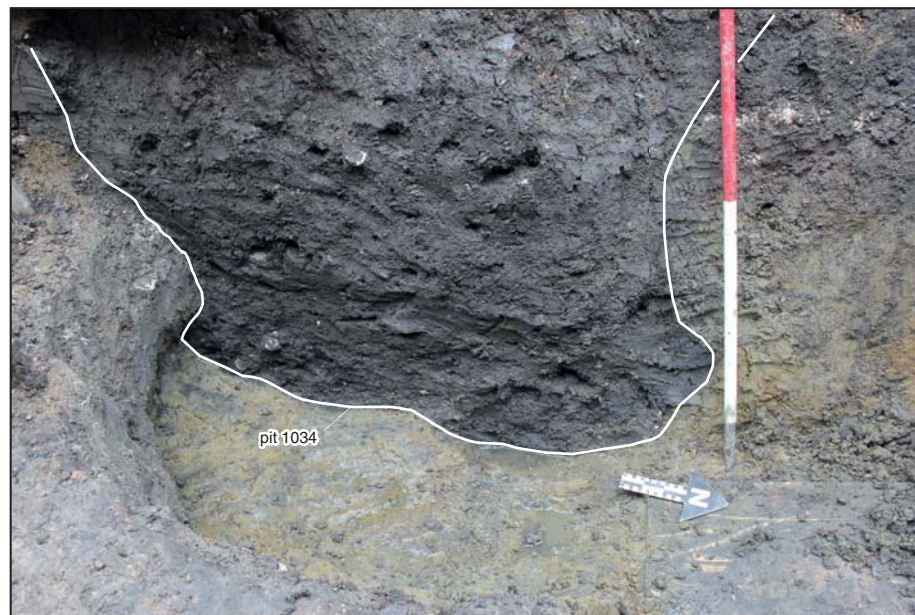
Pit 1034, looking west (1m scale)

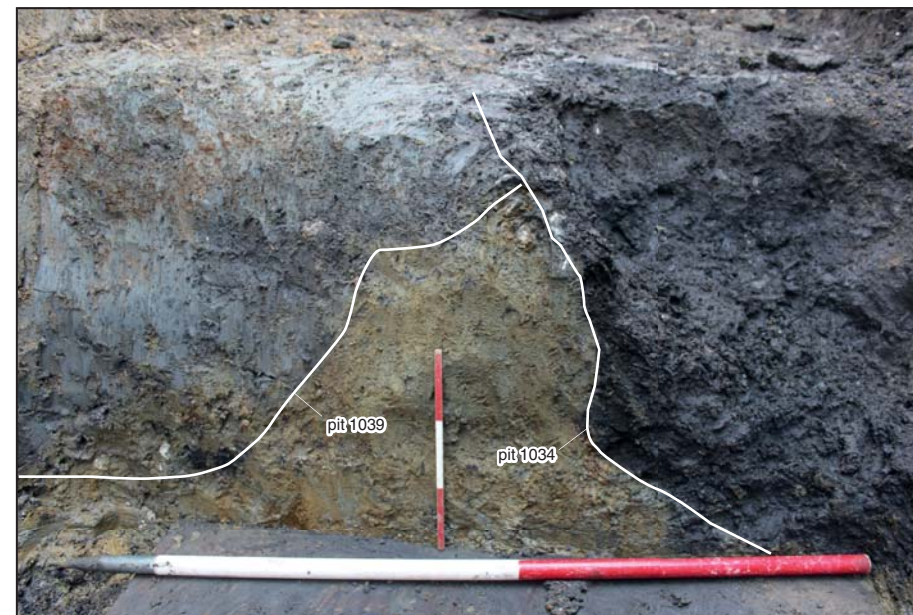
Pit 1039 and pit 1034, (1m and 0.3m scale)

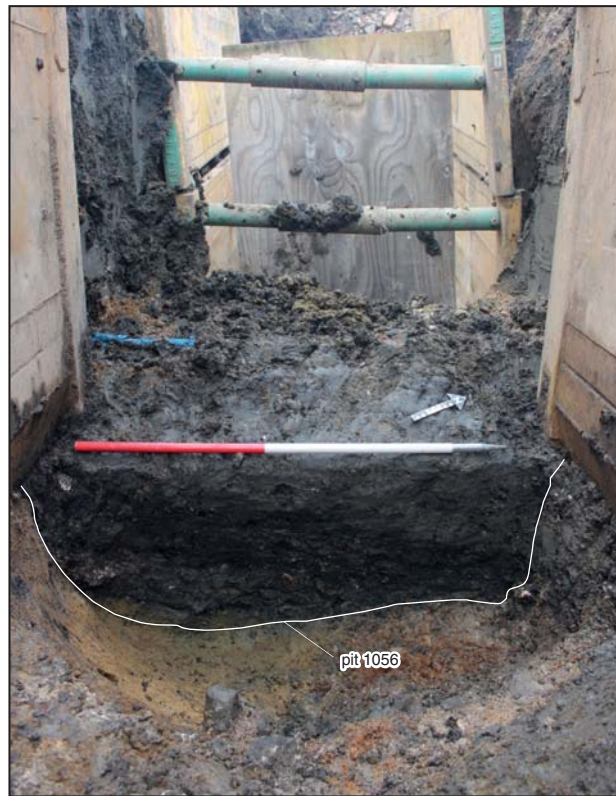
Pit 1056, looking north-west (1m scale)

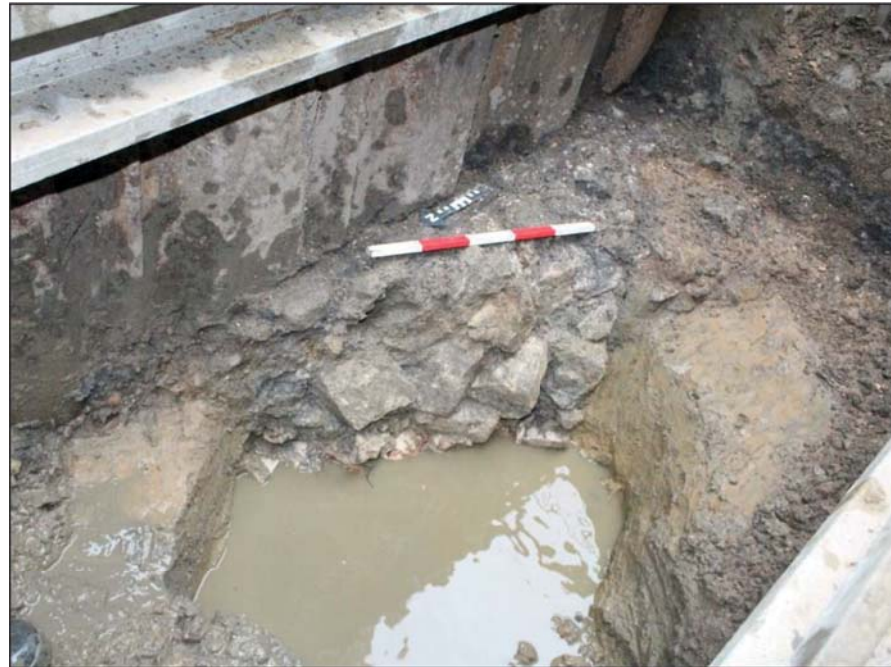
Wall footing 1016, looking south-east (0.5m scale)

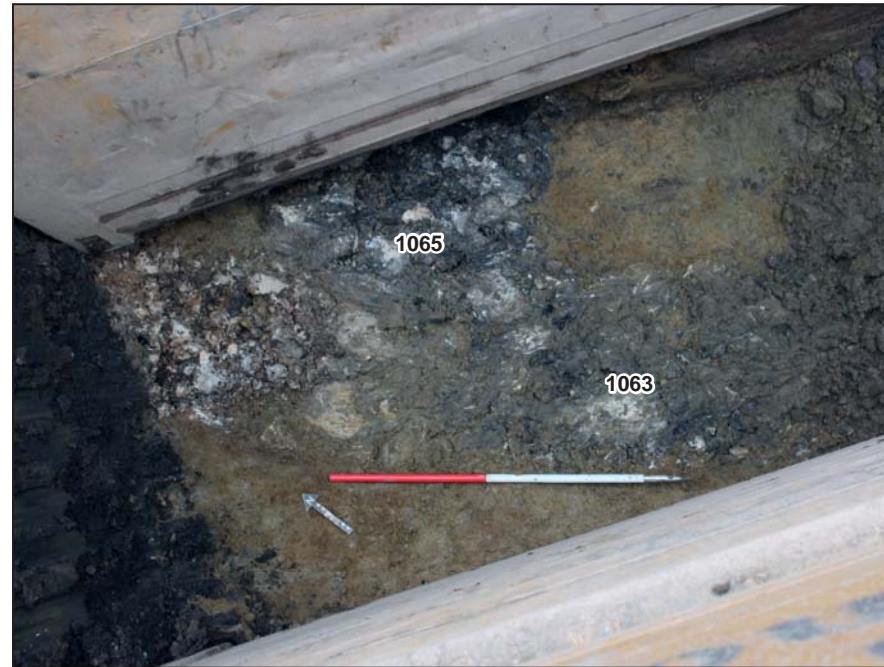
Wall footing 1063 and 1065, looking north-east (1m scale)

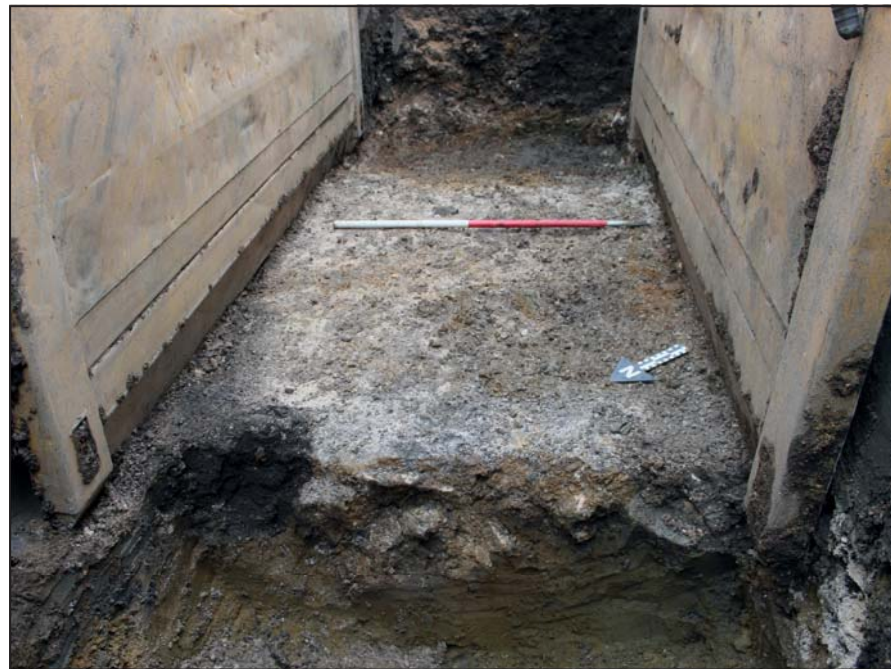
Surface 1044, looking south-east (1m scale)

- 5.7 Mortar and limestone rubble surface 1044 (12.75m AOD) was identified throughout the central and southern extent of the trench (Figs 3 and 8 photograph). It measured approximately 0.14m in thickness, contained two sherds of 2nd to 4th-century Roman pottery, and being principally derived from demolition material is comparable with deposits 617, 711 and 840 observed during the preceding evaluation (CA 2016). No stratigraphic relationship was observed between deposit 1011 and surface 1044 but both were subsequently cut by medieval pit 1039.

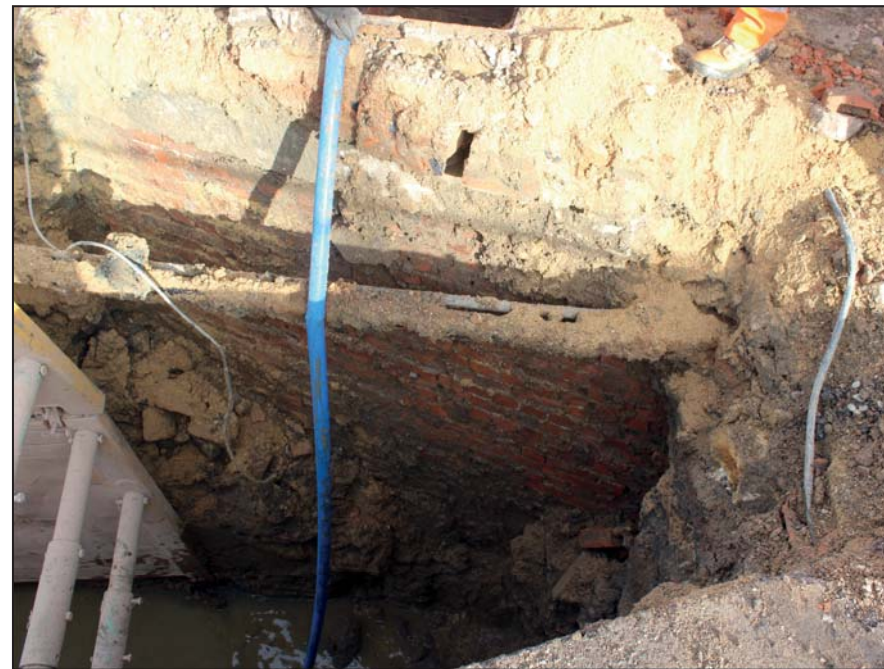
Manhole 3 at southern extent of drainage trench

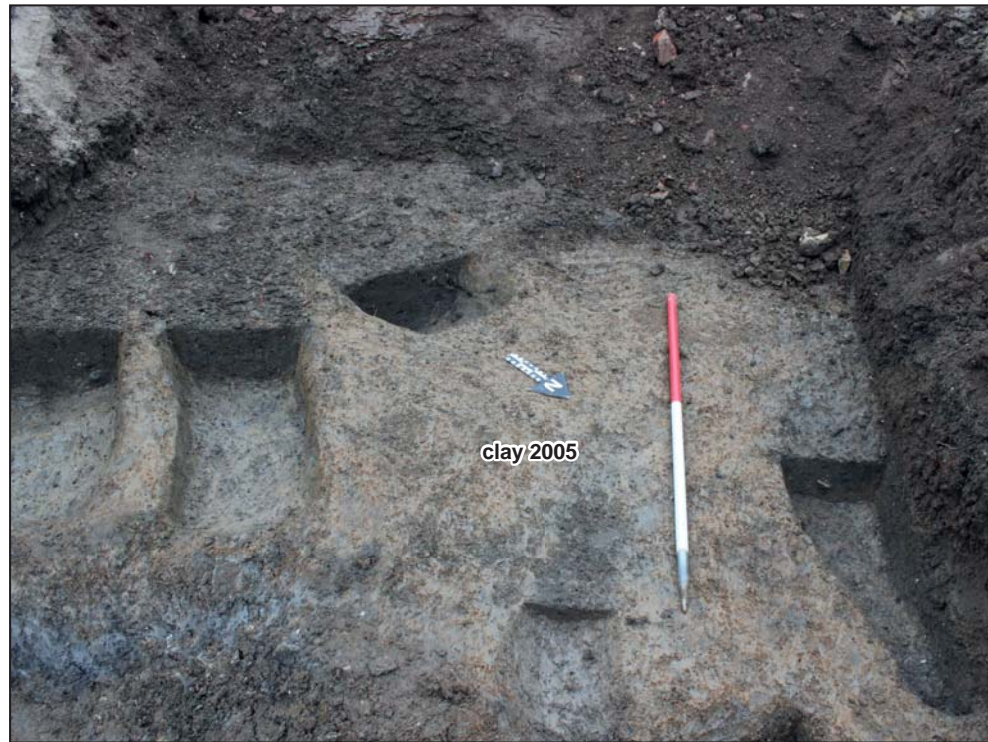
Post-medieval features, looking south-west (1m scale)

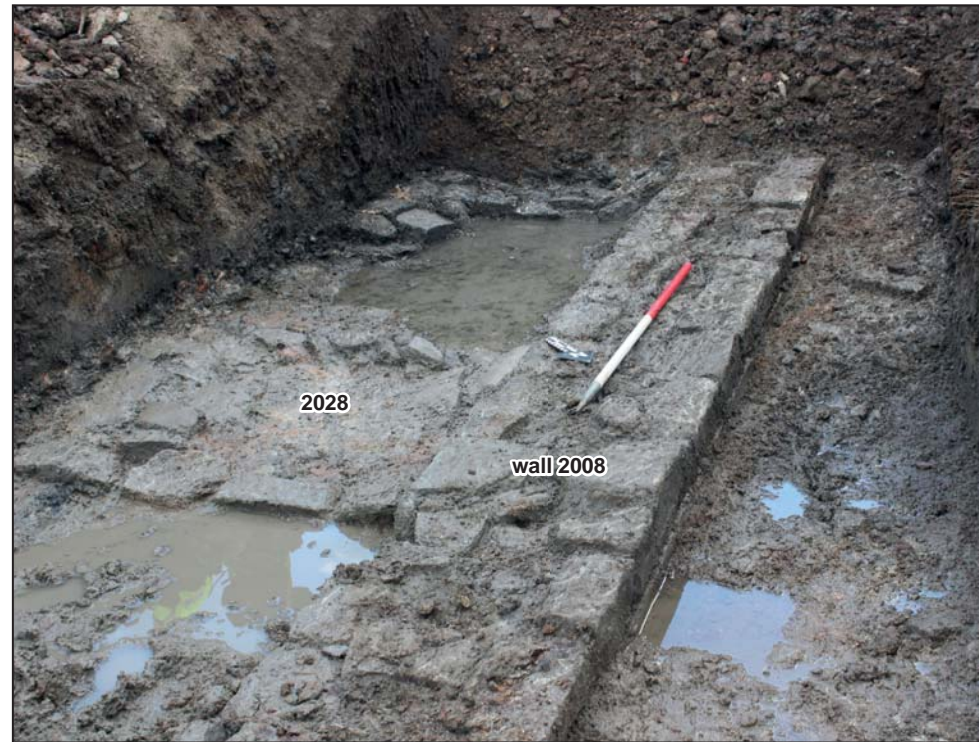
Wall 2008 and structure 2028, looking south-west (1m scale)

- 5.23 Abutting, and perpendicular to, the south-eastern elevation of the wall was rectangular structure 2028 (see Fig. 9 for location and extent and Fig. 10). It was founded in shallow, flat cut 2044, measuring at least 1.22m in length (before extending beyond the south-eastern baulk), 1.2m in width and 0.3m in depth. Fragments of limestone were revealed lining the base and along the north-eastern and south-western side that were in turn sealed by deposit 2045 comprising lime mortar and heat affect clays from which five fragments of Roman CBM were recovered. The function of this structure remains undetermined although it may represent a hearth or other internal structural element within the building.

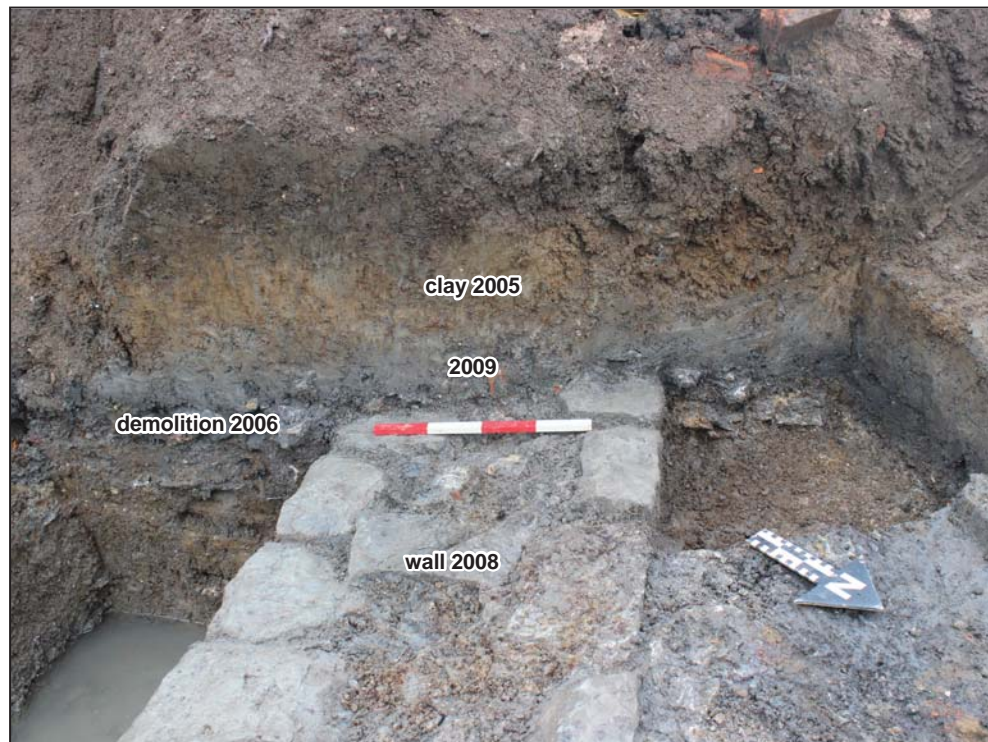
North-east facing section of Trench 2, looking south-west (0.4m scale)

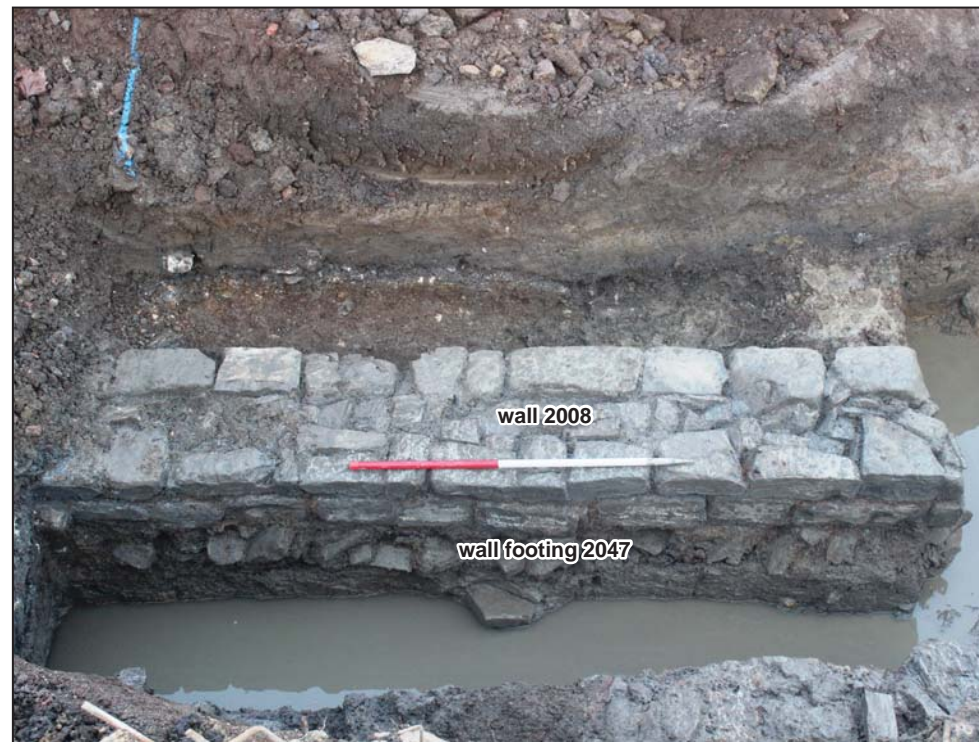
Wall 2008 and wall footing 2047, looking north-west (1m scale)

- 5.22 A corner of a probable stone building, defined by north-west/south-east aligned wall 2007 and perpendicular return 2008, was identified cutting deposit 2011/2041/2042/2043. The total length of the wall measured in excess of 13m, was typically 0.6m in width and survived to a height of 0.4m, with two courses of roughly dressed limestone present founded upon pitched rubble footing 2047 (see Figs 9 and 10). The associated foundation trench, 2014, was vertically sided with a flat base. A small quantity of yellow mortar was observed bonding the rubble core of the wall but was not present between the coursed facing stones. No artefactual material was recovered from within the wall or its rubble core, but two sherds of broadly dated Roman pottery and CBM were recovered from rubble footing 2015/2040.

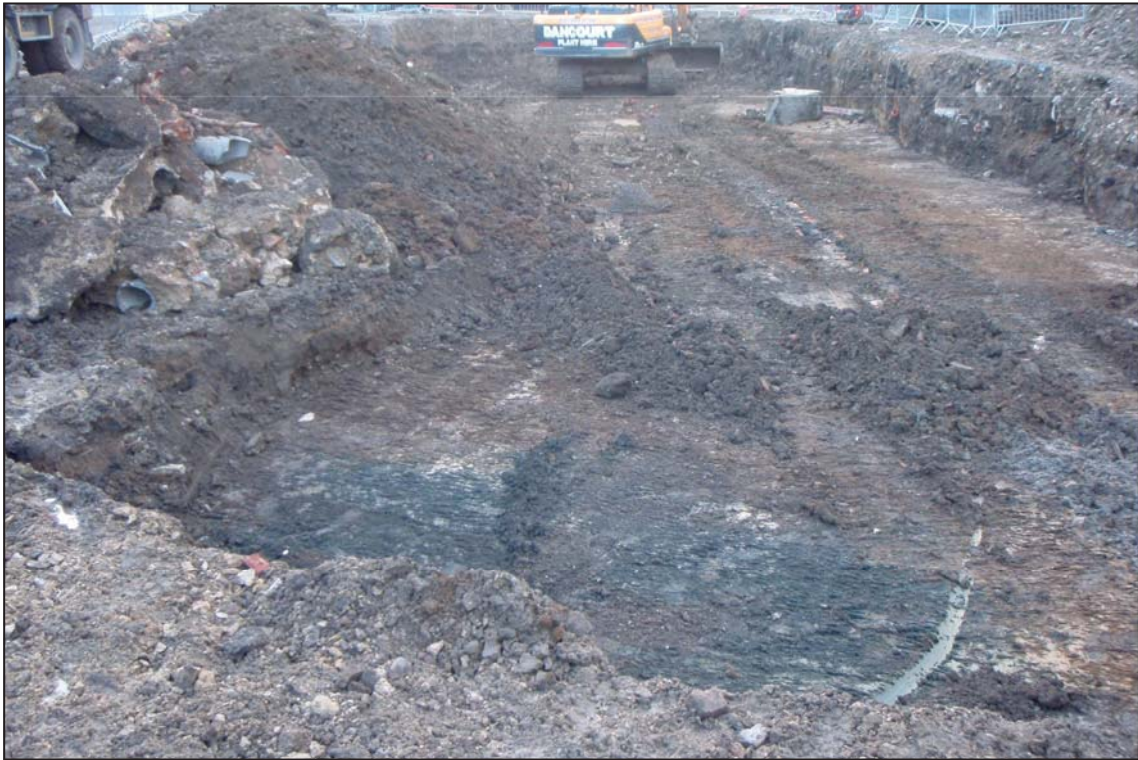
Trench 3, overview

5.1 The natural substrate was identified solely in Trenches 1 and 2, with the groundworks for Trenches 3 and 4 being founded much shallower. Throughout Trench 3 the groundworks for the attenuation tanks were restricted to a depth of 13.64m AOD (1.83m below the existing ground level (bpgl)) solely revealing post-medieval and modern deposits throughout (see Fig. 11 photograph). Consequently this trench is not discussed further.

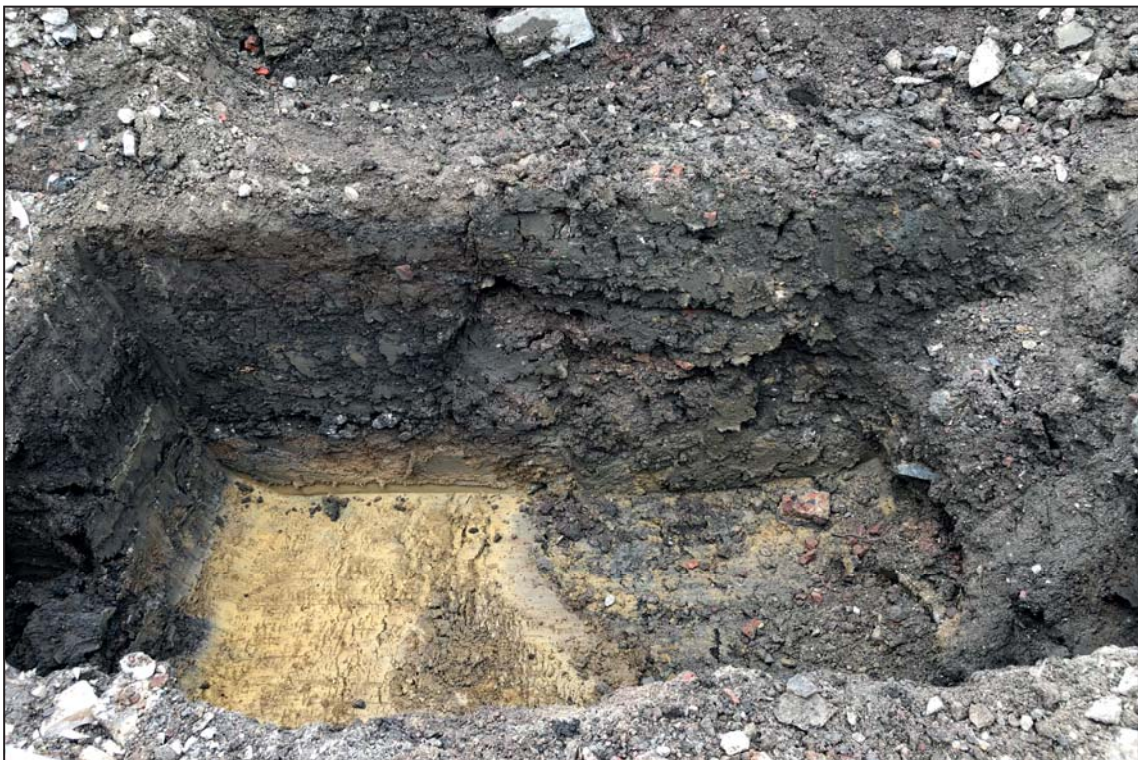
Trench 4, representative section
