The Sheds Perry Pear Orchard Barton-on-the-Heath Warwickshire Archaeological Evaluation

CA Project: 6099 CA Report: 17274

Archaeological Evaluation

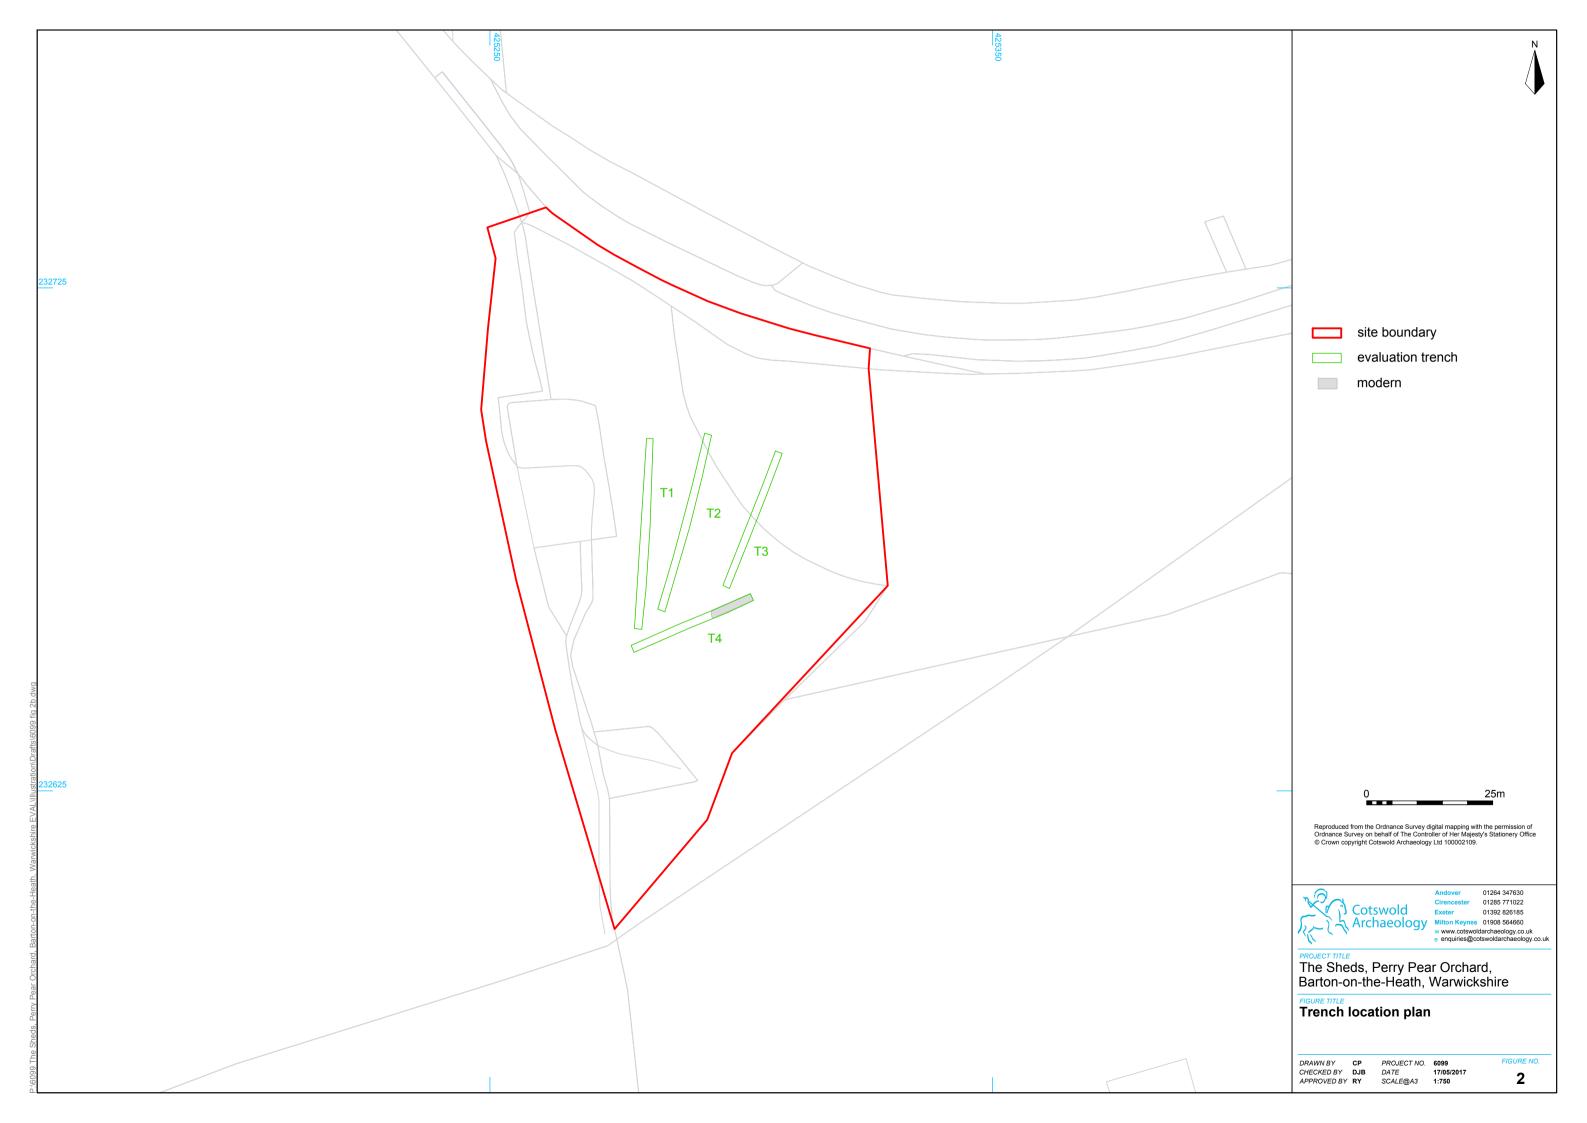
- 4.1 The fieldwork comprised the excavation of 4 trenches in the locations shown on the attached plan (Fig. 2). The trenches were restricted to the area of the proposed new build due to the presence of great crested newts on the remainder of the site. Trenches 1 and 2 were 40m long and 1.8m wide, whilst Trenches 3 and 4 were 30m long and 1.8m wide. Trenches were set out on OS National Grid (NGR) co-ordinates using Leica GPS and surveyed in accordance with CA Technical Manual 4 *Survey Manual*.
- 4.2 All trenches were excavated by mechanical excavator equipped with a toothless grading bucket. All machine excavation was undertaken under constant archaeological supervision to the top of the first significant archaeological horizon or the natural substrate, whichever was encountered first. Where archaeological

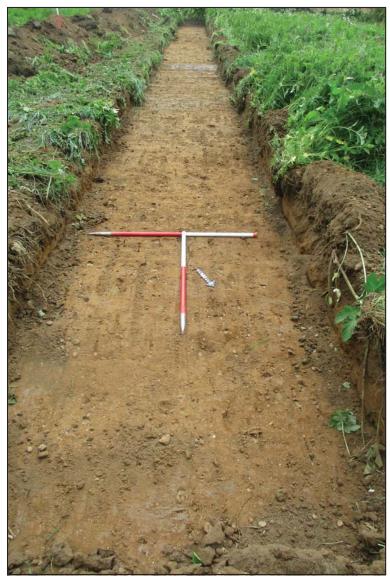
- 5.1 This section provides an overview of the evaluation results; detailed summaries of the recorded contexts are to be found in Appendix A.
- 5.2 The geological substrate, comprising sand and silts, was encountered at a depth of between 0.3–0.45m below present ground level (bpgl) in all trenches. It was overlain by a layer of subsoil, up to 0.2m thick, which was in turn sealed by up to 0.4m of topsoil.
- 5.3 Trenches 1-3 contained no archaeological features or deposits. One modern rubbish pit was identified within Trench 4. It cut the subsoil and contained modern bricks, plastic bags and barbed wire.

Trench 3, looking south-west (scales 1m)
