Land at Lurke Street and St Cuthbert's Street Bedford Bedfordshire

Archaeological Evaluation

CA Project: 660912 CA Report: 17293

June 2017

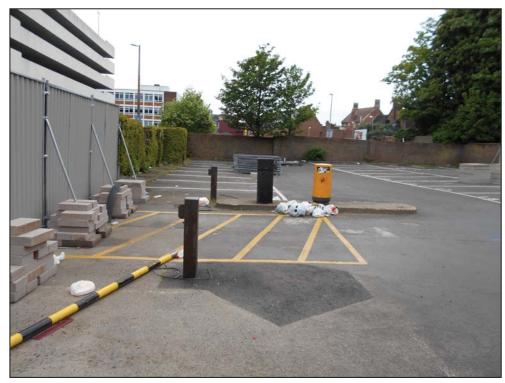
Site: plot A, pre-excavation, looking west

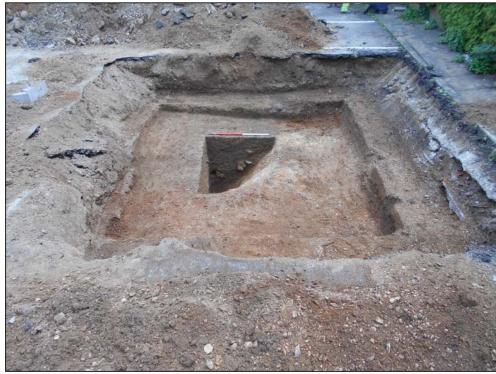
Trench 1, looking east (scale 1m)

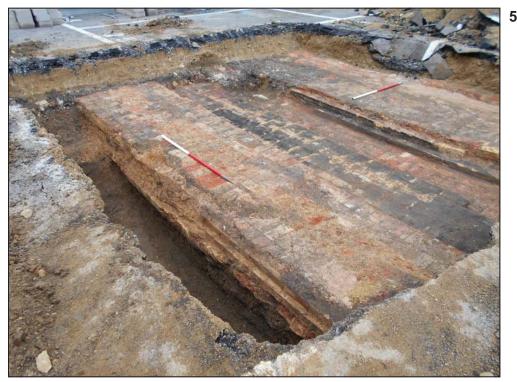
Trench 2 brickwork, looking north-east (scale 1m)

- 5.8 Foundation cut 210 was excavated into layer 211 and contained a slab of 0.5m thick concrete (209) that covered all but a 0.8m strip of the trench. Built on top of this was the remains a late 19th to early 20th-centuary building, comprising north/south orientated red-brick walls 203 and 206 and red-brick floor surfaces 205, 204 and 212. Walls 203 and 206 were identified for a length of up to 4.5m extending beyond the southern and northern limits of the trench. They were constructed of red-bricks (L. 240mm, B. 130mm, D. 70mm), in an English bond, with a white/light grey hard mortar. The floor surfaces were constructed of similar sized bricks.

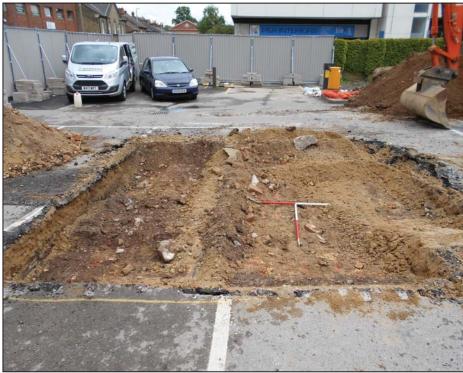
Trench 3, looking south (scales 1m)

5.10 Deposit 304, comprising loose dark brown grey sandy silt with brick, concrete rubble and metal inclusions, was identified within two sondages excavated at the base of the trench. It was identified at a depth of 0.64m bpgl and excavated by machine to a depth of 2.2m without the base of the deposit being reached. The concrete inclusions in the deposit indicated a later 19th century or 20th-century date for the deposit. It was overlain by further layers of demolition rubble (303 and 302 respectively), which most likely represent the same event. This was in turn overlain by silty sand bedding deposit 301, which measured 0.22m thick, which was in turn sealed by tarmac (300), measuring 0.1m thick.

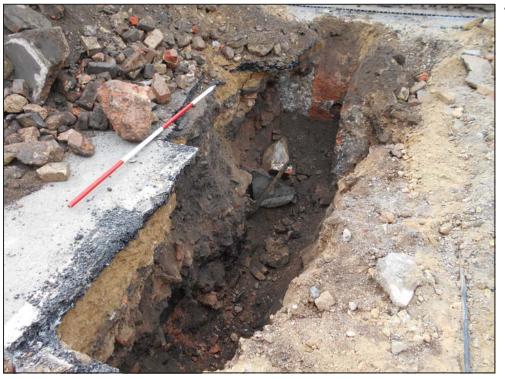
Trench 3, looking south-east (scale 2m)

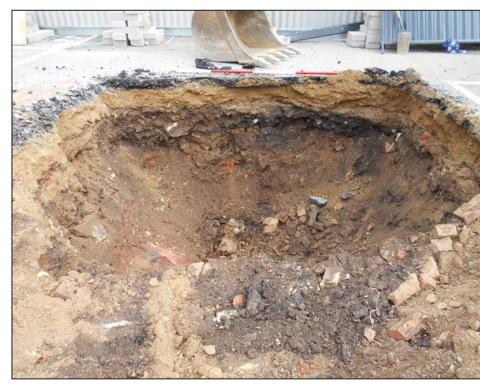
Trench 3, looking north (scale 2m)

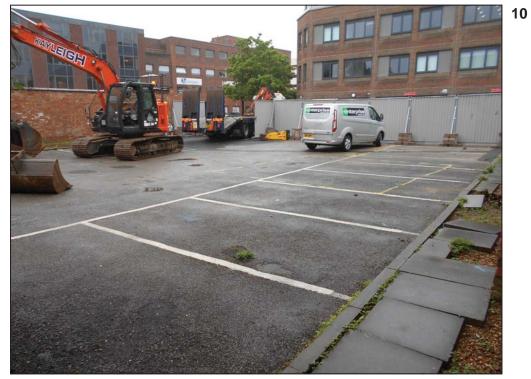
Plot B pre-excavation, looking south-west

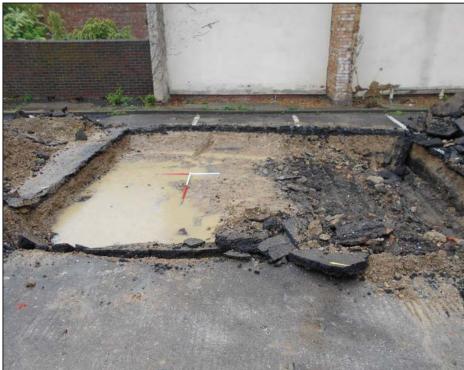
Trench 4a, looking north (scales 1m)

5.11 The earliest deposit encountered was post-medieval/modern grey brown sandy silt demolition layer 402b, which contained frequent brick and stone inclusions. It was encountered at 0.34m bpgl and observed to a depth of 0.64m bpgl. It was overlain by silty sand bedding deposit 401a, which measured 0.29m thick, which was in turn sealed by tarmac (400a).

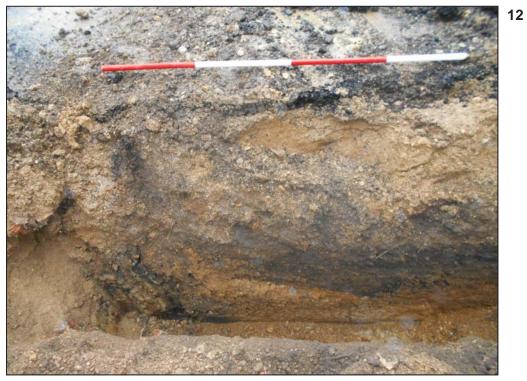
Trench 4b, looking west (scale 2m)

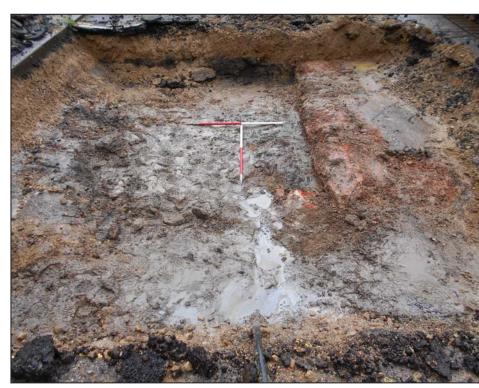
Trench 5a, looking west (scales 1m)

depth of 0.5m bpgl and cutting deposit 502a, was a red-brick rubble foundation 503a. This entered the trench from the west and ran for a distance of approximately 3m before turning to the north and exiting the trench via the northern baulk. It was composed of crushed red-brick and mortar and measured 0.65m wide and over 0.24m thick. This was in turn overlain by bedding layer 501, which measured 0.38m thick and was sealed by tarmac (500a) 0.12m thick.

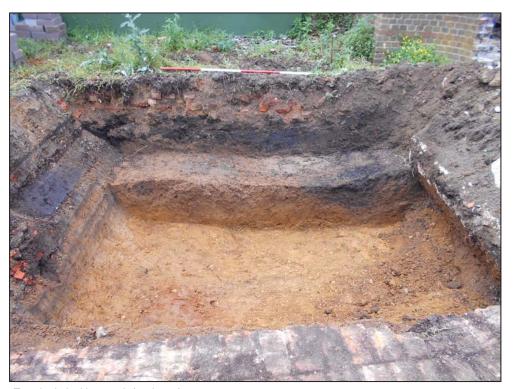
Trench 5b, looking south (scale 2m)

- 5.16 Partially overlying pit 506b was east/west orientated red-brick wall 501b. This wall was recorded for a length of 3.6m, extending beyond the eastern and western extents of the trench. It was 0.22m wide and survived to a maximum height of four courses (0.25m). It was constructed of red-bricks in an English bond with cement mortar. The brick foundations 501b to a post-medieval building could be seen running on an east/west axis through the section extending to a depth of 0.4m bpgl. Sealing all the deposits within the trench was topsoil 500b, measuring 0.1m thick.

8.10 The wide and deep pit identified within Trench 5b probably represents a quarry pit for gravel or sand extraction, presumably for use in the small scale building/repair within the site or its wider environs. Although this feature is indicative of quarrying, due to its limited exposure the exact form and nature could not be determined and it remains possible that it may relate to other activities.
