**Smart Systems Ltd
(Phase 5)
Arnolds Way
Yatton
North Somerset**

Archaeological Evaluation

CA Project: 880212
CA Report: 17297

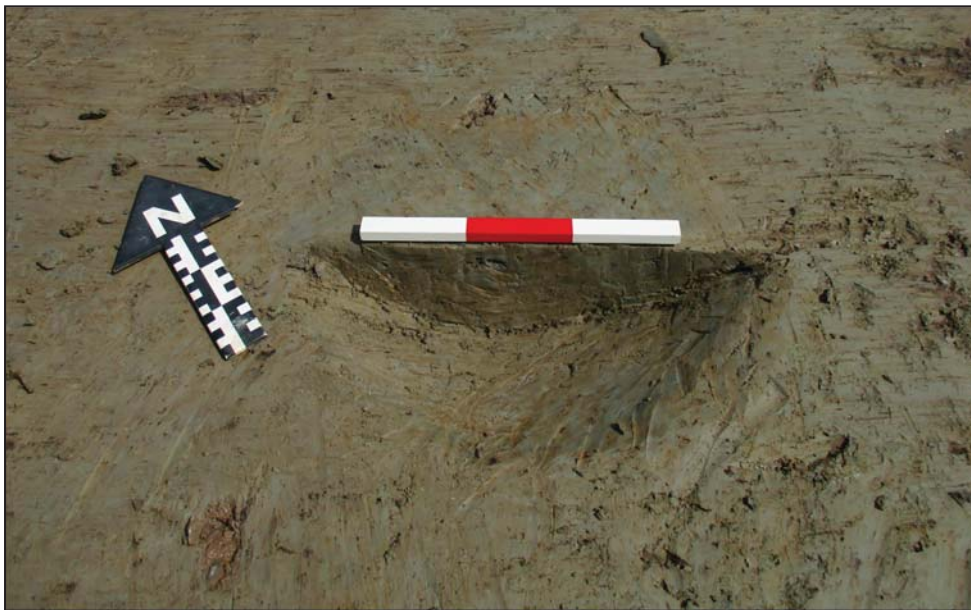
Trench 1: section and photograph

Section AA

Pit 104, looking north-east (0.3m scale)

- 5.1 This section provides an overview of the evaluation results. Detailed summaries of the recorded contexts can be found in Appendix A.
- 5.2 The natural substrate comprised blue-grey clay. It had been machine-truncated across the entire site to a depth of 0.45m–0.6m below its original surface level. The overlying topsoil and subsoil deposits had been entirely removed and the ground level had been made up with sandy/stony levelling deposits overlain with hardcore.
- 5.3 Sub circular pit 104 (Fig. 3) was identified at the north-western end of T1. This pit was cut into the natural substrate and sealed by a modern levelling layer. It contained a single undated fill (105).
- 5.4 T2–T4 contained no archaeological features.

- 6.1 The entire evaluation site has been machine-truncated. All topsoil and subsoil deposits have been removed and the underlying natural substrate has been truncated to a depth of 0.45m–0.6m below its original surface level. The Smart Systems groundworks team on site stated that this truncation took place in late summer/autumn 2016.
- 6.2 The base of a single undated pit was recorded in T1. It was not clear if this was the heavily-truncated base of a very deep earlier feature, or if was created during the truncation process. The extensive modern truncation will have removed any other archaeological features/deposits which may once have been present.
