**Land at Ricardo Court
Bramley
Surrey**
Archaeological Evaluation

CA Project: 770456
CA Report: 17537

September 2017

Archaeological Evaluation

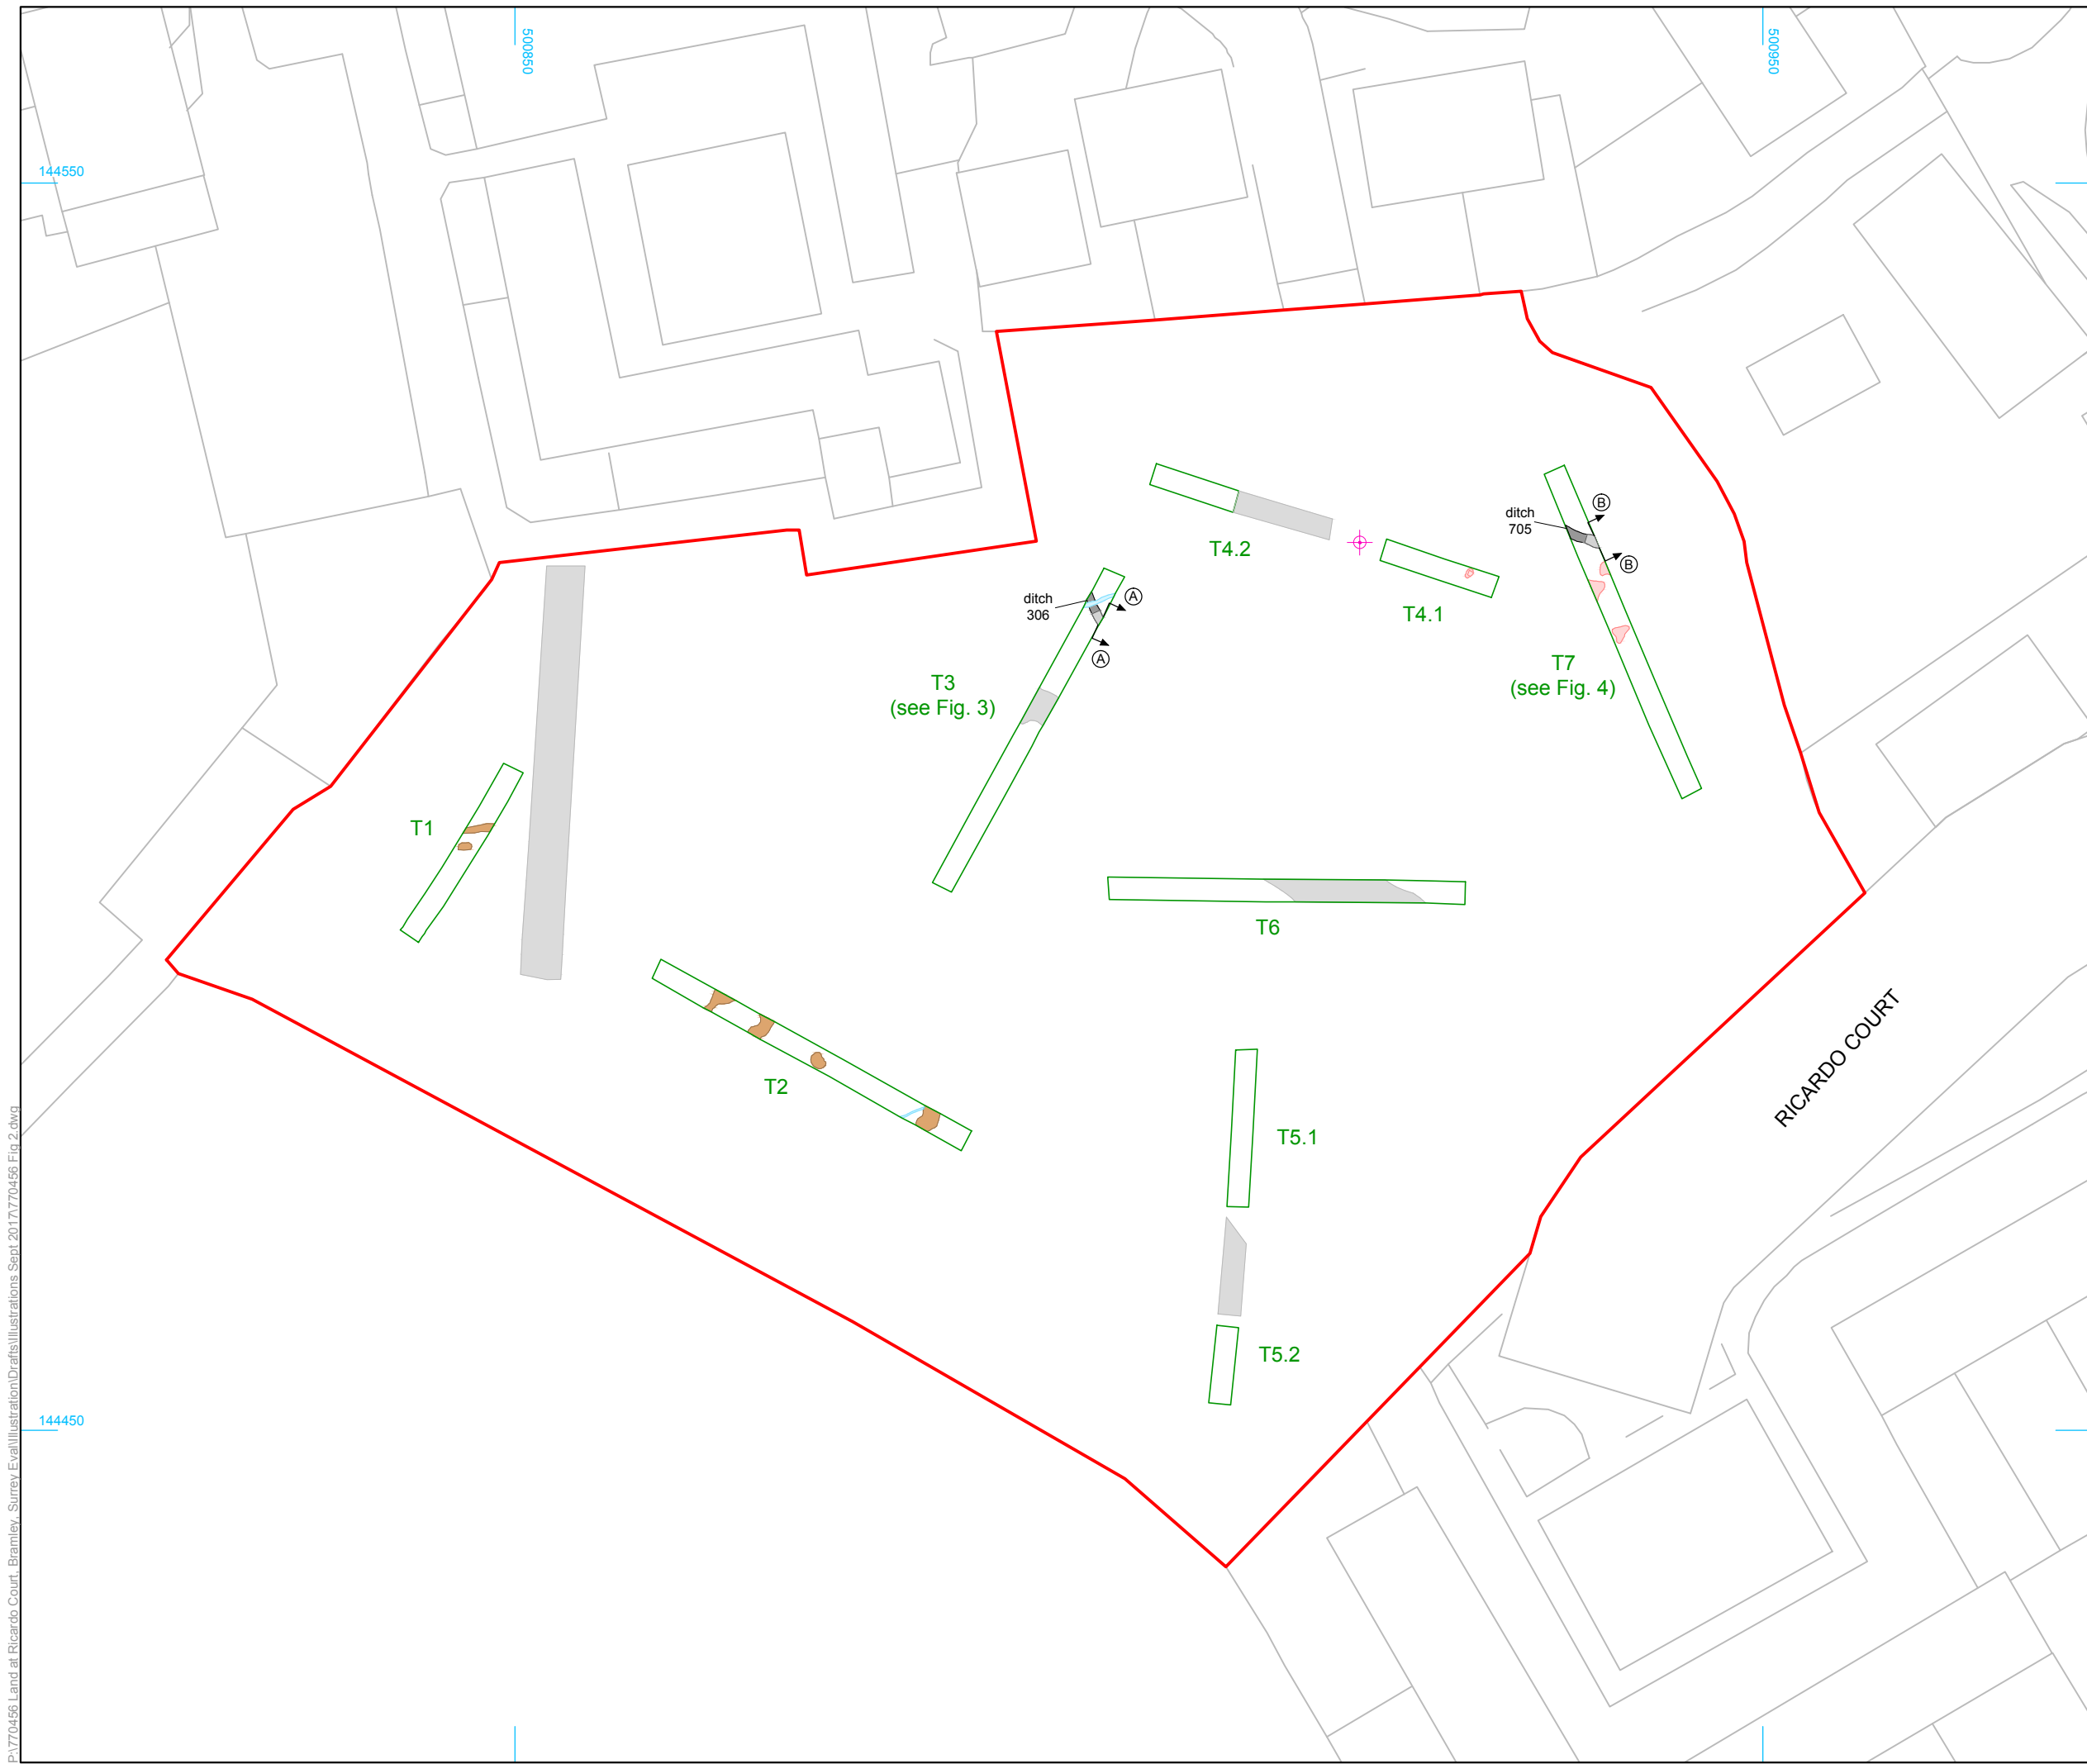
FIGURE TITLE
Trench location plan showing archaeological features

- 4.1 The fieldwork comprised the excavation of seven trenches, each 30m long by 1.8m wide, in the locations shown on the attached plan (Figure 2). **Trench 1, 4, 5, 6 and 7** were repositioned due to site boundary constraints, proximity to overhead cables or the position of the current site cabin with the approval of Nick Truckle, the Archaeological Officer for SHCT. Trenches were set out on OS National Grid (NGR) co-ordinates using Leica GPS and surveyed in accordance with CA Technical Manual 4 *Survey Manual*.

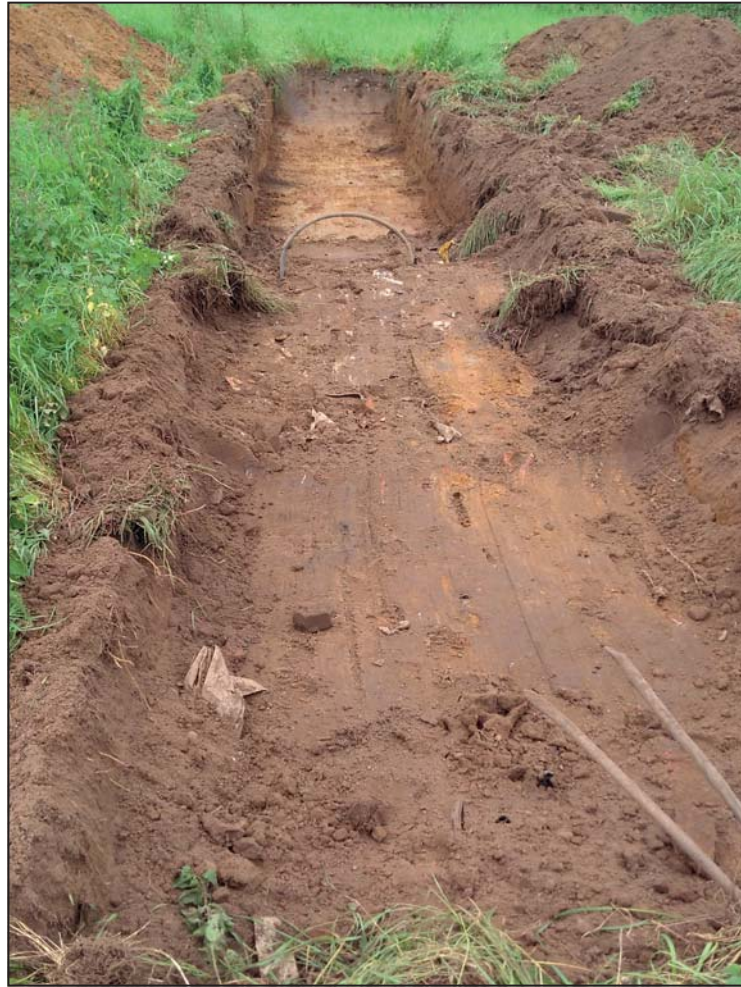
- 5.7 Modern disturbance was encountered in five trenches, located across the site. **Trench 1** had the remains of a hard standing, running across the north-western aspect of the trench, on a north-south alignment. **Trench 3** and **6** had modern disturbance running on a northwest-southeast alignment. This modern disturbance broadly corresponds to the current site entrance and probably represents the original site access. **Trench 4** contained a dump of modern construction materials and cables towards the centre of the trench, whilst **Trench 5** contained a compacted level of various construction materials for an unknown function.

Trench 4 showing modern disturbance

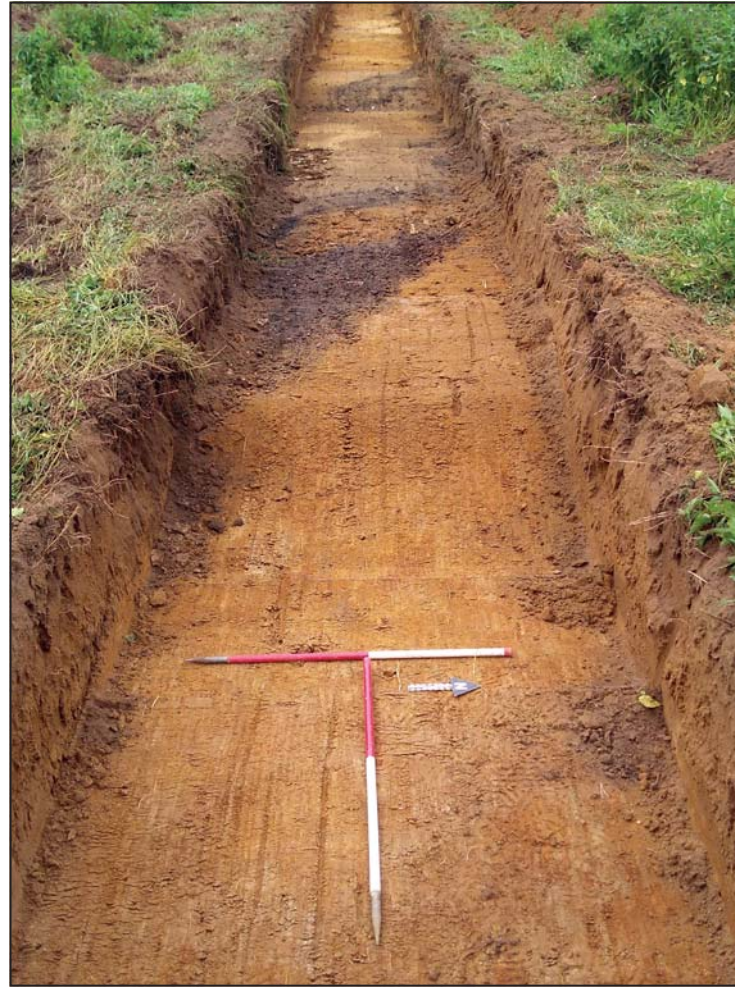
Trench 6 showing modern disturbance, looking west (scales 1m)

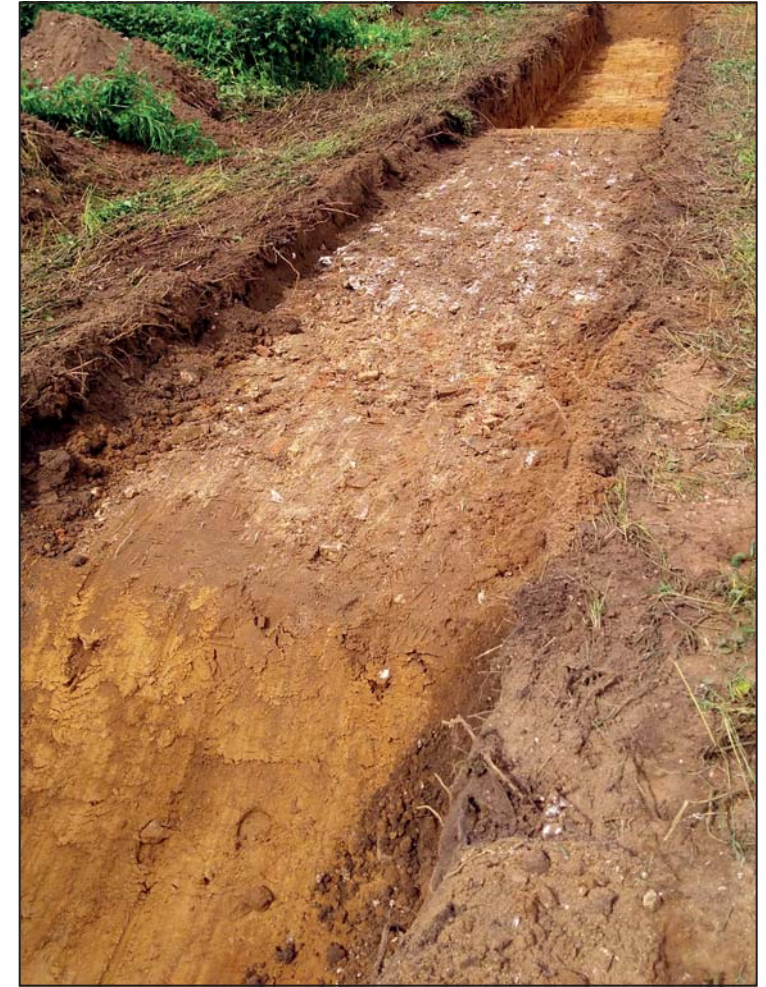
Trench 7 showing modern disturbance
