**Former Bus Depot
Friars Street
Hereford**
Archaeological Evaluation

CA Project: 6426
CA Report: 17703
HER reference: EHE80322

Archaeological Evaluation

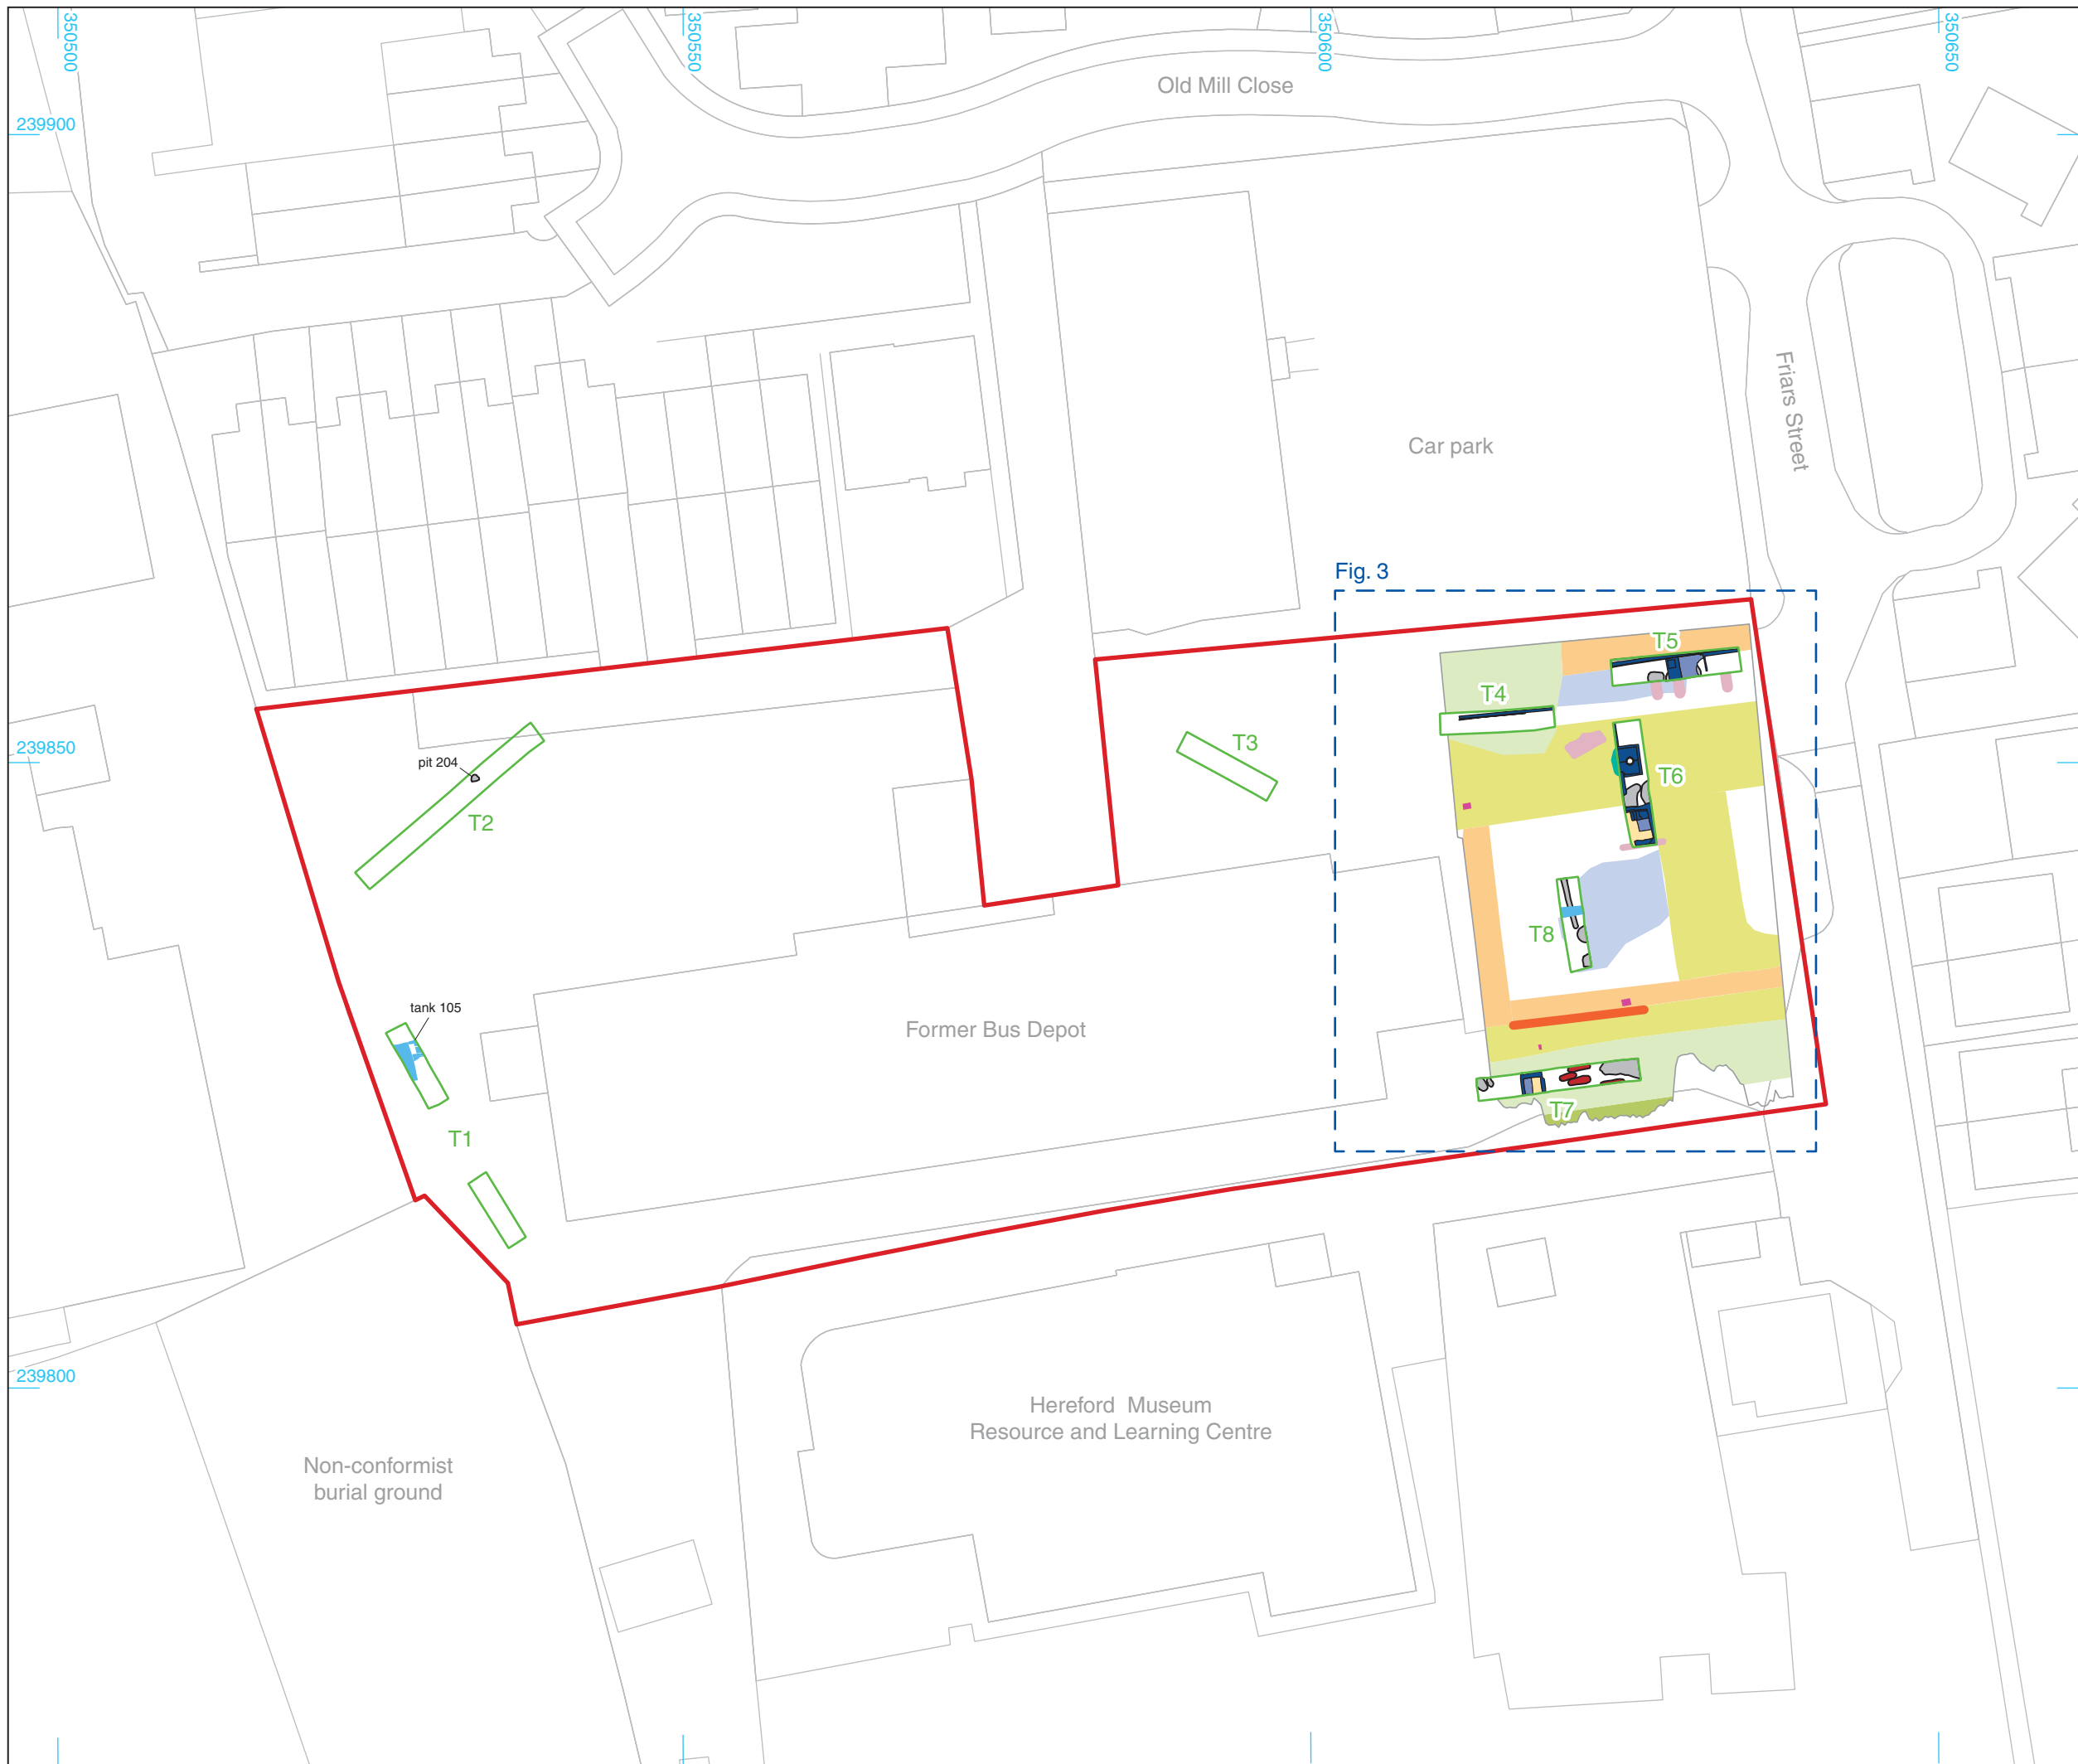
- 2.9 A recent Ground Penetrating Radar (GPR) survey (Archaeological Surveys 2017) has been carried out in the eastern part of the site (see Fig. 2). The survey identified a rectangular anomaly of possible archaeological origin within the northern part of the survey area. The function of this feature is unclear; however it may represent a vaulted feature or a modern soakaway/inspection chamber. Further anomalies, possibly representing the remains of former buildings or associated structural/demolition debris, were also identified in the northern parts of the survey area.

- 4.1 The fieldwork initially comprised the excavation of seven trenches in the locations shown on the attached plan (Fig. 2). Trenches 1 and 2 measured 20m in length and 2m in width. Trenches 3-7 measured 10m in length and 2m in width. Trench 2 was moved slightly from its original position, as set out in the WSI, and Trench 1 was split due to the presence of modern services. Following on-site discussions between CA and Mr Cotton an additional trench, Trench 8, was excavated and Trench 7 was

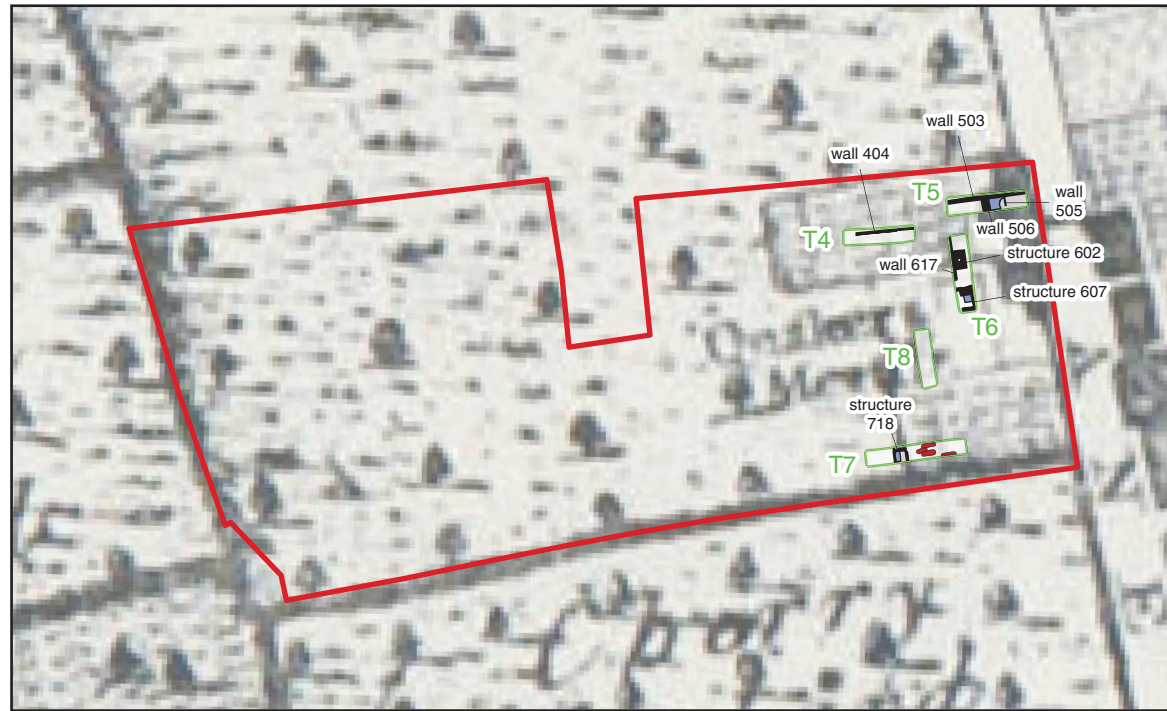
1757 Taylor's Map of Hereford

- 8.6 The north-eastern wall of structure 718, identified in Trench 7, appears to correlate with the western edge of the postulated burial ground depicted on Taylor's 1757 map of Hereford and suggests that at least part of the burial ground was demarcated by a wall. The function of this structure remains unclear; however its form raises the possibility that it represents a burial chamber or vault. Whilst there is some, albeit limited, evidence for the existence of brick or stone built burial vaults in Quaker burial grounds of late 18th and 19th-century date (Stock 1997), no human remains were identified within this structure during the evaluation, despite the complete removal of the exposed backfill contained within it. However, it is possible that any human remains, should they have been present, were removed from this structure following the disuse of the burial ground.

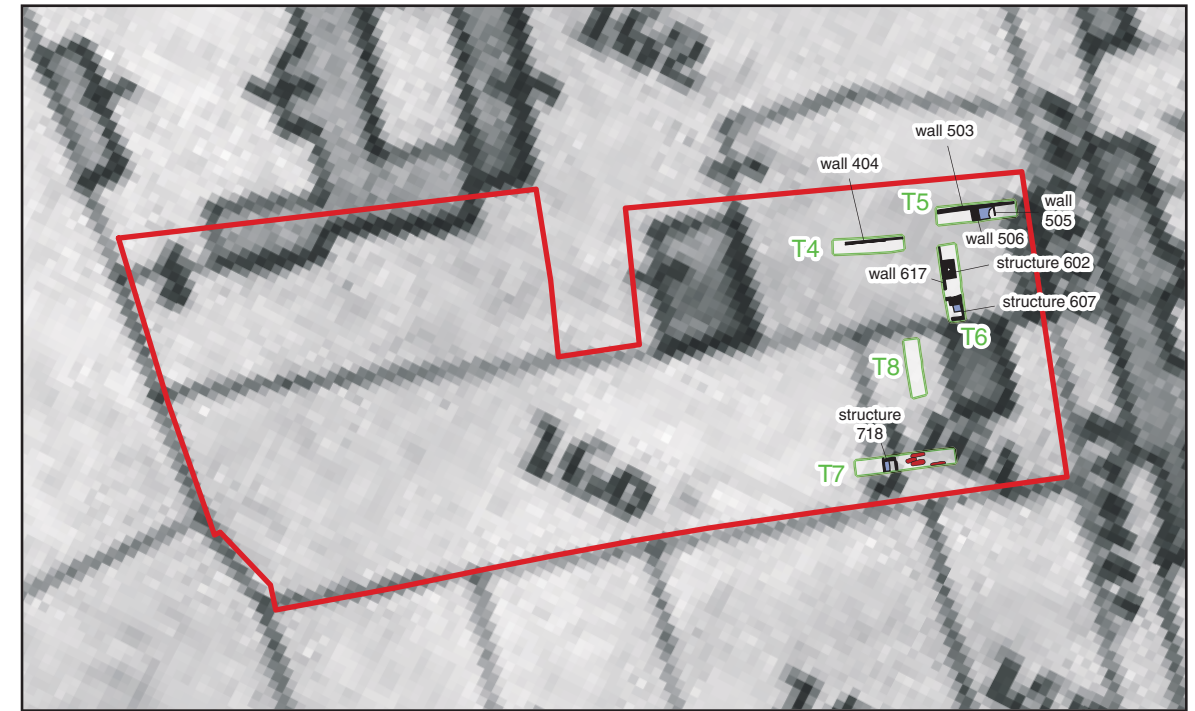
1842 Tithe map for the Parish of St. Nicholas

- 8.7 The southern wall of limestone structure 607, identified in Trench 6, correlates closely to part of a row of buildings first depicted on the 1842 Tithe Map (see Fig. 4) and it is likely, due to the depth at which it was identified, that it represents a cellar associated with one of these buildings. The buildings are thought to represent workers accommodation associated with the Hereford Iron Foundry Works, formerly located immediately to the north of the current site (CA 2017b). These buildings are shown on all later editions of OS mapping until 1967 after which they are no longer depicted.

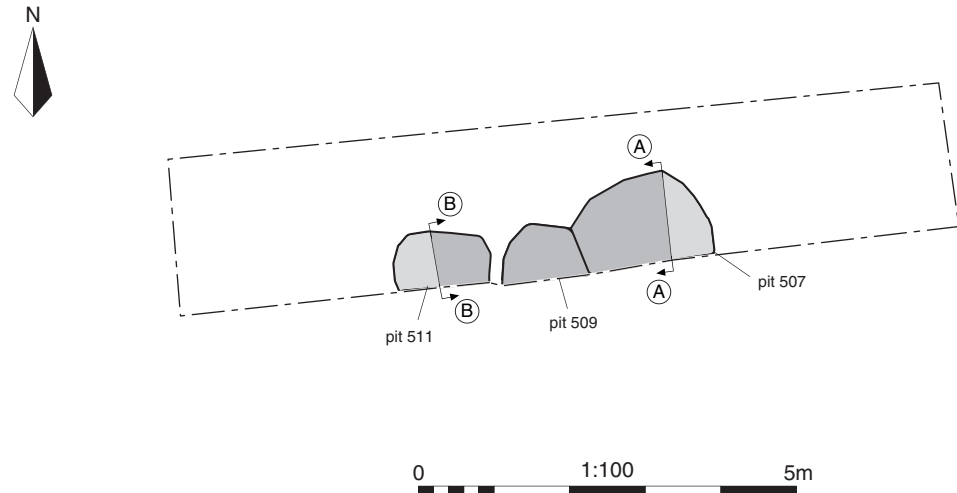
Trench 5 plan (after removal of post-medieval/modern structures)

- 5.5 The natural substrate, 513, was identified at 1.22m bpgl within the trench. It was cut towards the centre of the trench by partially exposed pits 507 (Fig. 5, section AA) and 511 (Fig. 5, section BB), both of which contained similar dark silt clay fills. Sub-oval pit 511 had a steeply sloping northern edge and contained a single undated fill, 512, from which 14 fragments of animal bone were recovered. Pit 507 measured at least 1.7m in width, 0.7m in depth, had a steeply sloping northern side and contained a single exposed fill, 508, from which three sherds of 11th to 13th-century

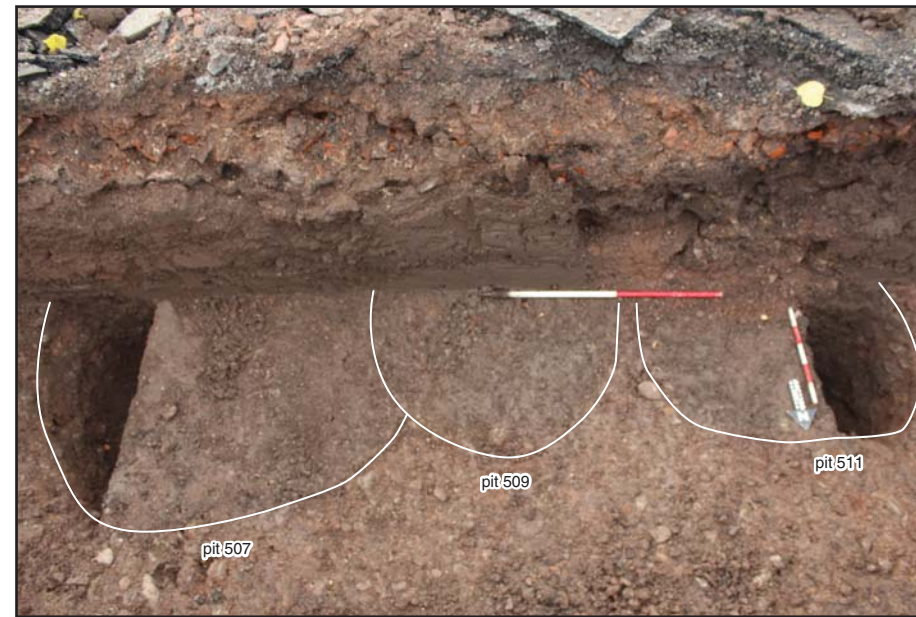
Pits 507, 509 and 511, looking south (1m and 0.5m scales)

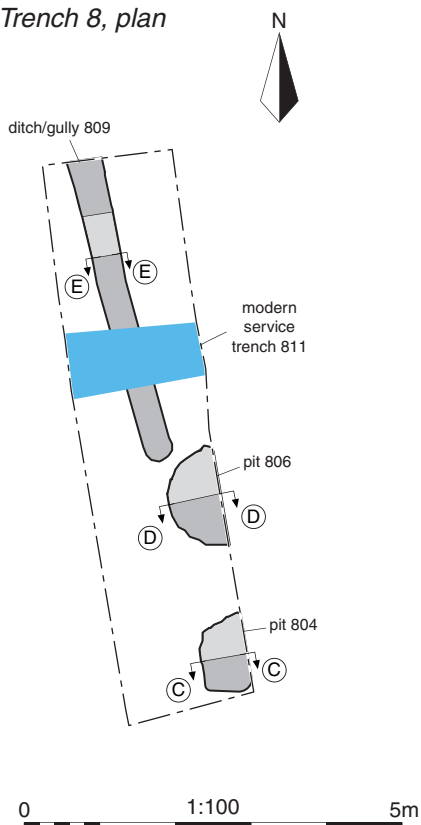
Trench 8, plan

- 5.13 The natural substrate, 803, was identified at 1.2m bpgl within the trench. It was cut by partially exposed pits 804 and 806 and by broadly north/south aligned ditch/gully 809. Sub-oval pit 804 (Fig. 6, section CC) was identified at the southern end of the trench. It had an open 'U'-shaped profile, measured more than 1m in length, 0.6m in width, 0.31m in depth and contained a single undated fill, 805. Sub-circular pit 806 (Fig. 6, section DD) was identified towards the centre of the trench. It had a near-vertical western side and contained a single exposed fill, 807, from which two sherds of 11th to 13th-century pottery, a fragment of 13th to 15th-century roof tile, a Cu alloy strip or buckle and 11 fragments of animal bone were recovered. Ditch/gully 809 (Fig. 6, section EE) was identified in the northern half of the trench. It measured more than 5m in length, 0.4m in width and 0.08m in depth, had a shallow profile, a concave base, and contained single undated fill 810. The fills of the aforementioned features were all sealed by subsoil 802, typically measuring 0.68m in thickness, which was in turn sealed by concrete and red brick bedding layer 801, typically measuring 0.35m in thickness. Deposit 801 was cut by modern service trench 811, the fill of which was sealed by the existing tarmac surface 800.

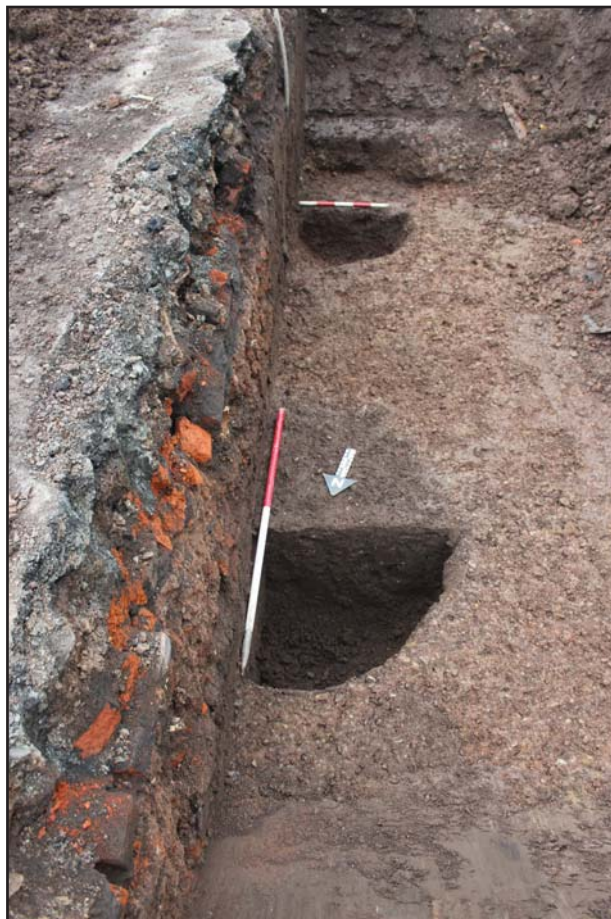
Pits 804 and 806, looking south-east (1m and 0.5m scales)

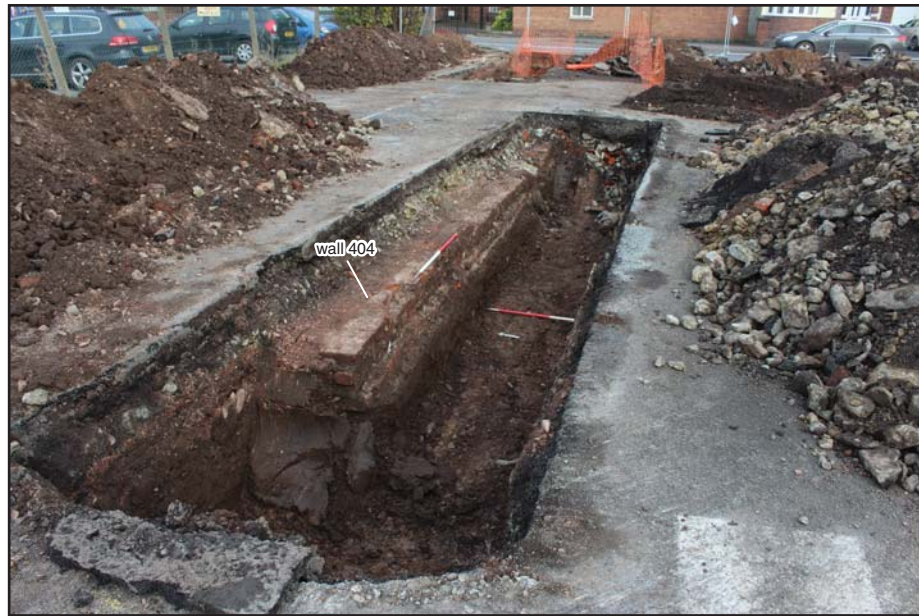
Trench 4, looking north-east (1m scales)

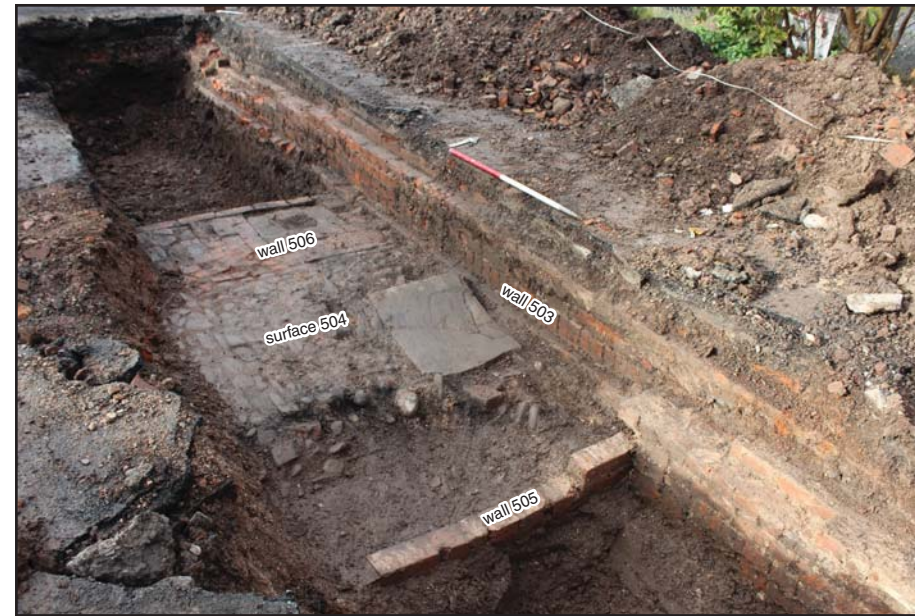
Trench 5, looking north-west (1m scale)

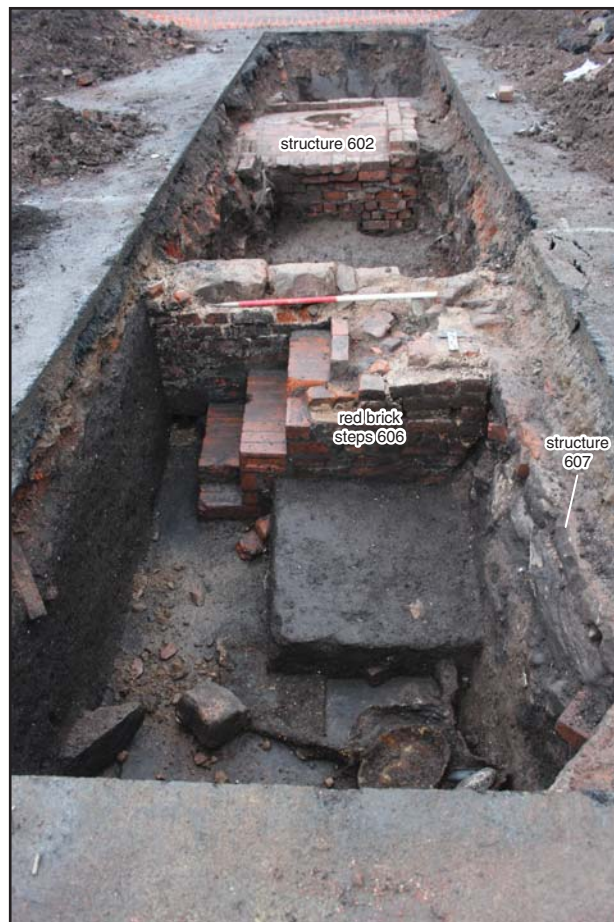
Trench 6, looking north (1m scale)

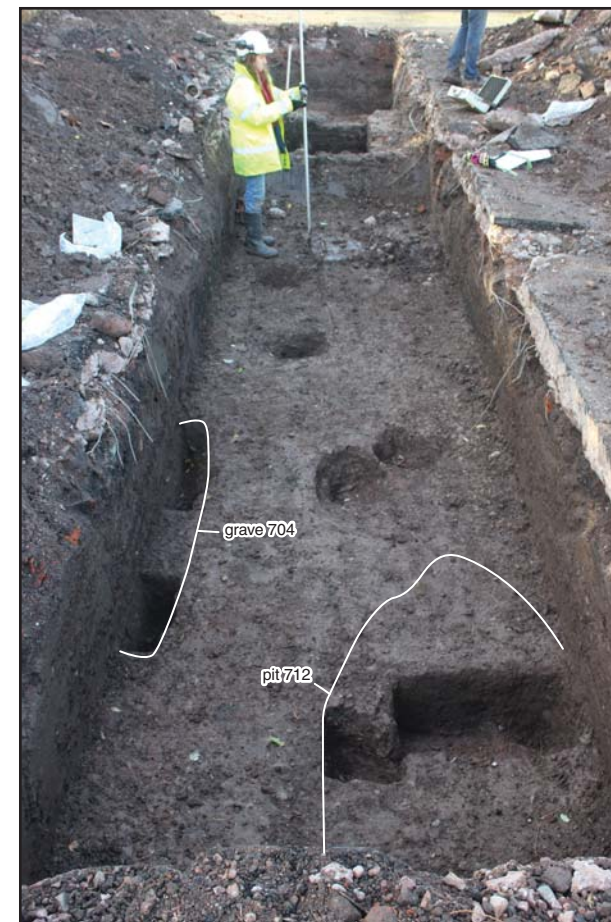
- 5.11 The natural substrate, 703, was identified at a typical depth of 1m bpgl within the trench. Four sub-rectangular, broadly east/west aligned graves, 704, 706, 708 and 710, were identified cutting the natural substrate in the eastern half of the trench. All were investigated by hand and were found to contain well preserved, articulated, human bone. Two further sub-rectangular features, 714 and 716, were partially exposed cutting the natural substrate at the south-western end of the trench, albeit on a slightly different north-west/south-east alignment. Feature 714, measured at least 1.2m in length, 0.8m in width and 0.29m in depth and contained a single undated sandy silt fill, 715. Feature 716 measured at least 0.9m in length, 0.5m in width and 0.14m in depth and contained a single undated sandy silt fill, 717. The fills of both features were fully excavated within the trench and were found to be devoid of human bone.

- 5.12 Construction cut 720 for rectangular structure 718 was identified cutting the natural substrate in the central-western half of the trench. Structure 718 comprised three walls, built as a single phase, and was of rough limestone block construction, bonded by a friable yellowish white lime mortar. It measured 1.8m in width, more than 1.8m in length and survived to a depth of 1.5m. The north-eastern wall of this

Trench 7: working shot, showing structure 718 and graves 704, 706, 708 and 710, looking west
