Royal British Legion Legion Lane, Tywardreath Cornwall

Archaeological Watching Brief

cotswold2-315792
CA Project: 880227
CA Report: 17582

October 2017

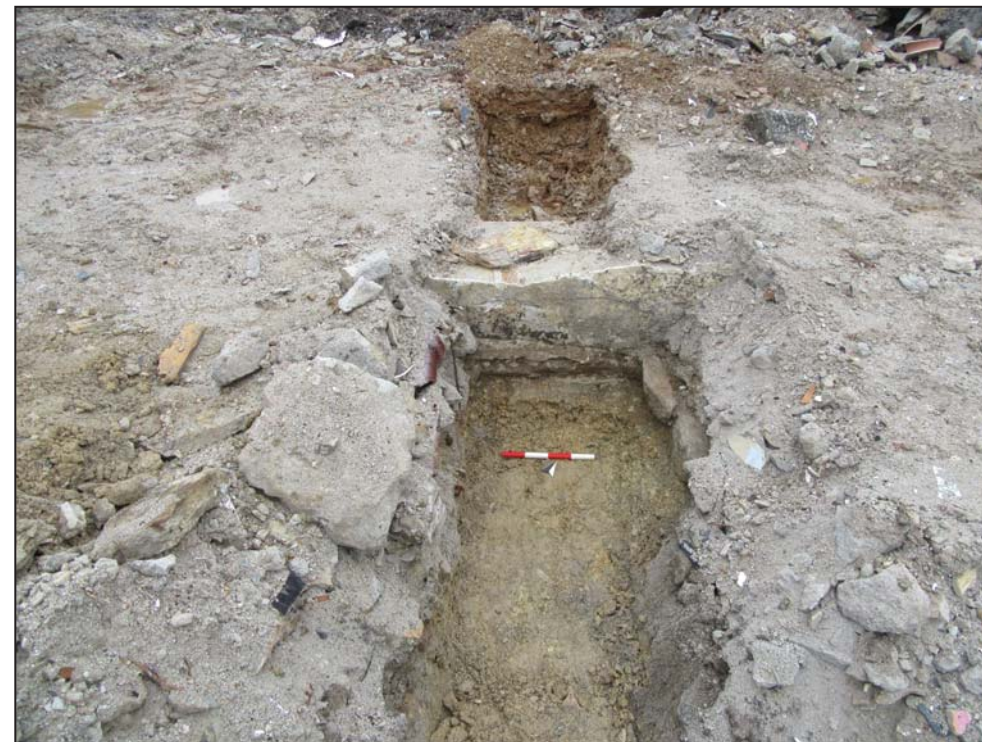
Section AA

- 5.3 A series of building foundations was recorded in the southern part of the site (walls 106/204 and 107). These foundations were constructed of mortar-bonded granite and limestone blocks. They passed through T1 and T2, but were also visible at the ground surface for the majority of their lengths. They formed a rectangular building measuring 27.5m in length and 5.5m in width, with its long axis aligned east-north-east/west-south-west. The foundations were cut into the surviving subsoil layer in T1 and T2.

- 5.5 Posthole 206 was identified within the centre of the building (T2). This posthole was 0.5m in diameter and contained modern CBM in its single fill (207). Remnants of internal granite floor surfaces 205 and 208 were also identified in T2. Surface 205

Wall 204 and floor 205, looking north-west (scale 0.4m)

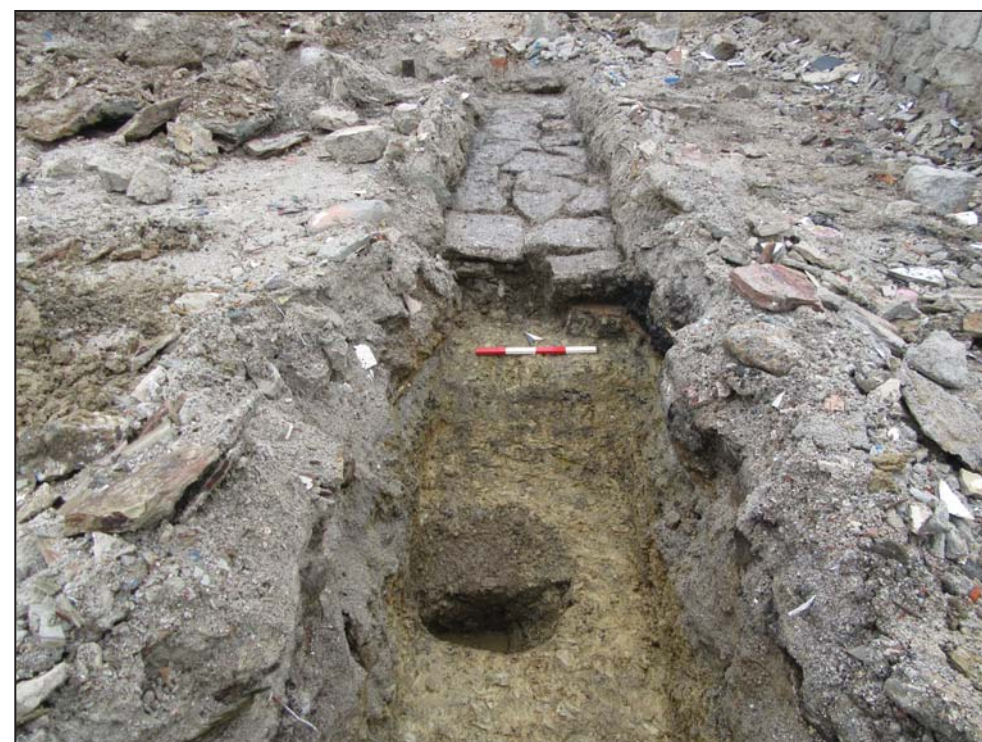
Section BB

was lain directly onto the natural substrate; surface 208 was lying atop clay bedding deposit 209.

Posthole 206 and floor 208, looking north-east (scale 0.4m)

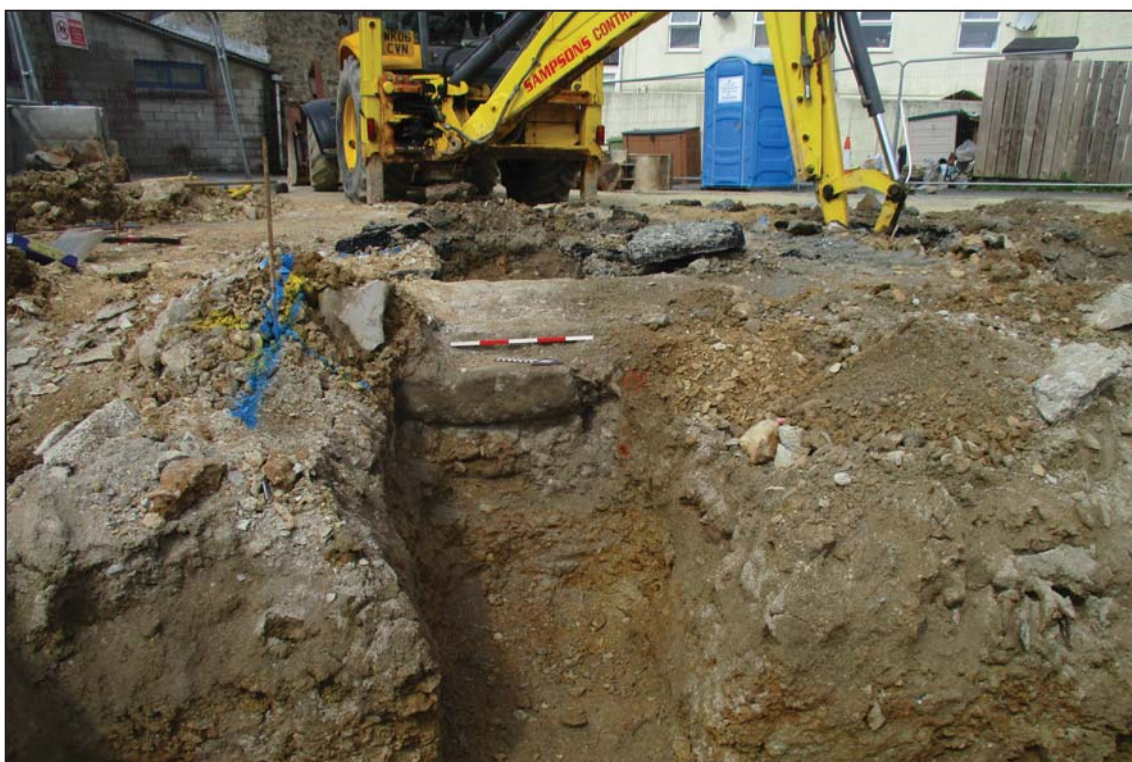
Trench 3: section and photograph

- 5.4 The western end of the building was formed by walls 300/400 and 304/404, which passed through T3 and T4 and were also visible at the ground surface. These walls were apparently later in date than the other wall foundations, being constructed of stone, brick and cement. They were cut into the truncated natural substrate in T3 and T4.

Wall 304, looking south-west (scale 0.5m)

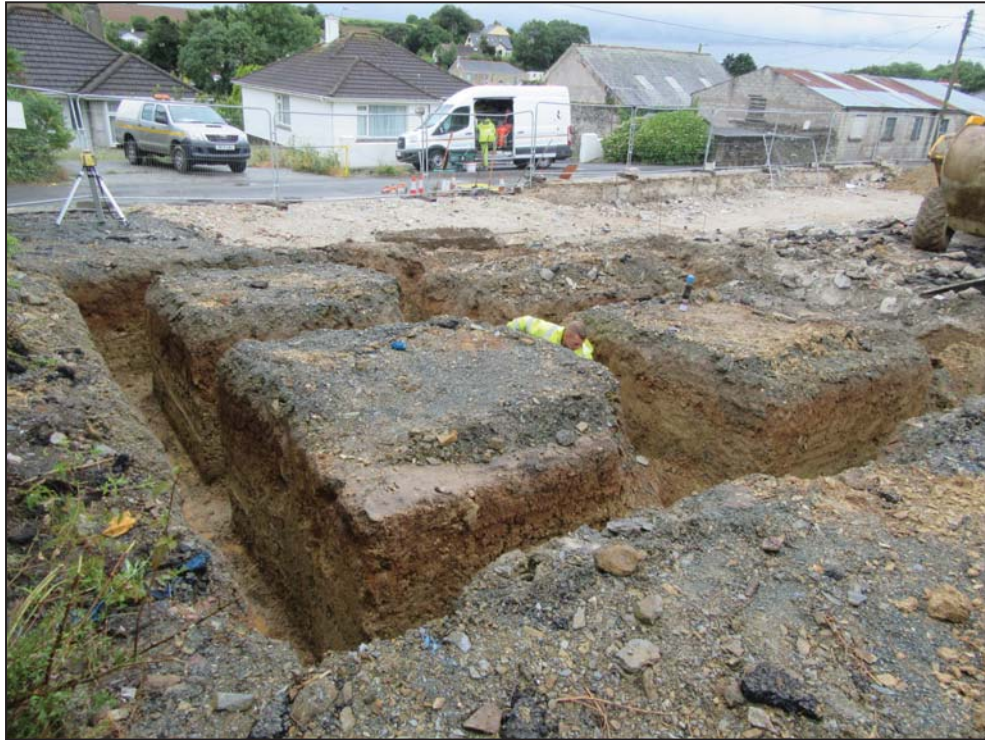
Trench 1, looking south-west

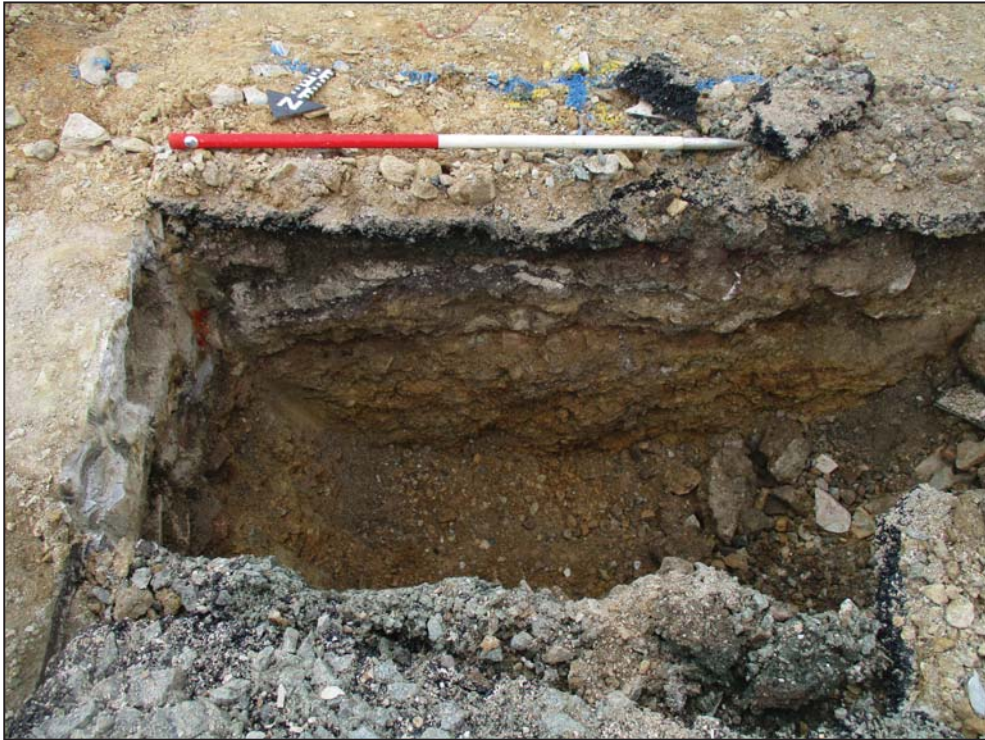
North-west facing section of Trench 4 (scale 1m)

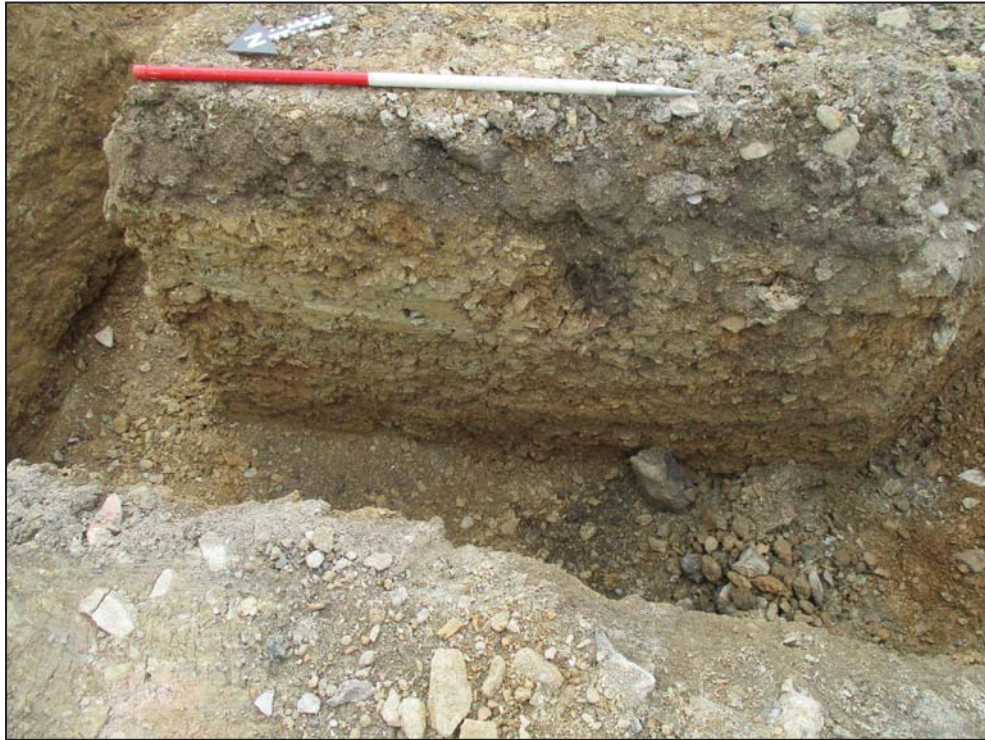
North-west facing section of Trench 5 (scale 1m)

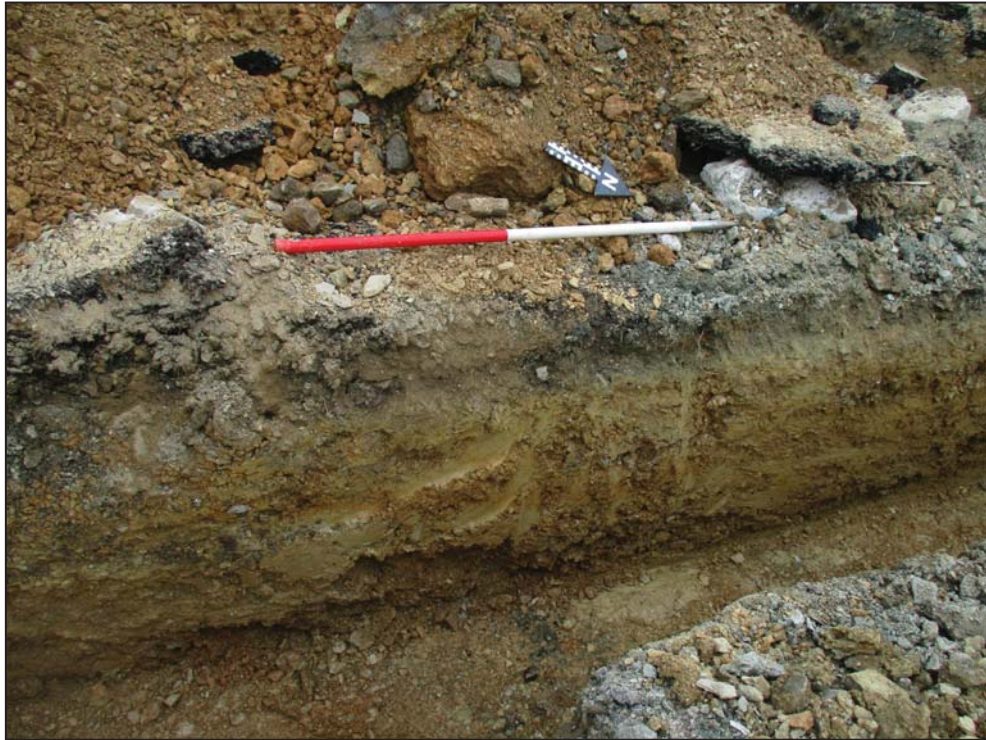
South-west facing section of Trench 6

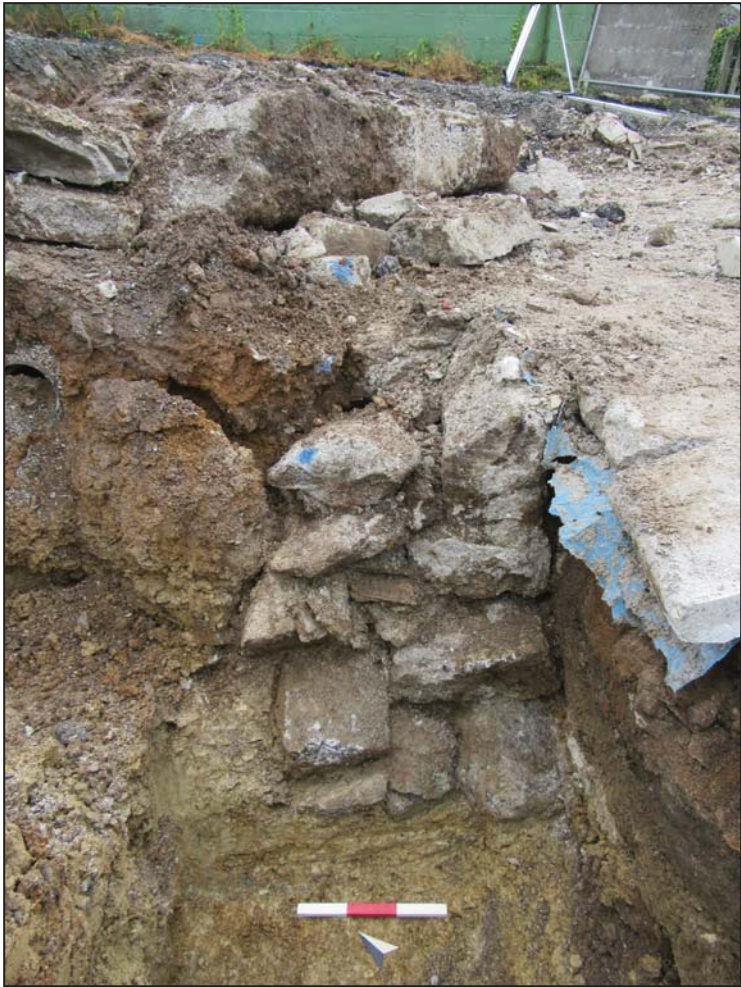
- 5.6 Mortar and surviving elements of concrete construction were visible in places on the upper surfaces of the stone wall foundations, indicating that they had been reused as the foundations of the later building at the site.

Wall 106, looking north-east (scale 0.3m)
