Maudslay Park, Great Alne Warwickshire

Archaeological Strip, Map & Sample Excavation

CA Project: 660114
CA Report: 13076

April 2013

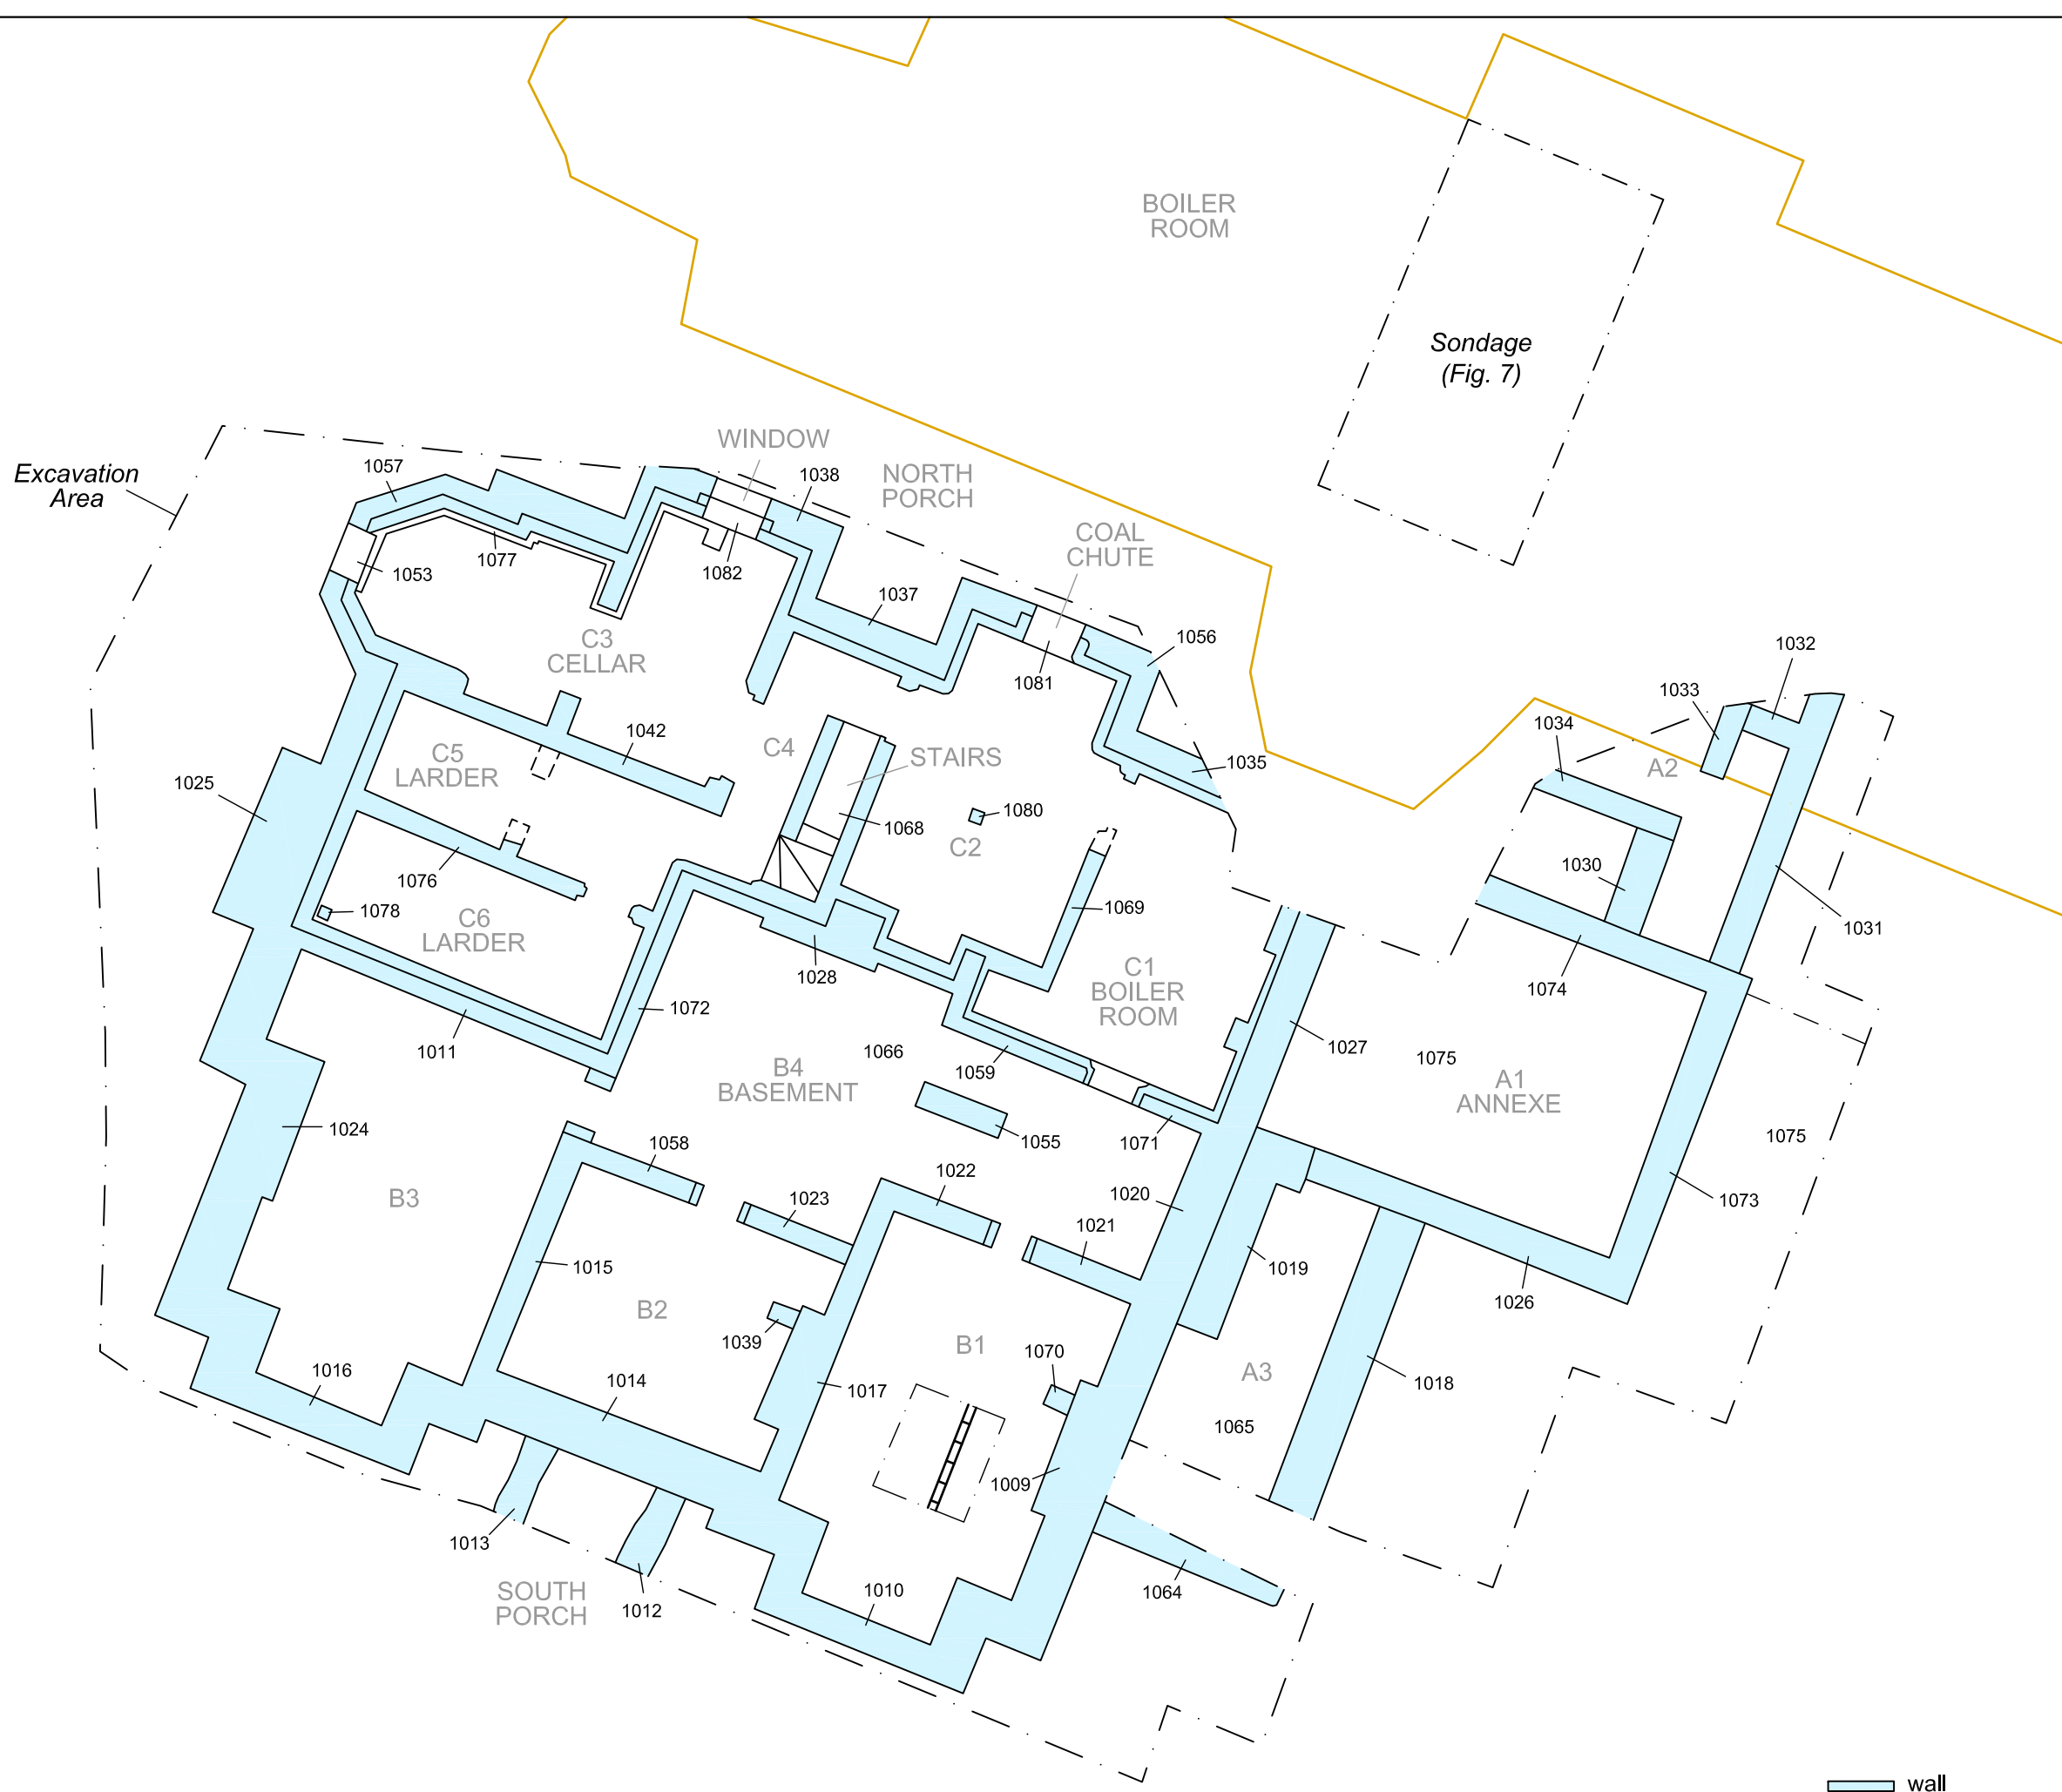
FIGURE TITLE
 Plan of the excavation

- excavation area
- archaeological feature
- 1950s office block

- 1.12 The excavation, which covered an area of c. 600m², comprised the investigation of the foundations, basement and cellar of the demolished house and, where possible, a 5m buffer zone around the footprint of the building's remains (Fig. 2). Due to the presence of large conifers, new fencing and large piles of demolition rubble from the former office block that once stood on the site, the buffer zone could only be excavated on the east and west sides of the footprint. The area immediately to the north of the house had been truncated to a depth of almost 2m by the boiler room and cellars of the office block, which would have destroyed any archaeological remains, had they occurred in this area, so the buffer zone was not extended in this direction, although a sondage was excavated to determine the degree of truncation.

- 2.1 The excavation area measured approximately 30m east to west by 20m north to south (600m²) and exposed the foundations, basement and cellar of the Victorian house (Figs. 2 and 5). Site constraints prevented the full excavation of the 5m buffer zone around the footprint of the building, with only limited areas to the east and west being accessible.

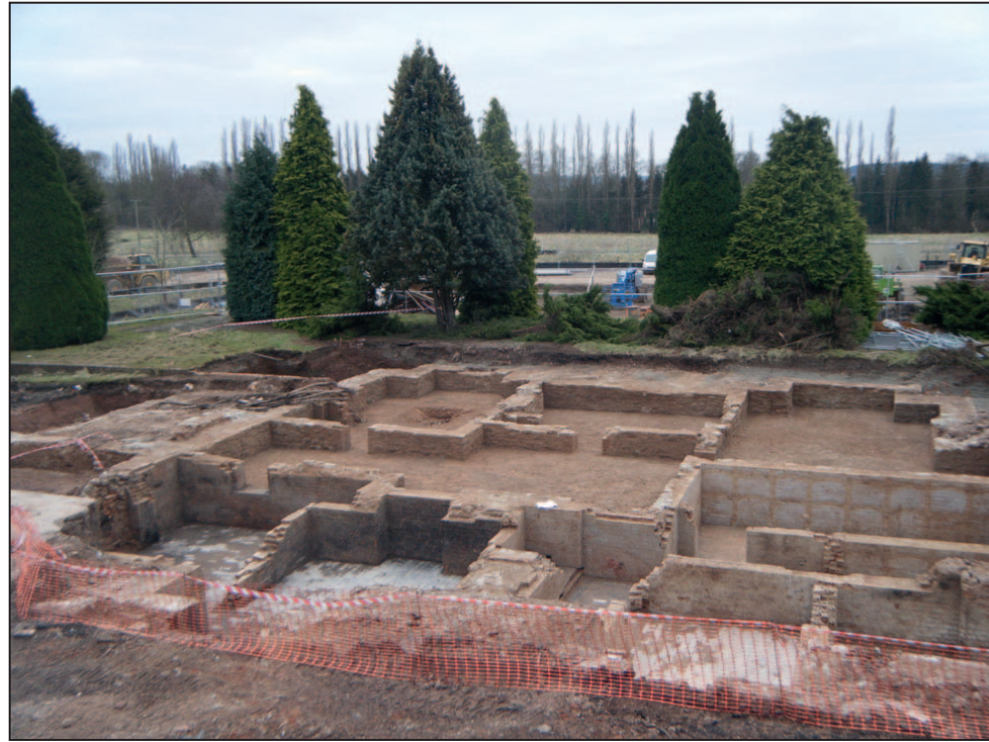
- 5 General view of the house foundations, looking south
- 6 Deposits in the south-east corner of the site, looking south. (Scale 1m)
- 7 Office block boiler room, looking west. (Scale 1m)
- 8 Basement B1 and B2, looking west. (Scales 1m)

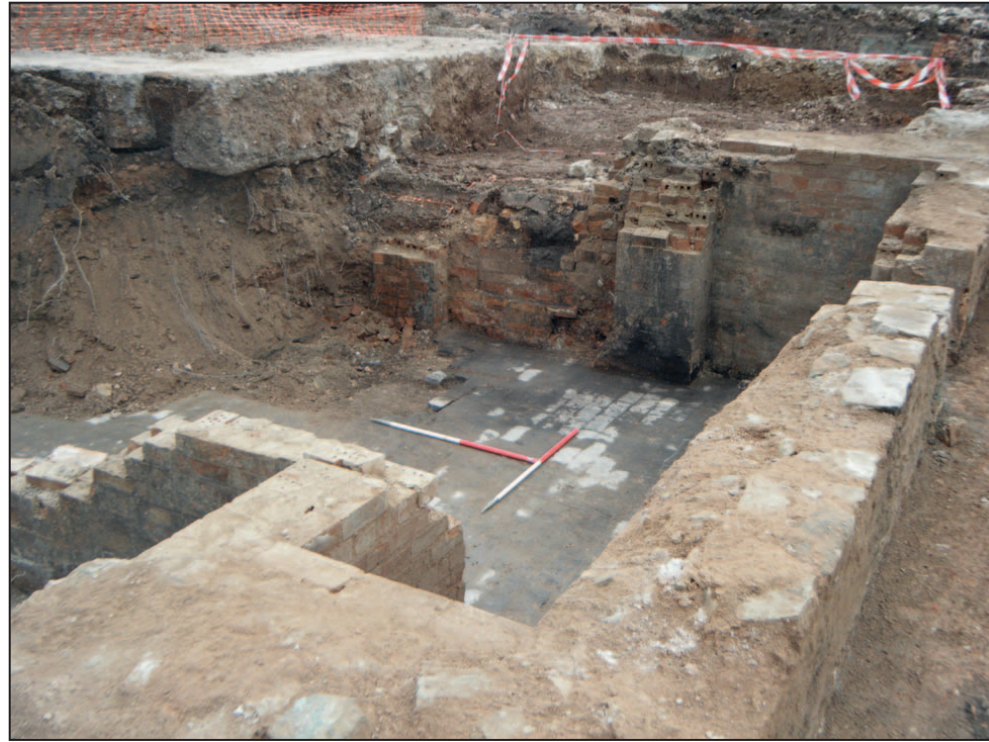
- 13 View of the boiler room (Cellar C1), looking east. (Scales 1m)
- 14 View of coal store (Cellar C2) and coal chute, looking north. (Scales 1m)
- 15 View of Cellar C3, showing the gutter on the right, looking west. (Scales 1m)
- 16 Window in the north wall of Cellar C3, looking north. (Scale 0.1m)

- 2.13 The boiler room, which measured 5.1m north to south by 3.6m east to west, was located in the north-eastern corner of the cellar (Fig. 13). The external walls were

approximately 0.95m thick and survived to a height of up to 1.8m; the east wall, 1027, was reinforced with brick buttresses that projected c. 0.21m from the wall's surface. The west wall, 1069, was constructed from engineering bricks and its southern end was angled to form a deep, narrow alcove in the south-west corner. Access from the coal store was through a door in the north-west corner of the room, in the west wall, 1069, and in the south wall, 1059/1071, was a doorway leading into the basement. The threshold of the basement door was positioned c. 0.8m above the floor of the boiler room, so there would probably have been a short flight of timber steps to provide access. The floor of the boiler room, 1067, was noticeably worn, with the surface of the setts pitted and occasionally cracked, and coal dust and black tarry residues had accumulated on its surface along the eastern side of the room. The walls were blackened with soot, especially in the north-east corner of the room where the walls were also slightly scorched, suggesting that the boiler's furnace had been positioned in this location.

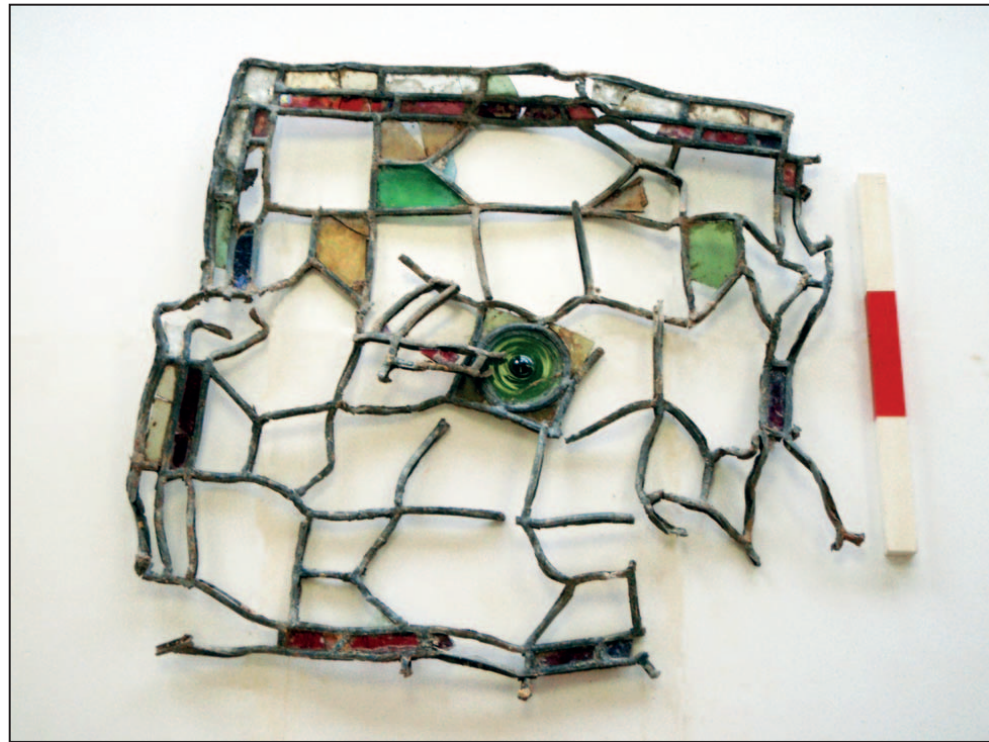
- 17 Leadlight window recovered from demolition deposits in Cellar C3. (Scale 0.3m)
- 18 Stairs to the cellar and passageway (Cellar C4), looking south-east. (Scale 1m)
- 19 Larder (Cellar C6), looking west. (Scales 1m)
- 20 Selection of jars and bottles from the larders (Cellars C5 and C6). (Scale 0.2m)

north porch on the north elevation. The lower part of a window with a cast iron frame remained *in situ* in the north wall; bullnose bricks had been used on the corners on either side of the window and the sill was edged with bevelled bricks (Fig. 16). The gutter from the west bay, 1077, continued along the north wall to an open drain beneath the window. The twisted, shattered remains of several leadlights were found immediately outside the building, by the base of the west wall (Fig. 17)

- 3.7 A collection of architectural fixtures and fittings recovered from the rubble in the cellar and basement give some indication of the lavish, High Victorian interior decoration of the house. There were fragments of polished, coloured marble from the fireplace surrounds and pieces of moulded white plaster would have formed the edge of coving around some of the formal rooms. Wall plaster was painted in a variety of colours, including light blue, dark blue, pale green and light ochre; one piece appears to have been decorated with a floral pattern, although the pattern could have been retained from coloured pigment residues from long-rotted wallpaper. Remains of a decorated floor were found, comprising shaped, coloured tiles set on a mortar base, along with several thick, glazed floor tiles patterned with medieval style motifs, manufactured in Stoke-on-Trent by 'Minton Hollins & Co' (Fig. 11). The twisted, broken remains of several leadlight windows had been thrown into the basement and cellar during the demolition, or piled against the west wall. Most were glazed with plain glass, although several still retained fragments of coloured and painted window glass. One leadlight held pseudo 'bulls-eye' lights, imitating the thick, lens-like pontil marks at the centre of Crown glass that were once used for glazing, giving the window a fashionable, medieval-style, Pre-Raphaelite appearance (Fig. 17).
