**Longfield Place  
Plymouth  
Devon**

Historic Building Recording

CA Project: 4686  
CA Report: 14115  
March 2014

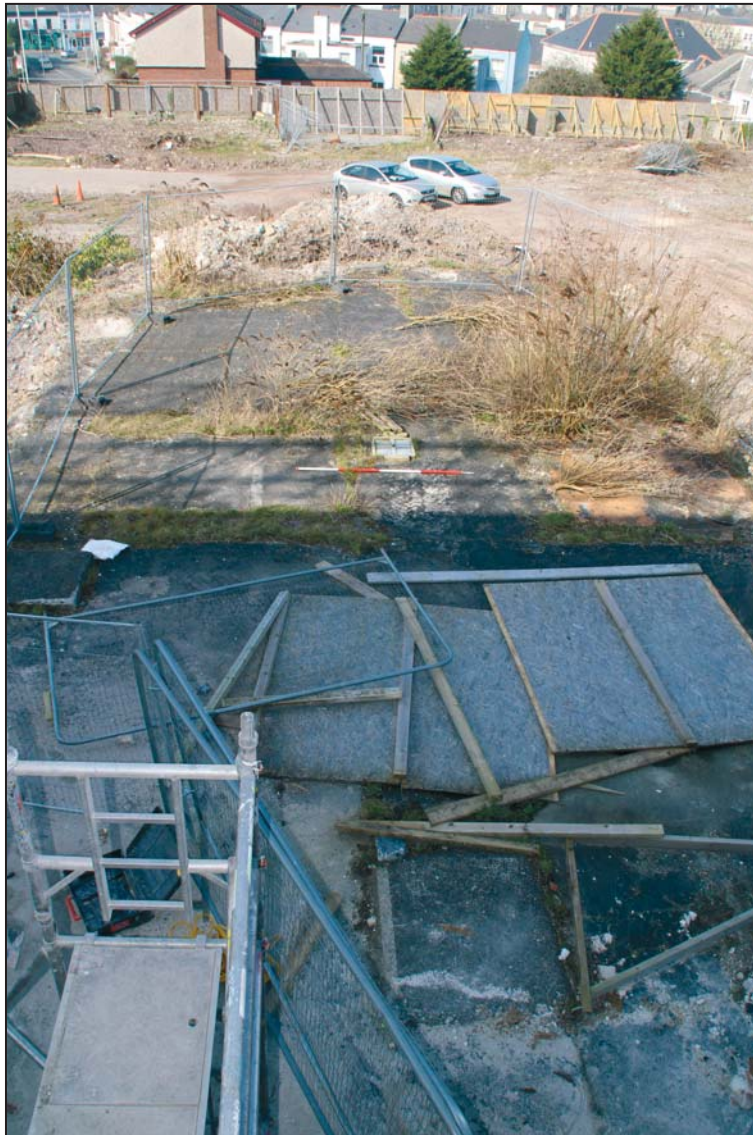
5

**5 The concrete ground floor of 1935 over the basement of the north-west range, looking north-west (scale 2m)**

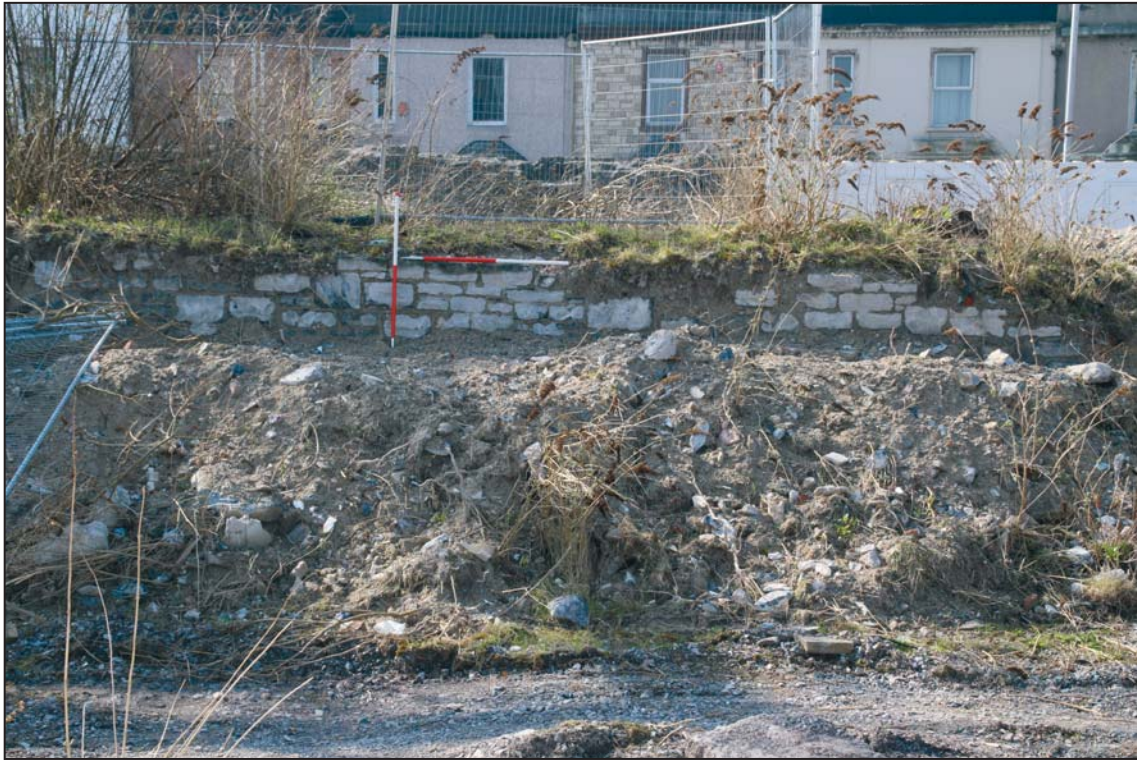
6

**6** The north-east side of the north-west block, looking south-west (scales 1m)

- 5.1 This was the north-west wing of the prison built to the designs of Fuller and Gingell in 1849. All that now survives of this block is the semi-basement capped by a concrete floor (Figs 3 and 5). The external walls were largely obscured by demolition rubble, although the highest part of them was visible above the scree (Fig. 6).

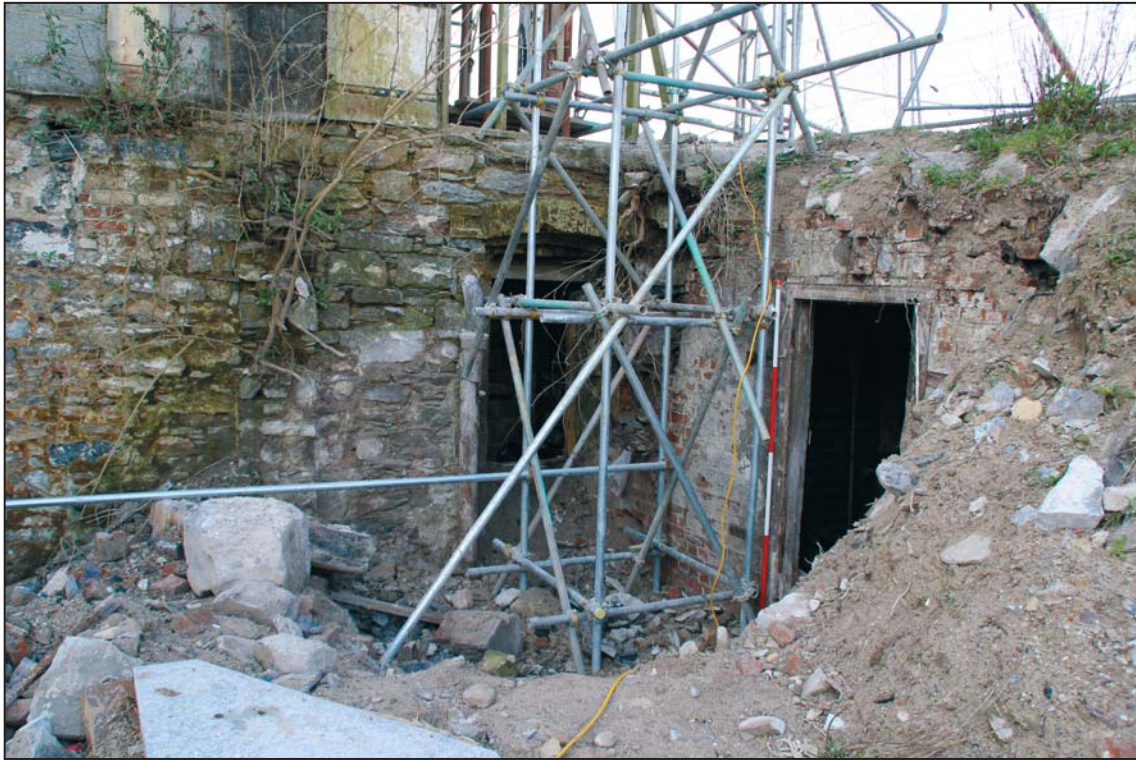
9

- 9** The brick wall (and door through it, on the right) which closed off the truncated Cellar 1, looking west; basement wall of central block on left (scale 2m)
- 10** The truncated section of jack-vault in Cellar 1, looking up and to the north, from the entrance to the Lobby

- 5.9 The room under the corridor (Fig. 3, Cellar 1) had been truncated to the south-east but seems never to have extended further north-west than its present extent, marked by a solid rubble wall with no openings in it. Its present south-eastern extent was marked by a brick wall (Fig. 9).

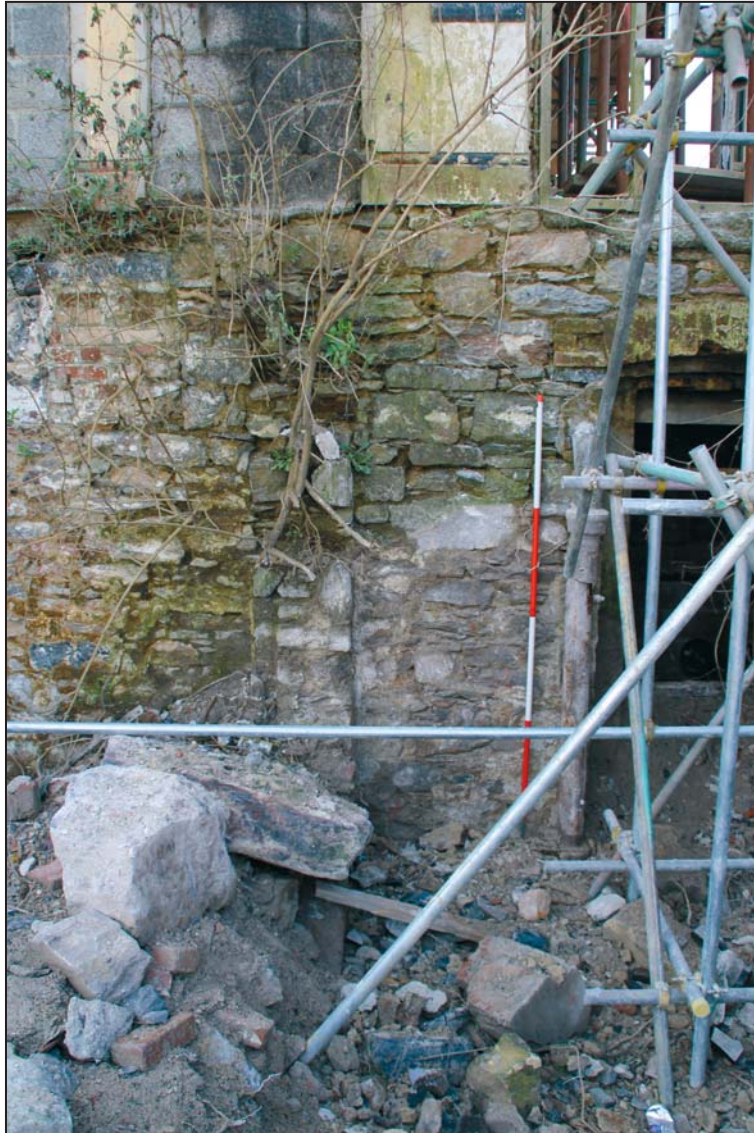
**11**

**11 The wall stub projecting from the basement wall of the central block, which would have supported the south-east end of the jack vault before it was truncated. Looking south-west (scale 2m)**

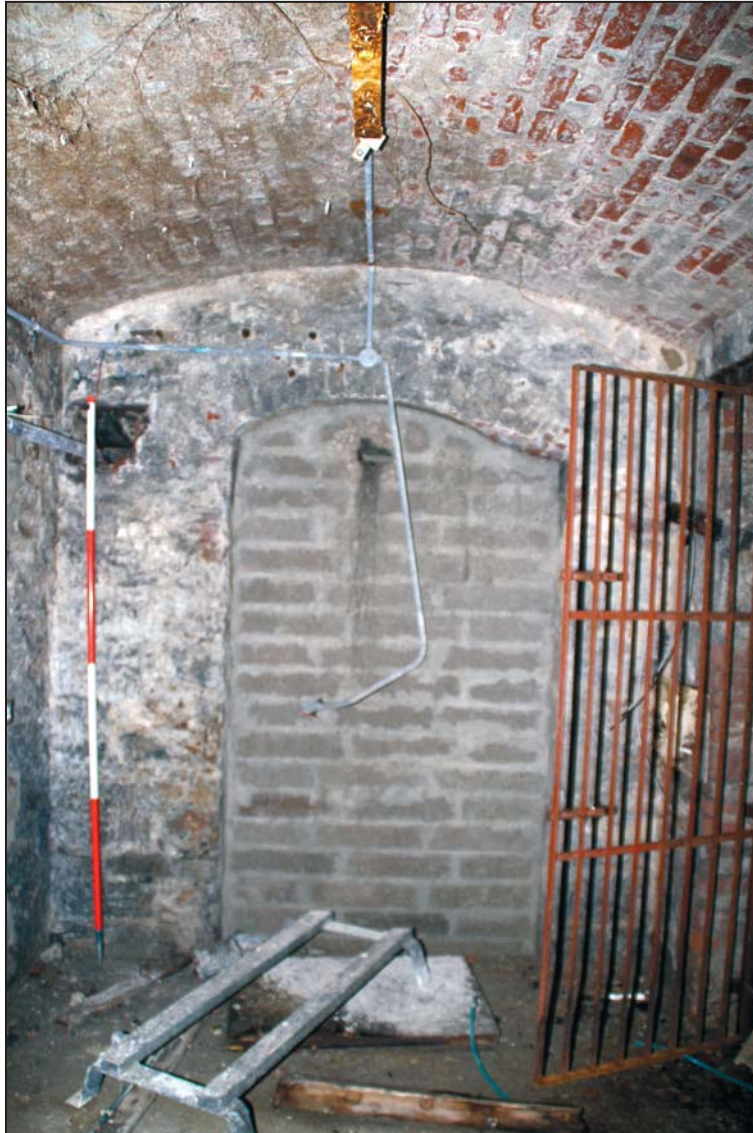
**12**

**12 The north-east end of Cellar 2 with the blocked doorway to Cellar 1**

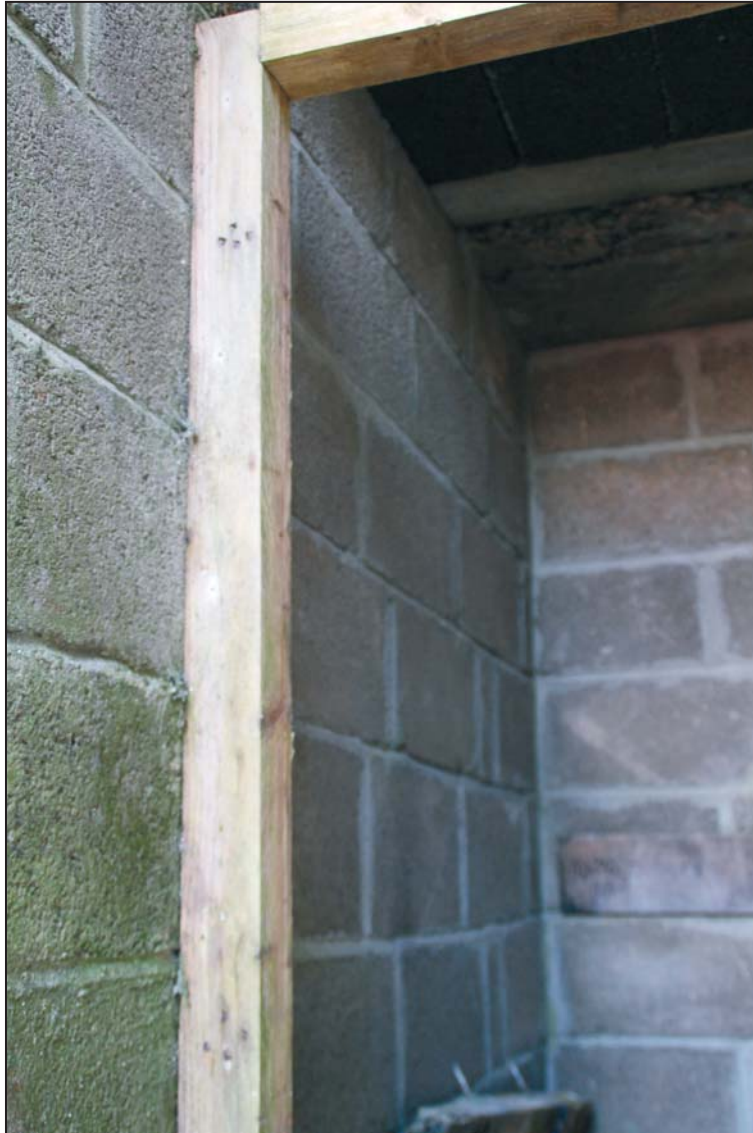
**13**

**13 The concrete block lining of the light well forming the lobby access to Cellar 2, looking south-west**

- 5.15 The cellars are now reached from a sort of lobby. This was constructed relatively recently, certainly post-World War II, by lining a light well of the original design with

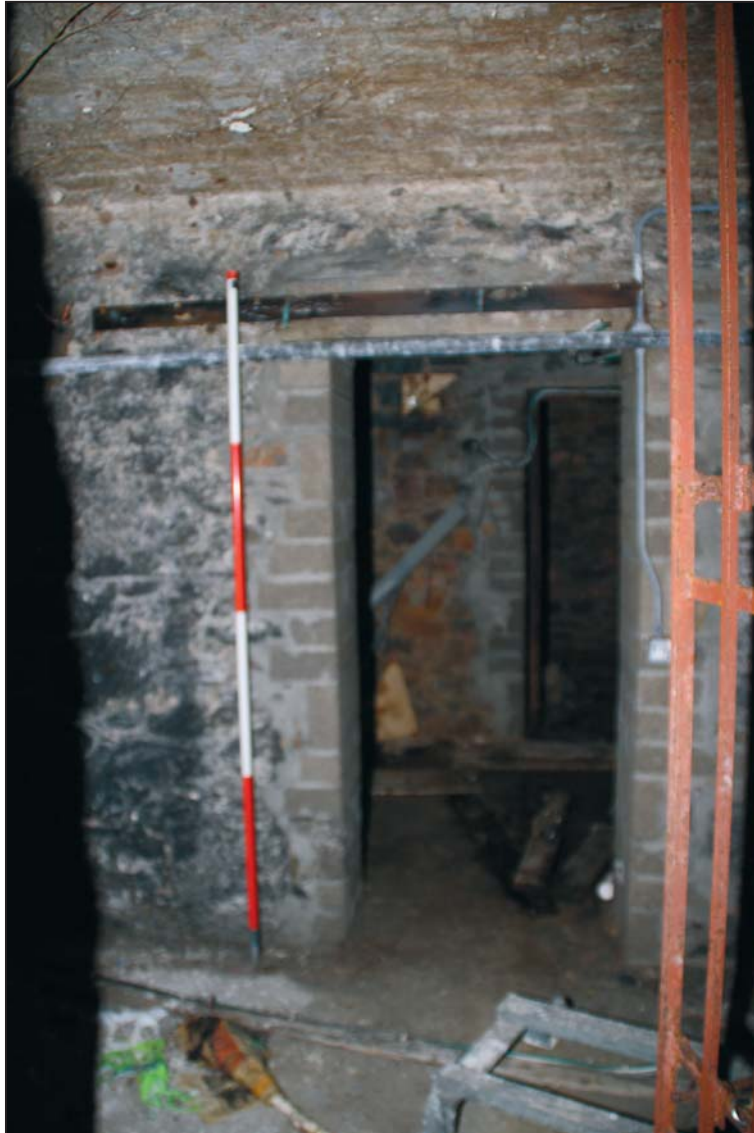
**14**

**14 The new or completely replaced concrete block door jambs from Cellars 2-3 and 3-4, looking north-west (scale 2m)**

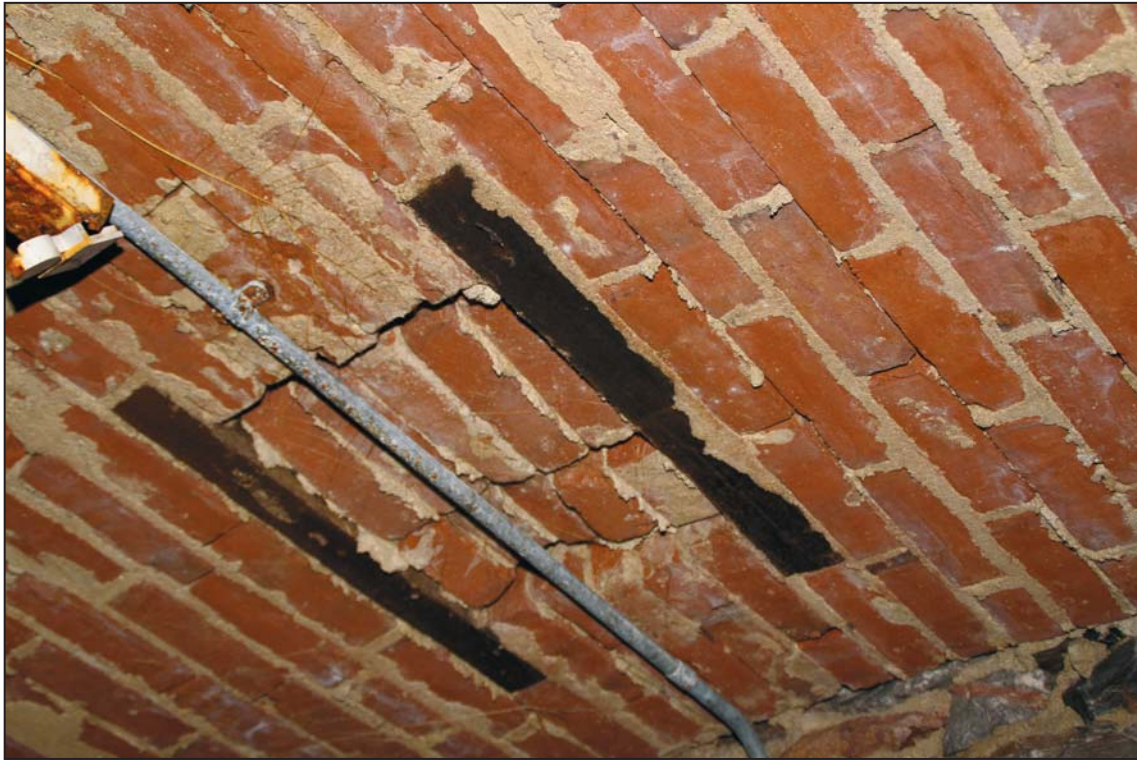
15

**15 Blocked delivery holes in the brick vaults of Cellars 3 and 4**

- 5.19 Cellars 3 and 4 were very similar but were rectangular in plan, and again contained no windows. A difference was that they had no doorways except those connecting them with each other and Cellar 2. These were insertions in the sense that they had concrete block jambs and a concrete lintel and there was no sign of an earlier doorway (Fig. 14). If they were not complete replacements of older doorways (i.e. leaving no older traces), then the only access would have been the manholes or chutes in the vaults towards the north-east end. These are now blocked with similar brick to the vault (Fig. 15). These chutes would have appeared in the floors of the south-western range of rooms in the north-western range. These were marked as “cells” in the 1856 OS plan.

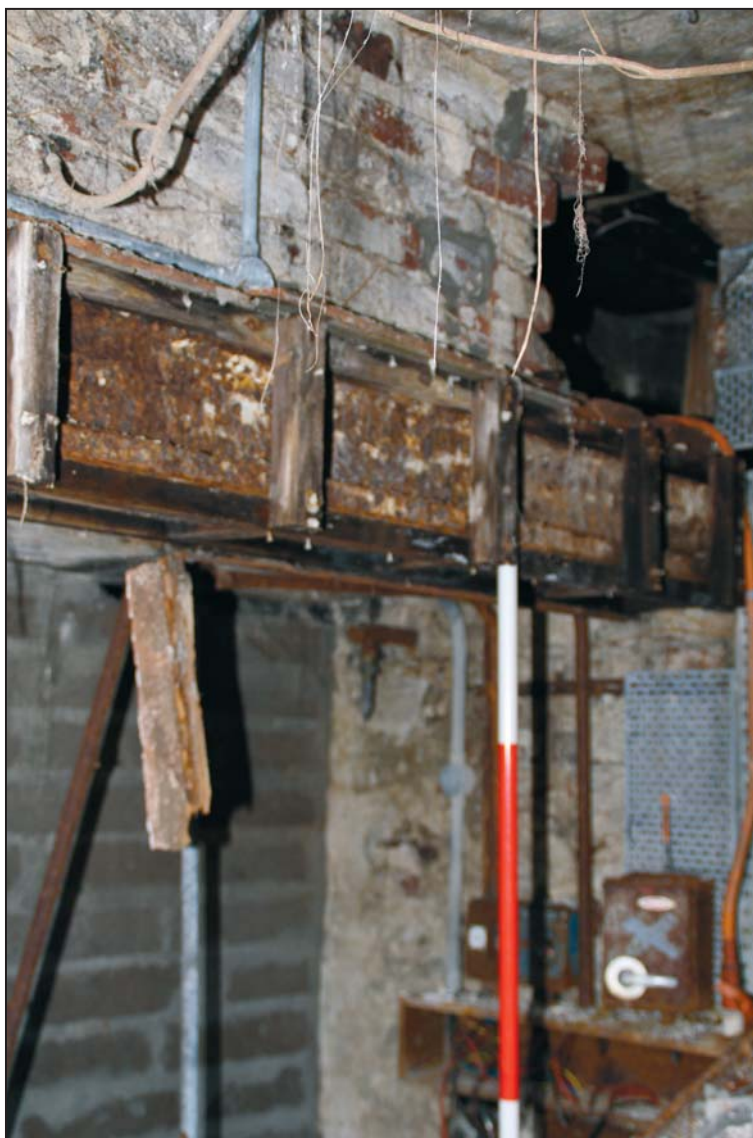
**17**

**17 The other end of the service duct in Fig. 16 in the vault of Cellar 1**

- 5.22 The other end of this duct was noted cutting through the brick vault of Cellar 1, built of brick and supported on steel girders (Fig. 17). It did not continue beyond the south-east wall of Cellar 1 and is presumed to have ended and the pipes emerged upwards.

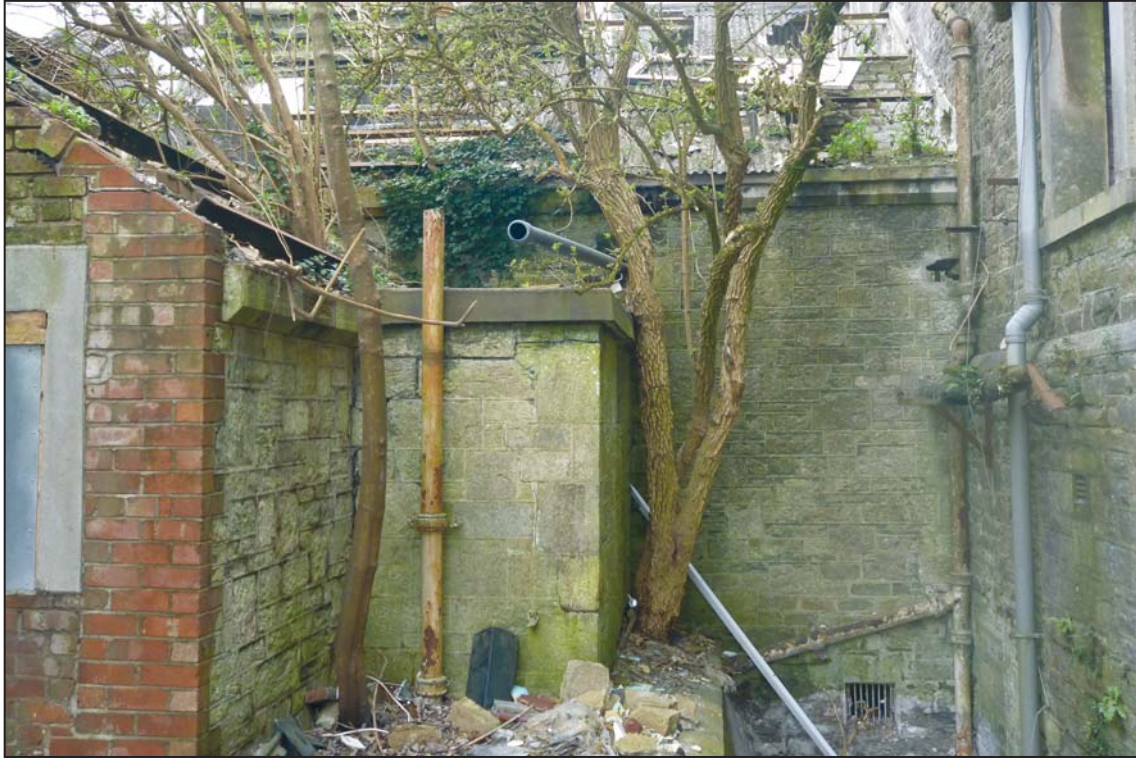
18 & 19

- 18** The exterior of the north-west wall of the later stone range, showing the rangework construction. Note the continuous corbel ledge at the eaves and the lower and truncated north-west range, extreme left
- 19** The interior of the south-east wall of the later stone range, showing the rubble construction and the brickwork alterations of the laundry building, looking south-east. The steelwork supporting the water tank is more recent again (2m scale)

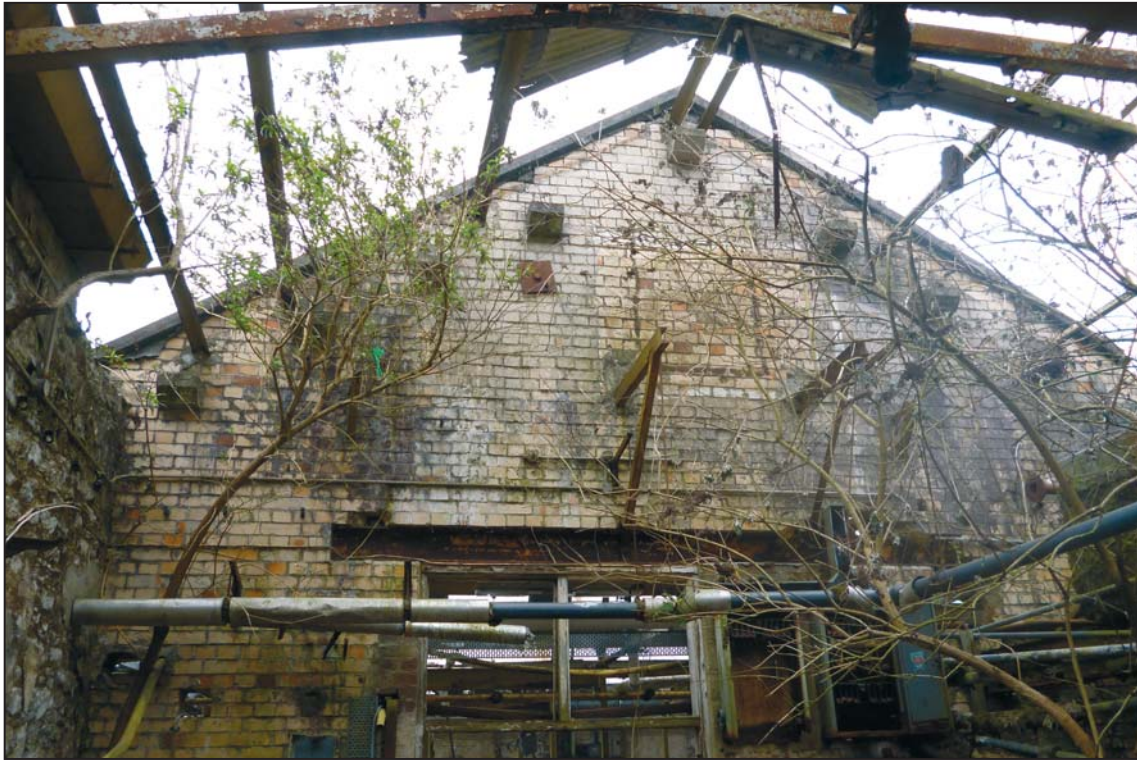
20

**20** The replacement gable of the stone range showing the large stone corbels to pick up the earlier roof, looking north-east

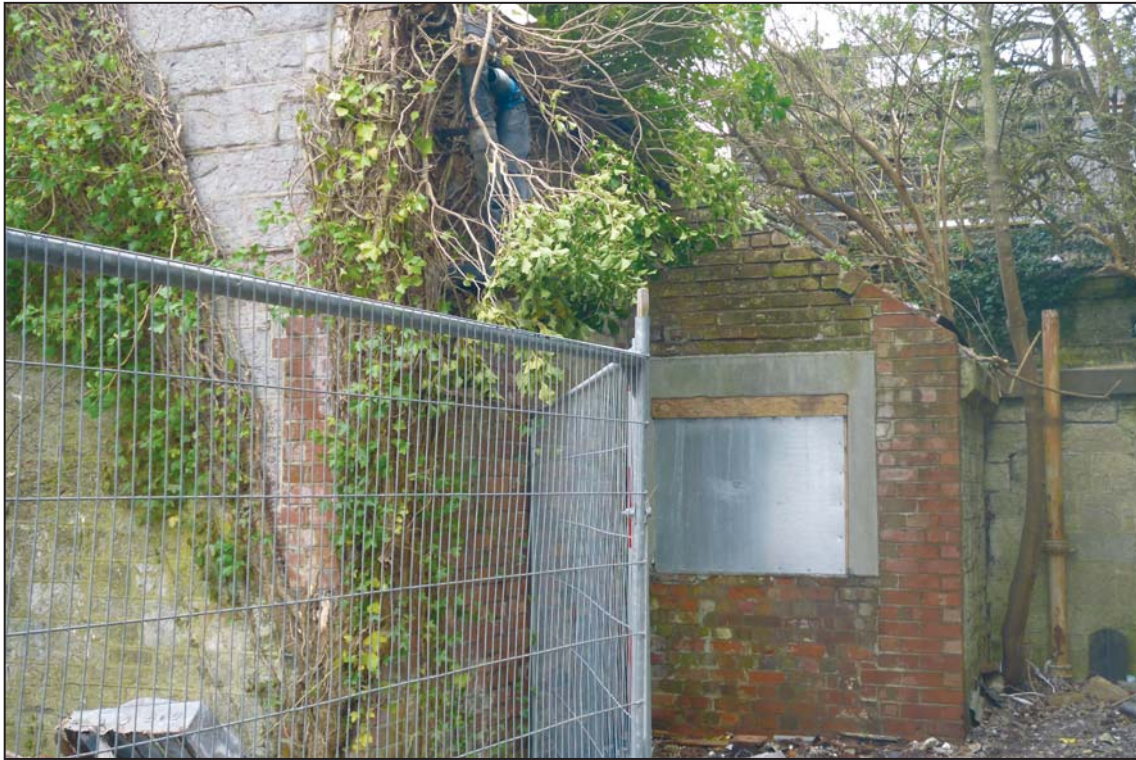
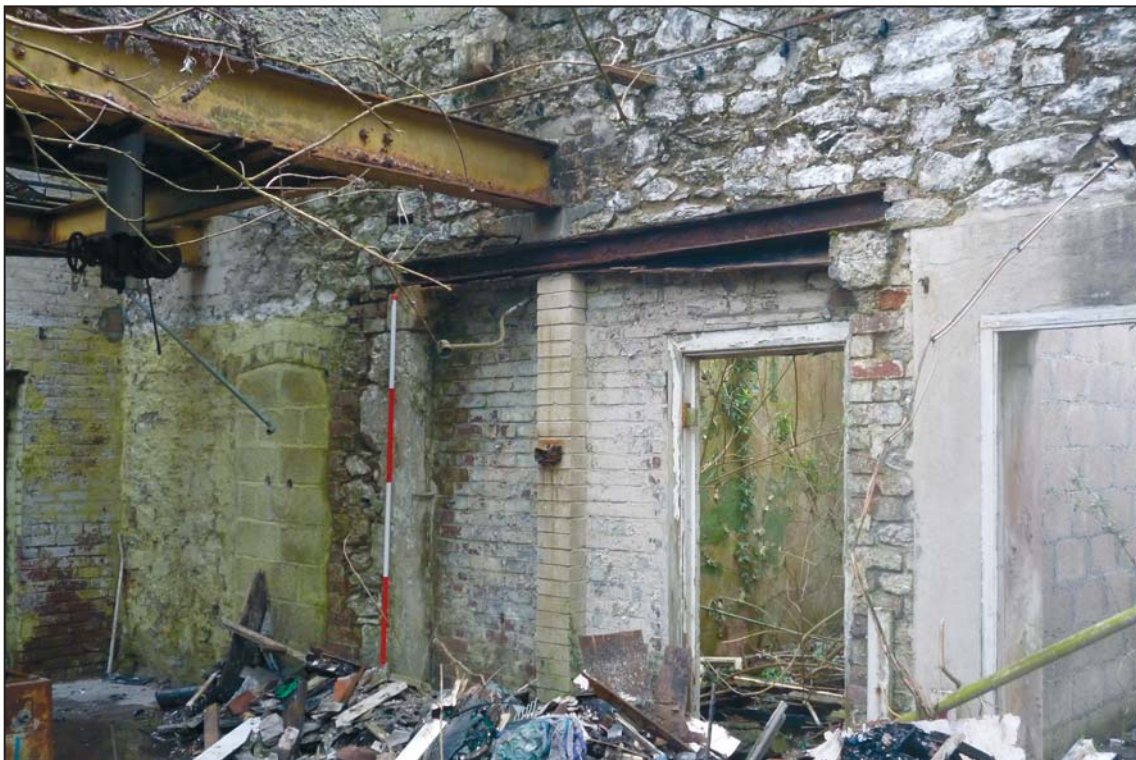
**22 & 23**

- 22** The cut-out corner in the north-western end of the stone range, rebuilt in brick, looking east. Note window on site of blocked door. Another blocked door was present behind the wire fencing
- 23** The succession of openings in the north-western wall of the stone range, looking north (scale 2m)

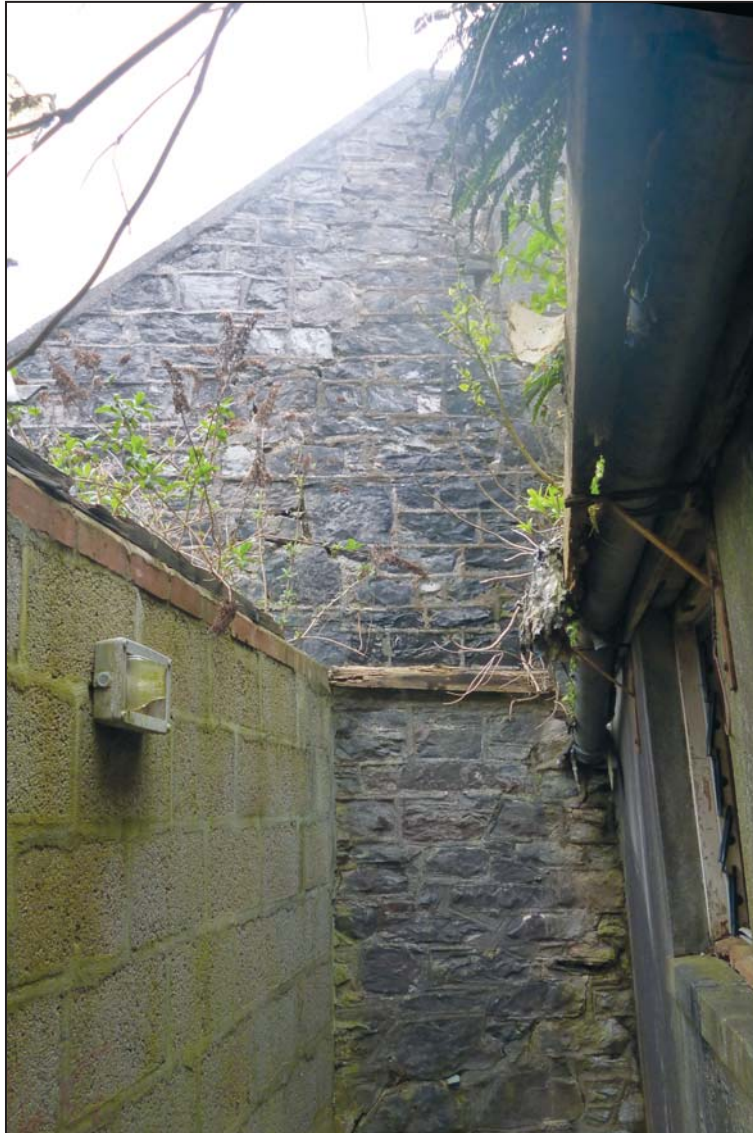
**24**

**24 The gable of a pre-laundry building against the north-east prison wall, looking north-east**

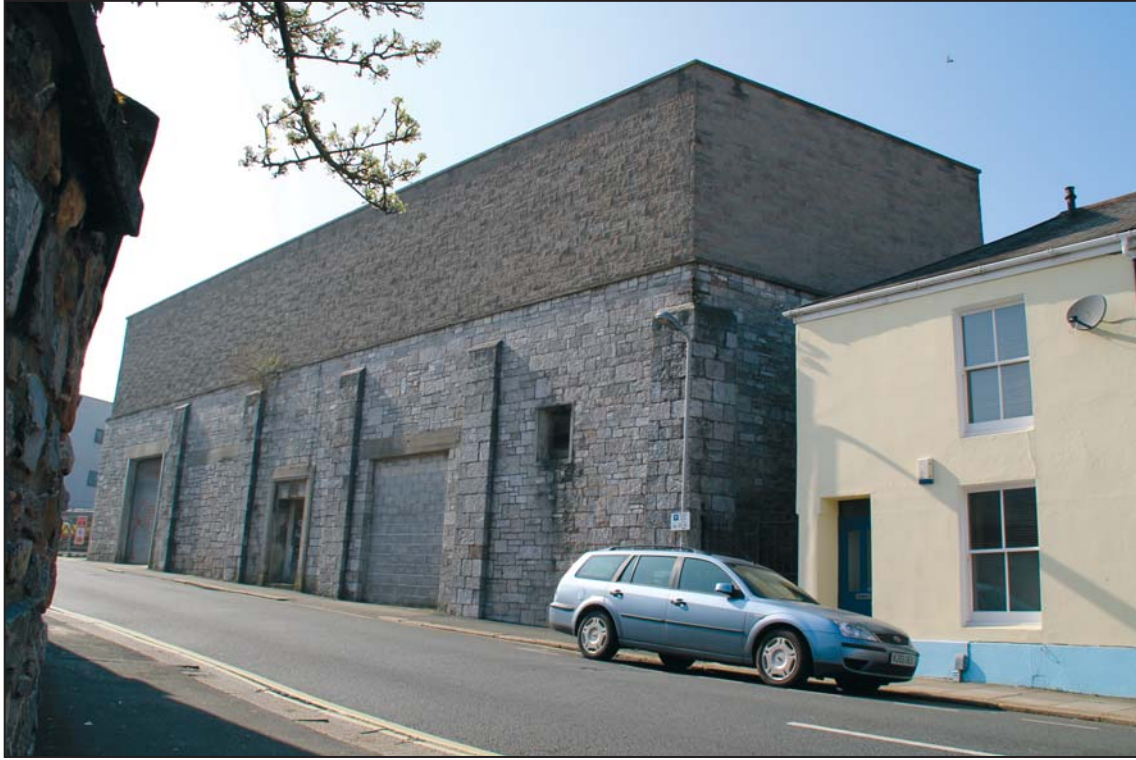
**27** The south-eastern prison wall along Longfield Place, as realigned between 1893 and 1907, the laundry access doors of different periods, and the post-war addition of the upper floor/south-eastern range, looking west

- 5.58 Externally the concrete and steel Longfield Place block is visible only at first floor level where it is a windowless, rectangular block apparently with a flat roof and clad in rusticated, stone range work (Figs 27 and 39). The south-western wall, south-east of the 1930s brickwork, is of similar construction, facing concrete blockwork (Fig. 4). Below the abutting roofline of the older shed the walls are of concrete blockwork throughout.

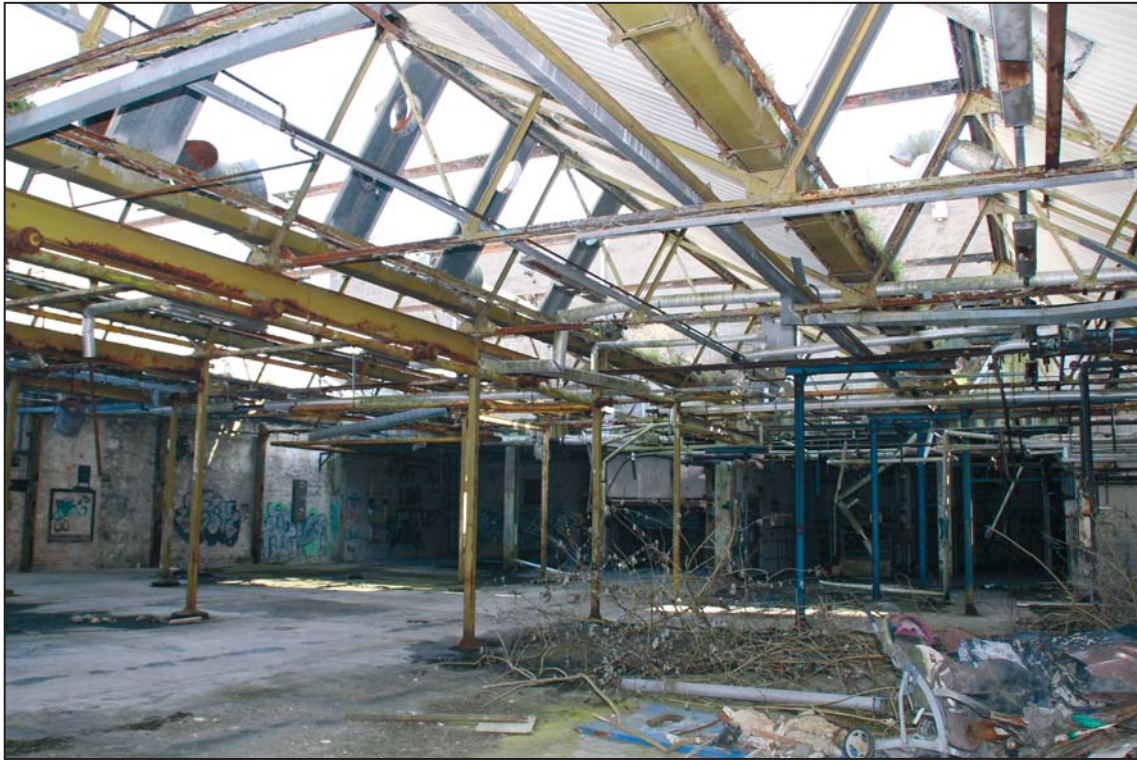
29

**29** General view of the interior of the laundry shed looking east

- 5.42 The laundry was a steel-framed single-storey structure with a saw-tooth, north-light roof of five rows aligned north-west/south-east (Figs 4 and 29). This is presently clad in plastic translucent roofing, much of which is missing and damaged. It is presumed that the roof was originally of some material such as corrugated asbestos or steel sheet with north-east facing glazing.

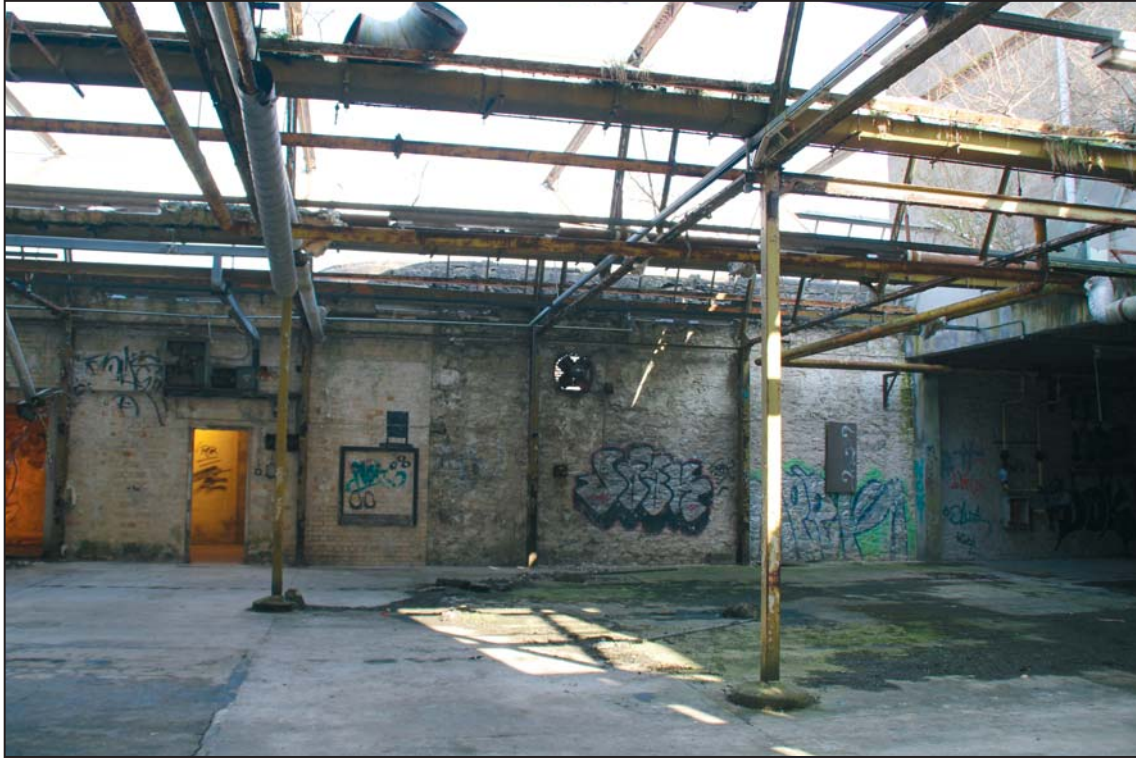
31 & 32

- 31 The north-western prison wall (south-east end) incorporated in the laundry wall (brick, to left), looking north-east
- 32 The stone wall of the northern part of the stone range of the later 19th century incorporated in the laundry's brick south-west wall , looking south-west (scale 2m)

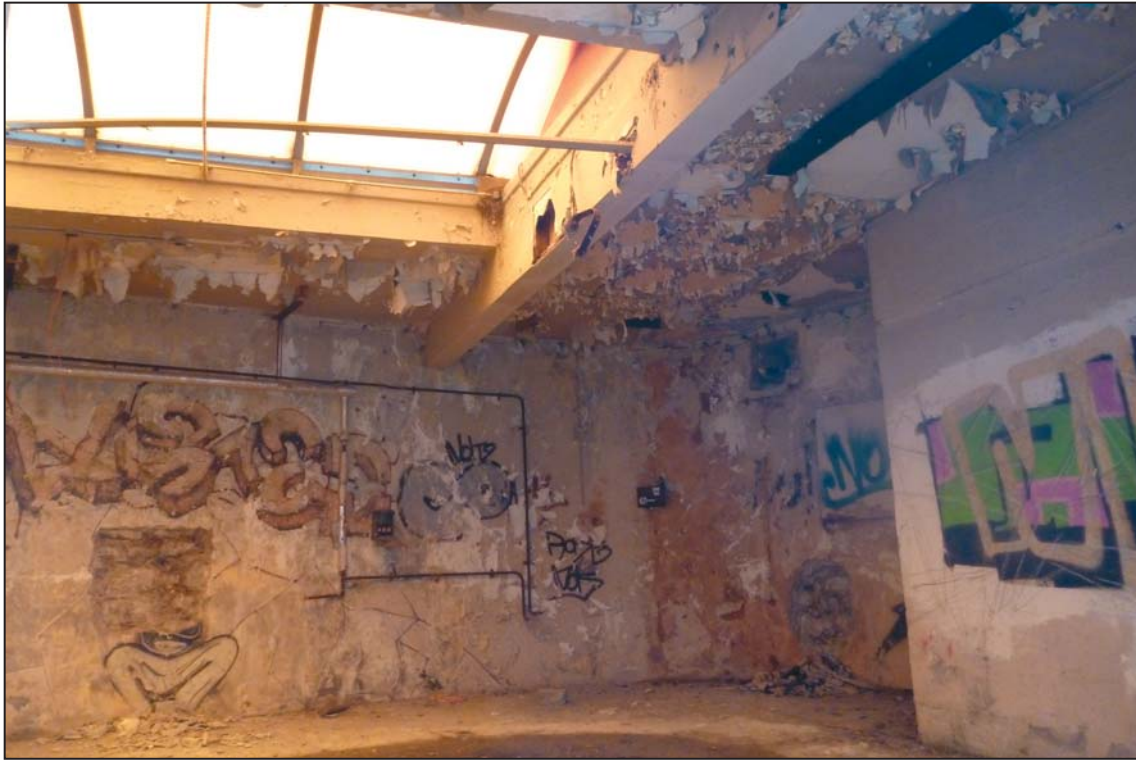
33

**33** The larger space north-east of the laundry main shed, with a skylight supported on a steel structure, looking north-east

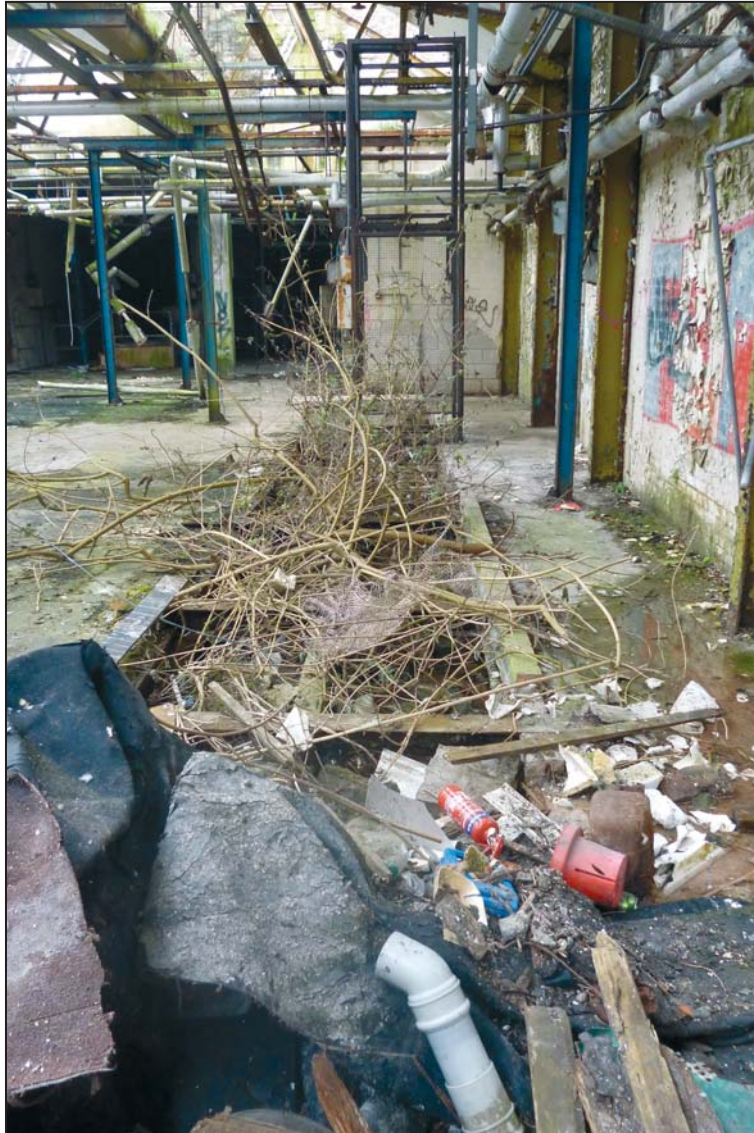
**34**

**34 View along the south-west side of the laundry shed to the south-east, showing the blue-painted machinery steels and the underfloor duct**

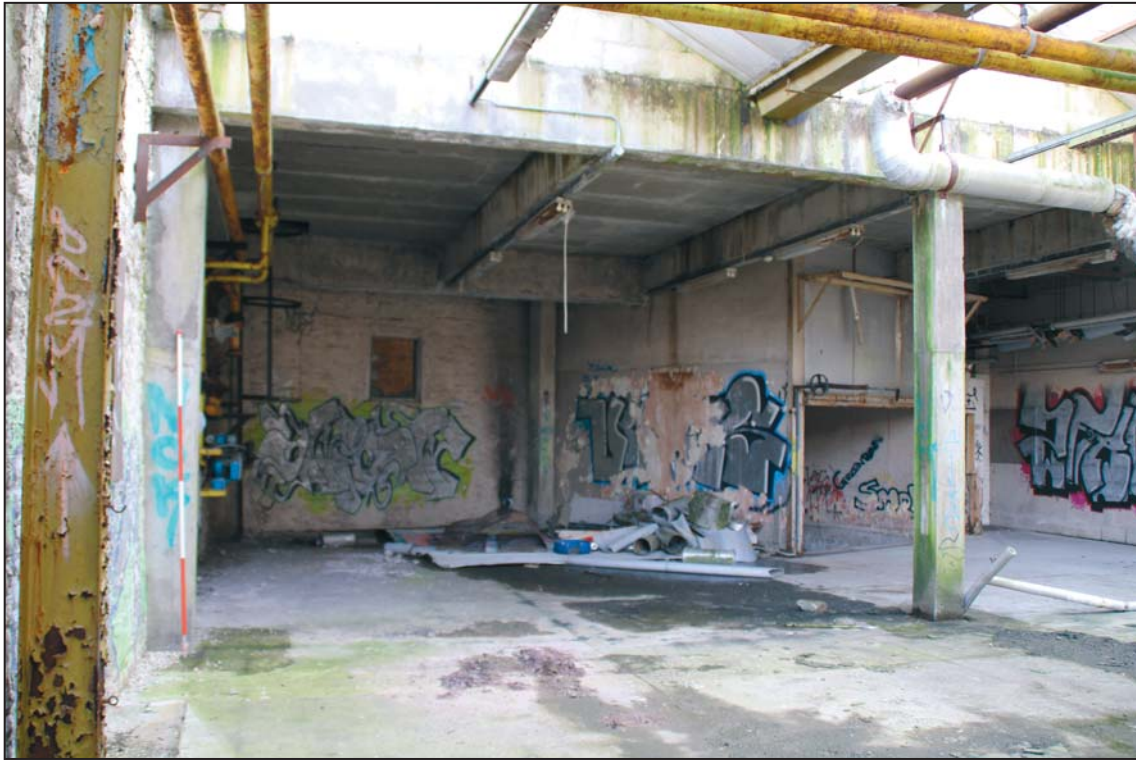
35

**35** View to south-east into the ground floor of the Longfield Place block, concrete structure and loading bay (scale 2m)

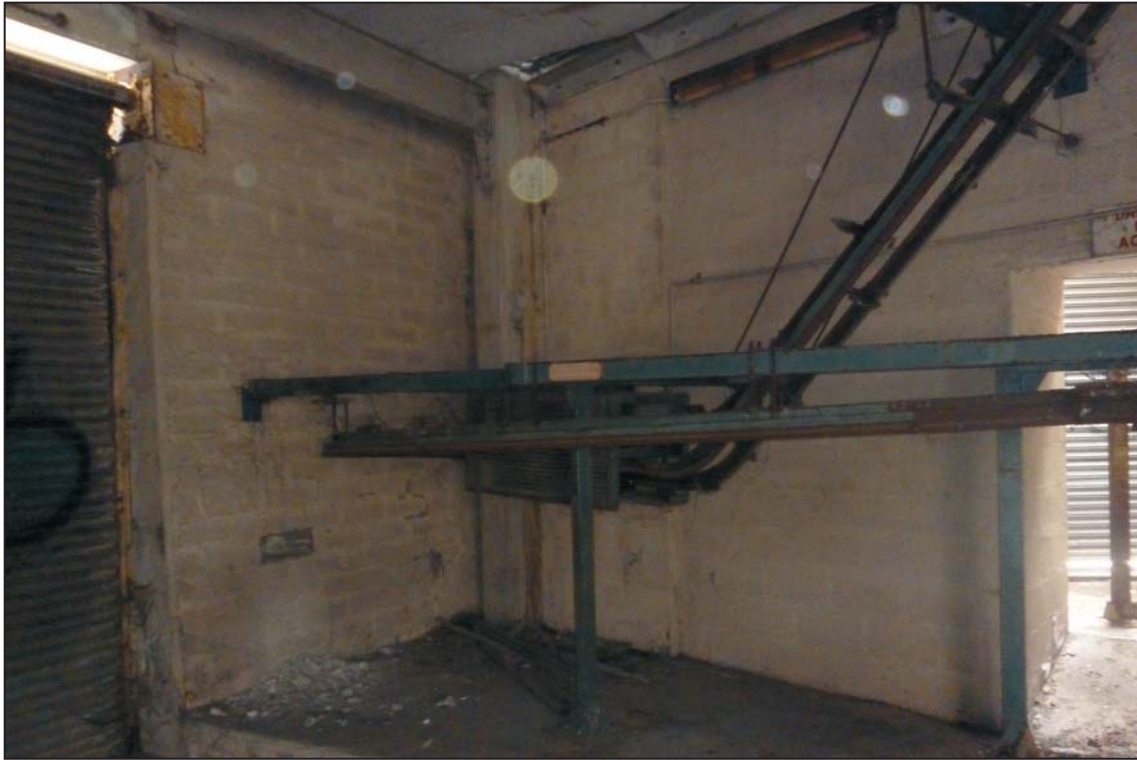
37

**37 The base of the railed conveyor system and motor, looking south, in the southern corner of the Longfield Place block. The installation of this must post-date the blocking of the loading bay behind it**

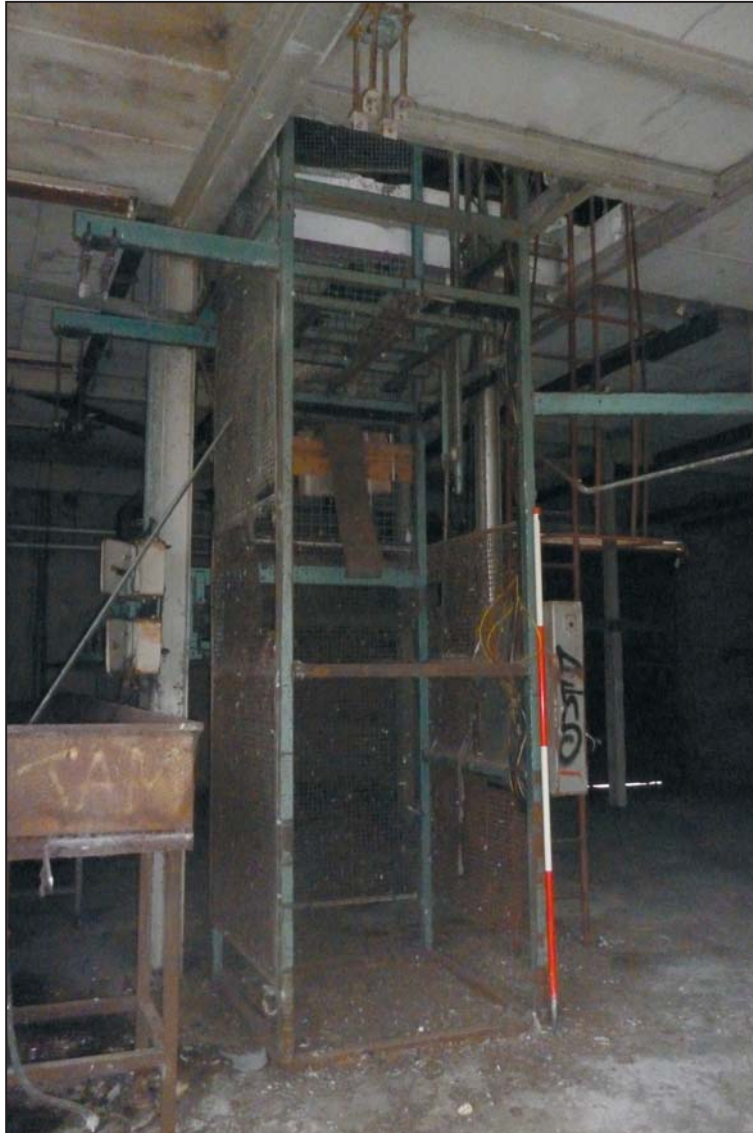
**38** The hoist cage in the south-western end of the Longfield Place block, with the end of the metal trough on the left (scale 2m)

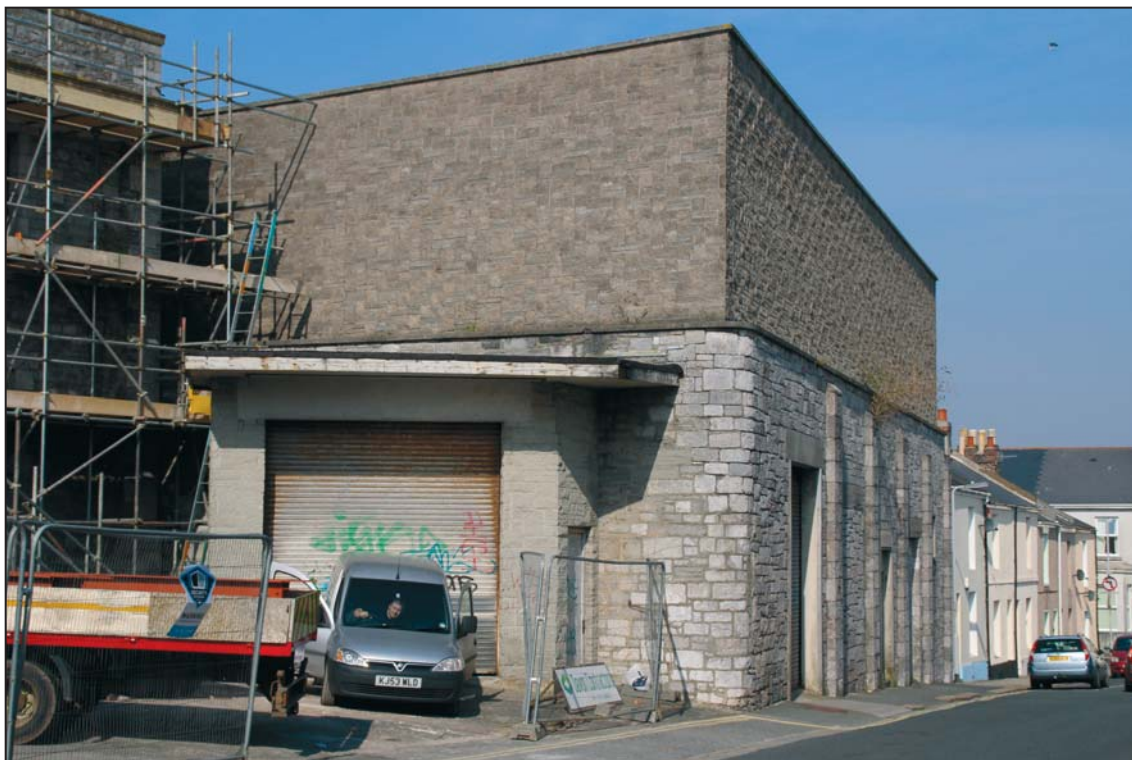
**39** The canopied loading door on the southern corner of the Longfield Place block, looking north, also showing the upper floor of the block

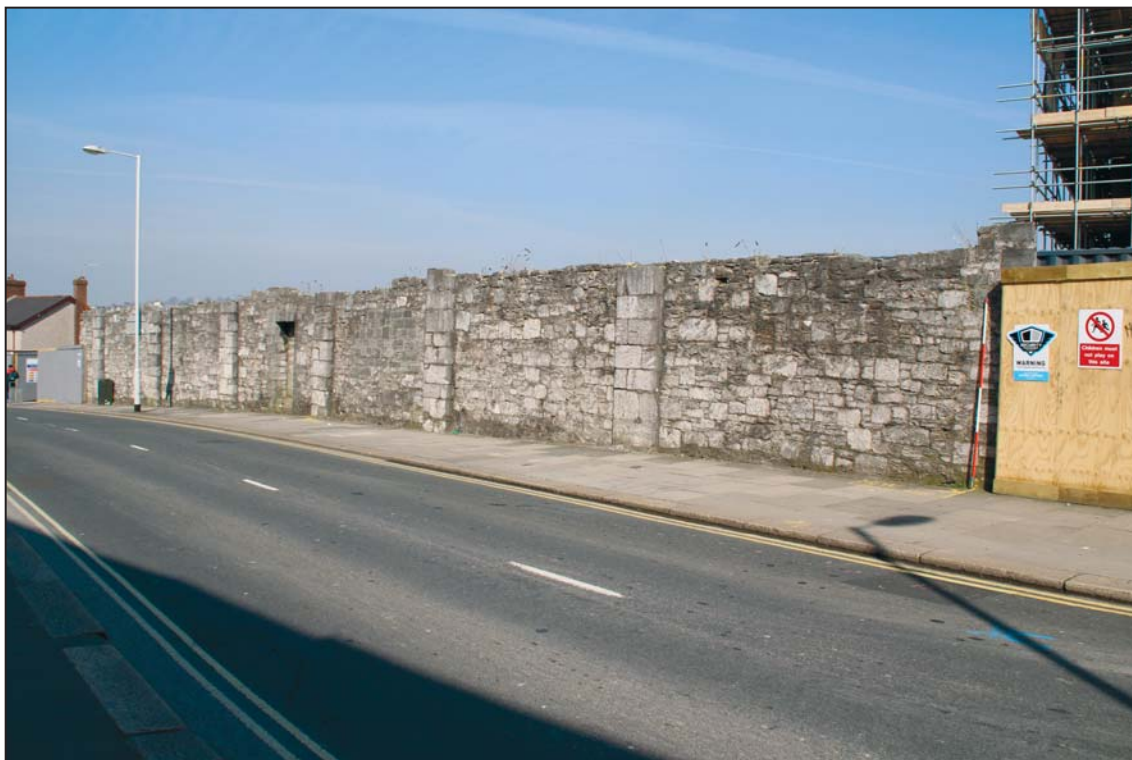
**41 The prison walls along Greenbank Road today,  
looking north (scale 2m)**
