New Woodland Classroom Chedworth Roman Villa Gloucestershire

Archaeological Watching Brief

CA Project: 6465
CA Report: 18008

March 2018

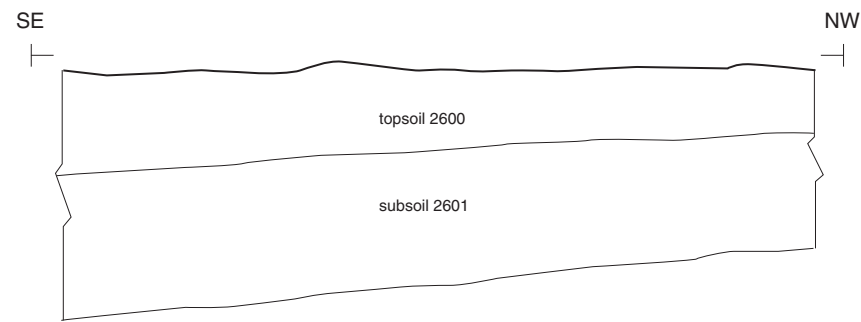
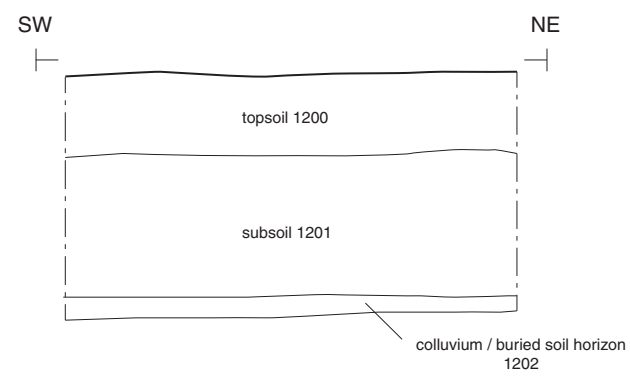
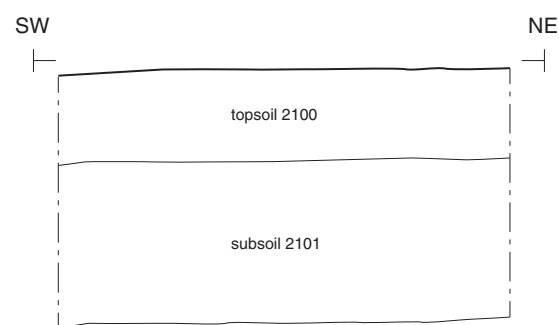
FIGURE TITLE
**Representative sections and
 photograph**

- 5.3 In Foundation Trenches 11 and 12 the natural substrate was overlain by thin silt deposits 1102 and 1202 respectively, both of which contained occasional flecks of charcoal and mortar. These deposits were overlain by heavily root affected sand-silt subsoil which was in turn sealed by topsoil, typically measuring 0.11m in thickness.

- 6.1 Deposits 1102 and 1202, identified in Foundation Trenches 11 and 12 respectively, contained flecks of charcoal and mortar and it is possible that they represent episodes of colluviation or a buried soil horizon. However, these interpretations are necessarily tentative due to the limited view afforded by the groundworks undertaken.
- 6.2 Despite the archaeological potential of the site (see *archaeological background* above), the watching brief identified no further archaeological remains within the area of observed groundworks. The absence of archaeological deposits may indicate that structural remains associated with Chedworth Roman Villa either do not extend as far as, or were not exposed by the development.

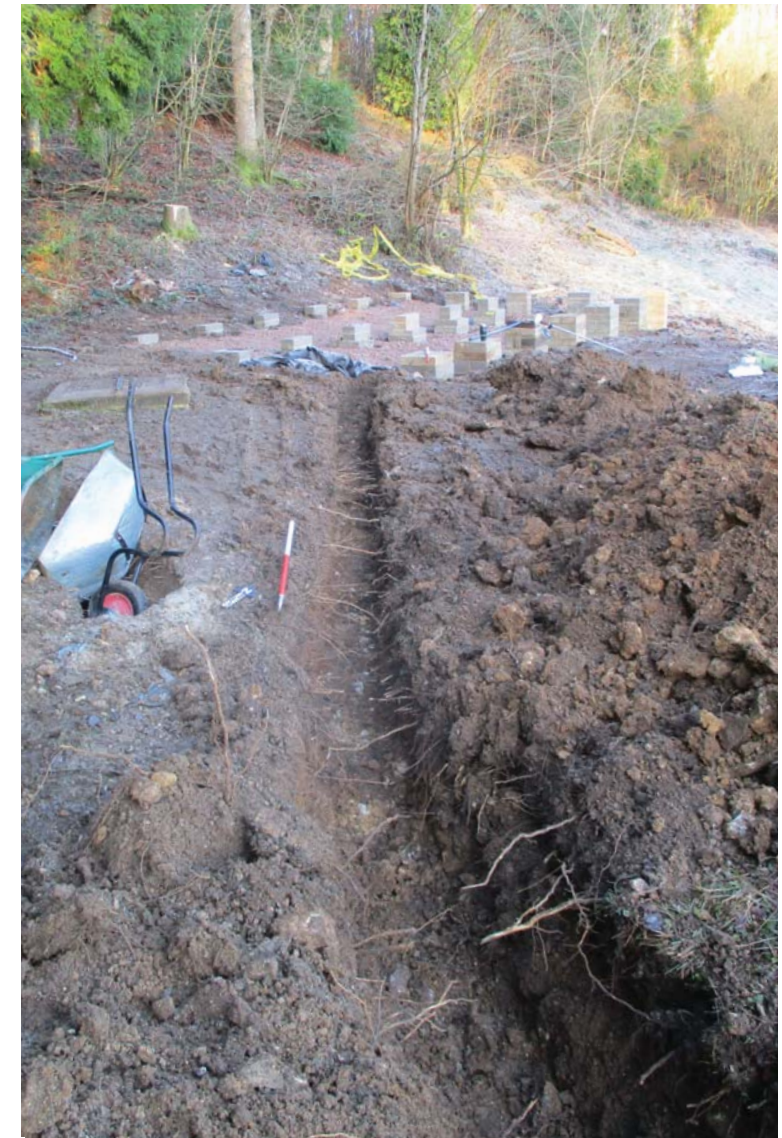
- 5.1 The natural substrate, comprising compact mid yellow limestone brash with occasional patches of silt sand, was encountered in all of the excavated foundation trenches and throughout the excavated service trench at between 0.3m and 0.37m below present ground level (bpgl).

Excavated foundation trenches and service trench, looking north-west (1m scale)
