The Grand Western Canal Tiverton Devon

Archaeological Watching Brief

CA Project: 880240
CA Report: 17722

December 2017

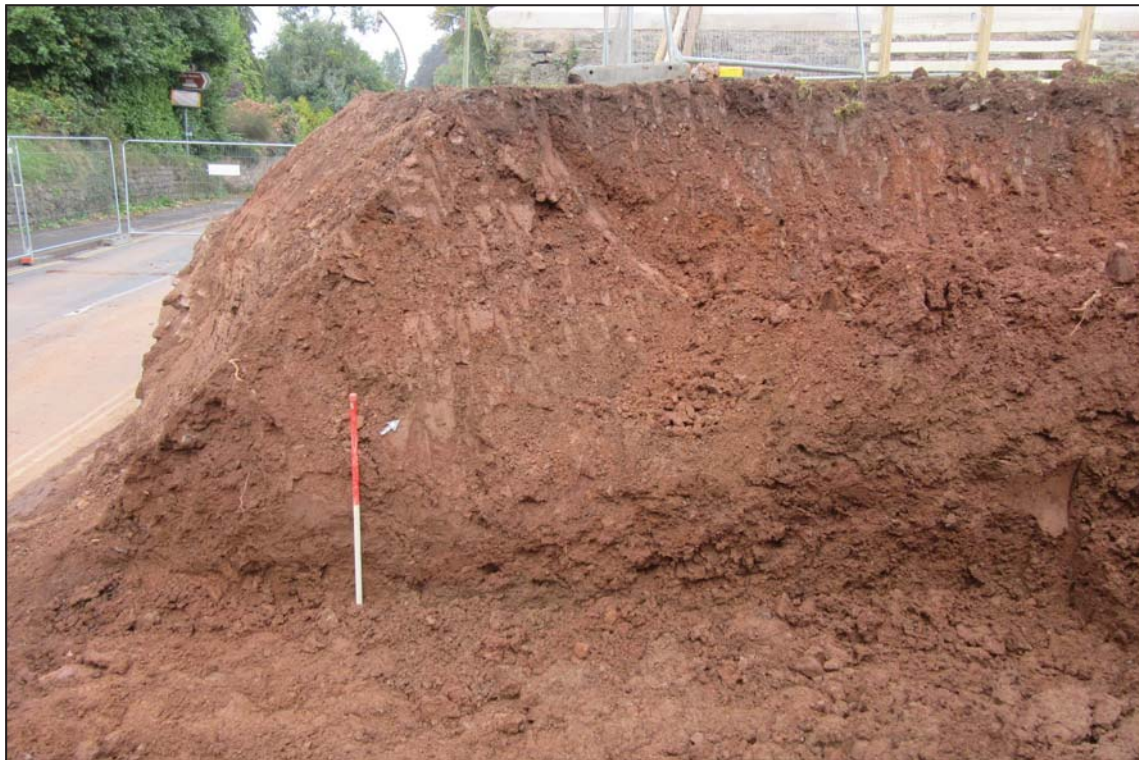
Trench 3: section and photograph

- 5.4 Abutting the north-eastern face of wall 308 (and sealing colluvial layer 401) was a series of made ground deposits (contexts 400, 303–307; Fig. 3), formed predominantly of redeposited natural sand and gravel with occasional late post-medieval/modern demolition rubble inclusions (brick and stone). Modern ceramics were observed in deposit 304, one of the earlier deposits in this sequence. These deposits were sealed by topsoil 300 and were piled up behind the wall to a height of c. 93.3m aOD (c. 2.5m above road level).

Made ground deposits formerly abutting wall 308, looking north-west (1m scale)

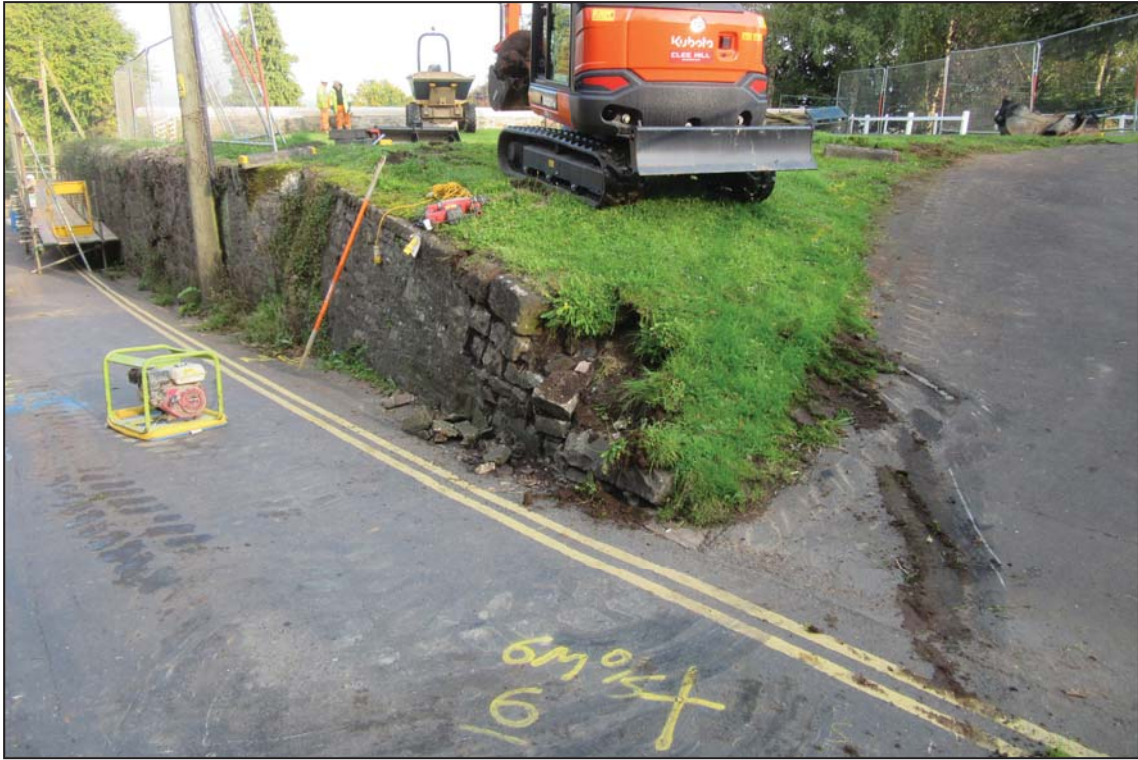
Retaining wall: photographs

- 5.5 The most south-easterly 5m of the retaining wall (context 302) was found to be a later abutment, constructed in the same manner as wall 308 (Fig. 4). The north-eastern face of wall 302 was abutted by a deposit of redeposited natural sand and gravel with demolition rubble inclusions (context 301).

Wall 302 during dismantling, looking north-west

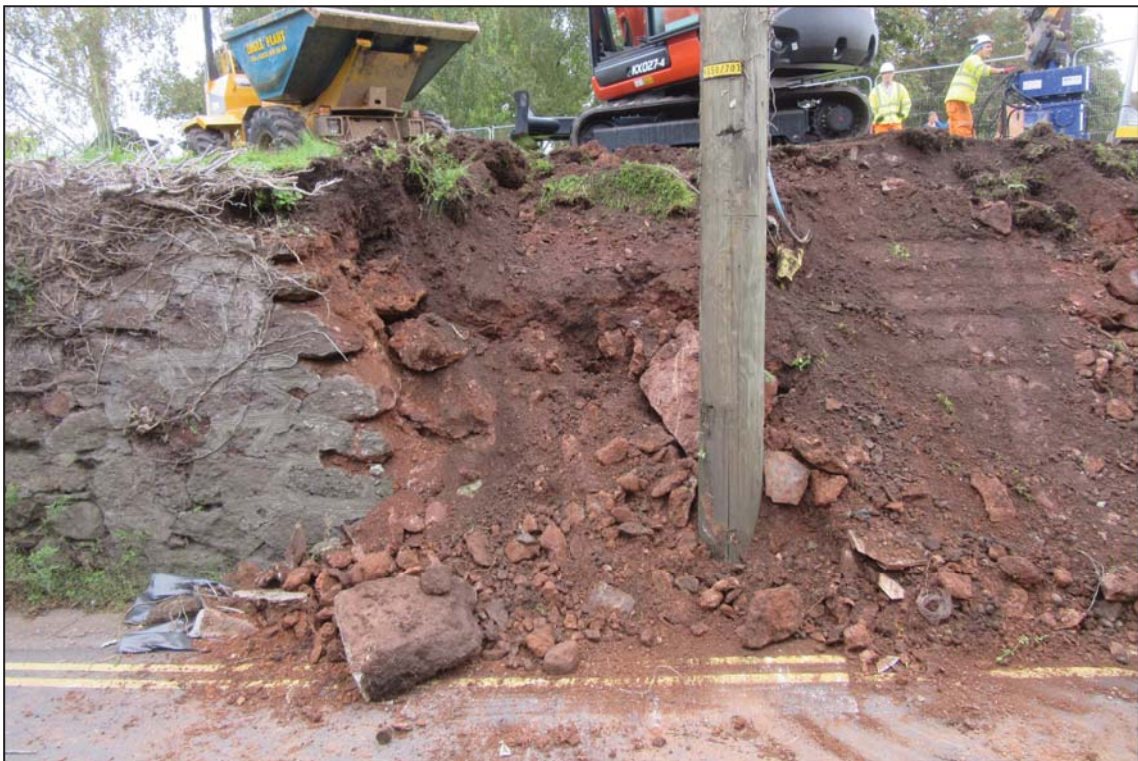
- 5.3 Retaining wall 308 (Fig. 4) was constructed of worked granite coursed as quoins with stressed corners. It was aligned north-west/south-east, with a gradual return towards the east at its south-eastern end. The construction cut of the wall was not observed, but it is assumed to have been cut into colluvial layer 401.

Wall 308 during dismantling, looking north-east
