**SPYE PARK HOUSE
SPYE PARK
CHITTOE
WILTSHIRE**

ARCHAEOLOGICAL WATCHING BRIEF

CA PROJECT: 2201
CA REPORT: 07028

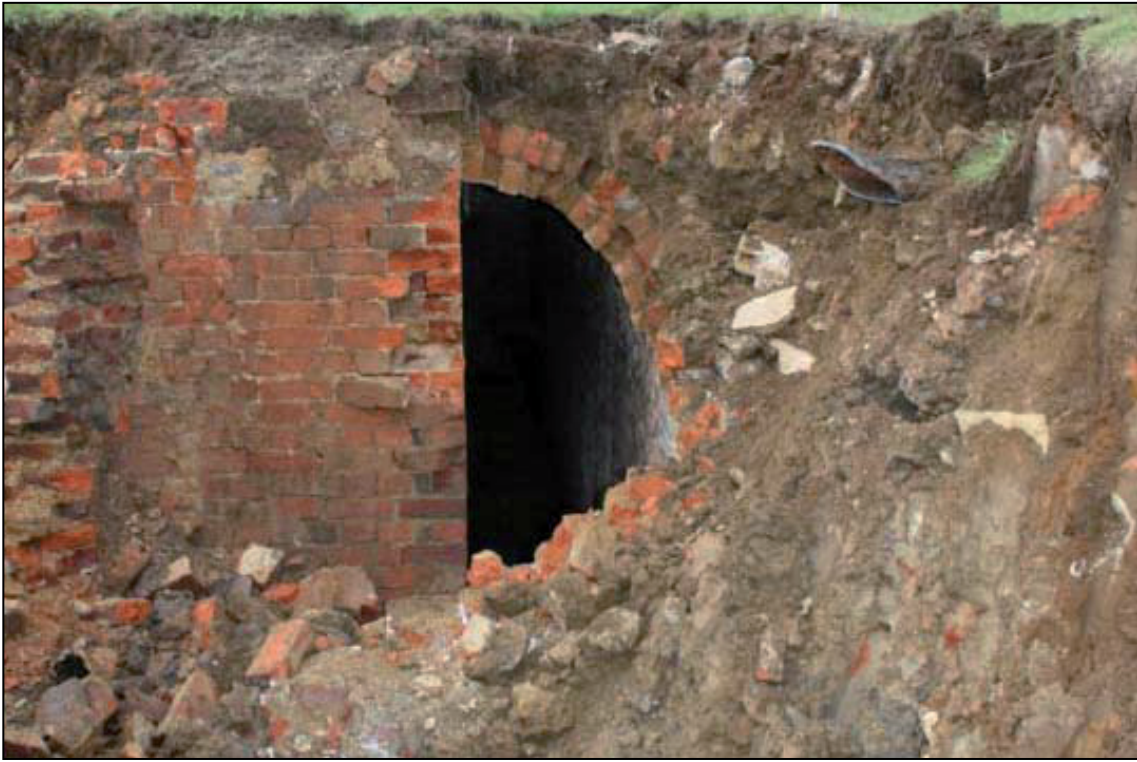
4

<p>4 Remnants of arch 18 and wall 5.</p> <p>5 View of south-west corner of area of groundworks</p>

- 2.2 The excavation of the area for the insertion of the new foundations showed that the area had been excavated before. Seven heavily truncated red brick walls, some retaining their lime plaster (Walls 3 and 4; Fig. 5) and Wall 1 its concrete foundations, were encountered. Wall 5 was abutted by the remnants of brick arch 18 to the north-east (Fig. 4), the function of which was unclear. Stone slab flooring was also observed adjacent to Wall 1 at approximately 3.7m BPGL (Fig. 3). The previously excavated area had been backfilled with brick rubble, burnt timber, and fragments of decorated stonework including a section of cornice showing egg and dart moulding with traces of gold leaf. This piece was retained by the landowner.
