Land at Denmark Road Gloucester

Archaeological Watching Brief

CA Project: 6681 CA Report: 18401

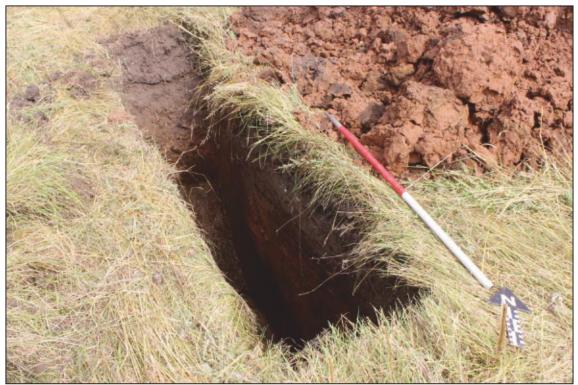
Test pit 45, looking north (1 m scale)

- 5.2 With the exception of Trial Pit 43, a similar stratigraphy was recorded across the site. The natural geological substrate, comprising red sand and gravel, was recorded between 0.75m and 1.8m below present ground level (bpgl) in Trial Pits 36-51. In Trial Pits 34, 36, 39-42 and 44-51, deposits of clay silt, sand and gravel that are likely to represent the backfill of post-medieval quarry pits, were recorded. With the exception of Trial Pit 34 where the quarry backfill was the earliest deposit recorded, the quarry pits cut the natural substrate. A single sherd of post-medieval pottery was recovered from the quarry backfill deposit 34001 in Trial pit 34.

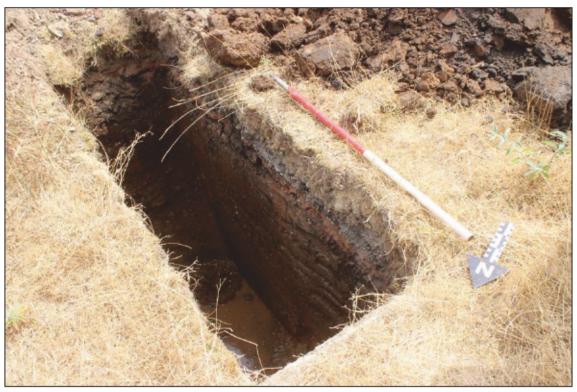
Test pit 51, looking south-east (1m scale)
