**Henrietta Garage Mews  
Bathwick  
Bath  
Bath & North East Somerset**

*Programme of Archaeological Work*

CA Project: 6146  
CA Report: 18123

July 2018

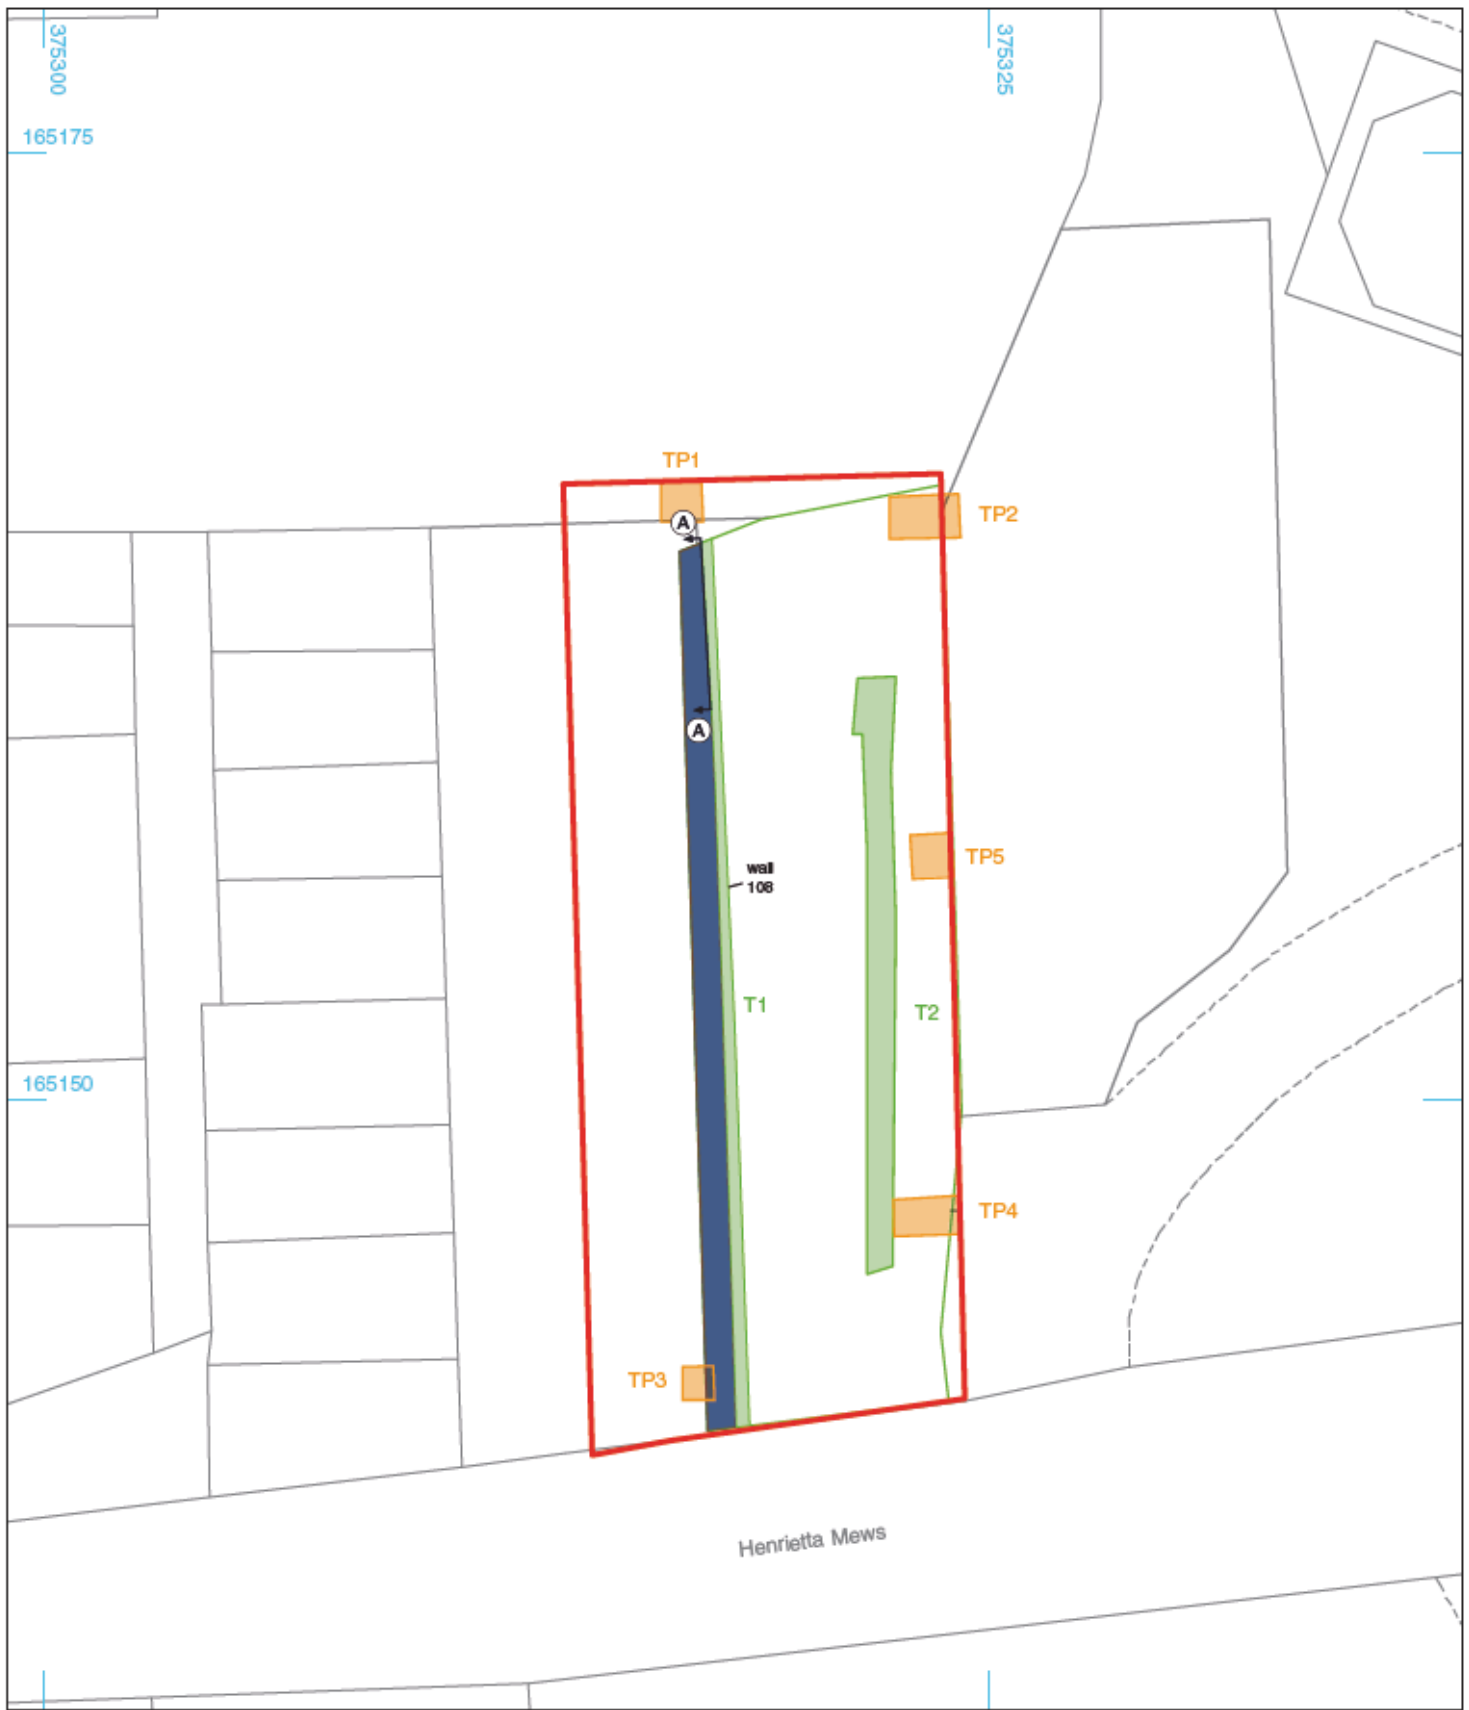
DRAWN BY	CP	PROJECT NO.	6146	FIGURE NO.
CHECKED BY	DJB	DATE	03/05/2018	2
APPROVED BY	SS	SCALE@A4	1:200

- 4.1 The fieldwork followed the revised methodology agreed between CA and Richard Sermon, Senior Archaeological Officer, BANESC (see *Paragraph 1.2*). An archaeologist was present during intrusive groundworks comprising an archaeologically controlled phase of ground reduction to facilitate the installation of a piling mat and the archaeological monitoring of five GI trial-pits, a service trench (Trench 2) and a trench excavated to remove a wall identified during demolition of the existing garages, prior to the commencement of piling (Trench 1; see Fig. 2 for location and extent).

**FIGURE TITLE**  
 The site, showing location of observed  
 groundworks and identified structural  
 features

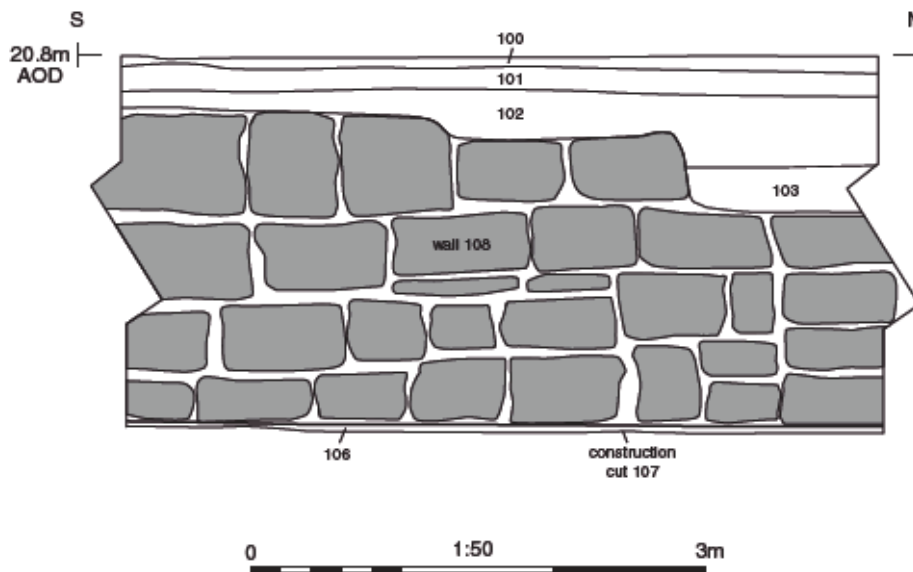
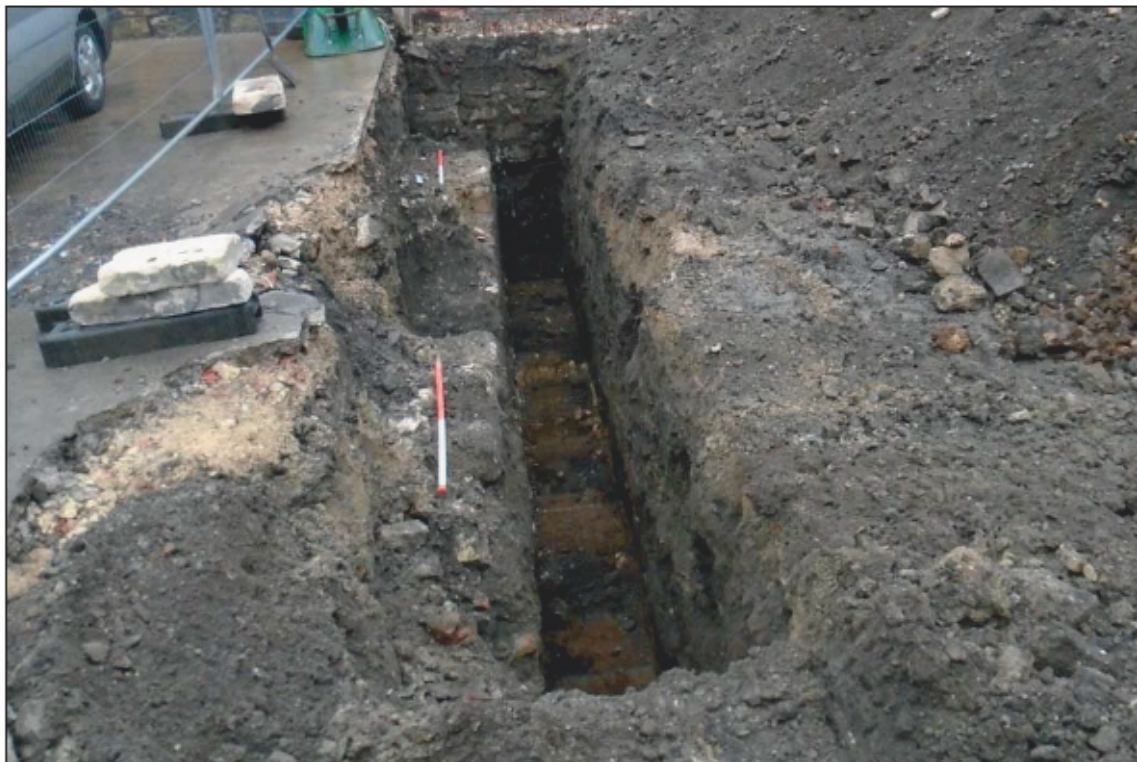
**4**

- 5.3 Trench 1 was excavated to remove a wall identified during demolition of the existing garages, prior to the commencement of piling. The earliest deposit encountered was probable subsoil 106, identified at a depth of 2.8m bpgl. It was cut by north-south aligned construction cut 107 for rough limestone block wall 108. Wall 108 (Fig. 4, section AA) survived to a depth of 2.1m, was bonded by dark grey cement mortar and correlates closely to part of a property boundary depicted on the 1888 First Edition OS map (see Fig. 3). Wall 108 was butted by make-up/levelling layer 104 which contained frequent limestone and red brick fragments and measured up to 1.6m in thickness. Make-up/levelling layer 104 and wall 108 were overlain by make-up levelling layers 103 and 102, both of which contained occasional fragments of modern glass and concrete. The latest of these deposits, 102, was overlain by crushed limestone and gravel bedding layer 101 for the existing concrete surface, 100.

Section AA

Wall 108, looking north (scales 1m)

**Wall 108: section and photograph**

- 6.1 Rough limestone block wall 108, identified in Trench 1, correlates closely to part of a property boundary, associated with two small buildings of indeterminate function, depicted on the 1888 First Edition OS map. This boundary is shown on all later editions of the OS mapping until 1930-1933 after which it is no longer depicted.

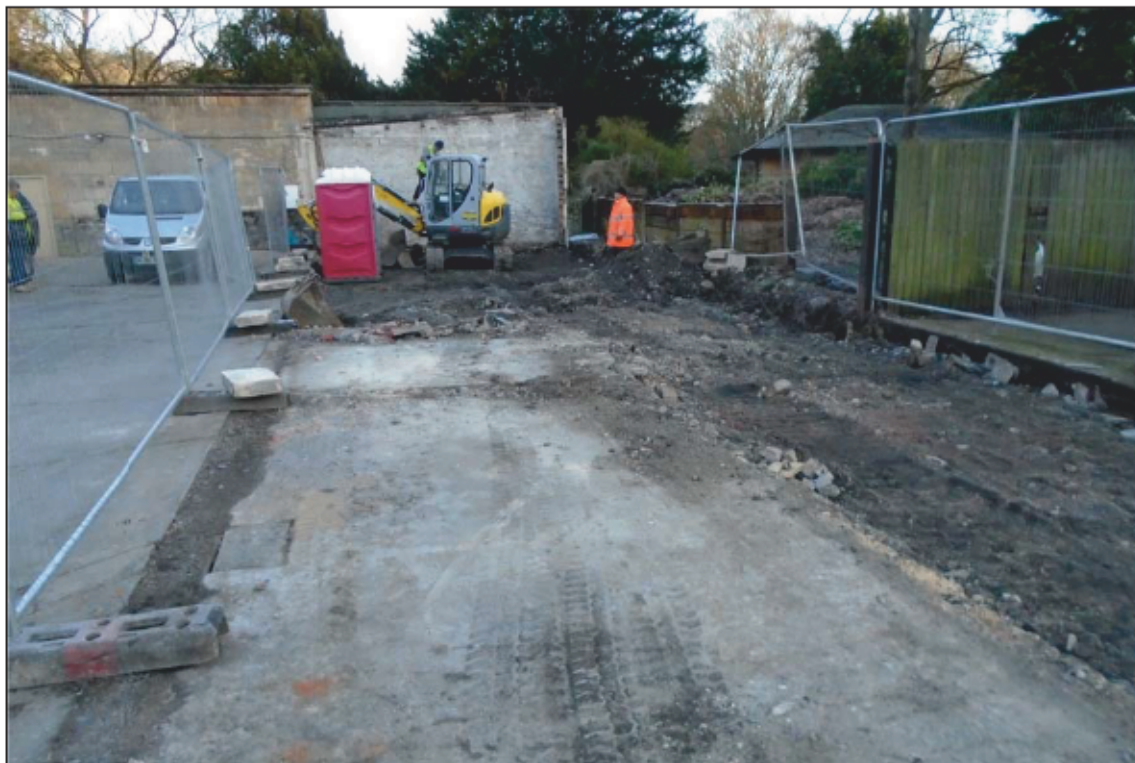
The site, looking north

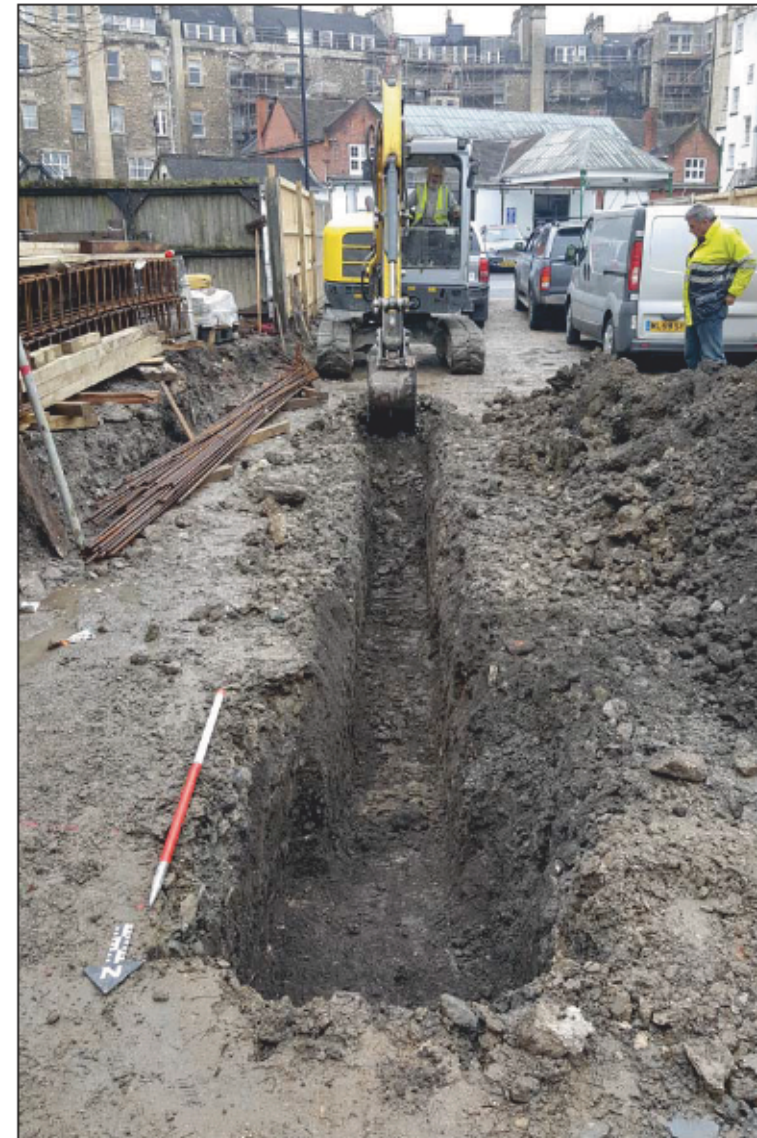
- 5.4 Trench 2 was excavated to a maximum depth of 0.85m bpgl. The earliest deposit encountered within the trench was make-up/levelling layer 202 which contained occasional fragments of modern glass and concrete and measured more than 0.55m in thickness. This was sealed by crushed limestone and gravel bedding layer 201 for the existing concrete surface, 200.

The site showing excavated drainage trench 2, looking south (scale 1m)
