**Land at Rufford Abbey (Play Park)
Ollerton
Nottinghamshire**

Archaeological Watching Brief

CA Project: 661083
CA Report: 18370

July 2018

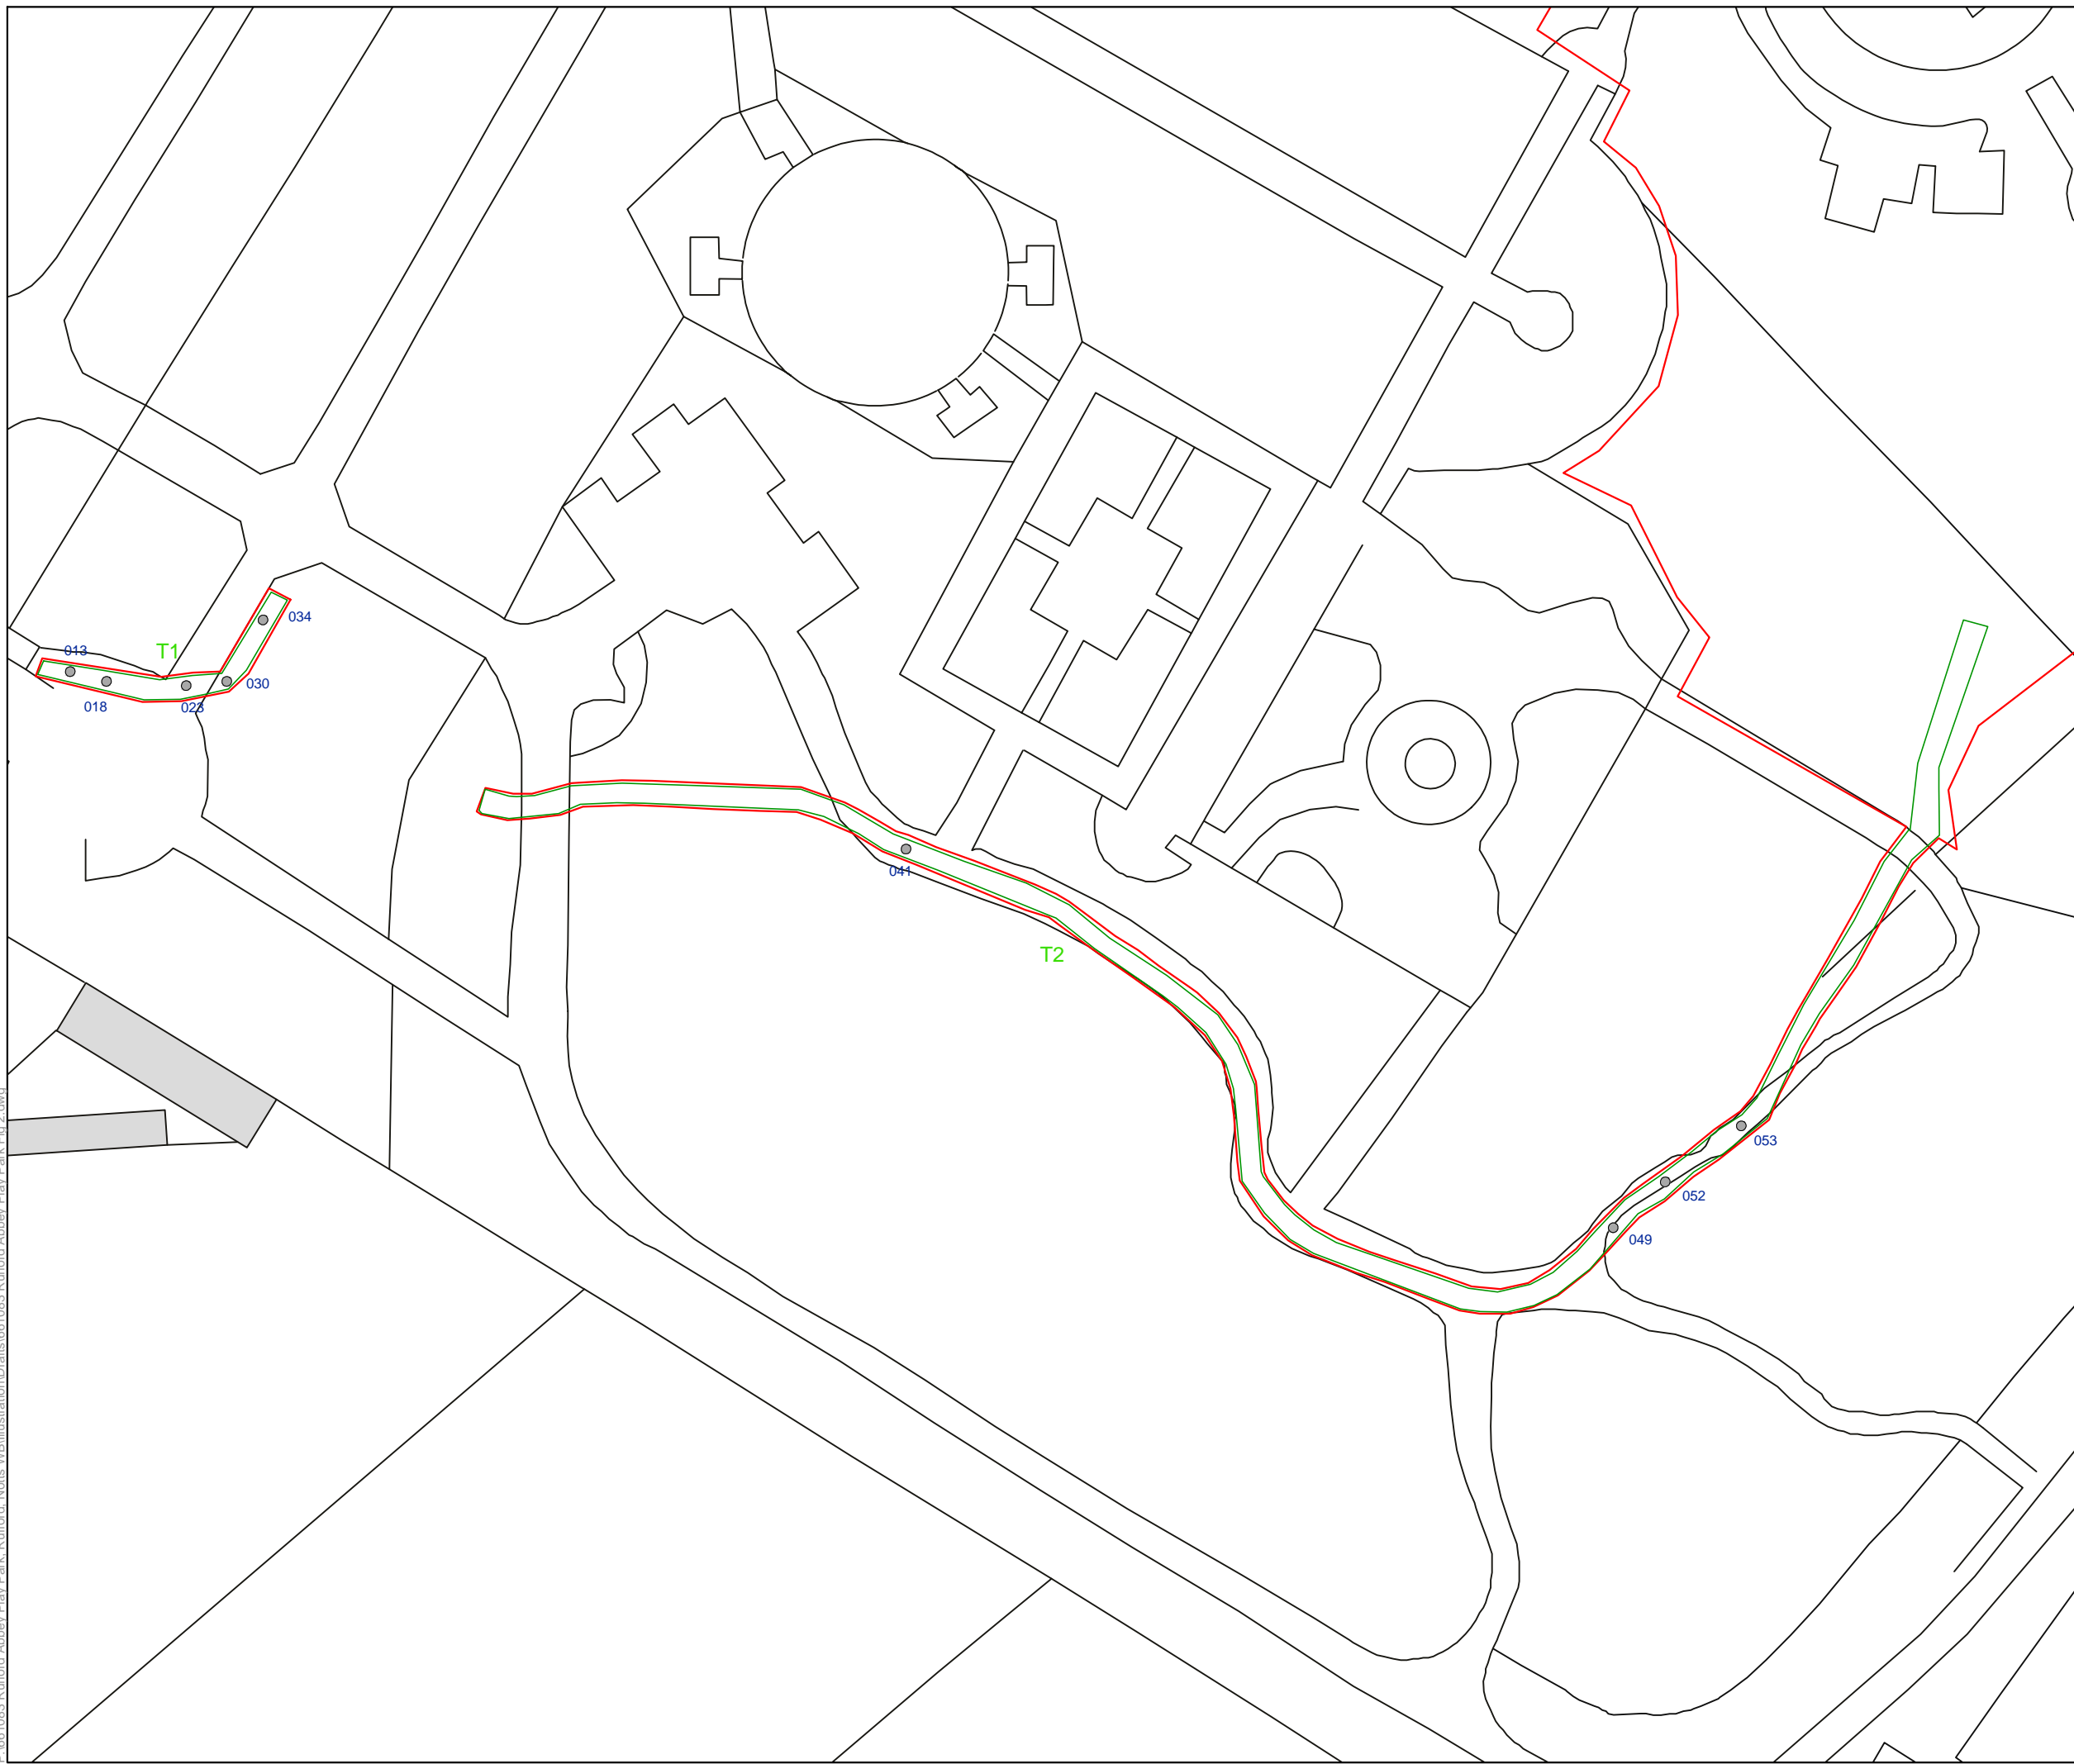
DRAWN BY TB	PROJECT NO. 661083	FIGURE NO.
CHECKED BY DJB	DATE 18.07.18	2
APPROVED BY MH	SCALE@A3 1:500

Fig.2: Trench Location Plan Showing Archaeological Features (1:500)

- 1.5 Two lengths of service trenching were excavated as part of the proposed site groundworks (Fig. 2). For the purposes of this report these have been called Trench 1, which measured approximately 23m in length and extended from the eastern corner of the Orangery structure, to the east and north, where it met with pre-existing utility tie-ins (Fig.3); and, Trench 2, which measured approximately 165m in length and extended east from an existing utility tie-in following the current path

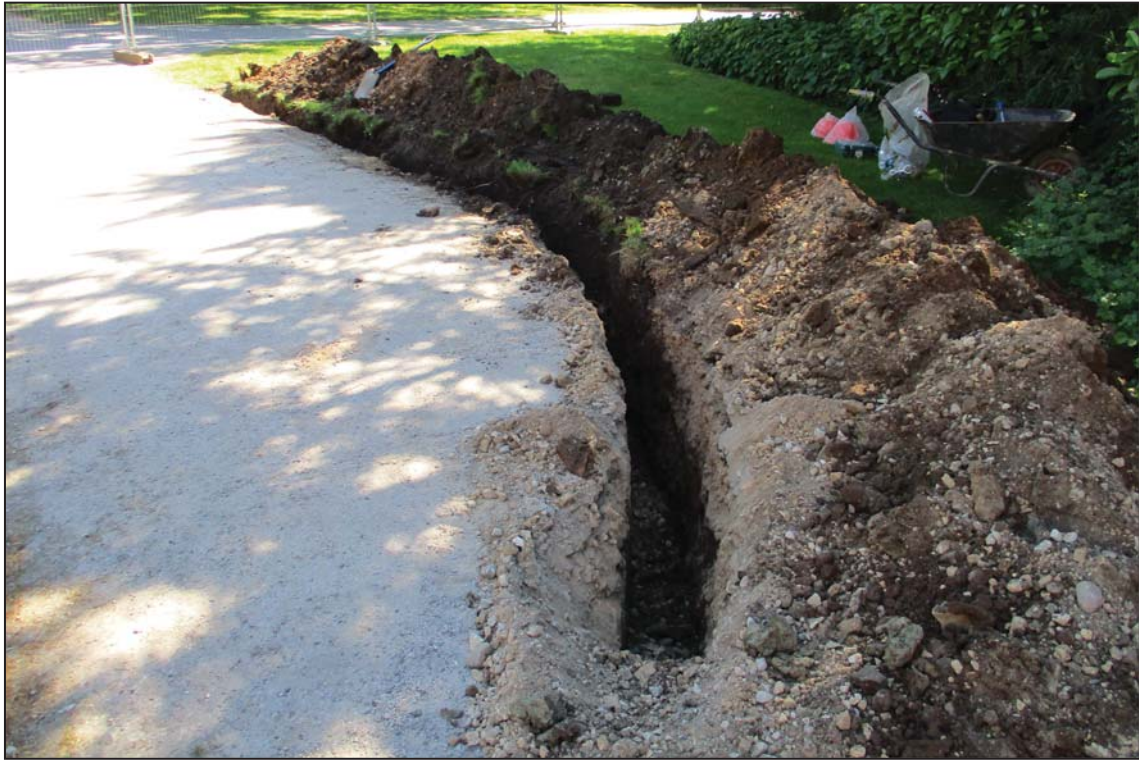
3

Trench 1, looking north-east

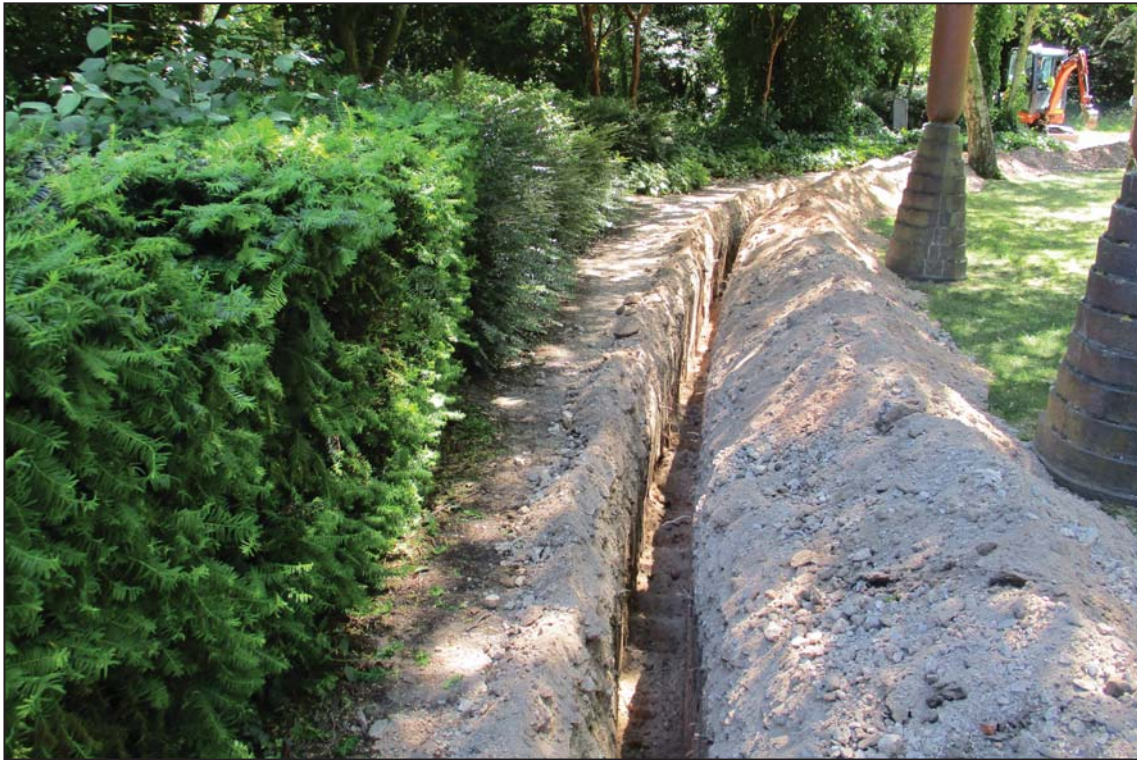
4

alignment (Fig.4) to the east and north towards the proposed play park development site (Fig.5).

Trench 2, looking south-east

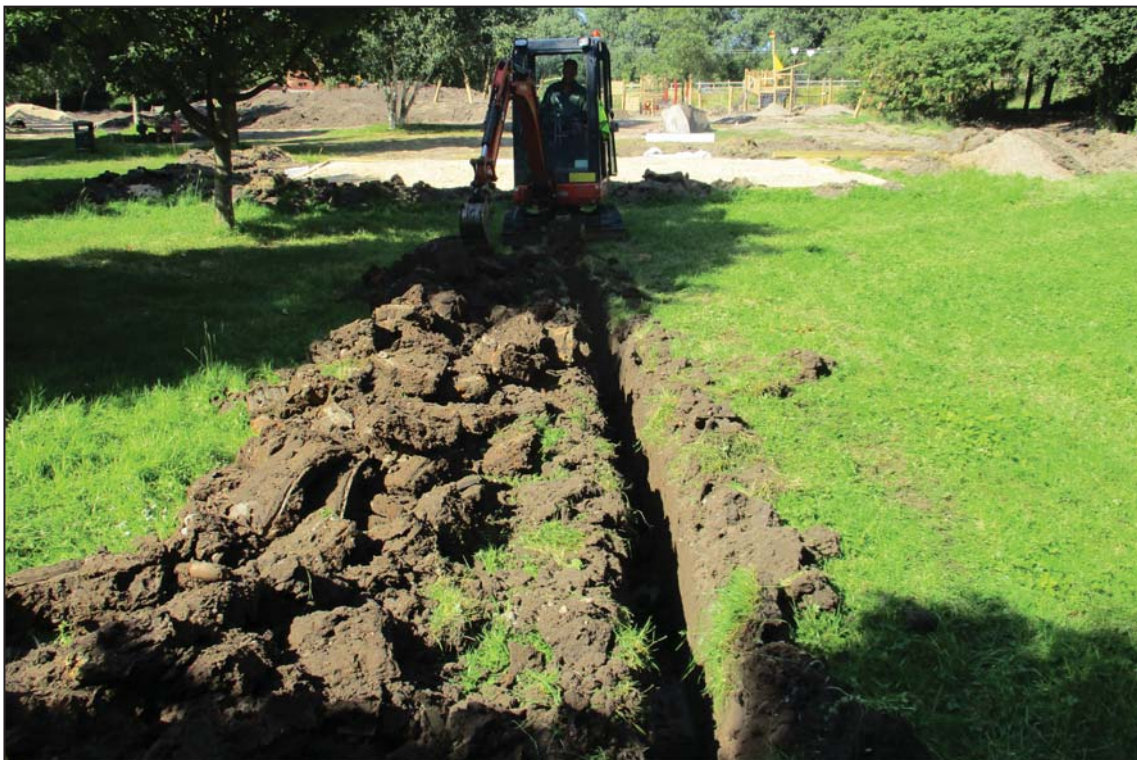
5

Trench 2, looking north-east

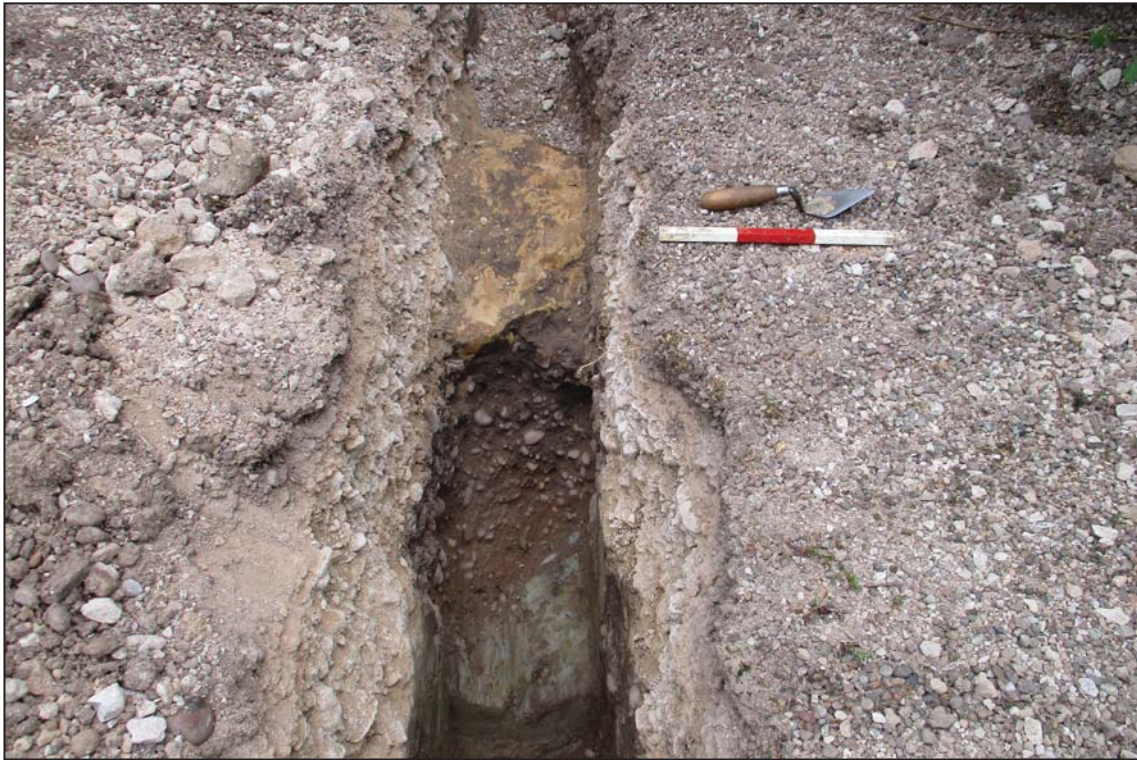
- 5.2 Brick and stone culvert/drain 013 is located closest to the Orangery, and cuts through deposit 010 (Figs 6-7). The culvert/drain runs north/south and was constructed using a stone slab base with seven courses of red unfrogged bricks (length: 230mm, width: 110mm, thickness: 60mm) lying flat, two courses deep, supporting a stone slab cover (max length: 600mm, width: 480mm, thickness: 130mm). The bricks were laid in a stretcher bond for the upper six courses, with the lower course being laid perpendicular. The brickwork was bonded using a lime-based mortar. The culvert/drain was encountered at a depth of approximately 0.24m below the present ground level (bpgl) and is approximately 0.98m wide from the outside of the brickwork.

- 5.3 Construction cut 016 of the culvert/drain 013 was filled with a thick packing of green clay 015 along the cut, with gravel fill 014 separating the brickwork from the green clay packing.

feature 013, looking west (0.3m scale)

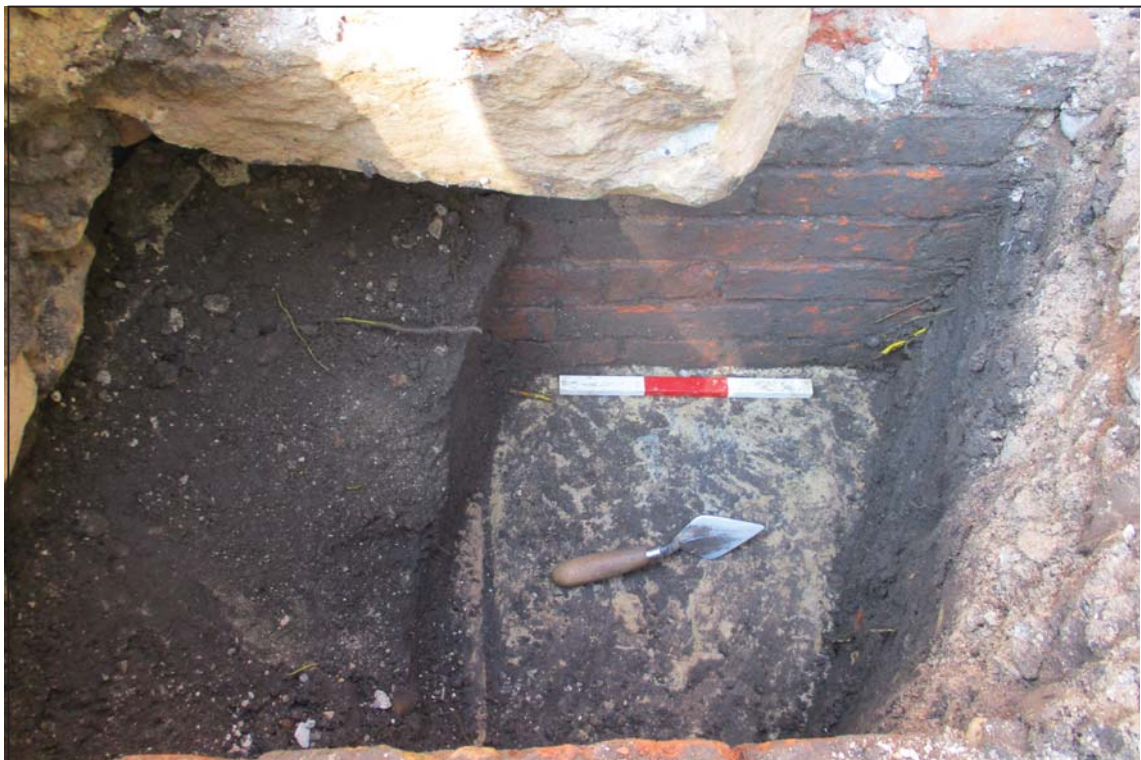
feature 013, looking west, showing brickwork (0.3m scale)

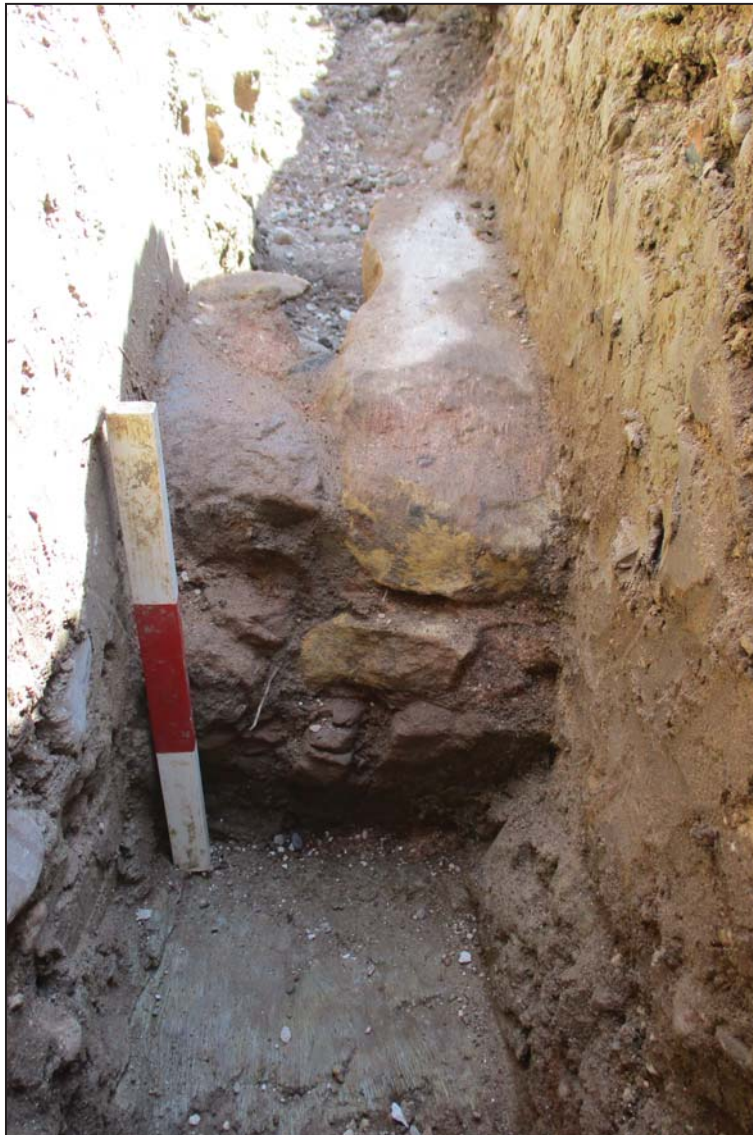
8

- 5.4 A potential wall foundation (018) lay to the east further along the trench. The wall foundation comprises various sizes of rough squared sandstone laid flat in a mid-to-light brown silt sand matrix (019). Only three layers of stonework were visible in the trench (< thickness 70mm, no length or breadth determined; Fig.8).

- 5.5 A compact green clay fill 017 is located adjacent to, and covering foundation 018, filling portions of the original construction cut (038). It is possible that this clay fill

- collapsed at some point or was deposited over foundation 018 following the removal of the upper wall sections.
- 5.6 A fragmented stone drain (023) was uncovered in an area of disturbance associated with numerous 20th century and more recent utilities (Fig.9). This feature consists of a series of large stone slabs laid flat (these were not possible to measure, due to physical access constraints). While no brick coursing remains as a result of later disturbance, these slabs are similar to those recorded for drain structure 034 suggesting this example may have served a similar function, though lying on a different orientation and with a different construction style (see below 5.9). Similar to culvert/drain 013, construction cut 025 is filled with a compact green clay 024 and gravel 044.

Wall foundation 018, looking east (0.3m scale)

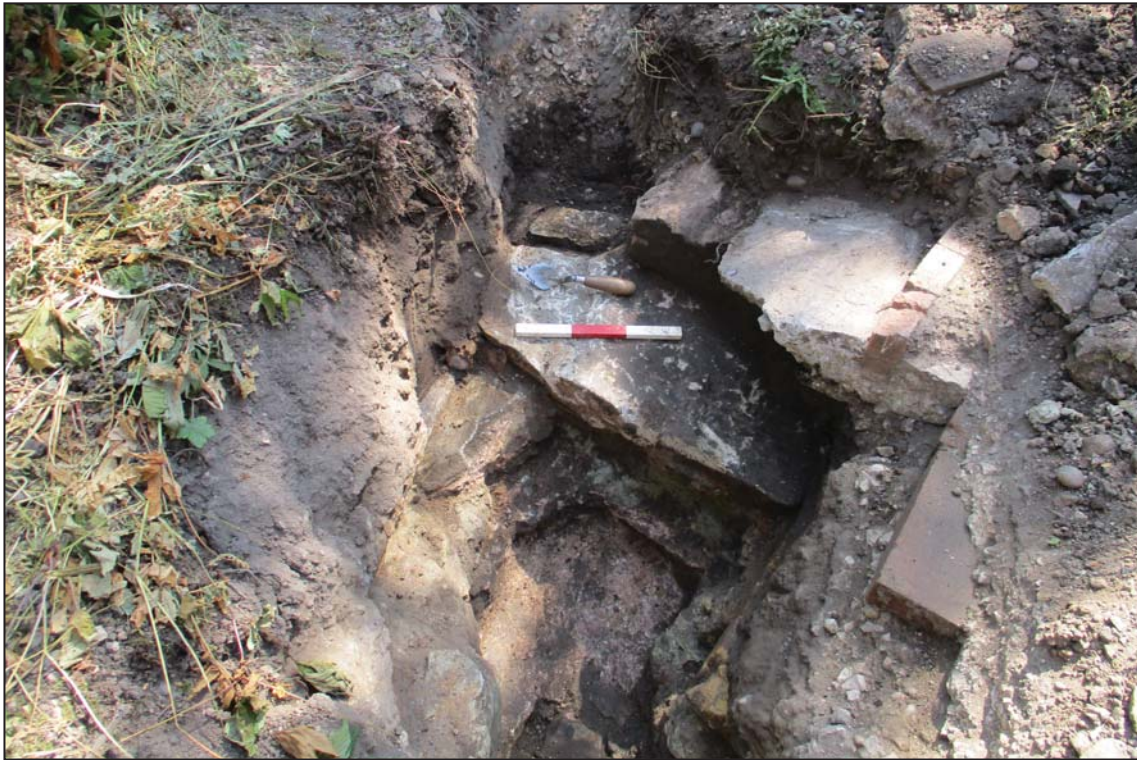
9

- 5.7 Underlying stone drain 23 at a depth of approximately 0.45m is compact light red silty sand deposit/surface 026. Due to the limited exposure of this feature it is not possible to determine its precise deposition or function. It is possible that this may represent an earlier drainage feature, perhaps later disturbed by the construction of stone drain 023, though this cannot be confirmed.

Drain slab 023, with potential surface 026 and modern concrete and brick feature 004, looking east (0.3m scale)

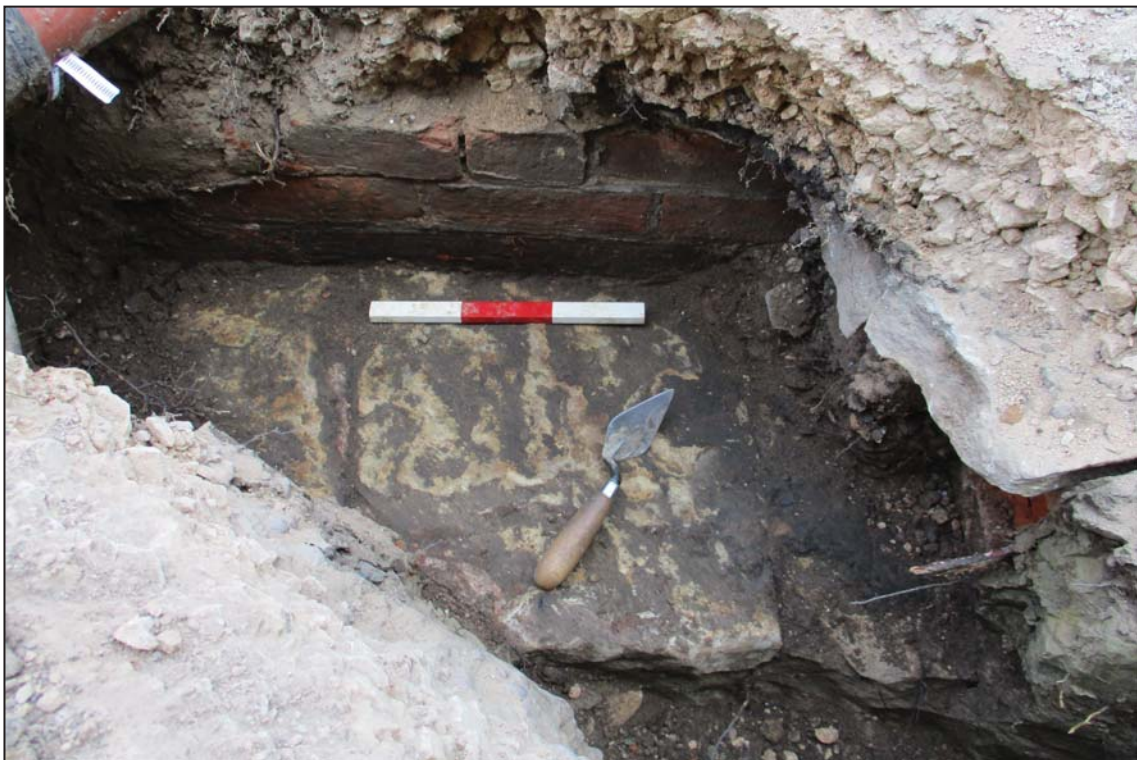
10

- 5.8 Structure 030 represents a stone and brick drain approximately 0.46m wide running south-west/north-east. The drain is constructed with three courses of unfrosted red brick (length: 220mm, width: 110mm, thickness: 70mm) laid in one row lying flat in a stretcher bond, with a base and top constructed of squared stones (unmeasured) (Fig.10). Mortar used in the construction of drain 030 appears to be lime-based. Construction cut 032 is filled with compact green clay 031.

Base and brickwork of drain 030, looking north-west (0.3m scale)

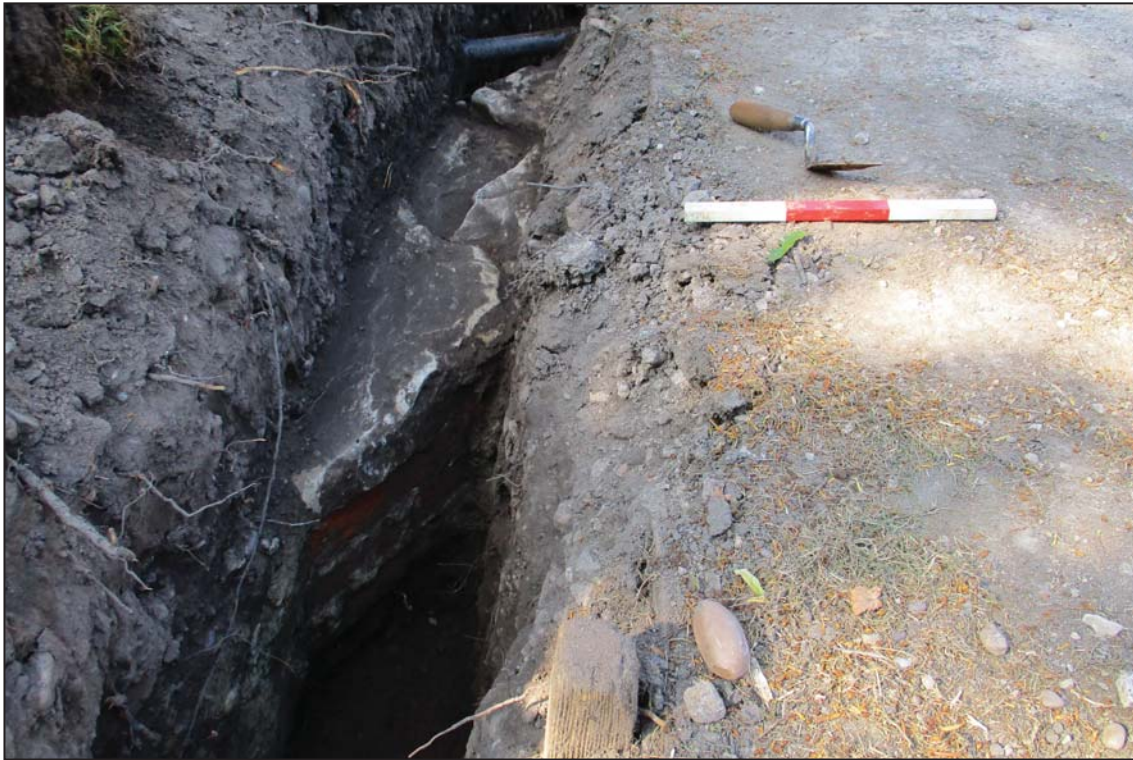
11

- 5.9 Structure 034 is the fourth brick and stone drain recorded in Trench 1 (Fig.11). This drain was encountered at a depth of 0.4m below the present ground level (bpgl) and runs on an east/west alignment. The drain is 0.45m in width and constructed using a red brick base laid perpendicular, with three courses of unfrosted stretcher-laid red bricks (length: 240mm, width: 110mm, thickness: 60mm) one course deep with a flat stone covering of varying sizes (maximum length: 500mm, width: 450mm, thickness: 80mm, minimum length: 330mm, width: 250mm, thickness: 80mm). Mortar used in the construction of this drain appears to be lime-based.

- 5.10 Similar to other drain and culvert structures located in Trench 1, construction cut 036 is filled with compact green clay 035.

Drain 034, looking south-east (0.3m scale)

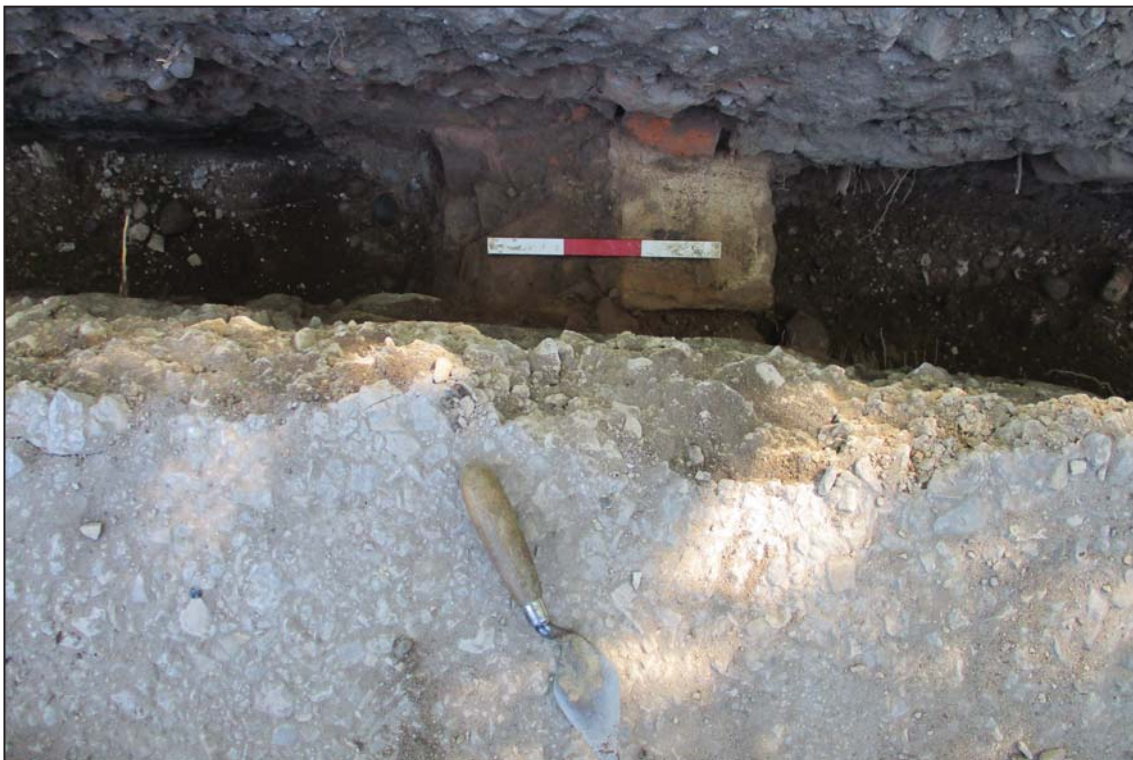
12

- 5.13 Located approximately 33m east along Trench 2 is a small segment of wall foundation 041 (Fig.12). Running south-west/north-east and at a depth of 0.63m bpgl, foundation 041 comprises roughly squared, weathered sandstone blocks (> length: 230mm, width: 200mm, thickness: 80mm) set randomly in a mid-brown silty sand matrix. Fill 042, comprises brown sand with frequent small to medium sub-rounded pebbles, and is located on either side of foundation 041 and within construction cut 043. Overlying foundation 041 is a deposit of mixed gravels and brick rubble, 045. This wall does not appear on any available mapping and its function remains unknown.

Wall foundation 041, looking south-west (0.3m scale)

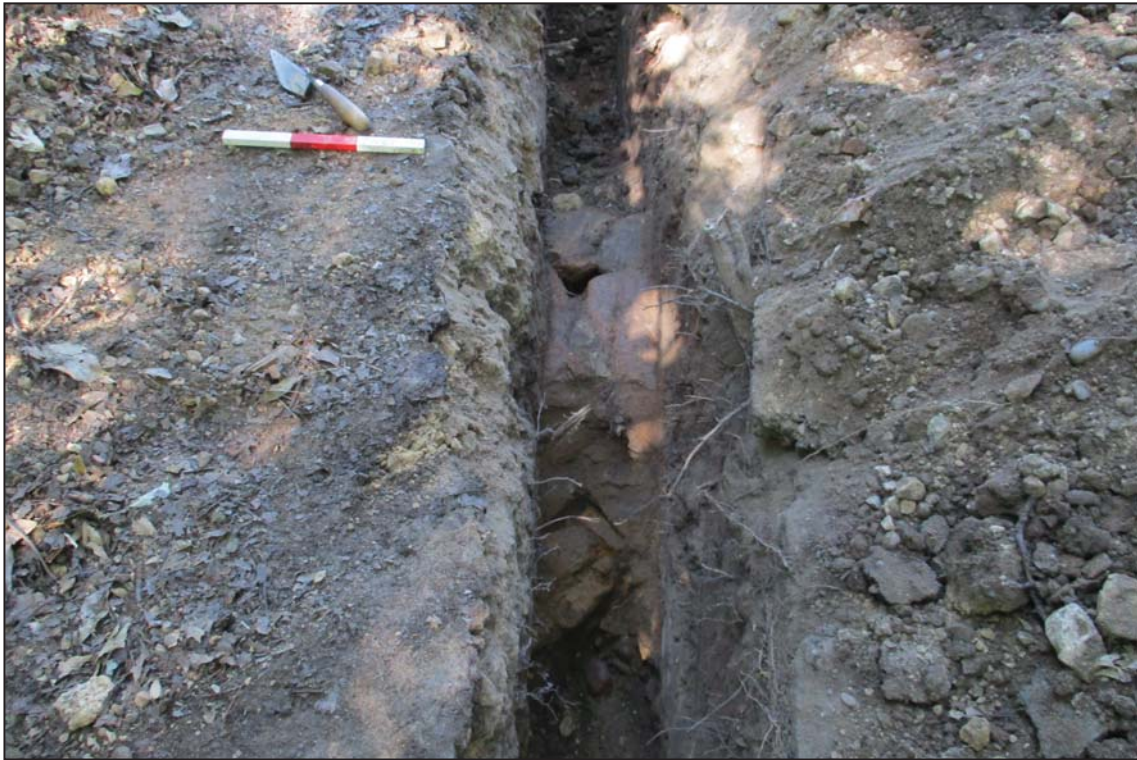
13

- 5.14 Approximately 82m south-east along Trench 2 from wall foundation 041 is wall foundation 049 (Fig.13). This foundation is similar in composition to foundation 041, being constructed of roughly squared and weathered sandstone blocks 70mm thick, laid roughly in a mid-brown silty sand matrix. This wall foundation was encountered at a depth of 0.55m bpgl and appears to run south-east/north-west. Overall it is wider than foundation 041, being approximately 1.4m in width at the base of the trench, narrowing to approximately 0.7m near its uppermost level. It is more similar to the sizes and orientation recorded in wall foundations 052 and 053 (see below).

Wall foundation 049, looking north-east (0.3m scale)

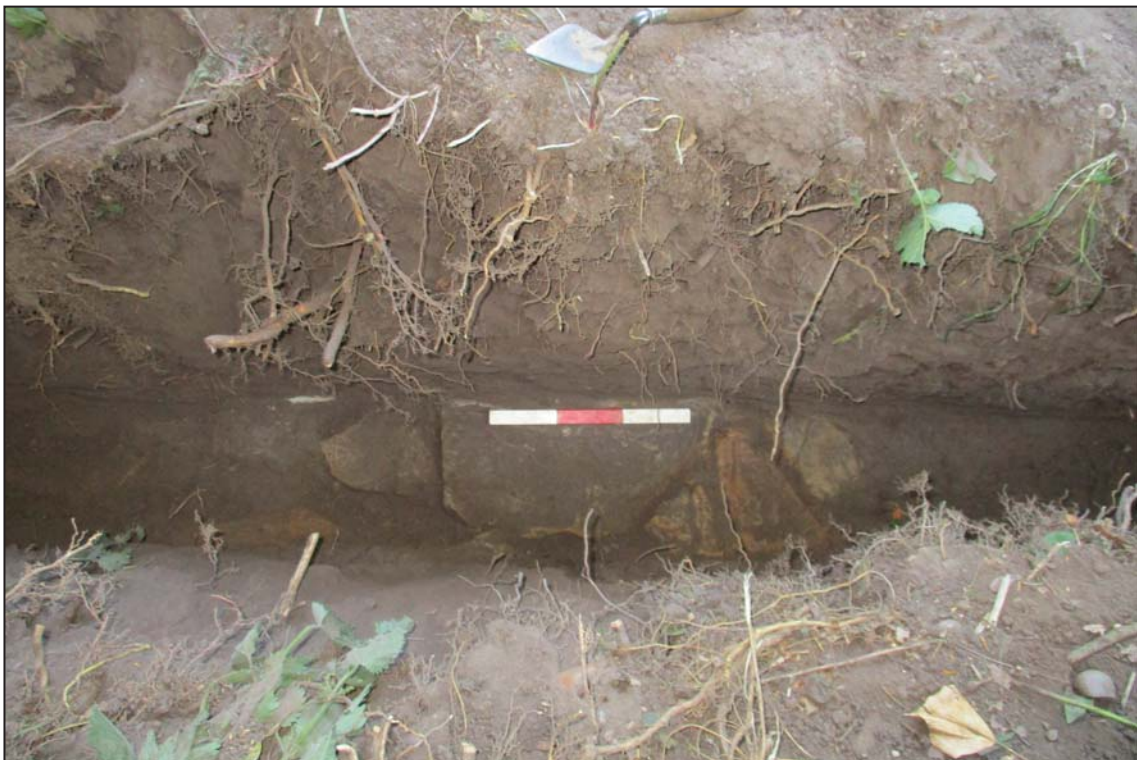
14

5.16 Similar in composition and size to foundation 041 are wall foundations 052 (top of foundation 0.67m bpgl) and 053 (top of foundation 0.35m below bpgl; Fig.14-15). These are located approximately 19m and 28m respectively from foundation 041. The foundations were both constructed using roughly squared and weathered sandstone blocks measuring between 60-70mm thick (due to trench width average stone length and width could not be determined). The foundation stones were laid randomly in a mid-brown silty sand matrix. Both foundations appear to be oriented south-east/north-west and do not indicate any evident relationship with any structures or features indicated on available historic mapping. It is possible that these foundations may have some relationship with the adjacent sluice feature, though this cannot be determined.

Wall foundation 052, looking east (0.3m scale)

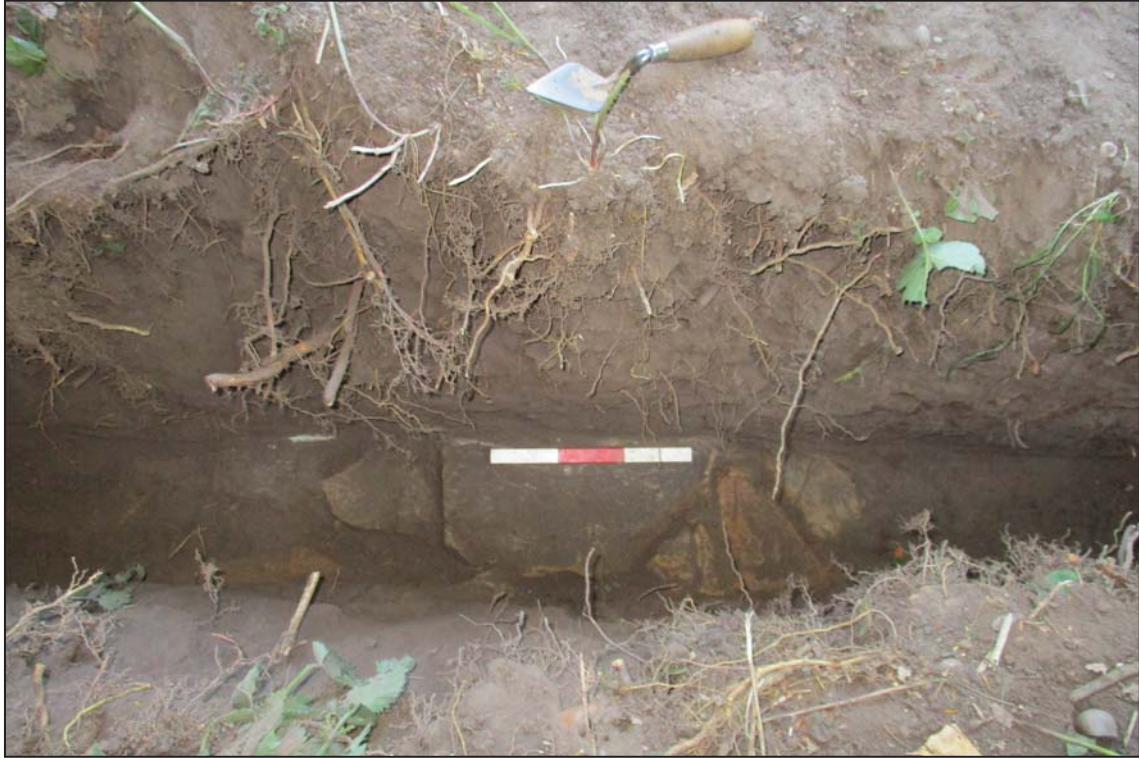
Wall foundation 053, looking south-east (scale 0.3m)
