**AFA HQ Scheme
Temple Back
Bristol**
Archaeological Evaluation

June 2019

Archaeological Evaluation

CA Project: CR0033
CA Report: CR0033_1
OASIS ID: cotswold2-346881

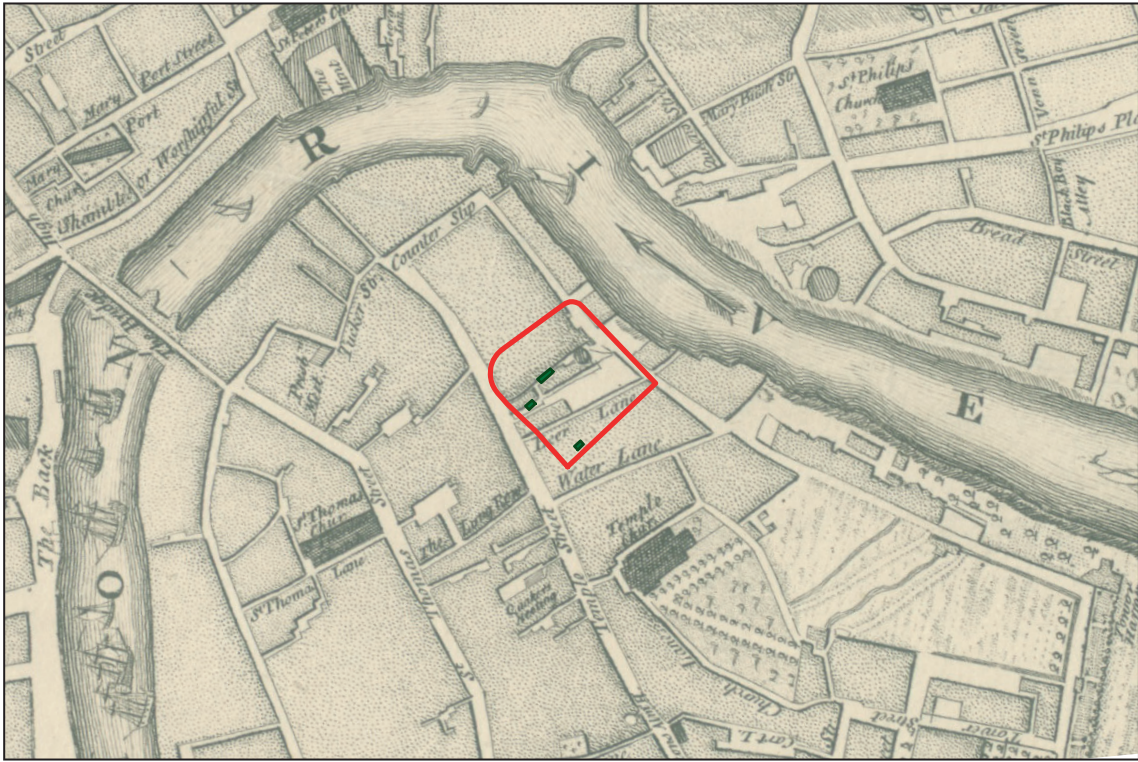
3

Trench location plan on extract of Roque's 1742 map (KYP 2019), scale 1: 4,000

- 2.10 Braun and Hogenberg's map of 1563 and Hoefnagle's map of 1581 show a block of houses occupying the western parts of the current site fronting onto Bear Lane, Temple Street and Counterslip. The eastern part of the site is shown as being enclosed by garden walls and bounded by water. The original course of the River Avon is shown, and an inlet appears to create a wide area of, presumably, waterlogged ground between the river bank and the easternmost side of the properties.

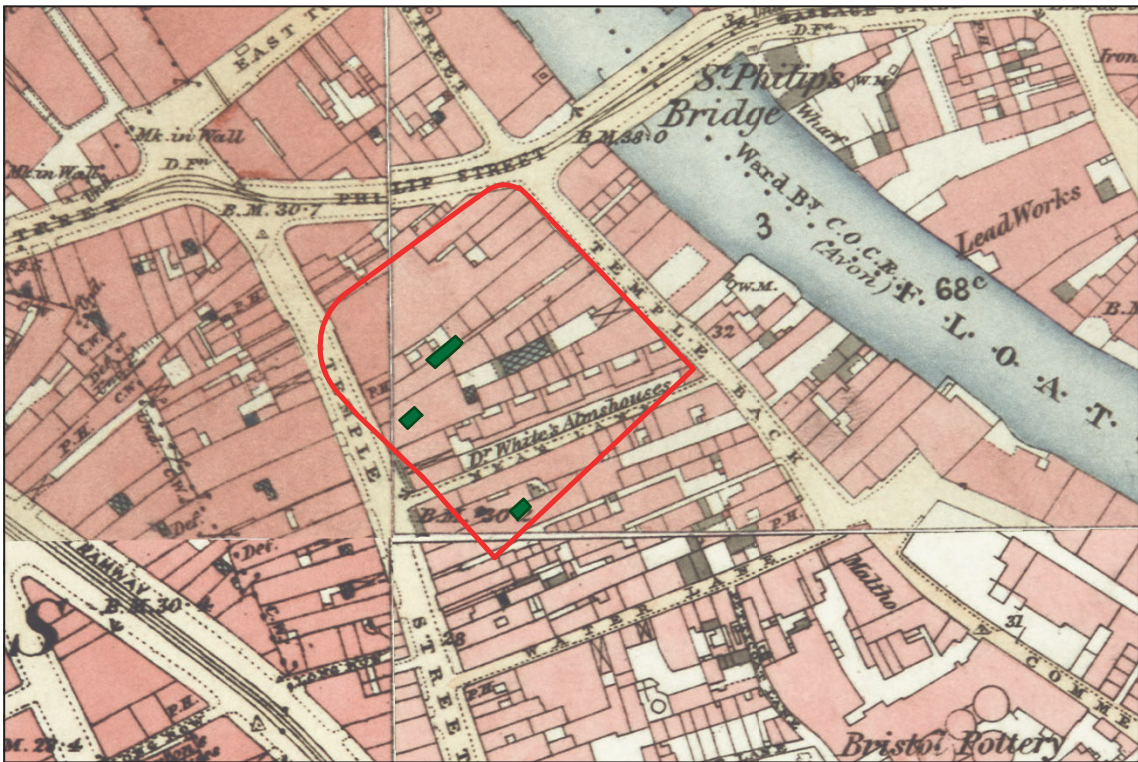
4

Trench location plan on extract of 1844-1888 First Ordnance Survey map (KYP 2019), scale 1: 2,000

- 2.12 The northern part of the site (to the north of Dr White's Almshouses) appears to have become increasingly developed by the mid-18th century and the 1887 Goad Insurance Map identifies a large Pantechicon warehouse (for the construction of carriages) and a public house within this part of the site.

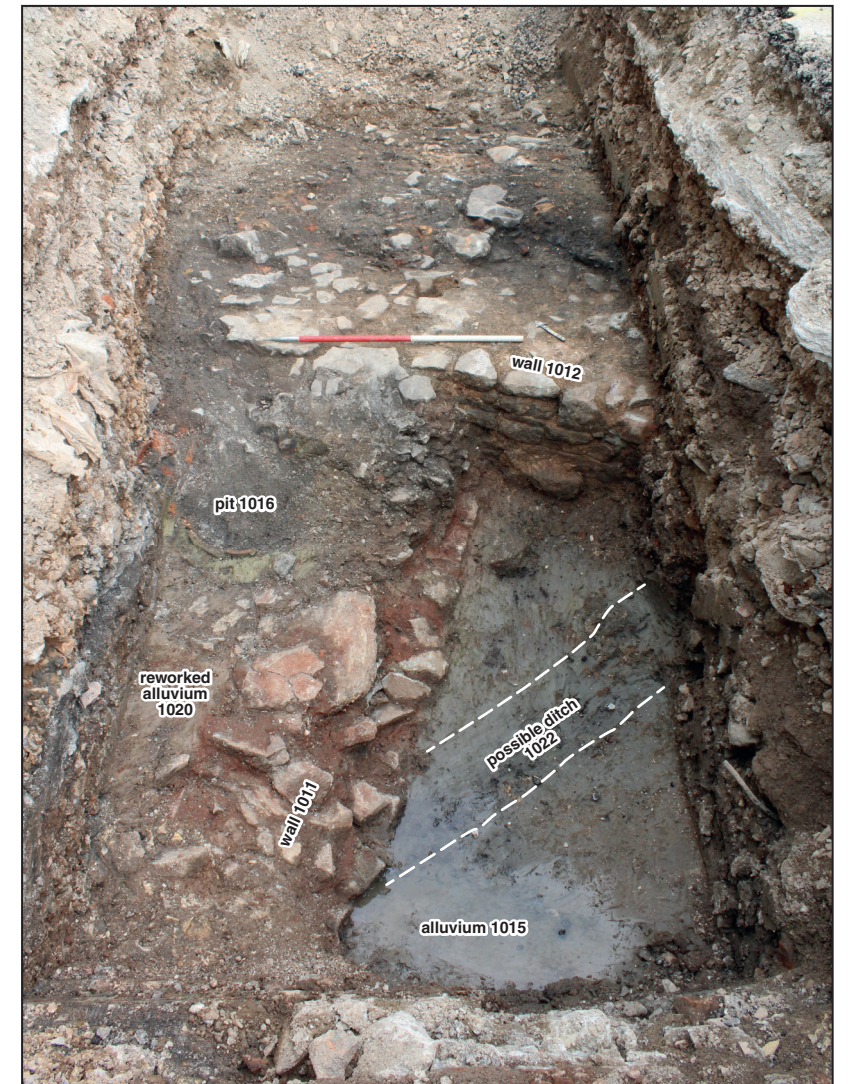
- 5.4 Alluvium 1020 was cut by broadly north-east/south-west aligned construction 1033, which measured at least 2m in length, 1m in width and 0.3m in depth. It contained wall 1011, which was constructed of regular courses of limestone blocks, bonded with a light orange-red mortar. The alignment of wall 1011 correlates to the orientation of plot divisions depicted within the site on historic cartographic sources from the 16th century onwards (see *archaeological background* above). Wall 1011 was sealed by reworked soil 1010, which measured approximately 0.3m in thickness.

upon which wall 1012 was founded. The latter measured at least 3m in length, 1.1m in width and 0.37m in height and was constructed from regular courses of roughly dressed limestone blocks, with a rubble core, bonded with a sandy lime mortar. Construction cut 1014 was backfilled by rubble 1013 and was sealed by reworked garden soil 1009, which measured approximately 0.25m in thickness.

Trench 1, looking north-east (1m scale)

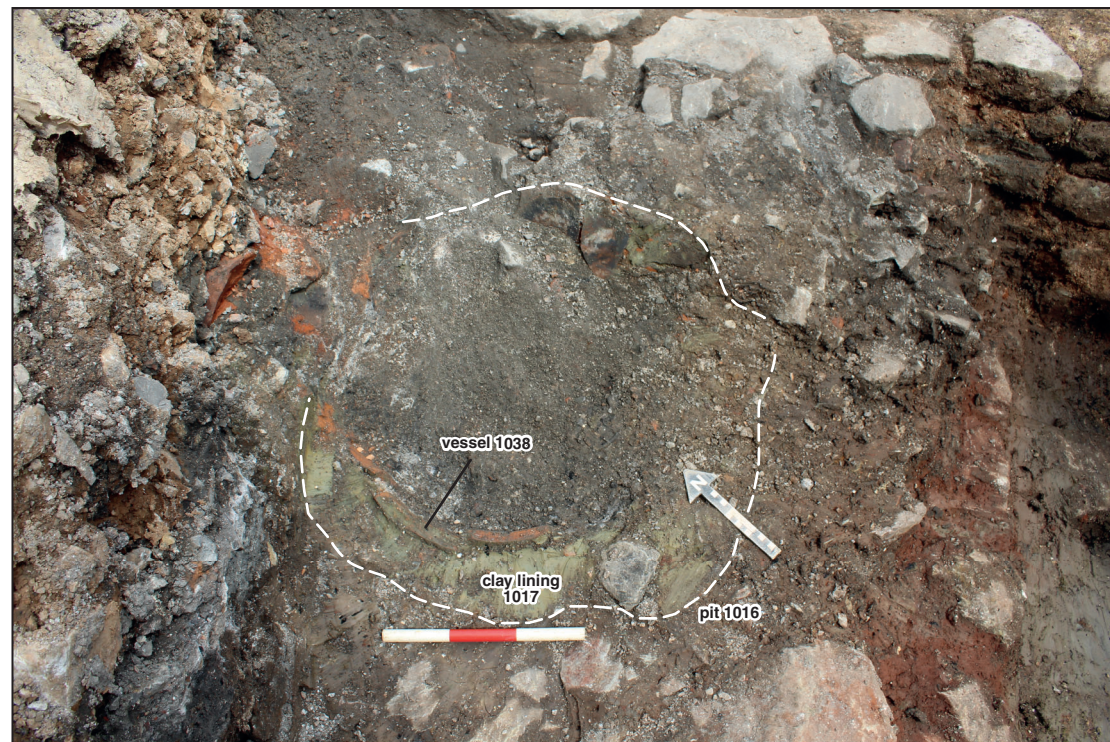
- 5.6 Reworked garden soil 1009 was cut by sub-circular pit 1016, which measured approximately 0.7m in diameter but remained unexcavated. The pit was lined with clay, 1017, and contained a complete glazed earthenware vessel, 1038, which dates to the mid-16th to 18th centuries and was backfilled by silt-clay 1018.

Pit 1016, containing vessel 1038, looking north-east (0.3m scale)

- 6.3 An unfeathered bodysherd (255g) in an unsourced glazed earthenware fabric (BPT 285) recovered from the large storage jar (1038) contained within pit 1016 is dateable to the mid-16th to 18th centuries.

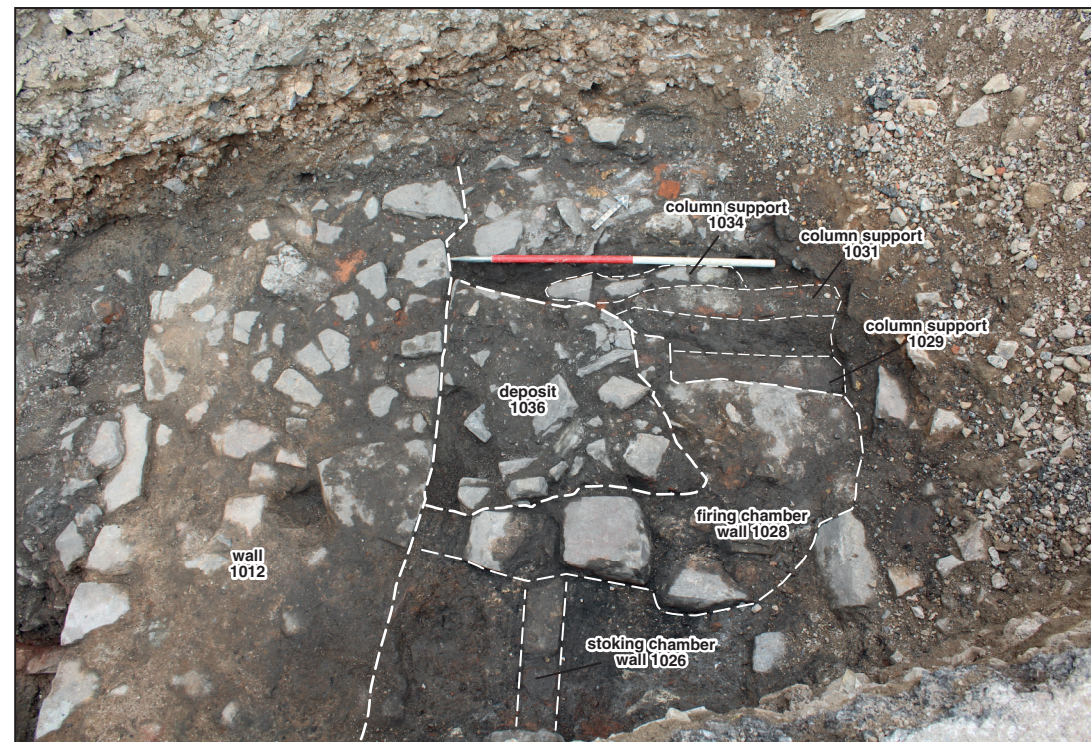
- 5.7 In the north-east of the trench, possible kiln 1039 was identified immediately to the north-east of wall 1012. Kiln 1039 consisted of firing chamber wall 1028, stoking chamber wall 1026 and column supports 1029, 1031 and 1034.

- 5.8 Firing chamber wall 1028 was aligned broadly north-east/south-west and measured at least 1.2m in length and 0.9m in width. The single visible course of stonework was constructed of limestone blocks bonded with a hard lime mortar.

- 5.9 Mortar bedding 1025 was overlain by stoking chamber wall 1026, which was aligned perpendicular to firing chamber wall 1028. It was formed from a single visible course of stretched bricks.

- 5.10 Internal supports 1029, 1031 and 1034 were aligned parallel with, and immediately to the north-east of, firing chamber wall 1028. They were constructed from single lines of red brick and limestone blocks, bonded by a compact grey limestone mortar.

Trench 1, kiln 1039 and wall 1012, looking north-west (1m scale)

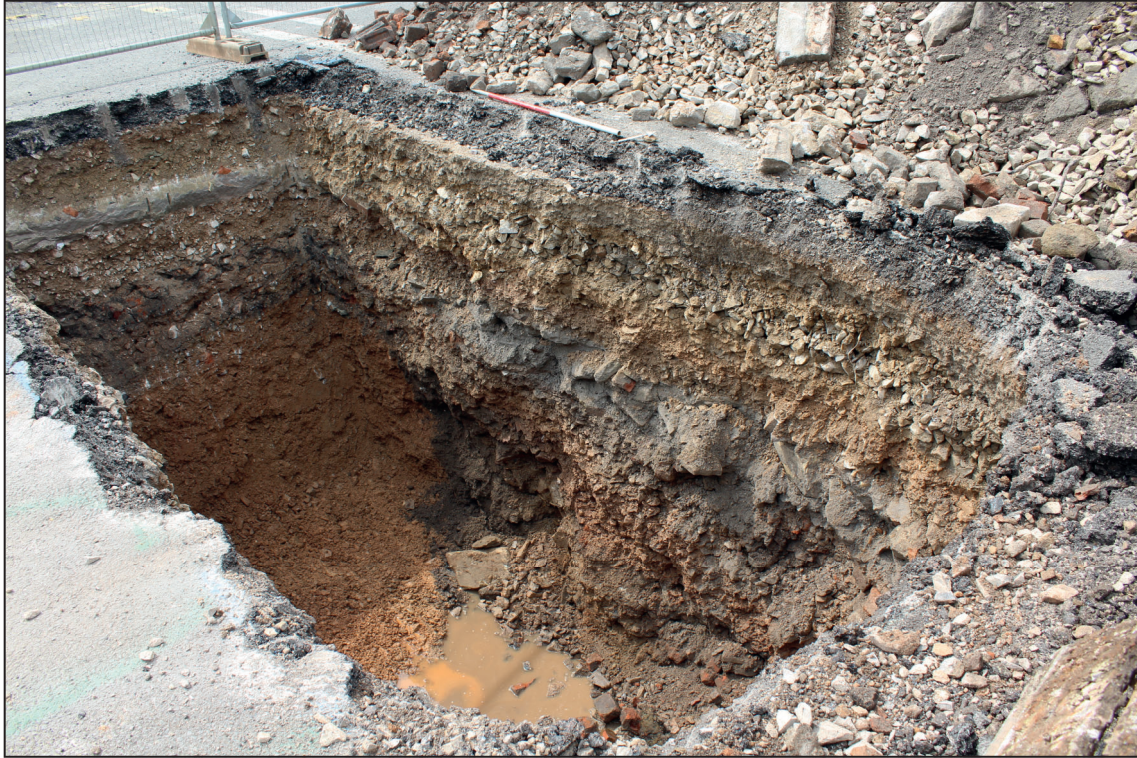
Trench 2; photograph

- 5.13 Natural sand and gravel 2007 was identified within Trench 2 at approximately 2.3m bpgl. It exhibited signs of modern truncation to this depth and was immediately

overlain by modern demolition material, made-ground, bedding and surfacing, measuring a total of 2.3m in thickness.

Trench 2, showing modern truncation, looking west (1m scale)

- 8.4 Modern truncation within the site was most prevalent in the area of Trench 2. The modern truncation identified here and elsewhere on site probably relates to the construction of the underground elements of the extant buildings during the mid-20th century. Beyond this zone of truncation, the identified archaeological deposits and structural remains survived to a greater extent, with a deeper depth of modern overburden identified within Trench 1. However, it was clear that much of the surviving archaeological remains had suffered from disturbance.

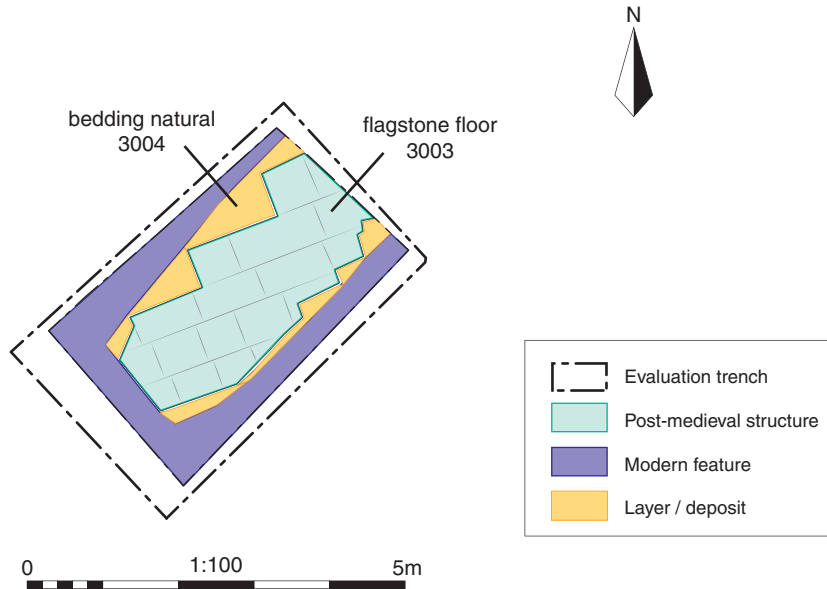
Trench 3 plan

- 5.17 The earliest deposit encountered within Trench 3 was bedding material 3004 identified at 1.04m bpgl. It comprised black sandy-silt, measured at least 4m in length and 1.9m in width. It was overlain by flagstone floor 3003, which was formed of rectangular limestone slabs. The surface was sealed by demolition rubble 3002, measuring 0.25m in thickness, and 0.7m of modern made-ground and surfacing.

- 8.3 The later structures revealed within Trench 1 are currently of an unknown purpose or function, whilst flagstone floor 3003 identified within Trench 3 may relate to an internal surface. Their construction suggests a post-medieval date, and their location may relate to structures shown on mapping from the 17th century onwards (see Figs. 3 and 4 for example). The possible 'kiln', 1039, in Trench 1 may relate to the glass cone noted on Millerd's map of 1715, or it may relate to small-scale industry, dating to the 19th century, such as activities within the 'Pantehnicon' shown on Goad's Insurance Map of 1887. Clay lined pit 1016, dated to between the mid-16th to 18th centuries, may also relate to such practices.

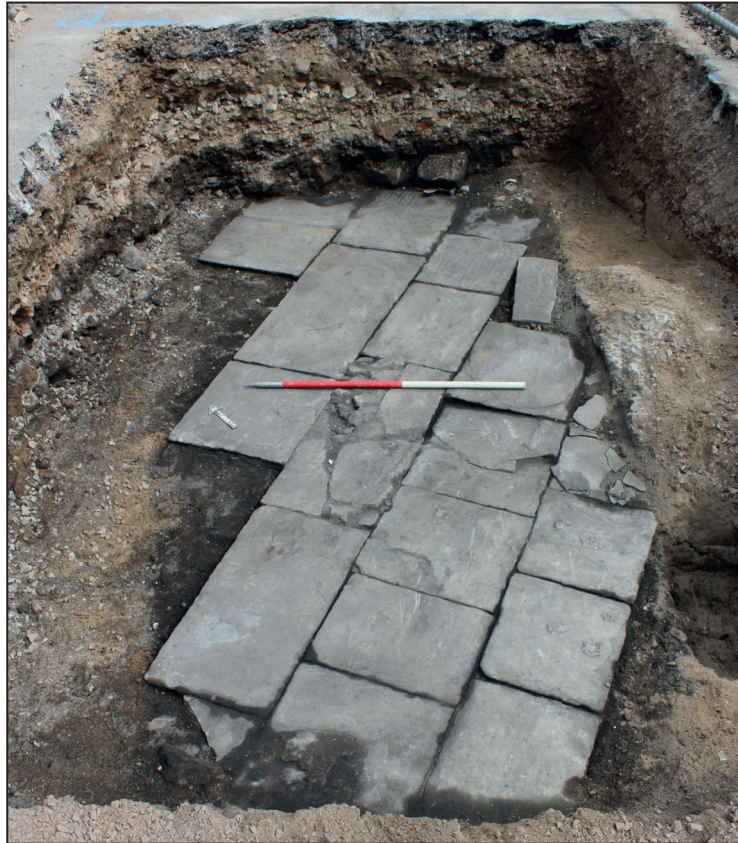
Trench 3, looking north-east (1m scale)
