Cokerhurst Farm Bridgwater Somerset

Archaeological Evaluation

CA Project: 880314
CA Report: 18231

May 2018

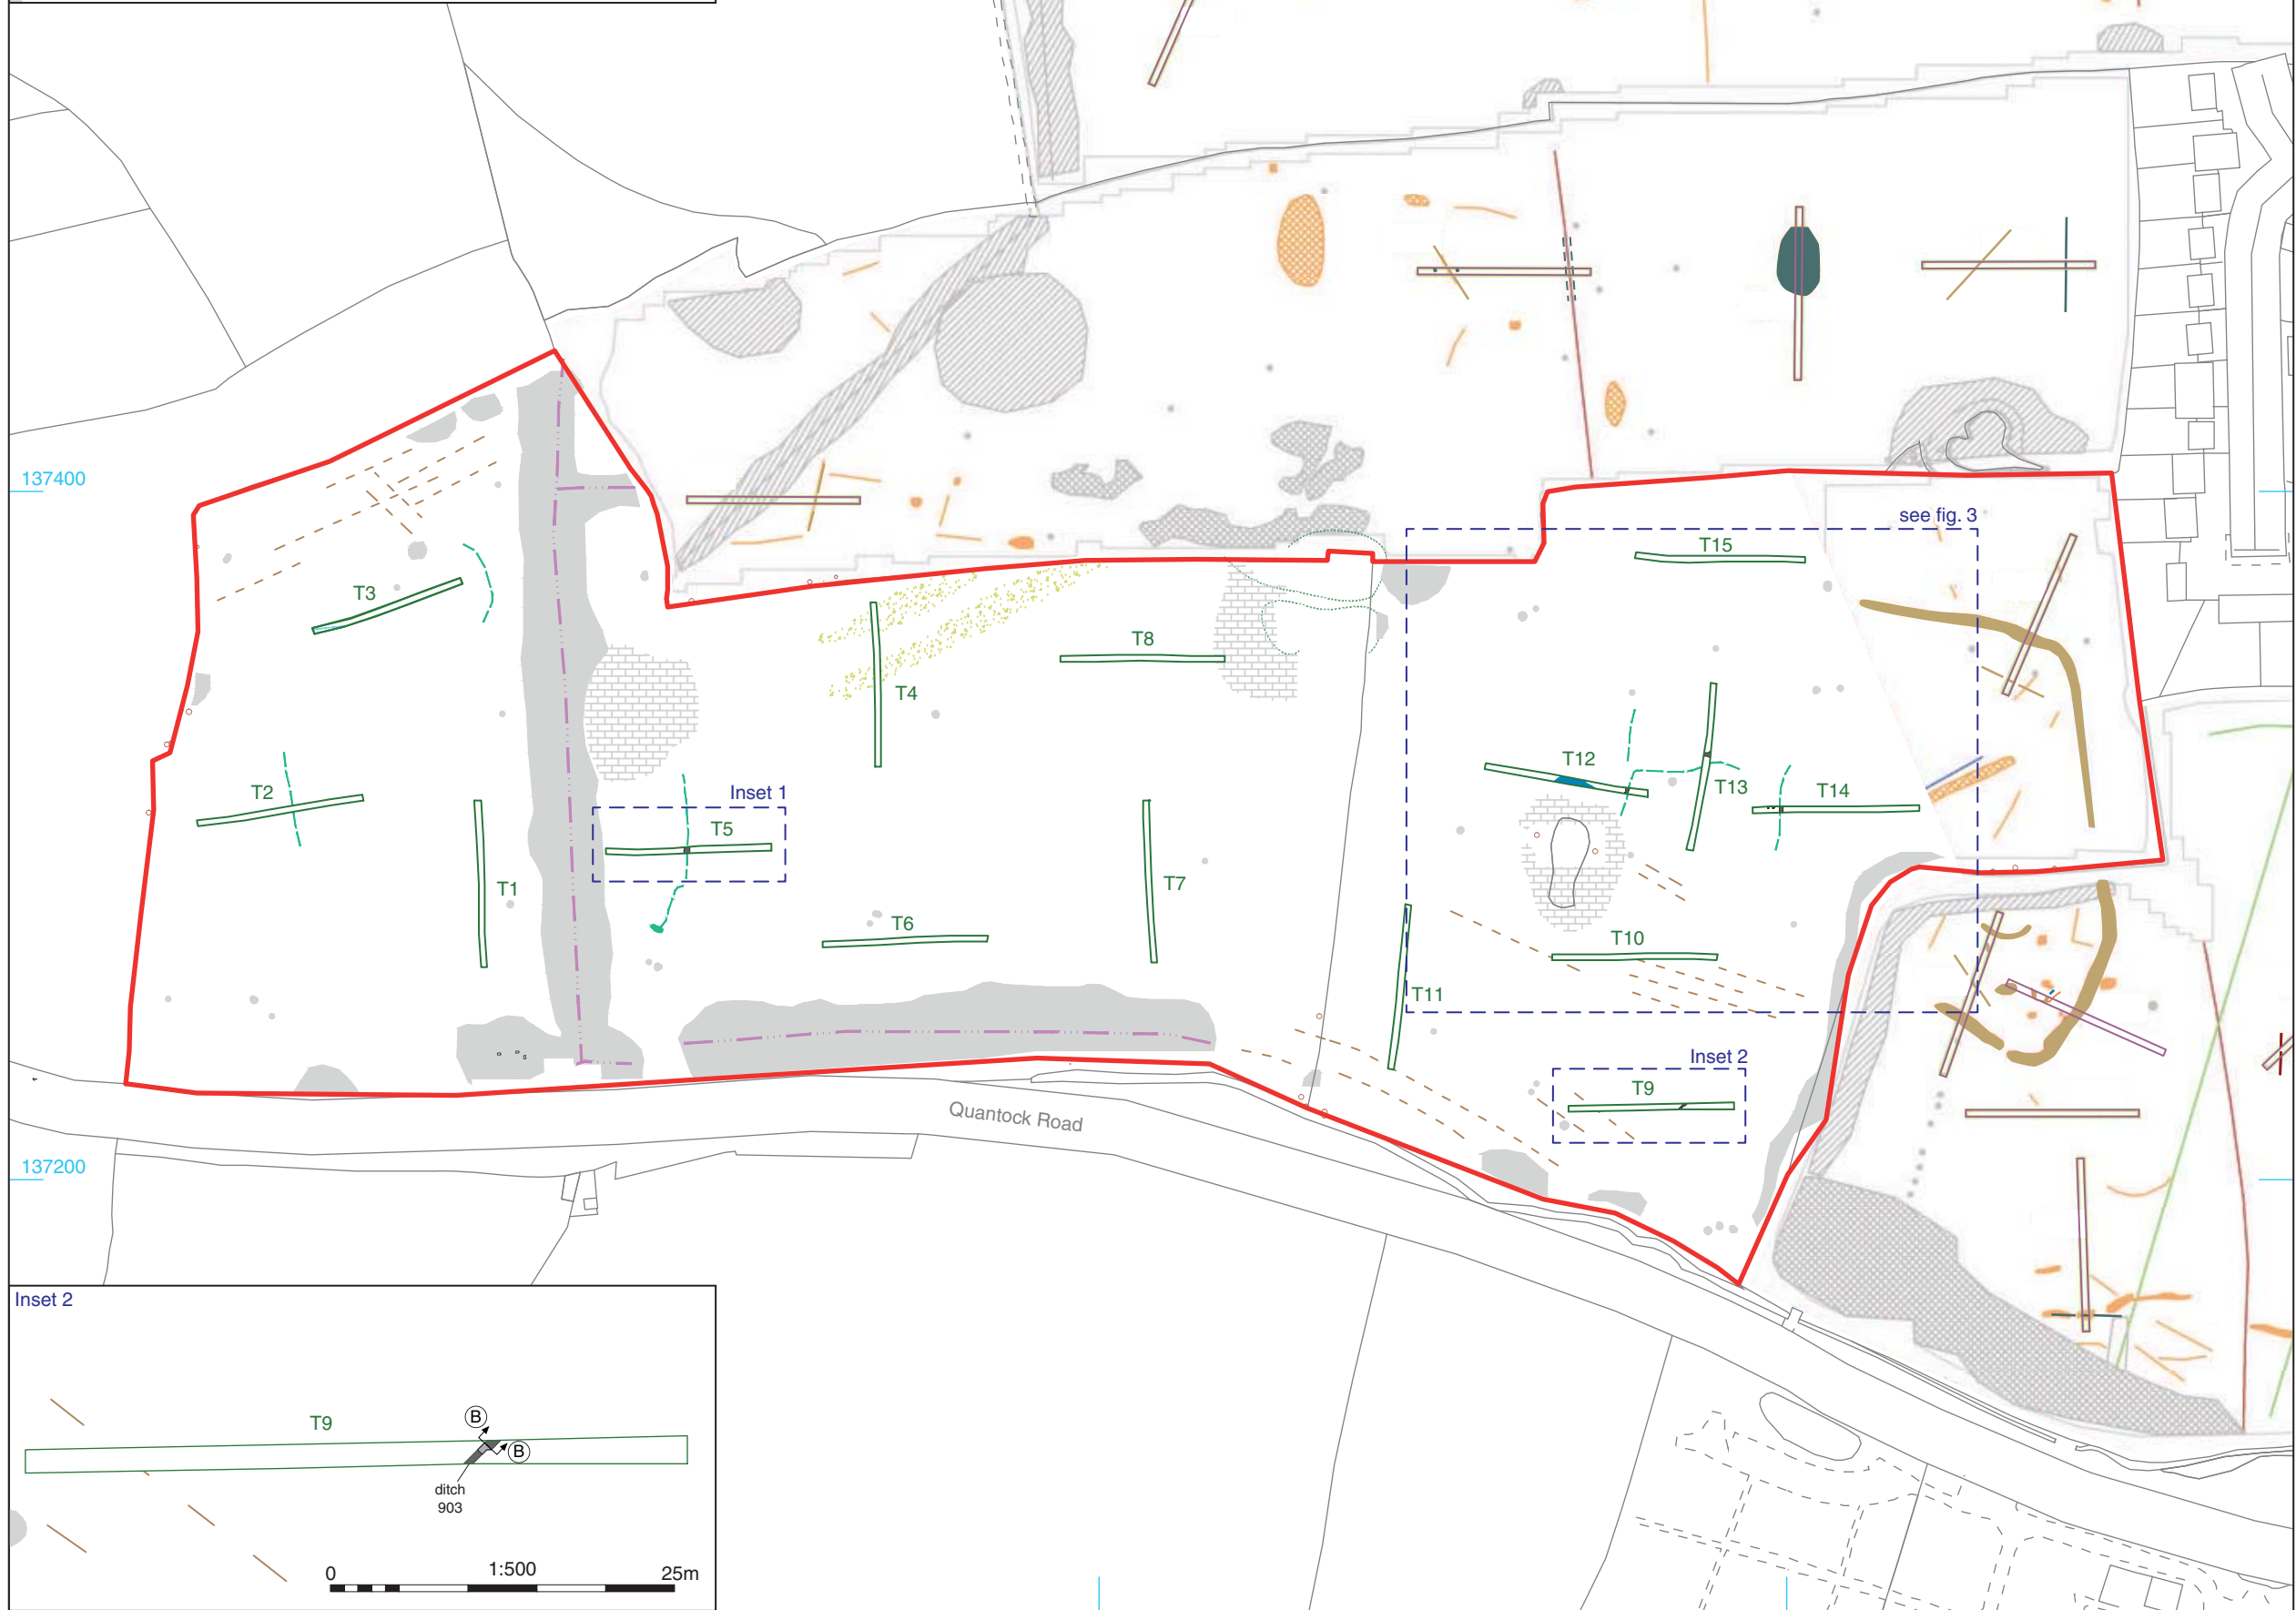
FIGURE TITLE
Trench location plan, showing archaeological features and geophysical survey results

- 4.1 The fieldwork comprised the excavation of 15 trenches (Fig. 2). All trenches were 50m long and 2m wide. The trenches were located to test geophysical anomalies, as well as to give a representative sample of the remainder of the site. The location of T3 was slightly altered from that specified in the WSI (CA 2018) in order to avoid an existing overhead powerline.

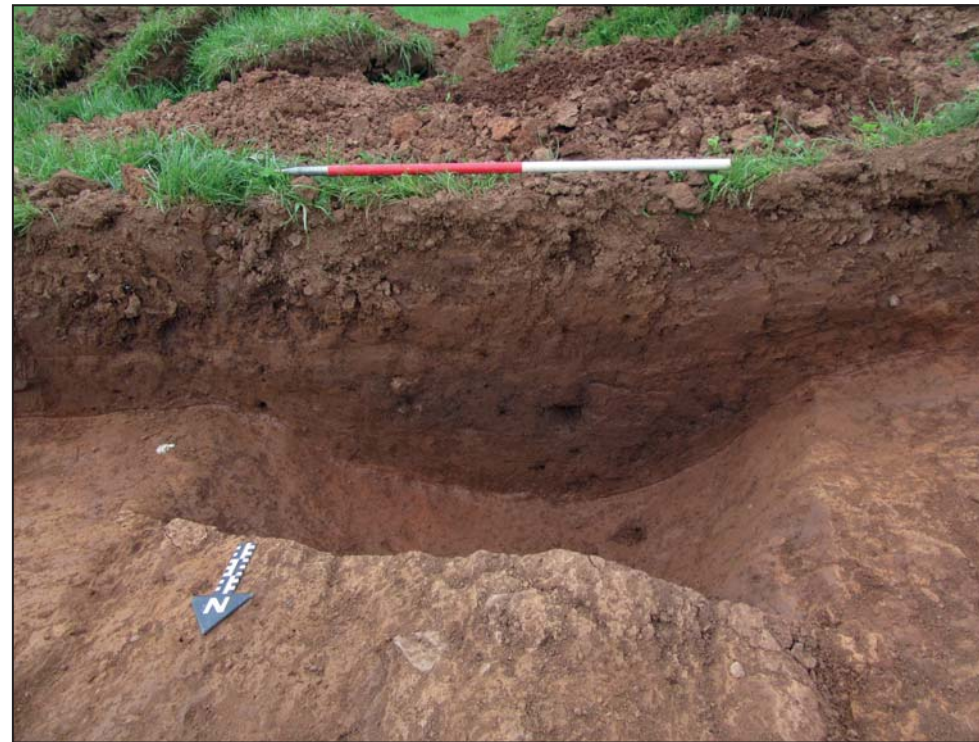
- 5.4 North/south orientated ditch 503 (Fig. 4, Sec. AA) was 2.18m wide and 0.7m deep. This ditch contained a single fill (504) from which modern pottery and ceramic building material were recovered.
- 5.5 Ditch 503 was cut into the subsoil. It corresponded closely to a linear geophysical anomaly.

Ditch 503, looking south (scale 1m)

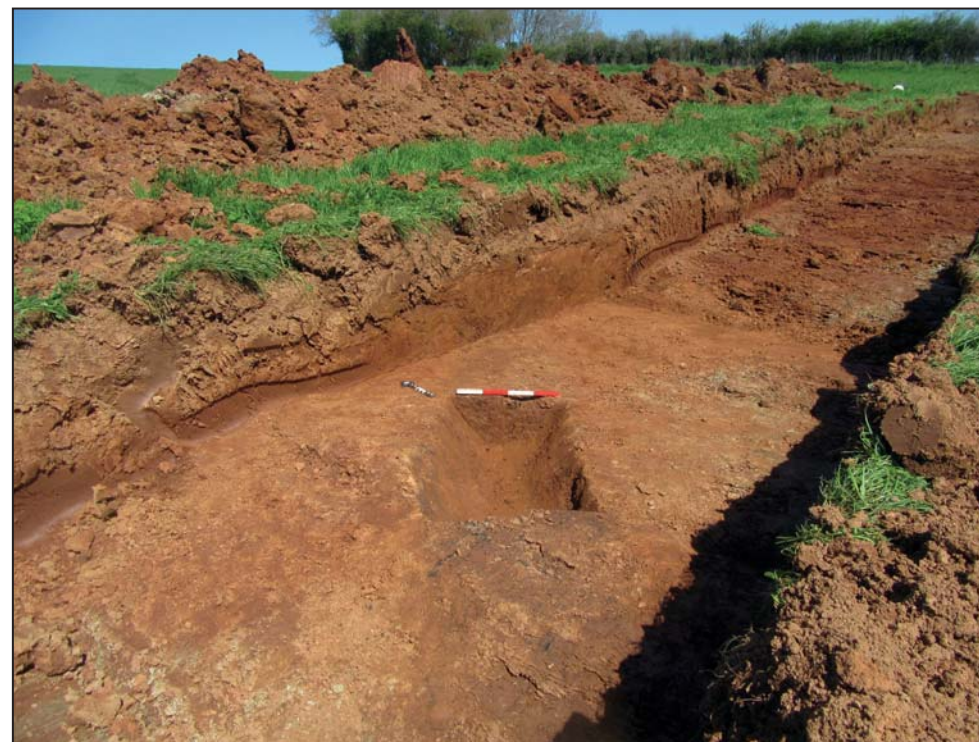
- 5.6 North-east/south-west orientated ditch 903 was 1.05m wide and 0.55m deep. It contained a single fill (904), from which no artefactual material was retrieved. This ditch was cut into the subsoil. It had not been detected by the previous geophysical survey.

Ditch 903, looking north-east (scale 0.4m)

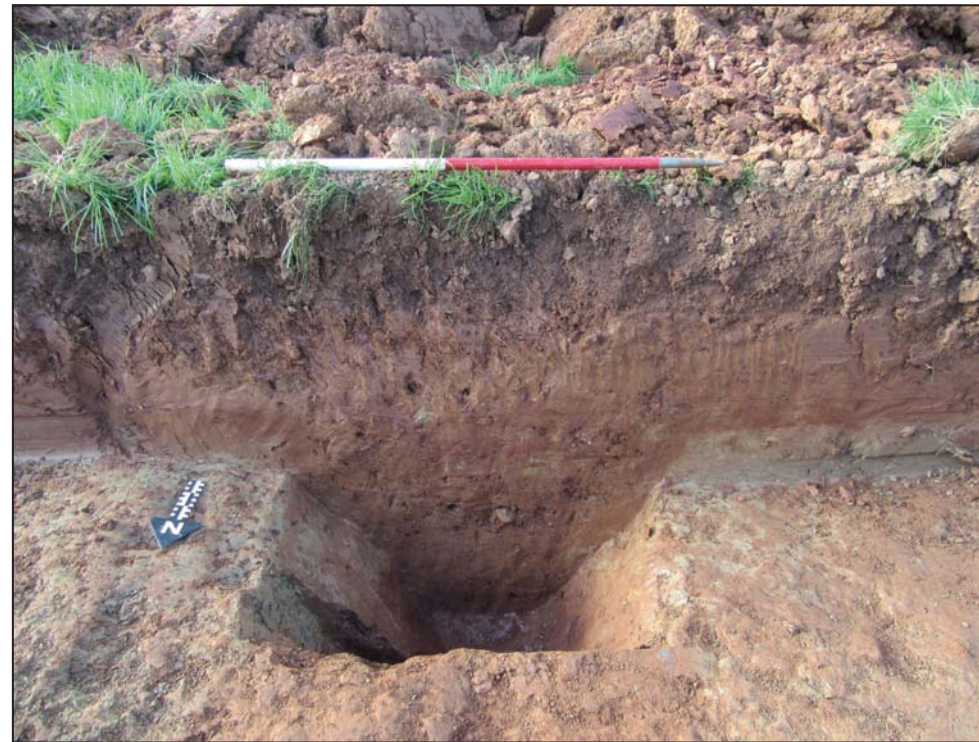
- 5.7 North-east/south-west aligned ditch 1203 (Fig. 5, Sec. CC) measured 1.24m in width and 0.72m in depth. It contained three fills (1204–1206). Six sherds of late prehistoric pottery were retrieved from middle fill 1205. Ditch 1203 corresponded to a linear geophysical anomaly.
- 5.8 The central part of T12 was disturbed by a large cut feature (1207). This pit measured 13m in width and was cut into the subsoil. Pottery and brick of post-medieval/modern date was present on its upper surface. This pit was to the immediate north of an area of magnetic disturbance identified by the geophysical survey.

Ditch 1203, looking south (scale 1m)

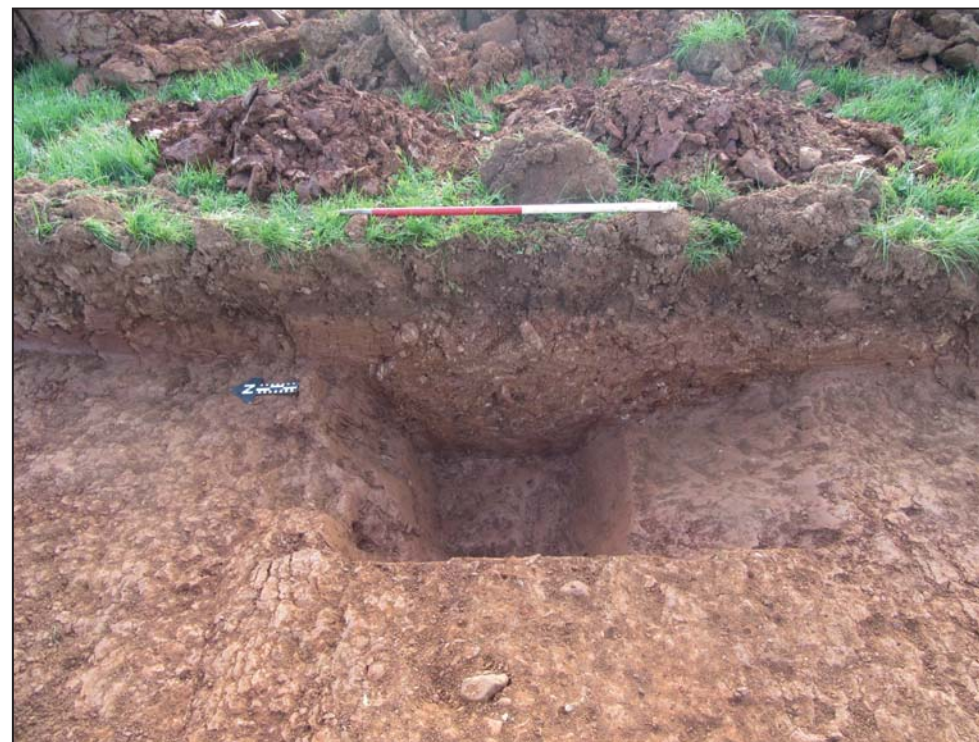
- 5.9 East/west aligned ditch 1303 (Fig. 5, Sec. DD) was 1.63m wide and 0.51m deep, with a single undated stony fill (1304). It was truncated by a later furrow or plough mark (1305). Ditch 1303 was on the approximate line of a linear geophysical anomaly.

Ditch 1303, looking east (scale 1m)

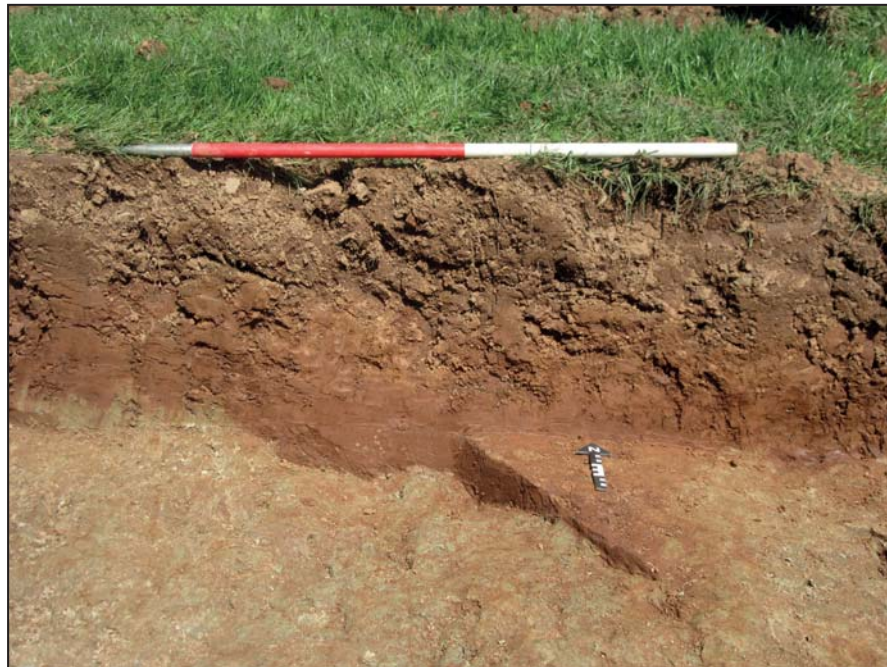
Pit 1403, looking north (scale 1m)

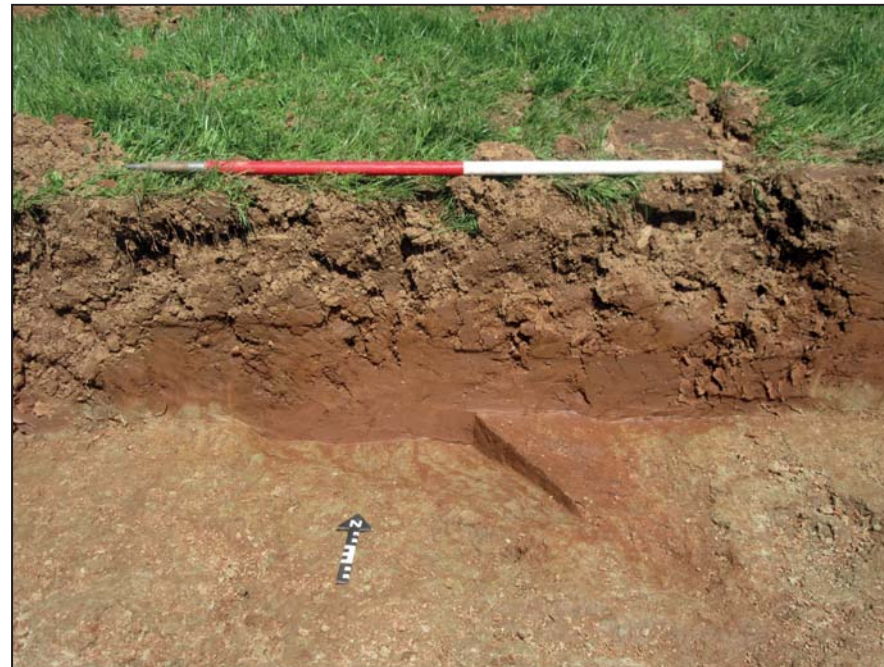
Pit 1405, looking north (scale 1m)

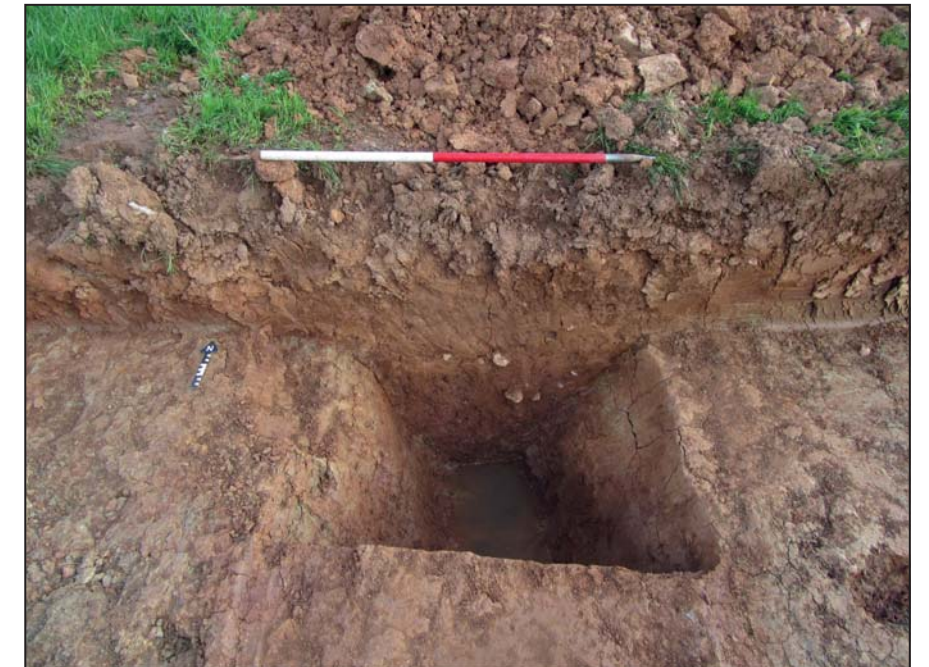
- 5.10 North/south orientated ditch 1407 was 1.32m wide and 0.82m deep, with two fills (1408 and 1409). Lower fill 1408 contained a single sherd of Iron Age/Early Roman pottery and a worked flint flake. A fragment of fired clay was retrieved from upper fill 1409. Ditch 1407 correlated closely to a geophysical linear anomaly.
- 5.11 To the immediate west of ditch 1407, shallow sub-oval pits 1403 and 1405 were 0.72m–0.75m in width and 0.13m–0.16m in depth. These pits contained single fills (1404 and 1406, respectively) from which no finds were recovered.

Ditch 1407, looking north (scale 1m)
