Puck Mill House Frampton Mansell Gloucestershire

Archaeological Watching Brief

CA Project: 6792 CA Report: 6792_1

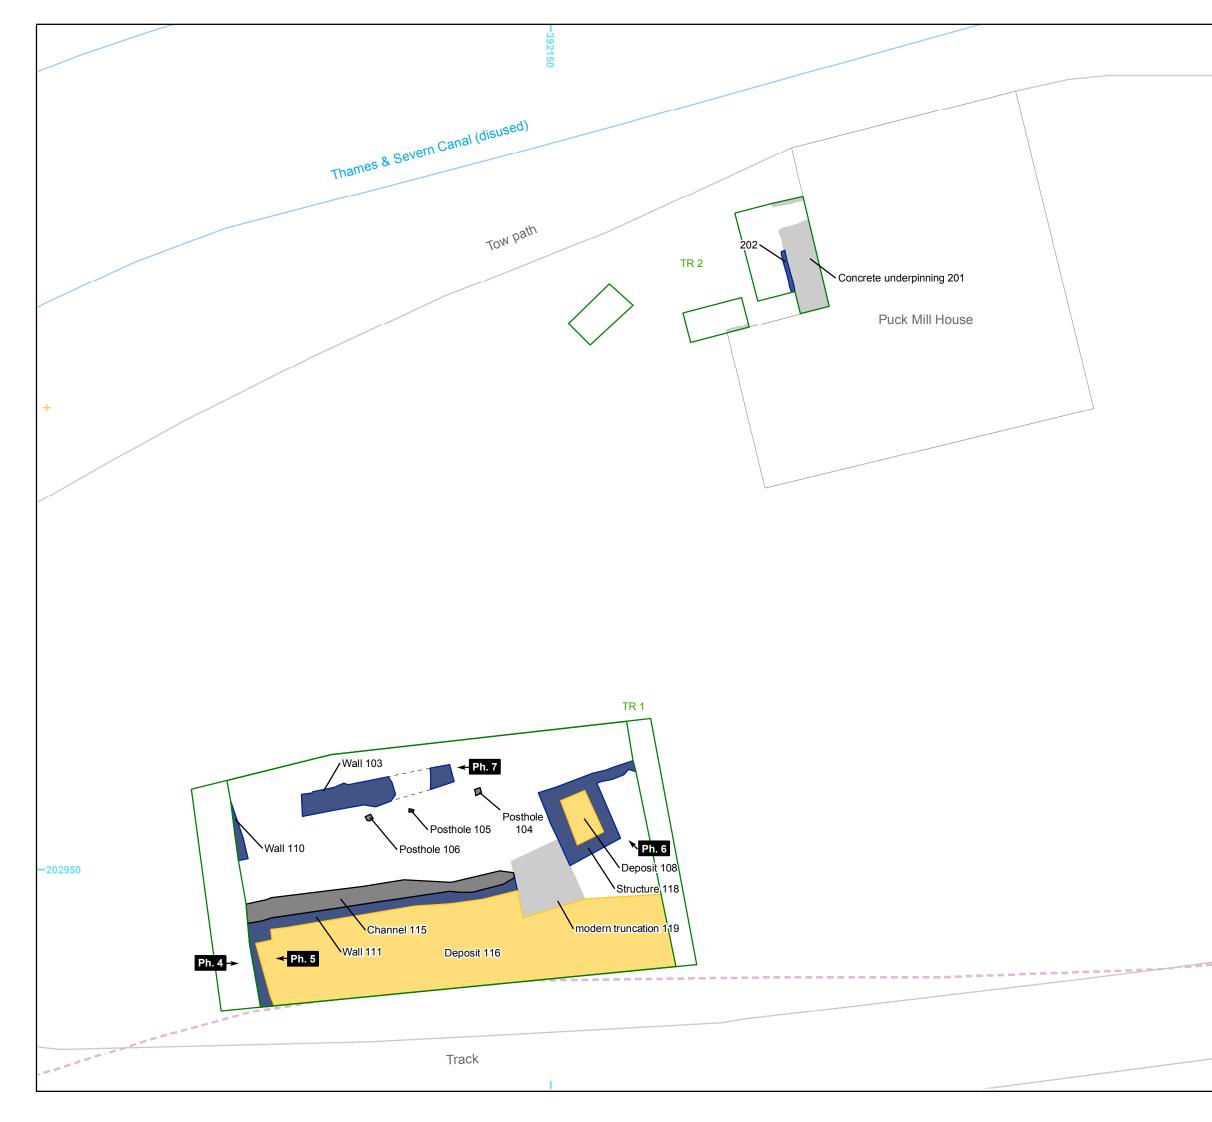
North/south aligned wall 110 was identified in the north-western corner of Trench 1 (Figs. 2 and 3). Constructed of limestone blocks, it measured at least 1.7m in length, 0.6m in width and survived to a height of at least 0.8m; it extended beyond the current works to the north. To the west of this wall, east/west aligned wall 103 was recorded. It was of similar construction to wall 110 and measured 4.1m in length, 0.6m in width and at least 0.26m in height (Figs. 2, 3 and 7). To the south of wall 103, an alignment of three square postholes (104, 105 and 106) was identified (Figs. 2, 3 and 7). These postholes typically measured 0.15m in length, 0.15m in width and 0.3m in depth and were probably of modern date.

In the easternmost segment of Trench 2, partially preserved structure 202, comprising two courses of rough limestone blocks was observed. It measured approximately 1.2m in length, running on a north/south alignment (parallel to the edge of the current Puck Mill House), and was at least 0.6m in depth. It was subsequently covered by concrete underpinning 201.

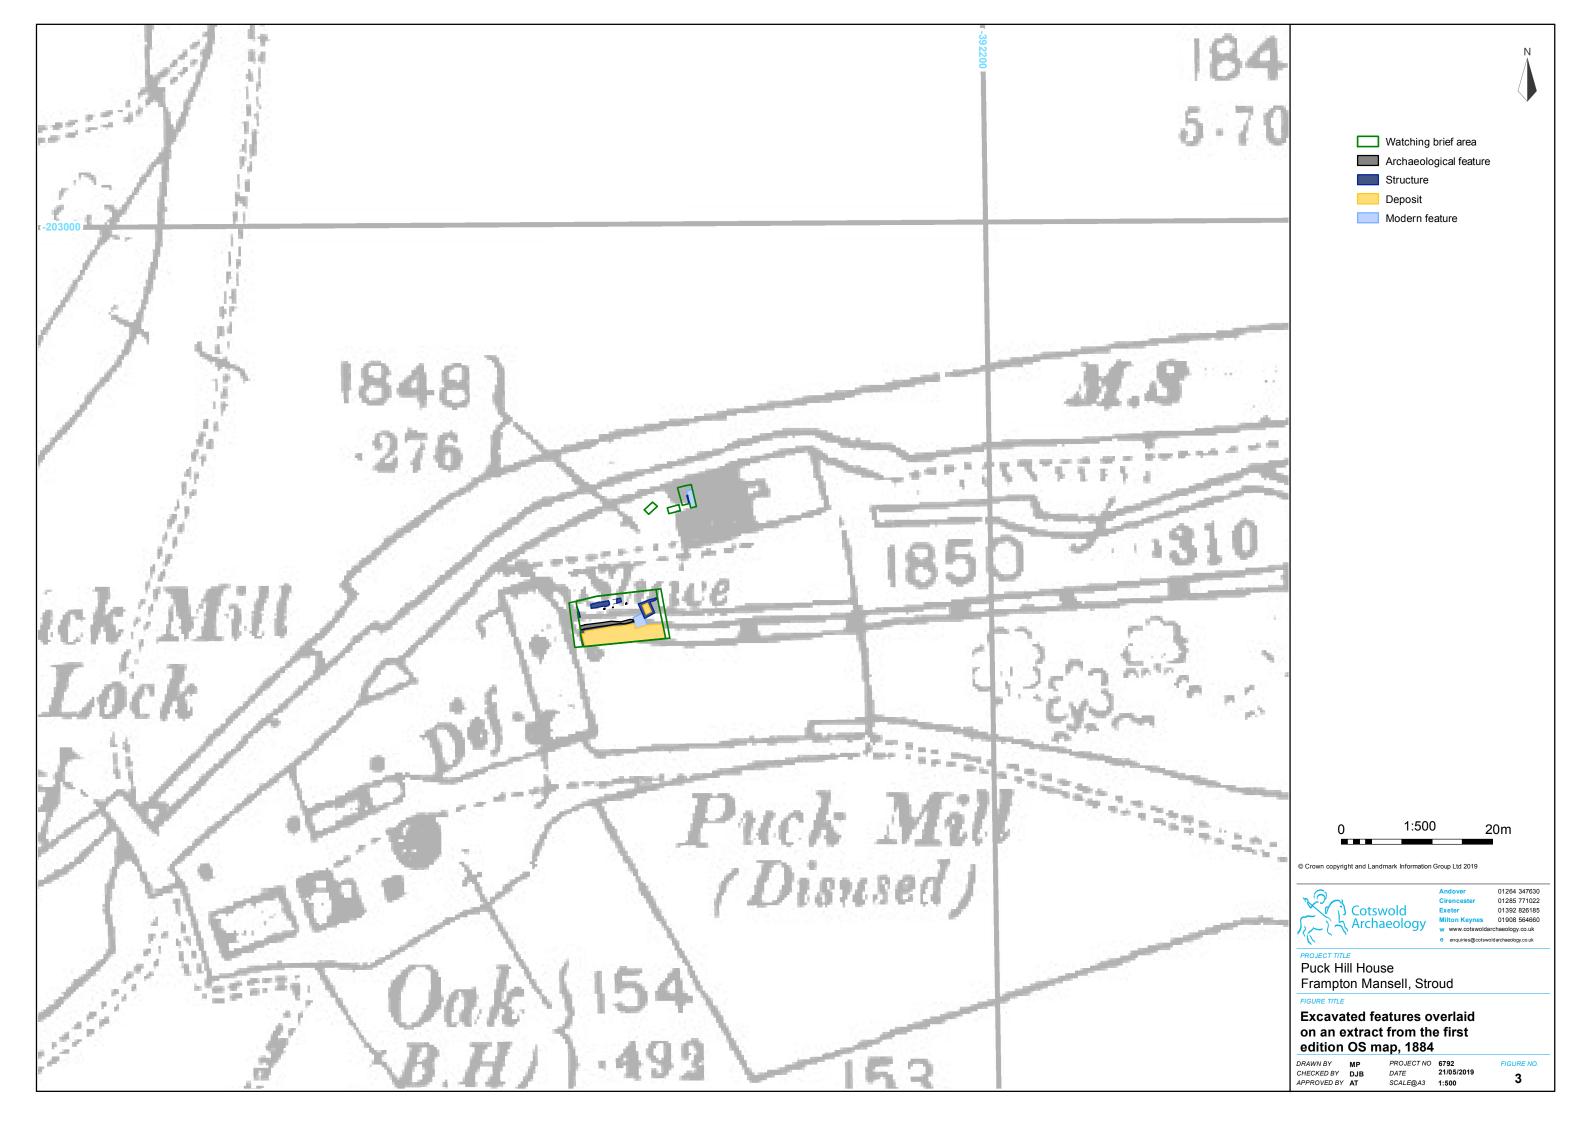
8.1 The structures and features revealed in Trench 1 correlate closely to the 19th century sluice associated with the silk mill buildings and the original course of the

River Frome depicted on the historic mapping (see archaeological background above; Fig 3).

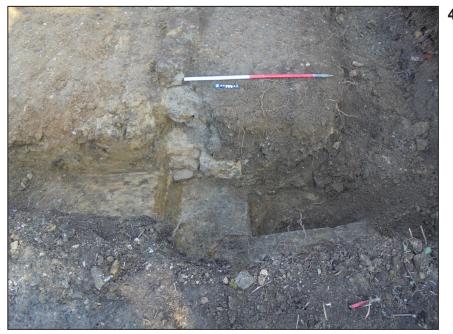
5.3 Within the southern extent of the trench, east/west aligned channel 115 was identified (Figs 2-5). It measured at least 7.5m in length, 3.16m in width and 0.85m in depth and extended south-east and west beyond the limit of the observed groundworks. It contained clay lining 114/117 to north, from which nine sherds of 18th to 20th century pottery were recovered. Overlying clay lining 117 and butting clay lining 114 Wall/culvert 111 was constructed of ashlar-cut limestone. It measured 0.56m in width, at least 0.63m in height and was east/west aligned along the length

Channel 115, with wall/culvert 111 and clay lining 114, looking east (1m scale)

- 8.2 Channel 115 correlates to the course of the river mill race and 'sluice' depicted on the First Edition OS map mapping. Wall/culvert 111, with its north/south return likely represents the formal canalisation of the river to form the mill race as it ran from west to east. Structure 118 is probably also related to the management of the water through the mill and may have been used for managing overflow or powering a mill wheel.

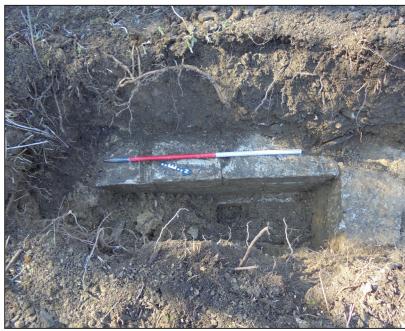
Wall 111, looking south-west (1m scale)

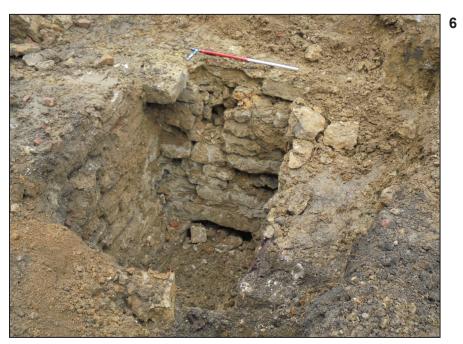
- 5.4 Within the east of the trench, rectangular stone structure 118 was identified. It comprised four walls (118, 107, 113 and 115) constructed of roughly dressed limestone blocks and measured 1.6m in length, 1.5m in width and at least 2.4m in depth, and was infilled by rubble deposit 108. An integrated culvert was recorded at the base of Wall 107, which formed the northern wall of the structure.
- 5.5 All observed features were sealed by clay silt subsoil 102, which was in turn overlain by gravel 101 and topsoil 100

Structure 118, looking north-west (1m scale)

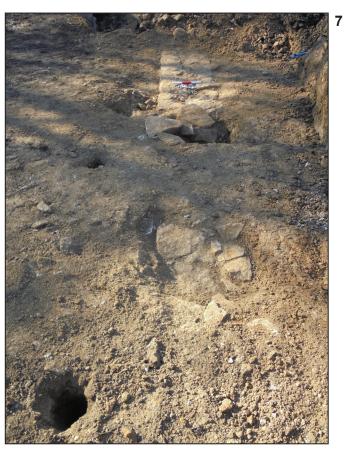
Wall 103 and postholes 104, 105 and 106, looking west (0.3m scale)

- 8.3 Walls 103 and 110 are most probably remnants of the mill buildings eastern extent and/or its associated structures, which appears as a substantial four-storey structure on a photograph of *c*.1900-1912 prior to its demolition in the 20th century (Fig 8).

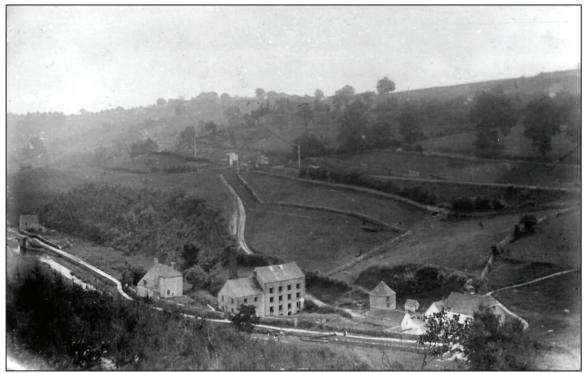
Photograph showing the derelict Puck Mill, centre, c. 1900-1912, looking south-east (Oakridge Community Archives 2019)
