**Free Rangers Nursery
Welton Manor Farm
Midsomer Norton
Bath & North East Somerset**

Historic Building Recording

CA Project: CR0041

CA Report: CR0041_1

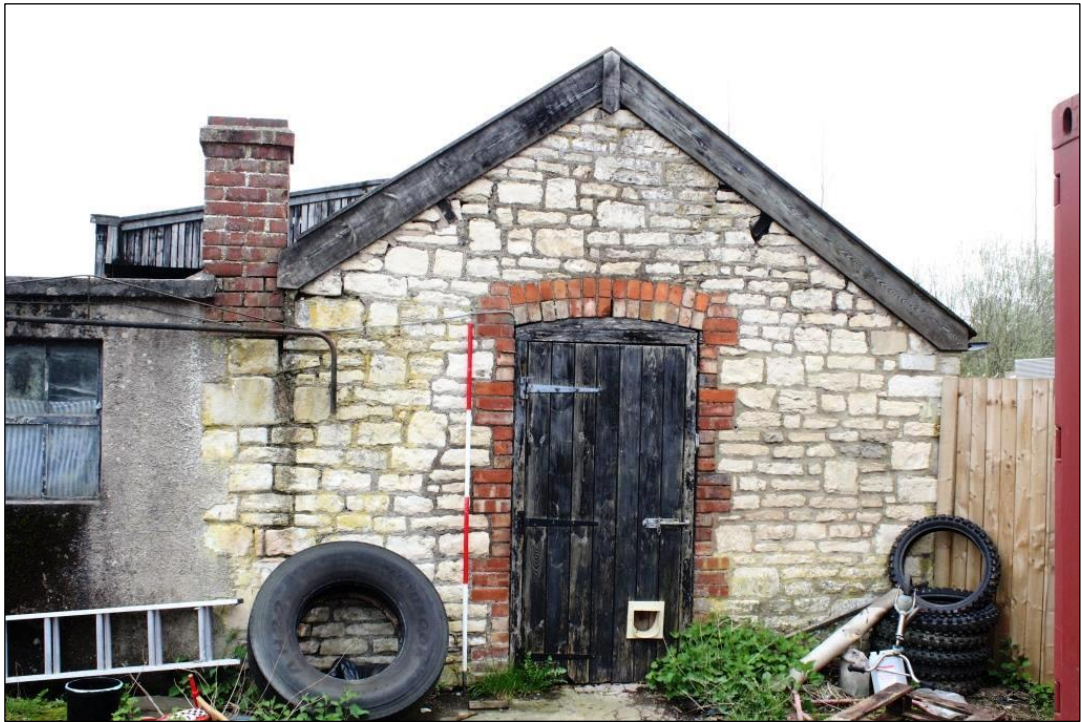
- 4.3. The north elevation is of two ranges; the east is a stone gable with a central door and appears to have been repointed. The door has a segmental arch head and is lined by brick (Photograph 1). The edge of the gable has barge boards and the purlins are visible in the wall plain. At the western extent of the gable is a brick chimney. The second range to the west is formed of the concrete rendered extension. It has a door to the west and a two by four light window to the east (Photograph 2). The joint between the bull pen (i.e. the host building) is concealed by render which prevents an understanding of how the structures are joint.

Photograph 1 Western range of north facing elevation of the bull pen

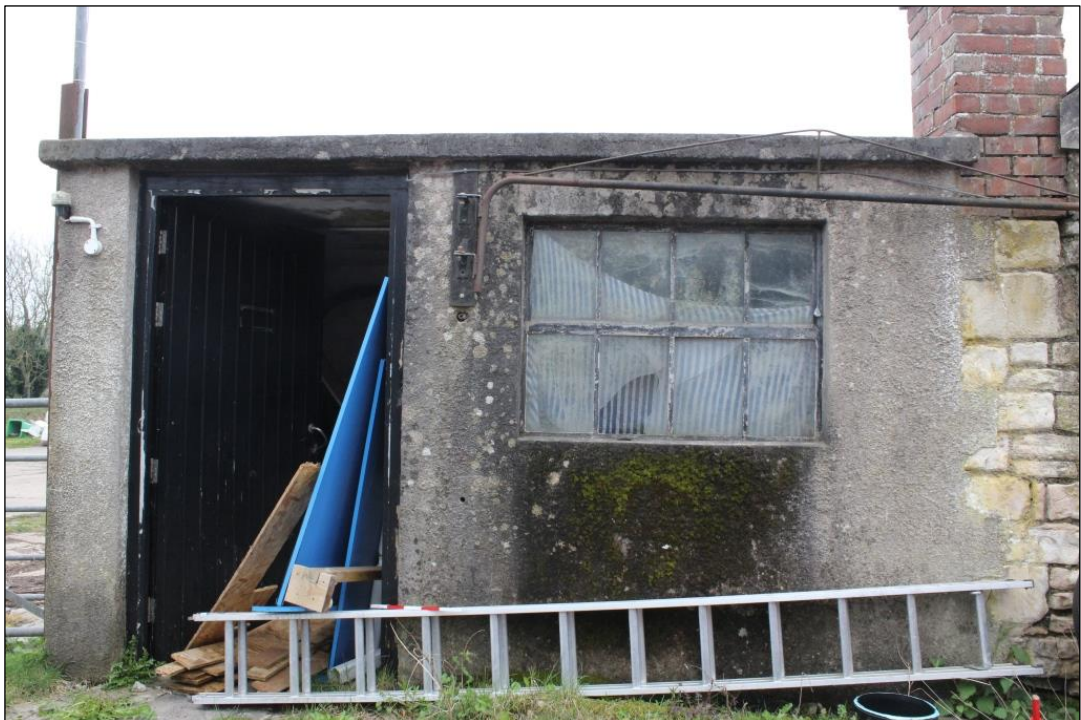
Photograph 2 Eastern range of north facing elevation of the bull pen

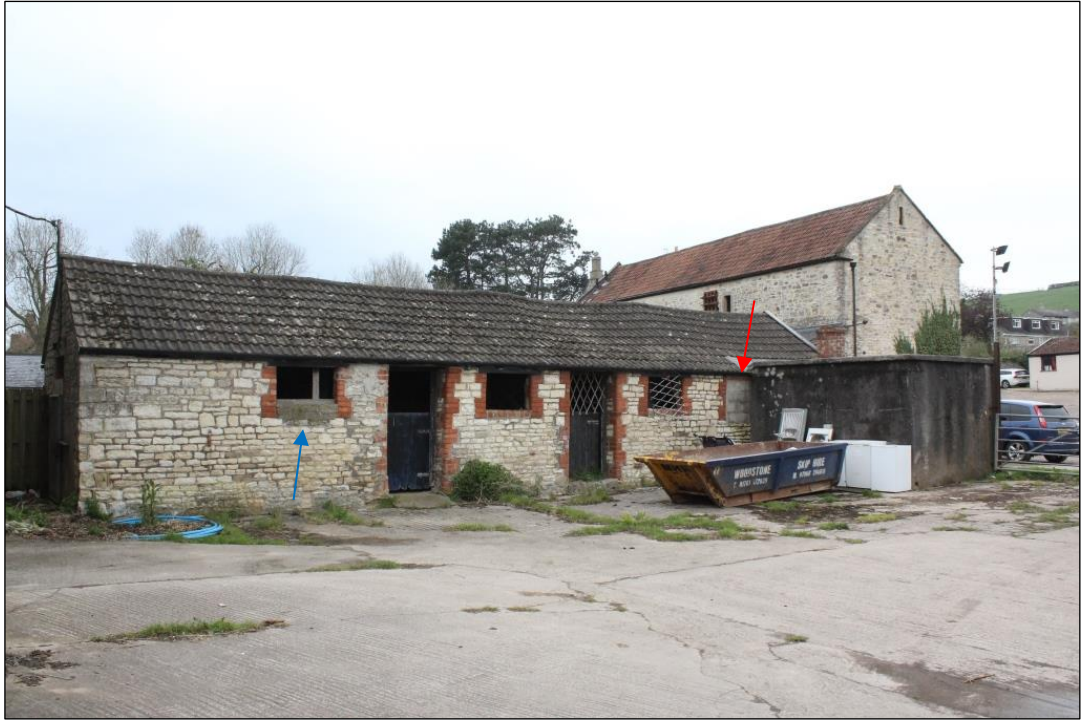
- 4.4. The east elevation is of two ranges (Photograph 3). The north range is of the concrete rendered extension and has no features or evidence of previously having any. The southern range is of the bull pen and comprises three windows interspaced with a door. There is a fourth window at the junction between the extension and host building which has been blocked up concrete blocks and is partially overlaid by the extension. The windows and doors are all lined with brick and set at eaves height. The base of the southernmost window has been relined with concrete.

Photograph 3 East facing elevation of the bull pen and south facing elevation of the extension. The red arrow shows the blocked-in window and the blue arrow the concrete base of window

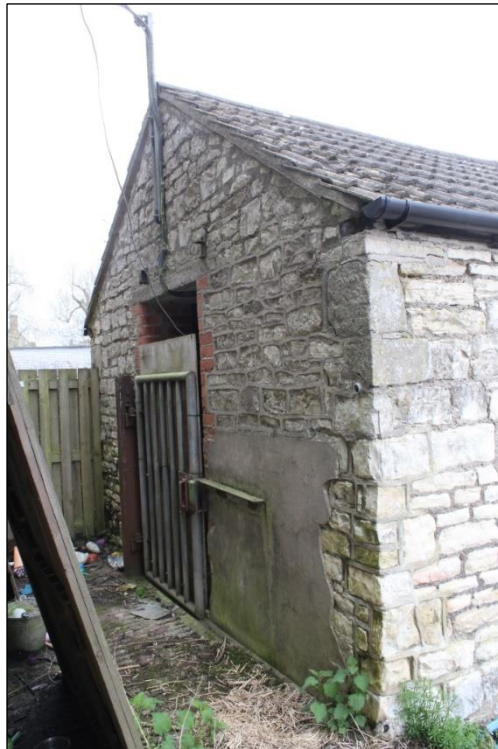
- 4.5. The south facing elevation of the bull pen is formed of a gable with a door in the centre (Photograph 4). The sides of the door are lined with brick, whereas it has a concrete lintel. This indicates that it has been the subject of alteration or repair at

some instance. There is also a section of concrete render on the east of the door with a metal bar, which appears to relate to the metal grate over the door. In contrast to the north gable, there are no barge boards along the edge of the roof. The south elevation of the extension has no features.

Photograph 4 South elevation of the bull pen

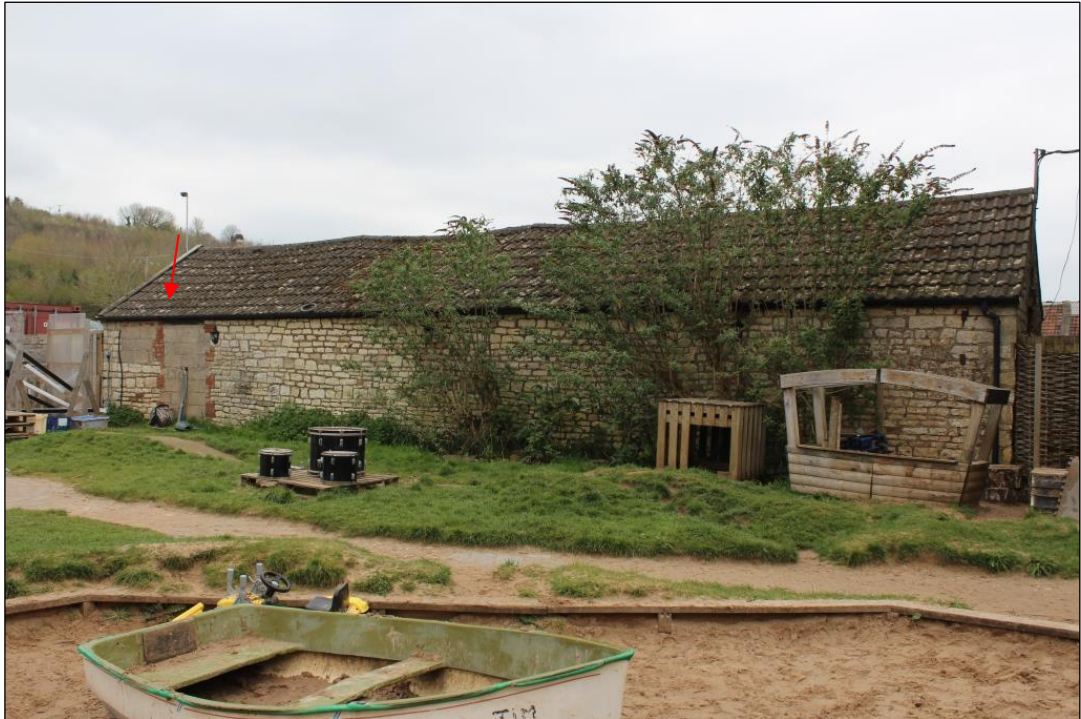
-
- 4.6. The west elevation is a single range, with a blocked-in door and window at the northern extent, both of which were originally lined with brick and set at eave height (Photograph 5).

Photograph 5 West elevation of the bull pen. Red arrow shows the blocked-in window and door

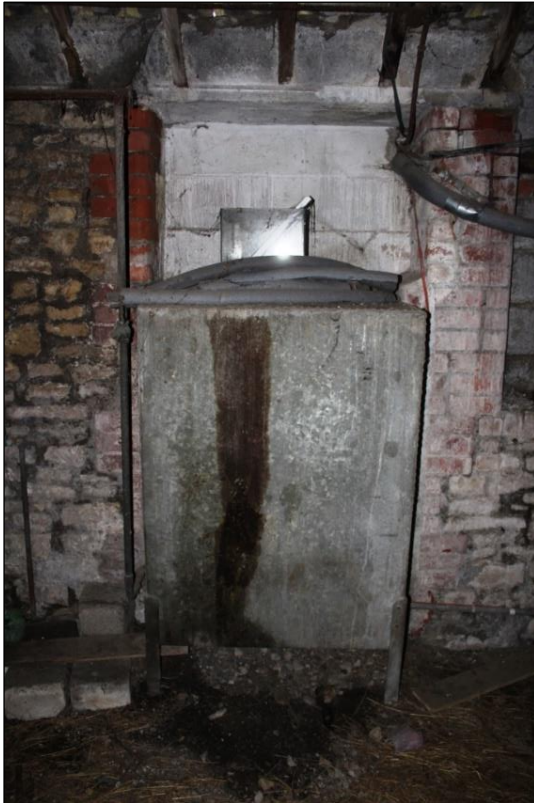
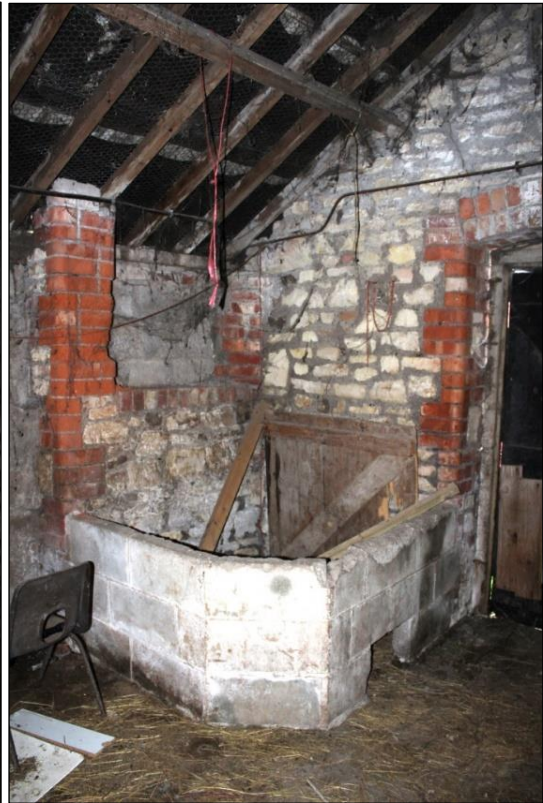
- 4.7. The interior of the bull pen comprises four rooms with the majority of the features relating to those on the exterior; for example, windows and doors. The additional features include a blocked-in door in the east wall of the room 1 (north), as noted on the west elevation (Photograph 6) and a concrete block sty in the north-west corner of the room (Photograph 7). Whilst the dividing wall between rooms 1 and 2 is of stone (Photograph 8), the wall between rooms 2 and 3 is timber (Photograph 9) and the wall between rooms 3 and 4 is of brick (Photograph 10). These walls retain no features which might relate to the buildings former use as a bull pen, for example feeders or tethering rings, except for a hatch in the brick wall between rooms 3 and 4.

Photograph 6 Blocked-in door in east wall of room 1
Photograph 7 Concrete block sty in north-west corner of room 1

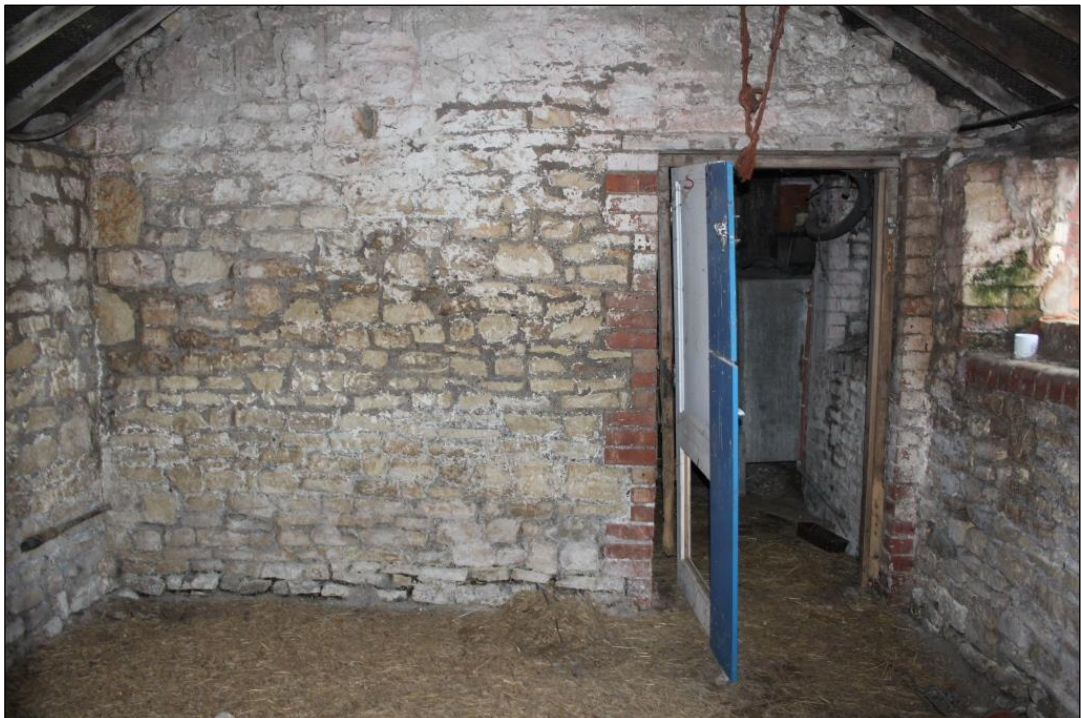
Photograph 8 Stone dividing wall between rooms 1 and 2

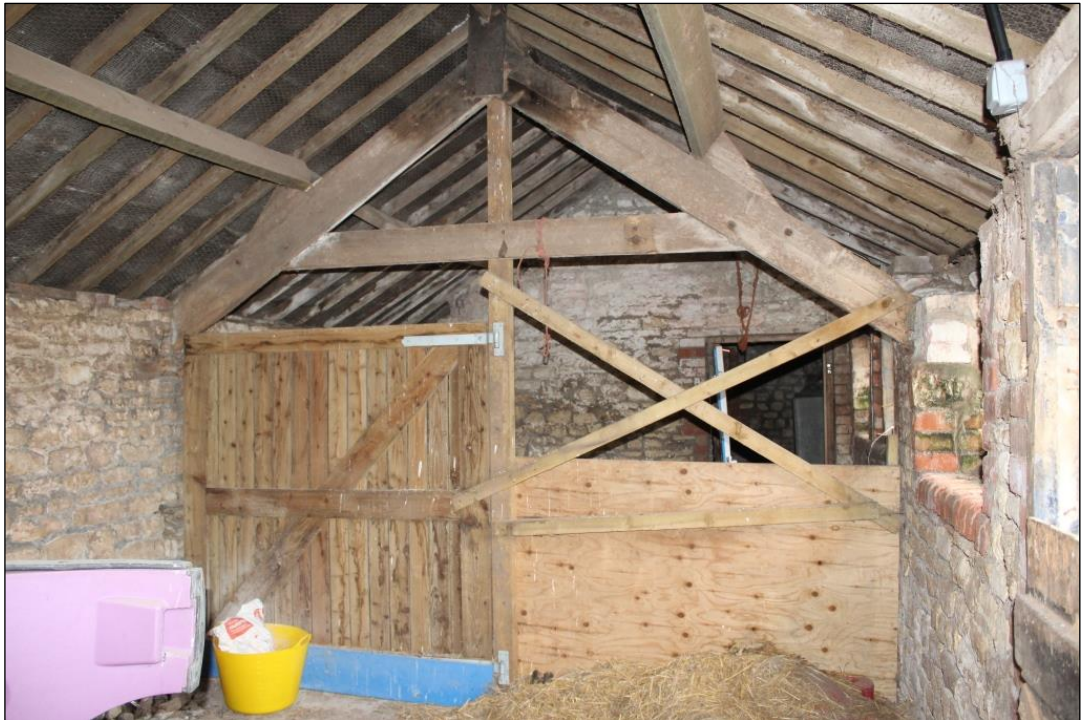
Photograph 9 Timber dividing wall between rooms 2 and 3

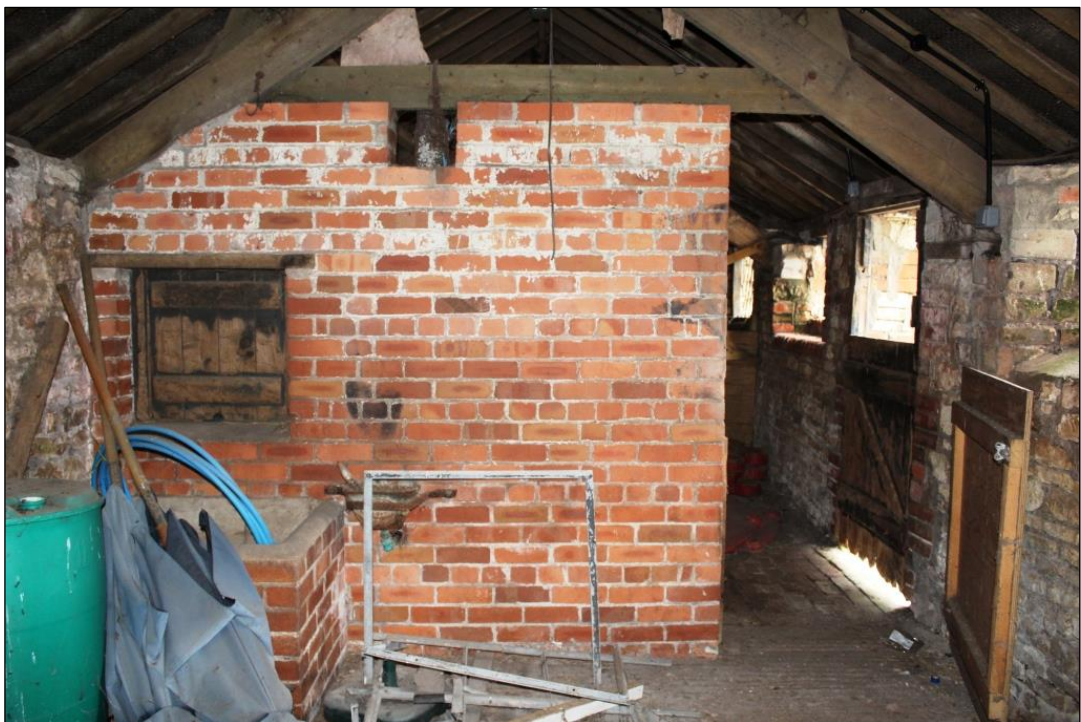
Photograph 10 Brick dividing wall between rooms 3 and 4 with hatch

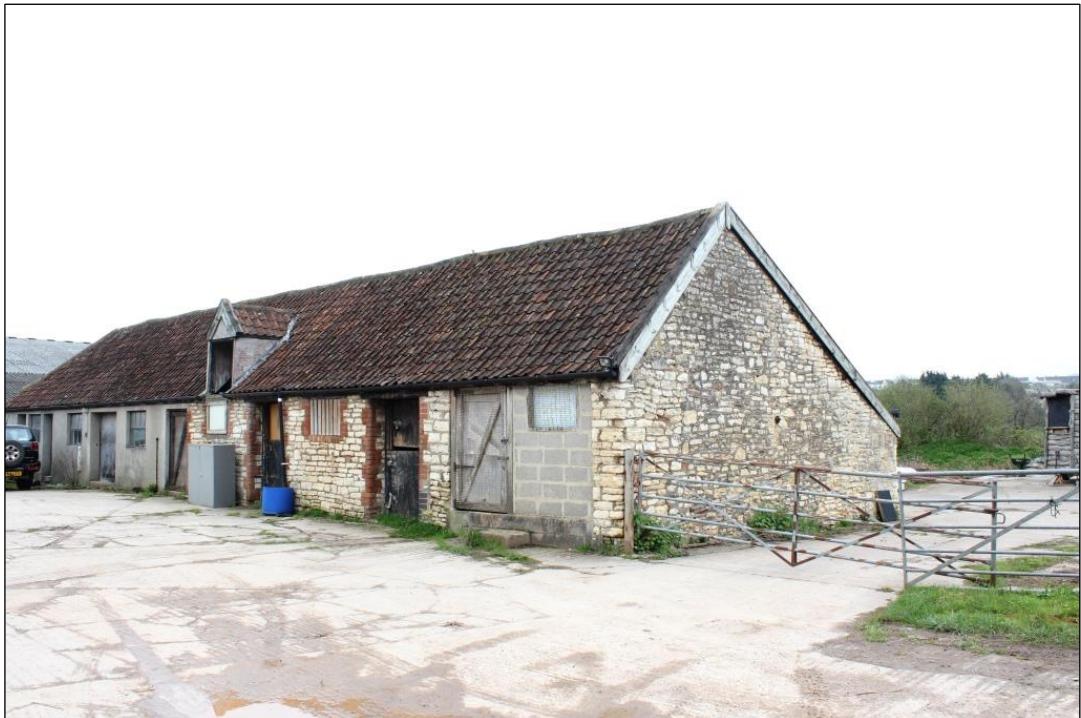
- 4.10. The western extent of the north elevation is a stone construction, with the eastern extent obscured by concrete render (Photograph 11). The eastern extent may have formerly been open and later infilled, with a pattern of windows and doors replicating the pattern of alternating doors and windows within stone (west) part. The western most bay, which is to be subject to the alterations, comprises a blocked-in opening using concrete blocks with a door and windows framed in timber.

Photograph 11 North facing elevation of the stable and dairy block

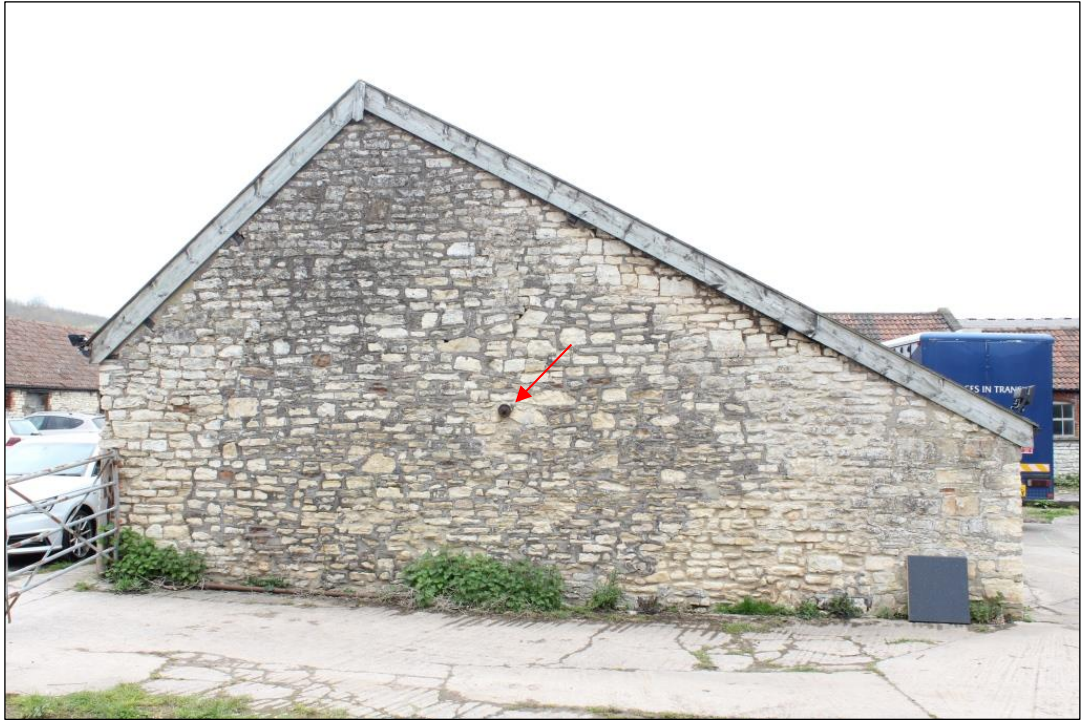
-
- 4.11. The west elevation is a gable of stone construction with a metal plate in the centre, the nature of which is unknown and barge boards (Photograph 12). The elevation is a-symmetrical with the southern extent extended out, as a result, the south eaves are at a lower height.

Photograph 12 West elevation of the stable and dairy block. Red arrow shows metal plate

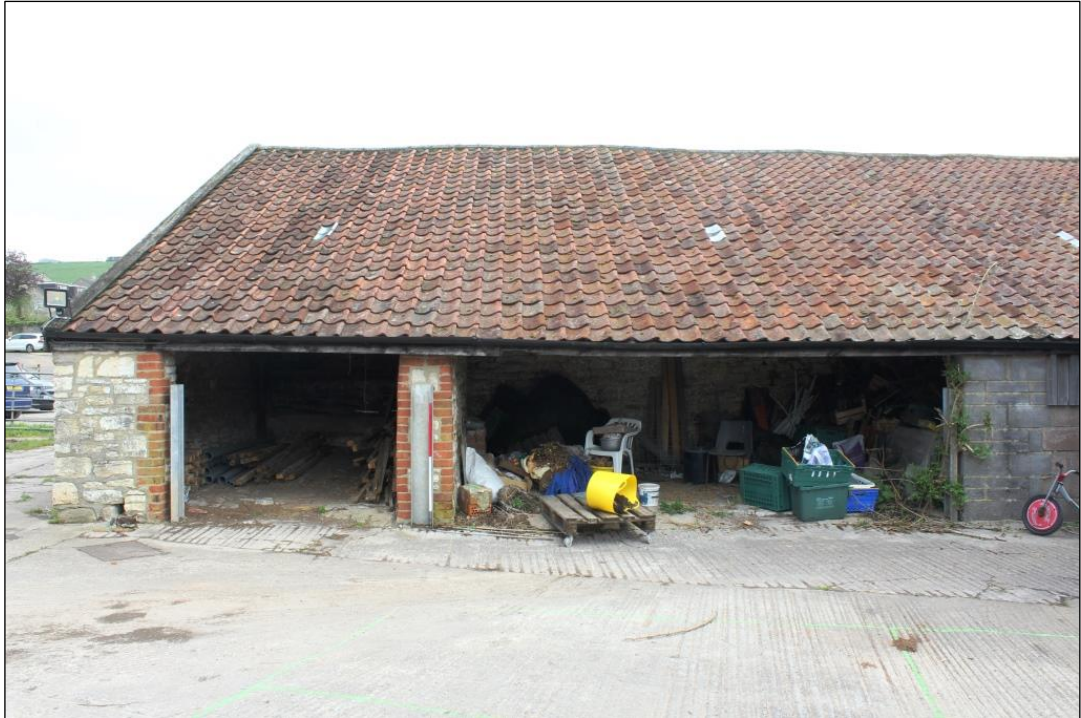
- 4.12. The south facing elevation is similar to the north in that the eastern extent has been the subject of later alterations with inserted concrete block walls. The western extent is of two large openings lined in brick and a small section of stone walling at the corner of the building (Photograph 13).
- 4.13. The north-south aligned section of the building is of stone construction and is the same design as the remainder of the buildings (Photograph 14).

Photograph 13 Western extent of the south facing elevation of the stable and dairy block

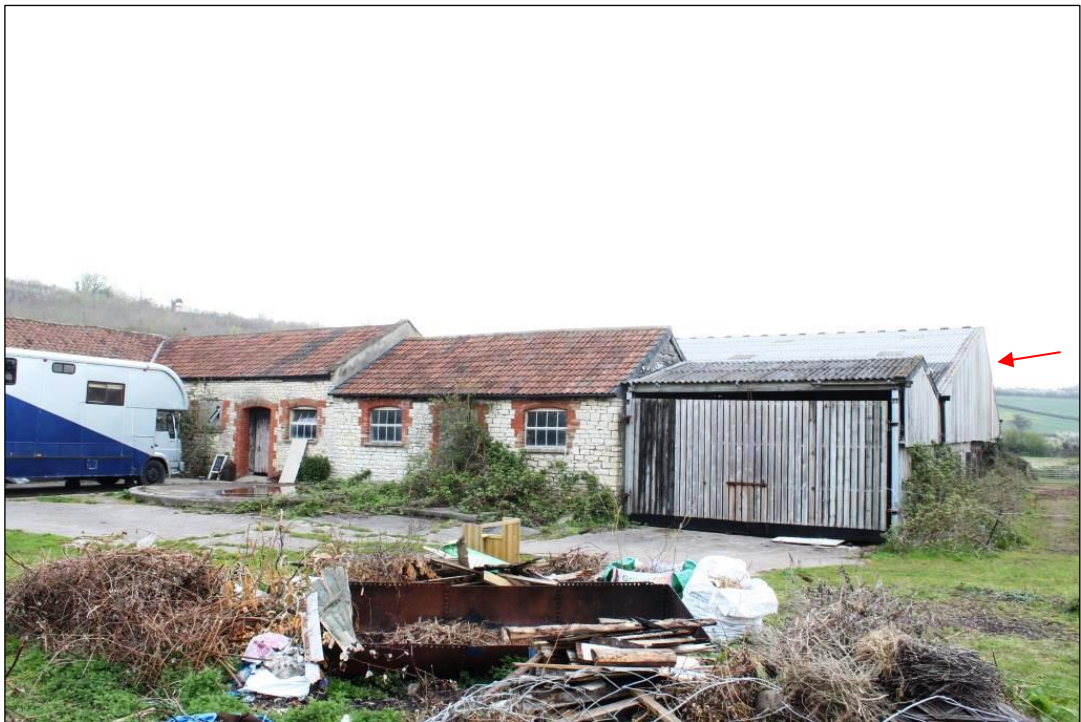
Photograph 14 West facing elevation of the stable and dairy block with modern timber clad structure behind, indicated by red arrow

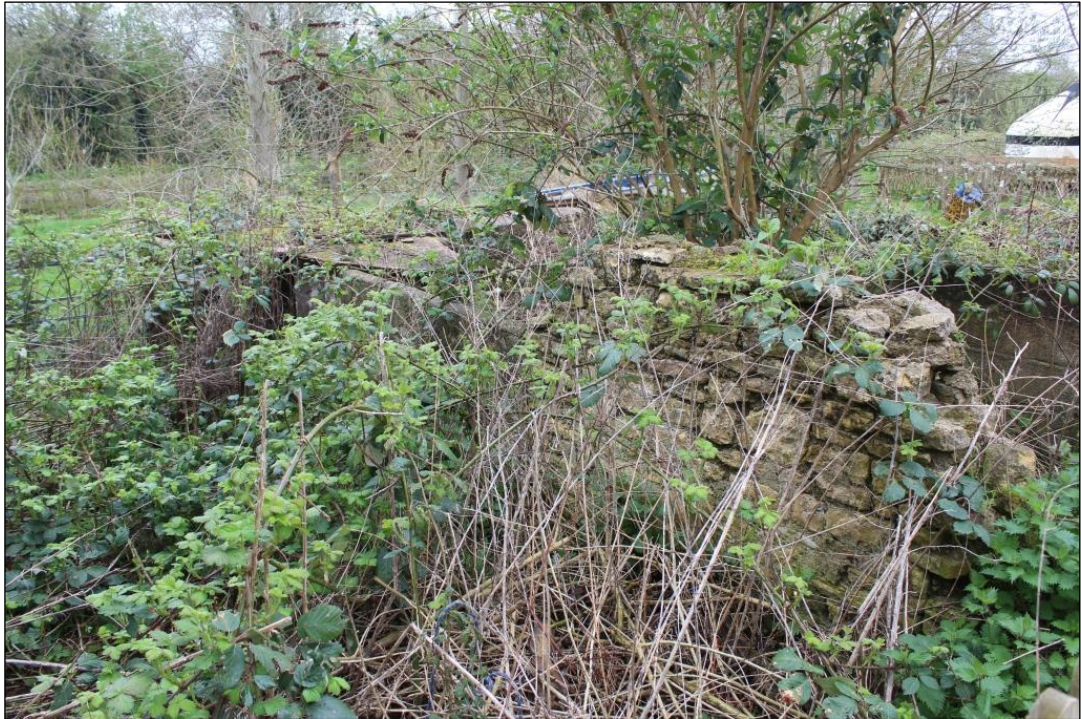
- 4.14. The pig sty is constructed of semi coursed lias lime stone with modern concrete block for the upper sections of the walls. It has no roof and the walls are too

degraded to determine the former profile of the roof. The walls survive to a maximum height of 900mm.

- 4.15. Due to the structure being heavily overgrown with vegetation it was not possible to view it or record it at an appropriate level during the Site visit (Photograph 14). As such, a subsequent phase of recording will be undertaken following the clearance of the vegetation.

Photograph 14 General view of pig sty

- 5.3. A subsequent phase of recording will be undertaken in relation to the pig sty following the clearance of vegetation.
