Land at 61 Court Street
Woodville
South Derbyshire

Archaeological Excavation

CA Project: MK0033
CA Report: MK0033_1

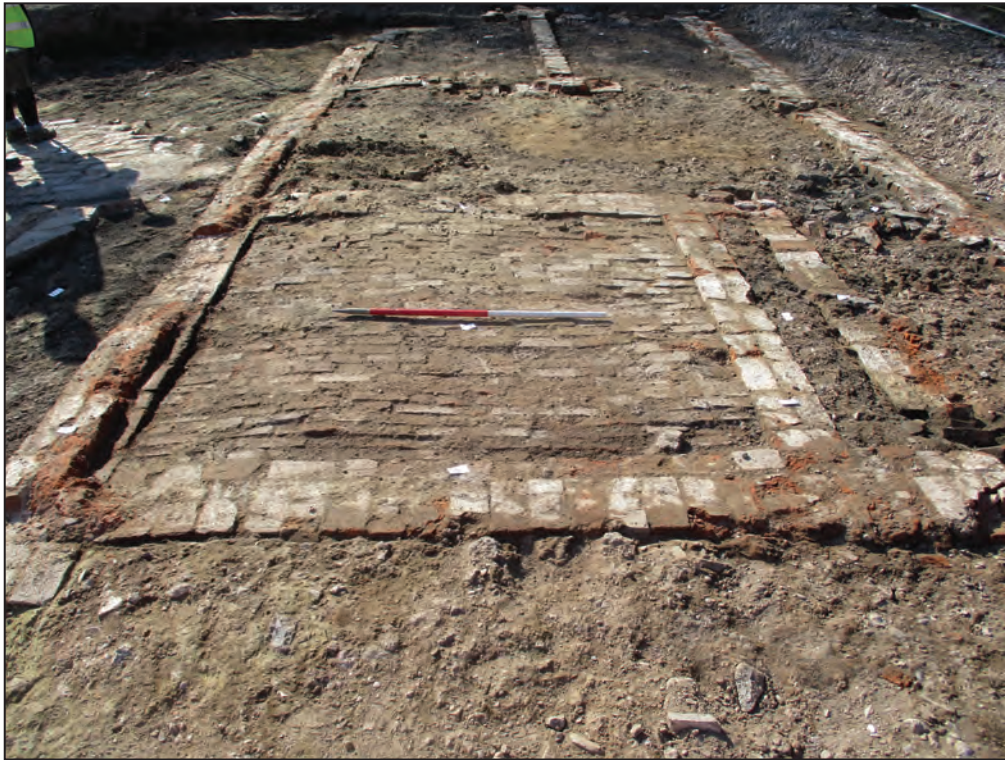
Floor 1021 within Building A, looking west (1m scale)

the southern side near the centre of the structure and led directly into Room 1. This room which measured 2.24m square was the only room in Building A with a preserved surface, floor 1021 comprised red bricks laid on edge in a stretcher bond (Fig. 5).

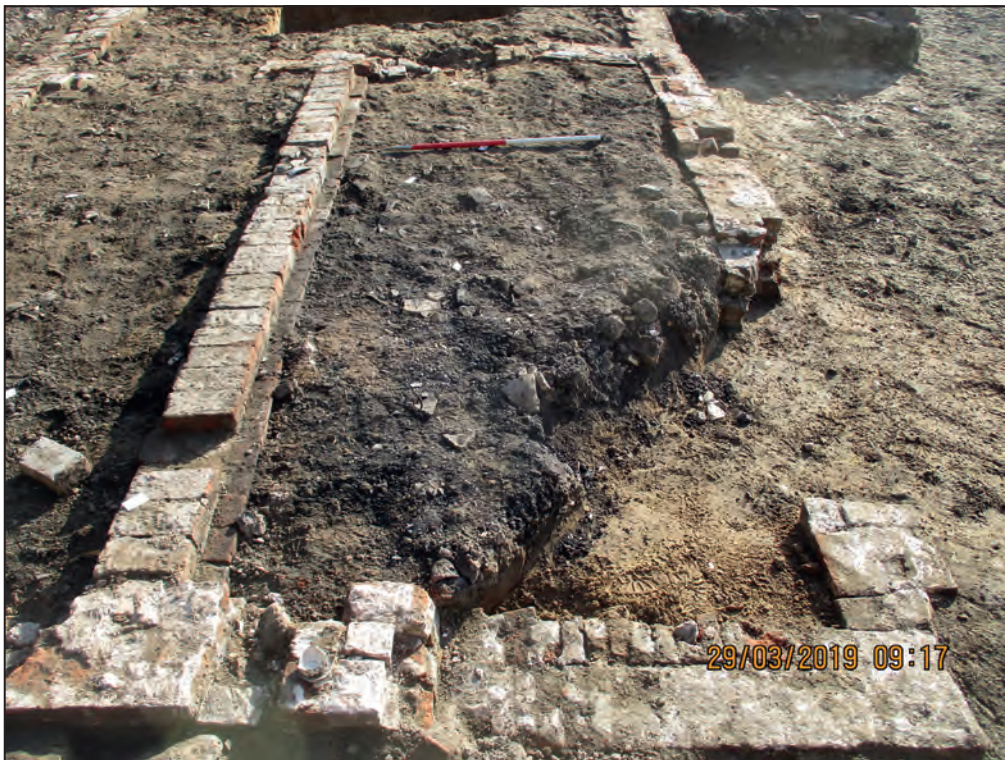
Room 4, within Building A, looking east (1m scale)

- 5.8 Rooms 3 and 4, were two small rectangular rooms located at the west end of Building A, and measuring 4m by 1.73m. Both rooms had doorways into Room 2. Wall 1005, at the western end of Room 3 was partly truncated by later demolition works. The south-western corner of Room 4 was also partly truncated during the excavation of an evaluation trench (CA 2019) (Fig. 5). Both rooms were filled with similar deposits (1011) and (1012), comprising dark grey brown silty sand containing frequent small stone and rubble, butting up to the walls. Where the evaluation trench had truncated the corner of Room 4 deposit 1011 was shown to be 0.2m thick and overlying subsoil (1062). Both (1011) and (1012) contained frequent fragments of post-medieval pottery dating to between the 18th and 20th centuries.

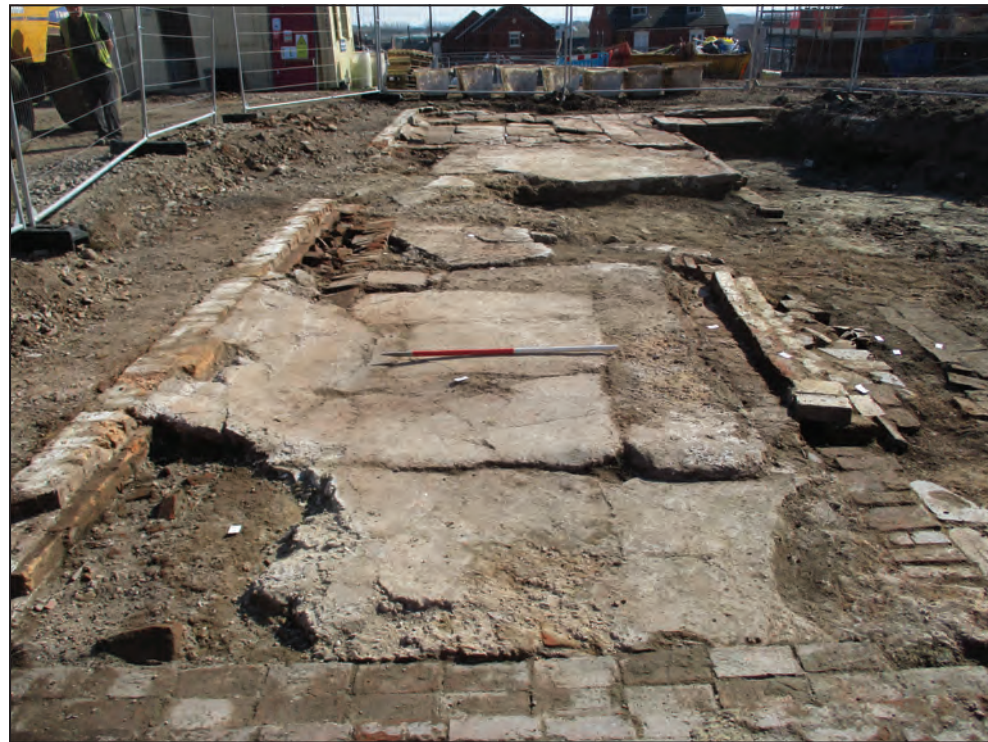
Building B, north end, looking south (1m scale)

- 5.11 Room 5 was located at the northern end of Building B and measured 4.2m by 3.95m. The northern and southern walls of Room 5, 1022 and 1023, abut walls 1006 and 1015 of Building A respectively. The entirety of Room 5's eastern wall and half of its southern wall 1023 had been truncated, presumably during or shortly after demolition. Robber trench 1026 was identified where these walls once stood. Made ground (1024), comprising mid yellow brown sandy clay with frequent stone inclusions, was found abutting the walls within Room 5. A sondage was excavated which showed that (1024) had a thickness of 0.12m and overlay subsoil 1062. Four fragments of CBM were recovered from (1024) but no pottery. This is in marked contrast to the rest of the deposits within Building A, which contained significant amounts of artefacts.

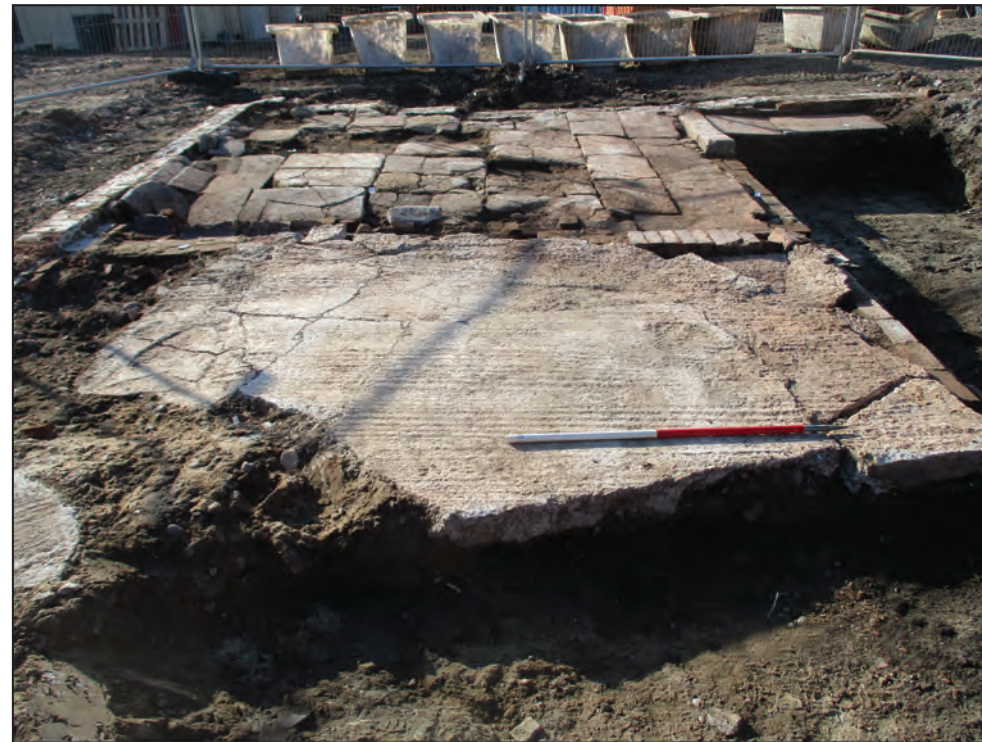
Building B, south end, looking south (1m scale)

- 5.15 The southern portion of Room 6 was surfaced with a textured concrete 1051 which overlay made ground (1050) and (1064), similar to (1040).
- 5.16 Room 7 was located in the south-eastern end of Building B, separated from Room 6 by internal brick wall 1052. Wall 1052 measured 0.24m wide and spanned Building B. Ceramic drain 1053 abutted wall 1052 running along the northern edge of Room 7 (Fig.7). Room 7 measured 3.6m by 4m and contained (1056), a dark brown grey silty sand, found to be abutting the walls within it. Overlying this, and abutting drain 1053, was floor 1054 comprising concrete slabs. Internal wall 1052, originally separating Rooms 6 and 7, was overlain by the concrete surface 1051 of Room 6 indicating a structural remodelling of Building B, opening up the space within.

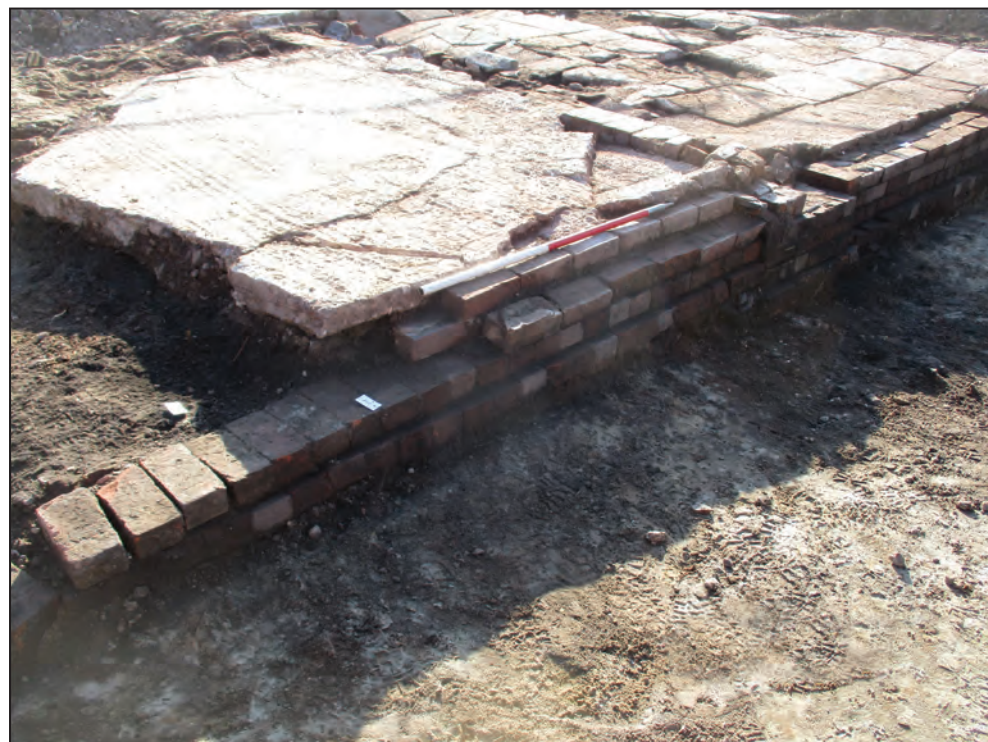
Building B, external wall 1049, looking south-east (1m scale)

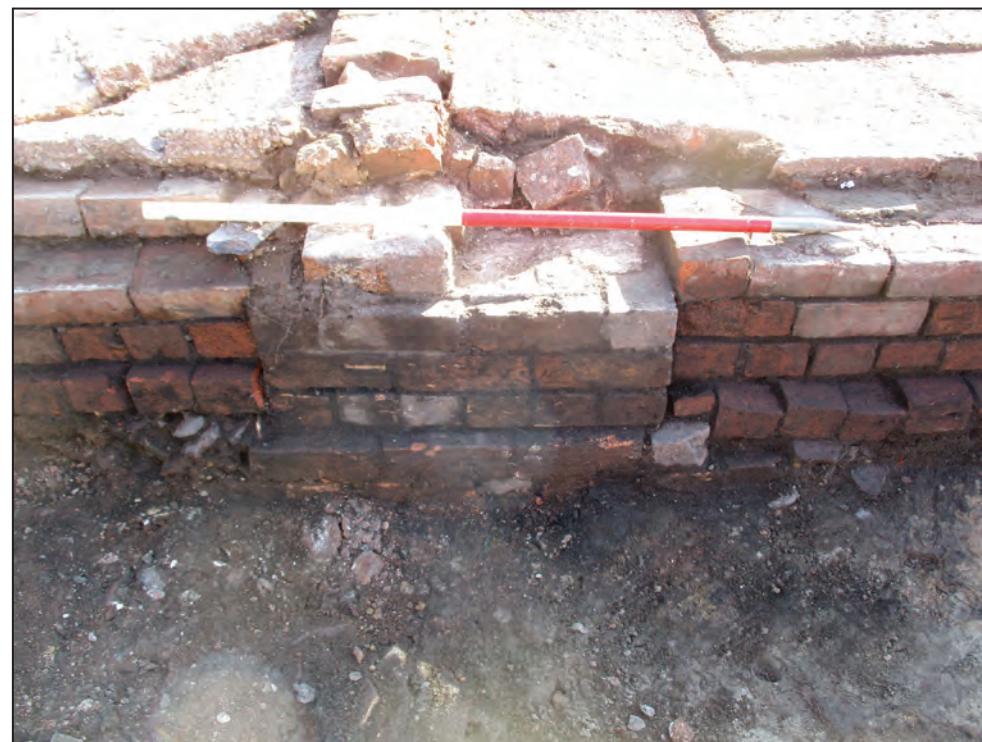
Building B, blocked doorway 1057, looking east (1m scale)

- 5.10 Building B was attached to the eastern end of Building A and extended south at a right-angle forming an L shape. Building B measured 19.6m by 4.7m although the centre of Building B was completely truncated by an evaluation trench. The external walls were constructed with brick, which were exposed to their full depth along the western side of the building. Two courses of foundation headers were overlaid by two courses of stretcher bond with a total height of 0.3m (Fig. 6). The two external walls along the length of Building B were reinforced with brick buttresses 1038 and 1057.

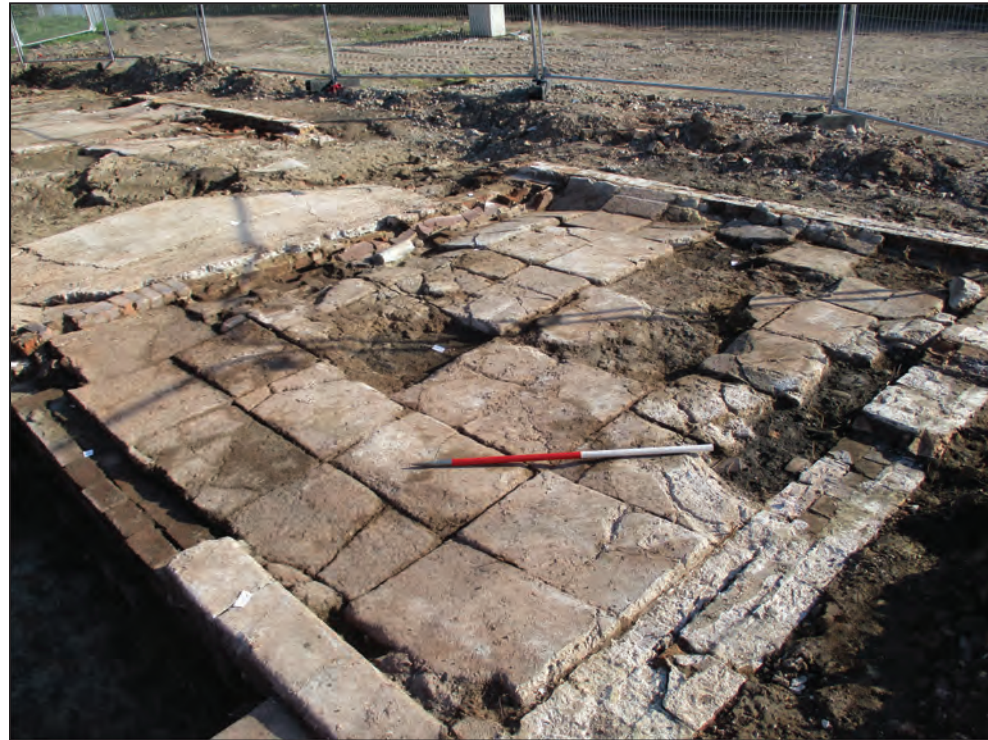
Floor 1054 within Building B, looking north-east (1m scale)

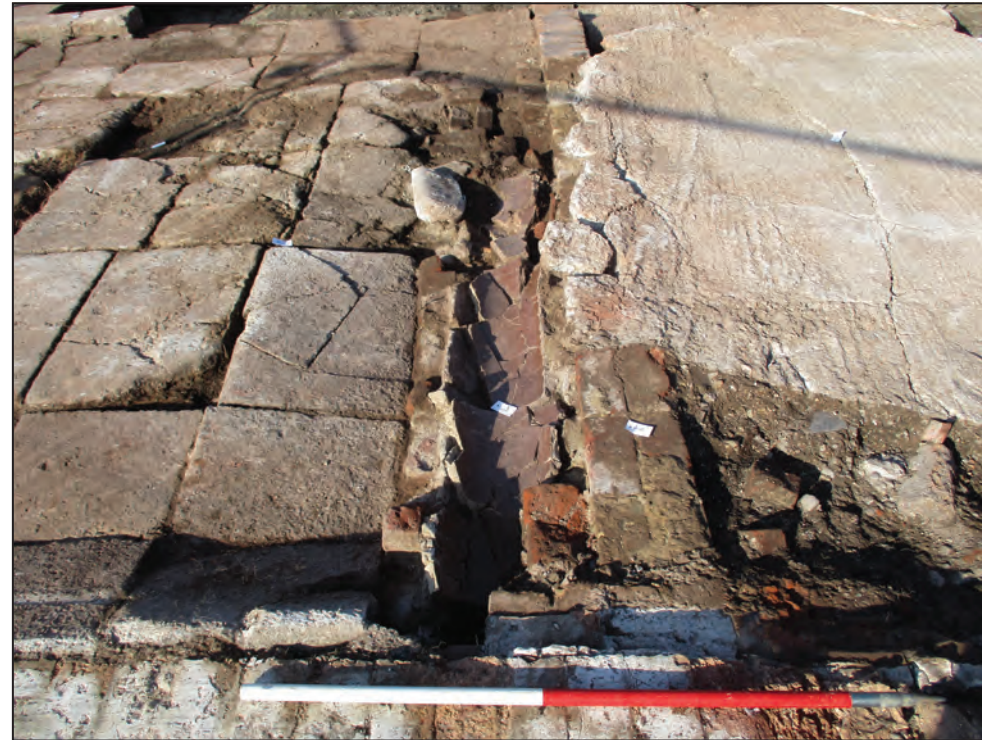
Drain 1053 within Building B, looking west (1m scale)

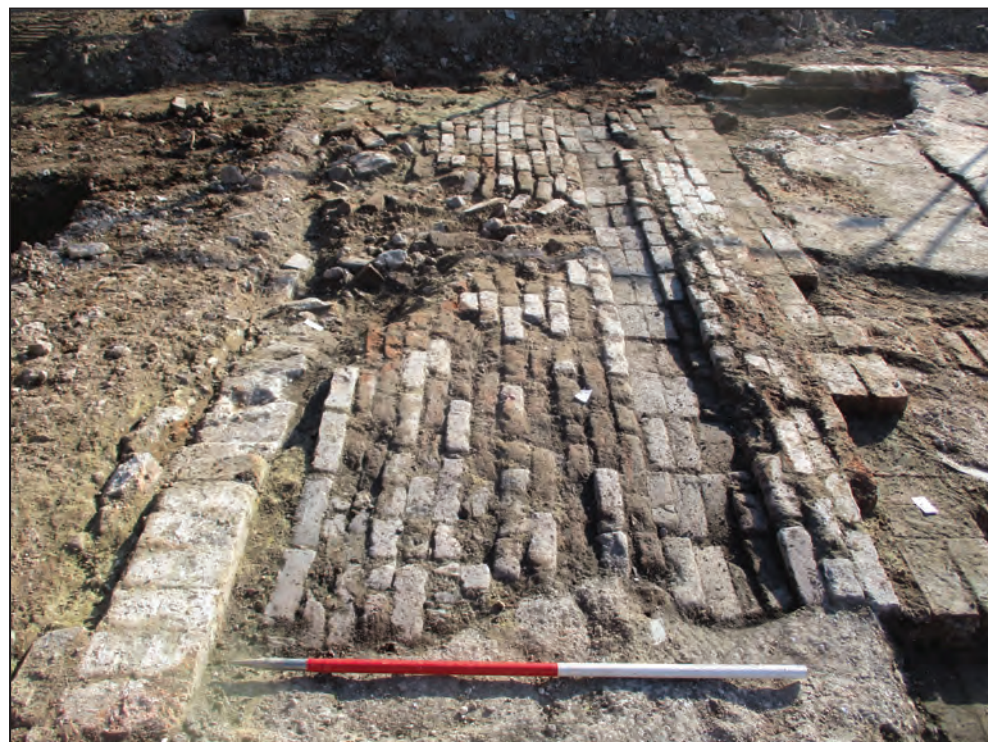
Passageway 1034, looking east (1m scale)

- 5.19 In the northern part of the courtyard further remains of yard surfaces were observed including step 1032 constructed outside the entrance to Building A. Step 1032 only partially survived and comprised concrete slabs surrounded by a brick border measuring 1.22m by 0.66m. To the west of the step, on the other side of concrete drain 1031, the remains of brick surface 1029 was exposed (Fig. 7). An area covering 1.83m by 1.23m of 1029 survived that included blue and orange brick laid on bed in a stretcher bond. To the south the bricks were edged with large concrete kerbing (1028) and to the north the brick surface was patched with concrete (1030). To the east of Step 1032 the remains of a tarmac surface were also exposed, this butted passageway surface 1034 and measured 1.5m by 1.2m.

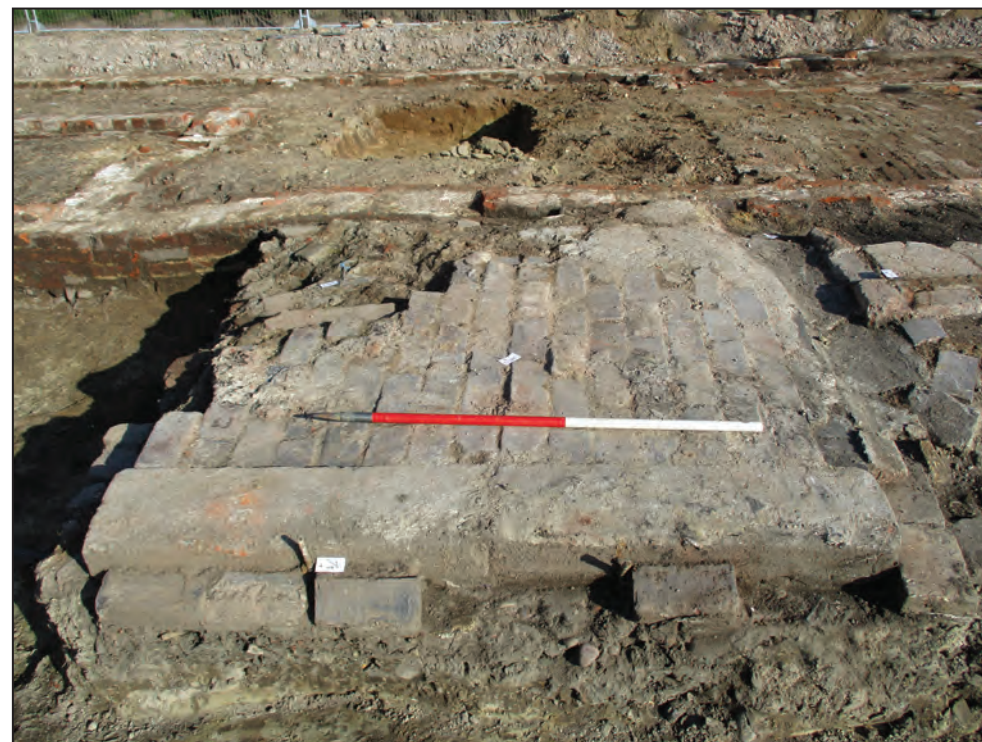
External surface 1028, looking north (1m scale)
