South East Thatcham Flood Alleviation Scheme, Thatcham West Berkshire

October 2019

Archaeological Watching Brief

CA Project: AN0062
CA Report: AN0062_1

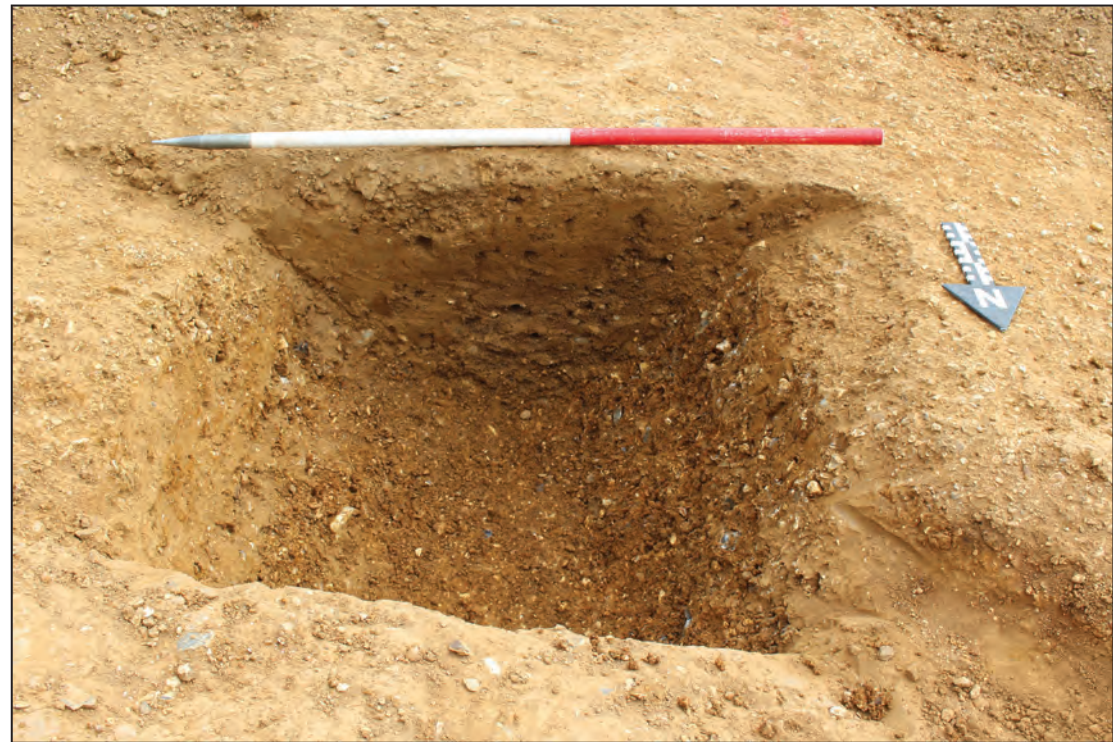
FIGURE TITLE
**Ditch 3095: plan, section and
 photograph**

Ditch 3095 within trench 3.8

Ditch 3095, looking south (1m scale)

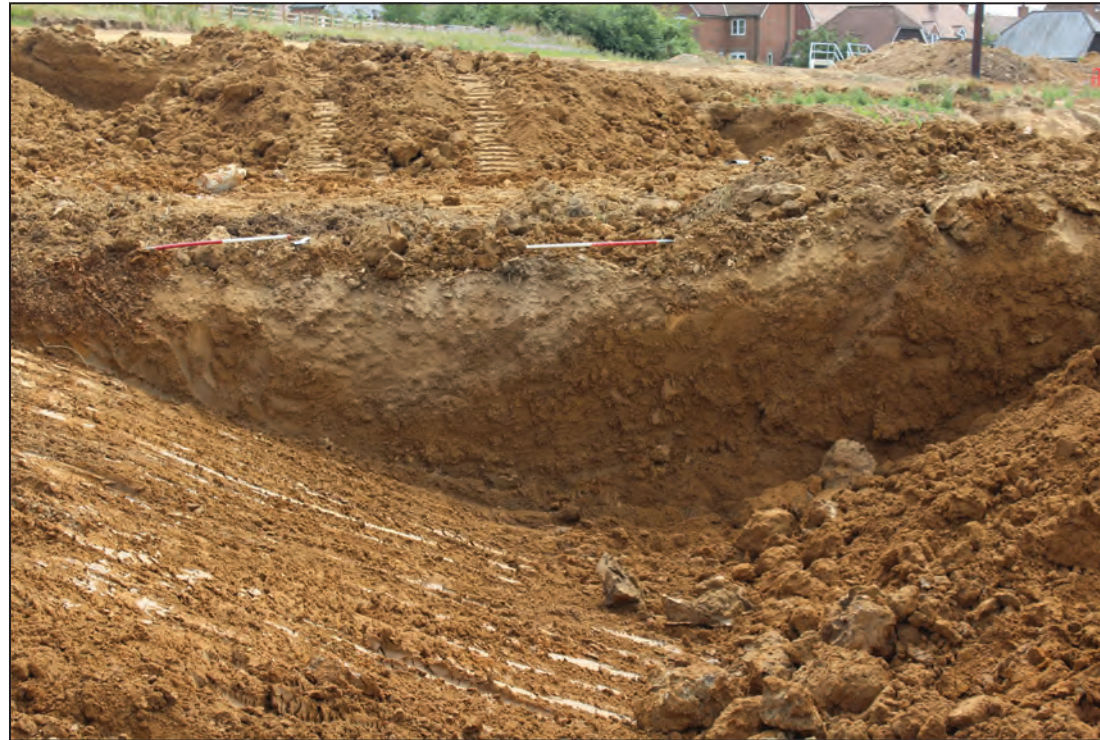
Representative section of Trench 1.4, looking south-east (1m scales)

- 5.7 **Trenches 1.4, 1.5, 1.6** and **1.7** were extended prior to the construction of the flood detention basin. A sequence of natural gravels mixed with sandy silt/clays was recorded most likely associated with the river terrace system (fluvial deposits). A few burnt flints were recorded within the gravels, **1041**, which were probably redeposited by the fluvial action.

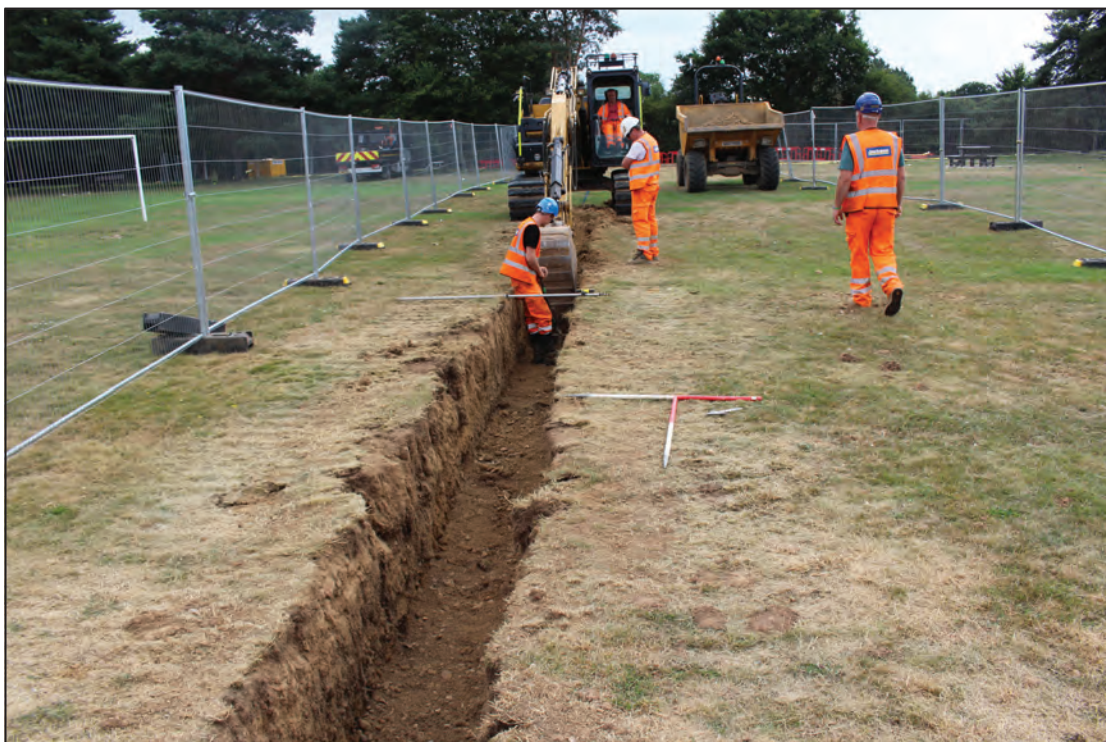
General view of Trench 2.1, looking south-east (1m scales)

- 5.13 **Trench 2.1** was c. 57m long, 0.60m wide and c. 0.72m deep. The natural geology, **2003**, consisting of reddish brown silty clay with gravel, was encountered at a depth of 0.50m, sealed by yellowish brown silty clay with well-sorted gravel, **2002**. This was overlain by a thin 0.10m madeground deposit, **2001**, which was in turn was sealed below medium greyish brown silty clay topsoil, **2000**, 0.10m thick.
