Chesterton Farm Foul Water Pipeline Hills Quarry Route Gloucestershire

Archaeological Evaluation and Watching Brief

CA Project: CR0257
CA Report: CR0257_1

January 2021

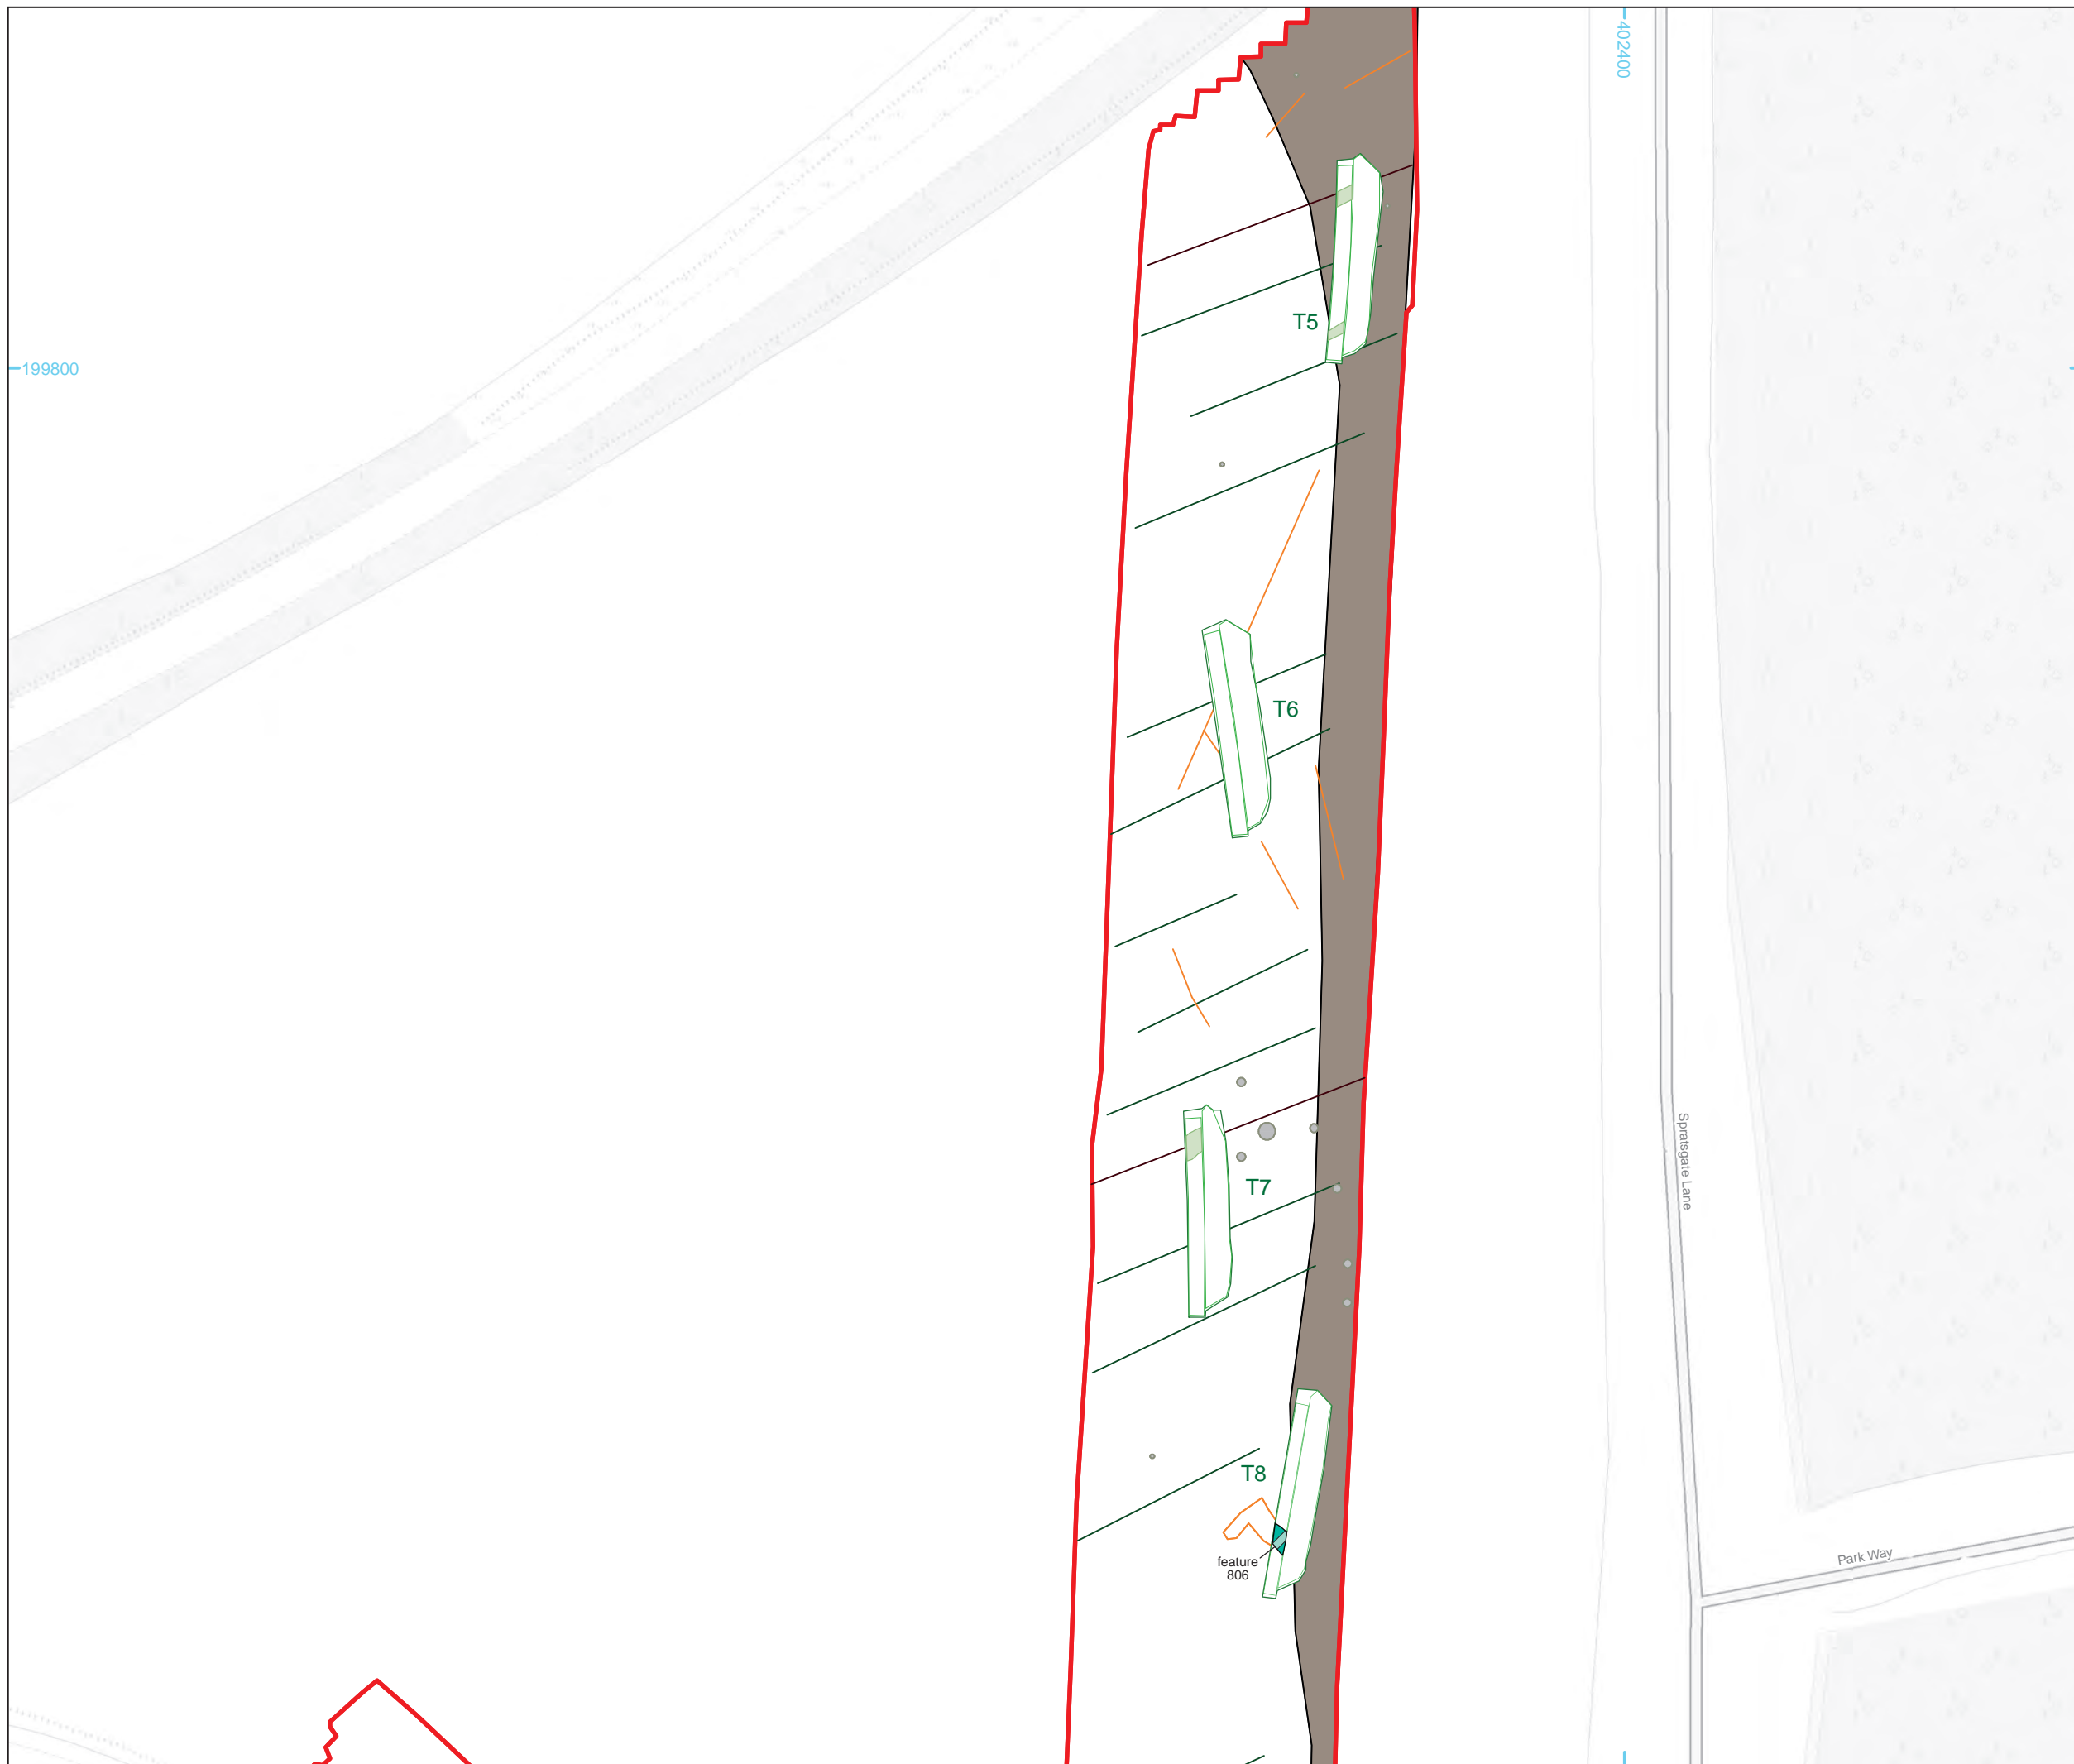
<small>DRAWN BY</small> EE	<small>PROJECT NO.</small> CR0257	<small>FIGURE NO.</small> 5
<small>CHECKED BY</small> DJB	<small>DATE</small> 28/08/2020	
<small>APPROVED BY</small> REY	<small>SCALE</small> @A3 1:750

FIGURE TITLE
**Trenches 5 to 8 showing
 archaeological features and
 geophysical survey results**

- 5.4. Feature 806, identified within Trench 8 (Fig. 5), was partially exposed in plan, and corresponded with an irregular geophysical anomaly. It was broadly aligned north-west/south-east with moderately sloping sides and a concave base, and measured at least 2.0m in length, 1.9m in depth and 0.5m in depth (Fig. 20). It contained three fills: one sherd of late 18th to 19th-century AD pottery was recovered from silty basal fill 805, and 15 sherds of residual Roman pottery, animal bone and post-medieval ceramic building material (CBM) were recovered from rubble-rich secondary fill 804.

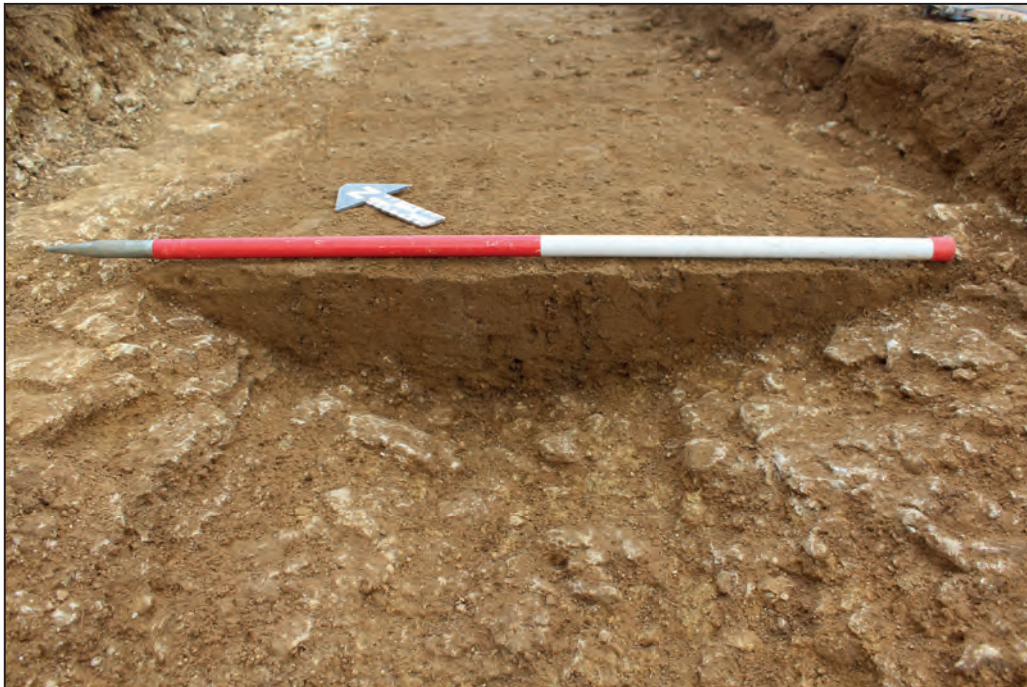
Ditch 2403, looking north-east (1m scale)

6.7. Only small quantities of artefactual material were recorded and the Roman material, which makes up the majority, appears to be largely redeposited. More significant is a sherd of early medieval pottery from ditch 2403. As has been noted, artefactual evidence for this period is uncommon from the Cirencester environs, although

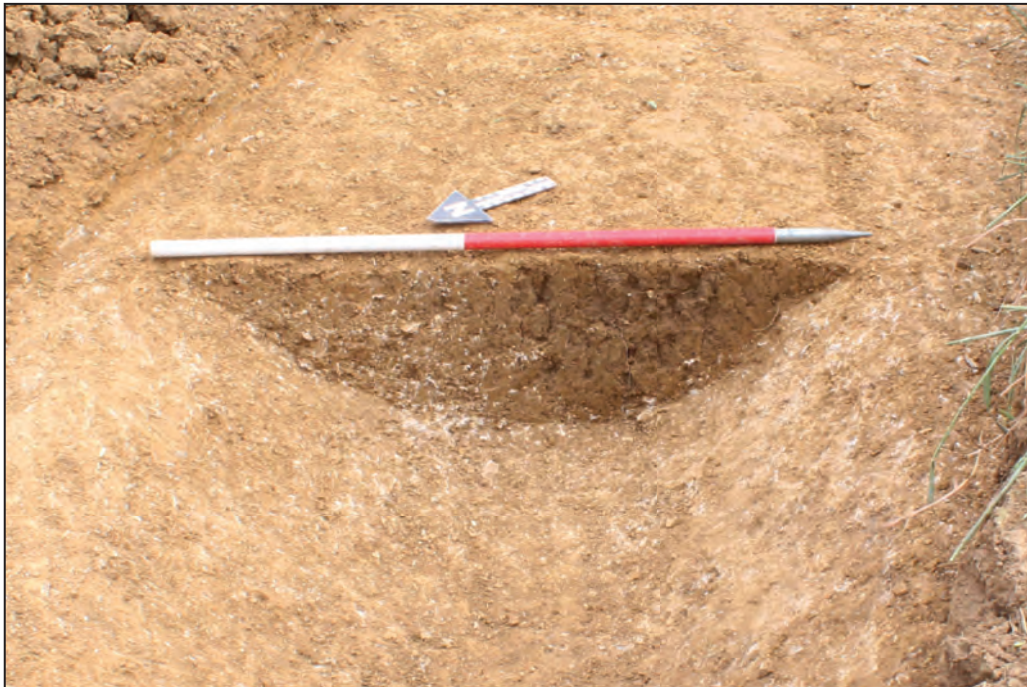
Ditches 3905 and 3907, looking south-east (1m scale)

Trench 39 (Figs 14, 18 and 20)

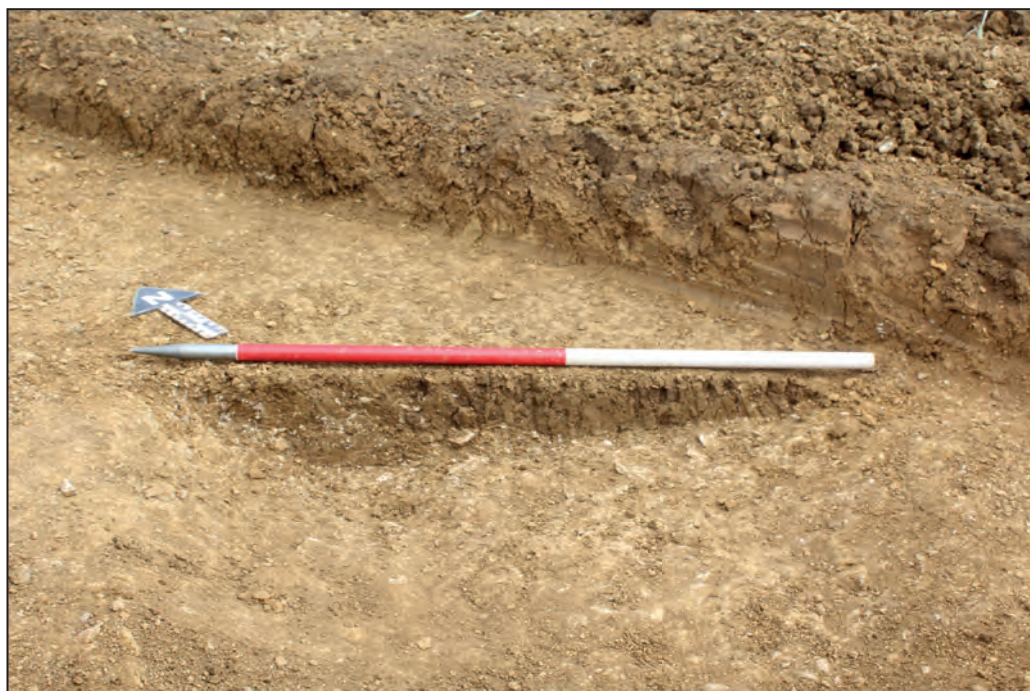
Ditch 4003, looking north-east (1m scale)

Trench 40 (Figs 14 and 19)

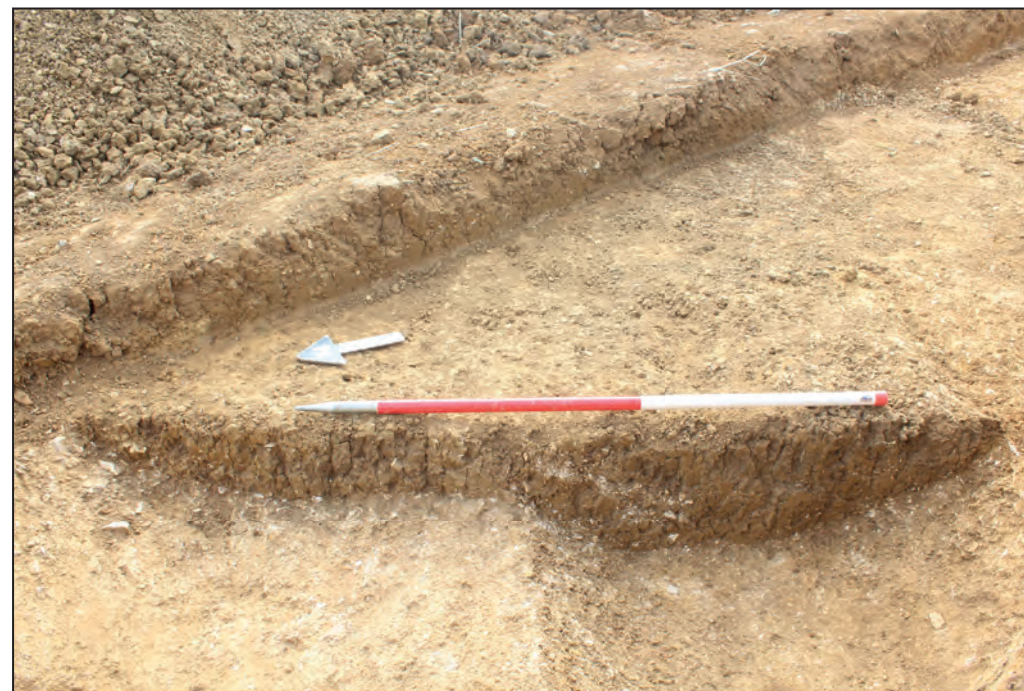
Ditches 4007 and 4009, looking south-east (1m scale)

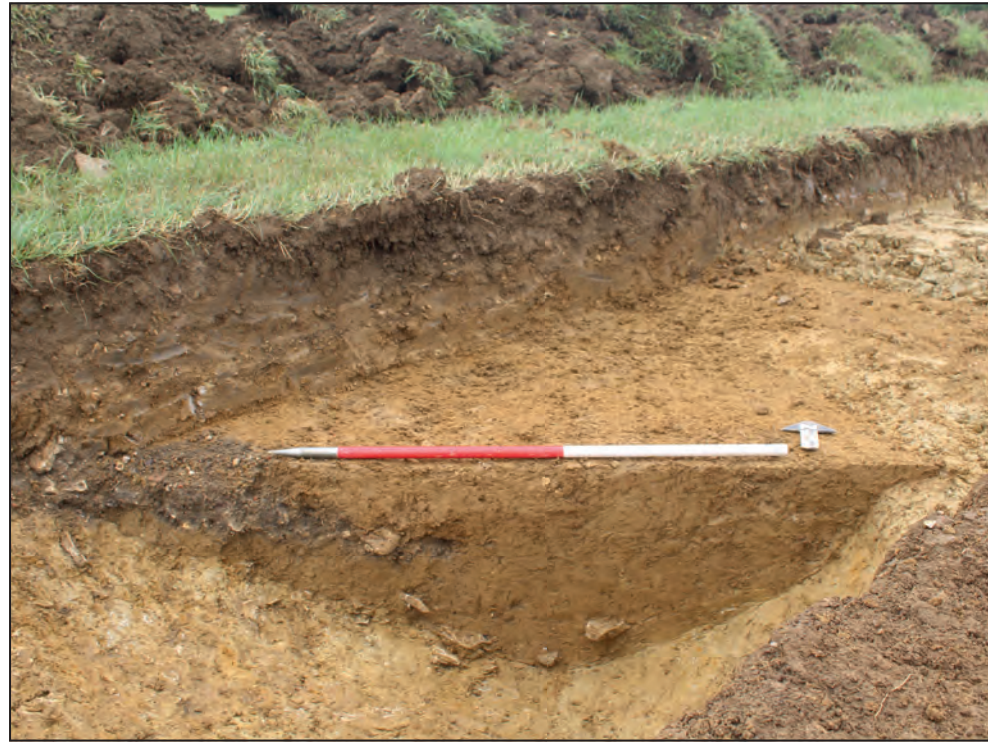
Trench 8, post-medieval feature 806, looking north (1m scale)

- 7.1. Animal bone amounting to 39 fragments (726g) was recovered from fills 803 and 804 of feature 806 alongside artefactual material dating from the post-medieval period (See Table 1, Appendix C). The bone was well preserved but fragmented, however it was possible to identify the remains of cattle (*Bos taurus*), sheep/goat (*Ovis aries/Capra hircus*) and pig (*Sus scrofa sp.*) Where modern damage was present and re-fitting was possible, the fragments are counted as a single bone.

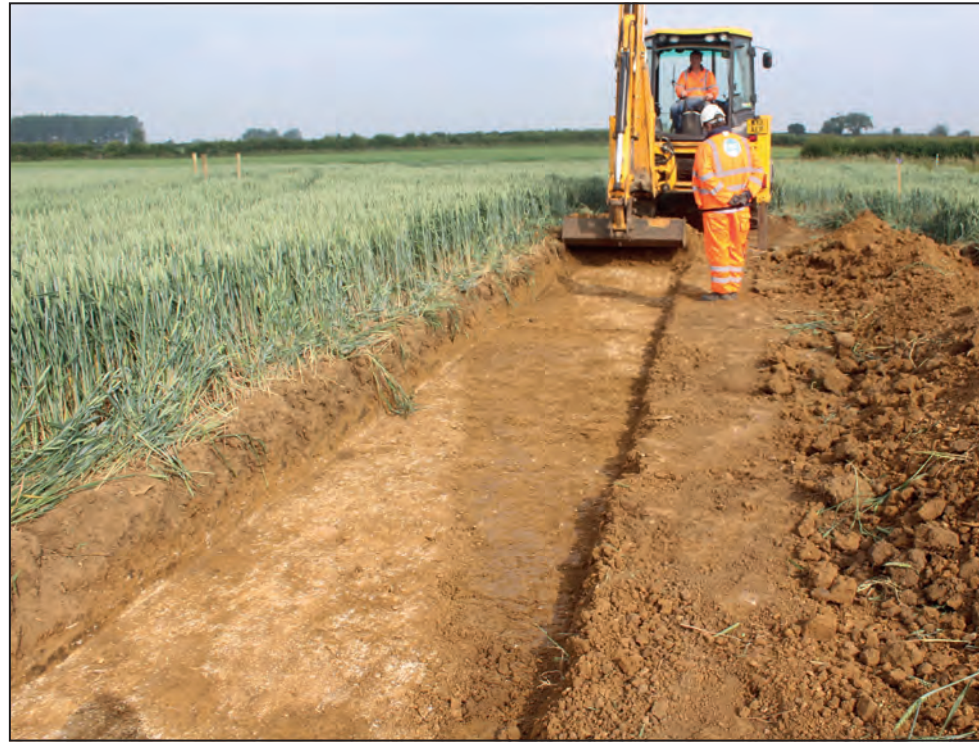
Trench 39 during machine excavation, looking north-west

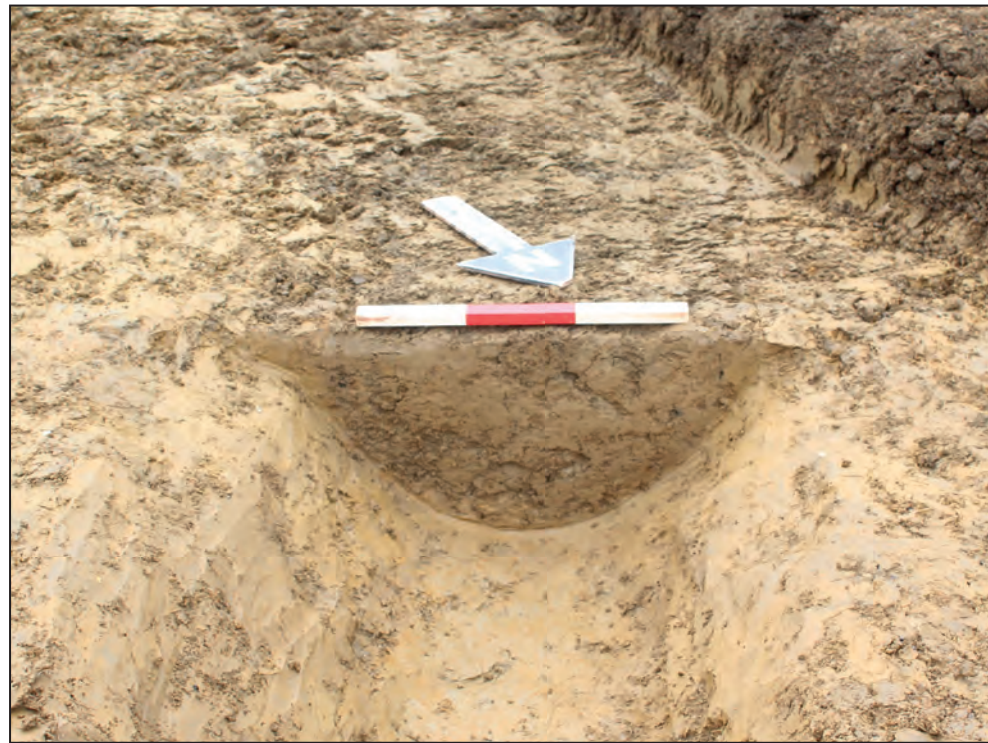
Trench 28, Post-medieval ditch 2803, looking south-west (0.3m scale)

- 5.3. The subsoil was cut by post-medieval ditches within Trenches 27, 28 (Fig. 20), 30, 32 and 36. Medieval and/or post-medieval furrows were identified in Trenches 5, 7, 10, 11, 12, 14, 15, 17, 19, 23, 42, 44, 45, 46 and 47). Natural features associated with tree rooting or animal burrowing were identified in Trenches 19 and 45.

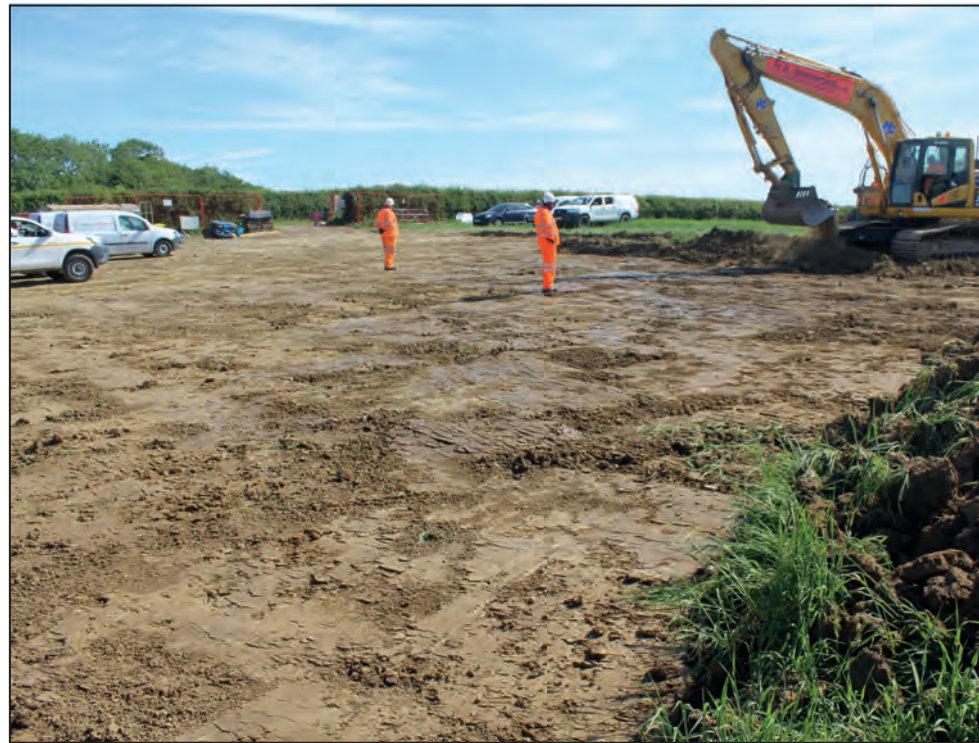
Working shot of watching brief Area 2, looking north-east

- 4.4. Trenches 1 to 4 inclusive and Trenches 21 and 22 were not excavated due to the construction levels not impacting upon the natural substrate in these areas. Instead, construction work within these locations (Areas 1 and 2; Fig. 2) were monitoring

during an archaeological watching brief, which observed the removal of topsoil. Natural substrate was not exposed. Where the pipe trench crossed within Area 1, subsoil was removed to the top of natural substrate.

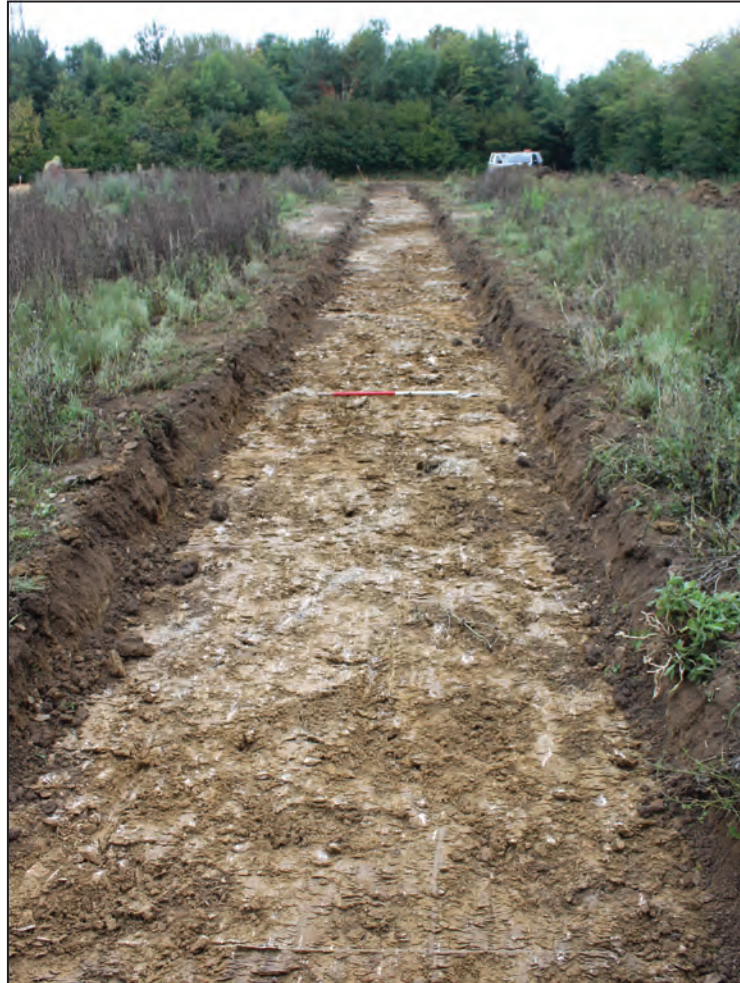
Watching brief Area 1 pipe trench to top of natural substrate, looking south (1m scale)

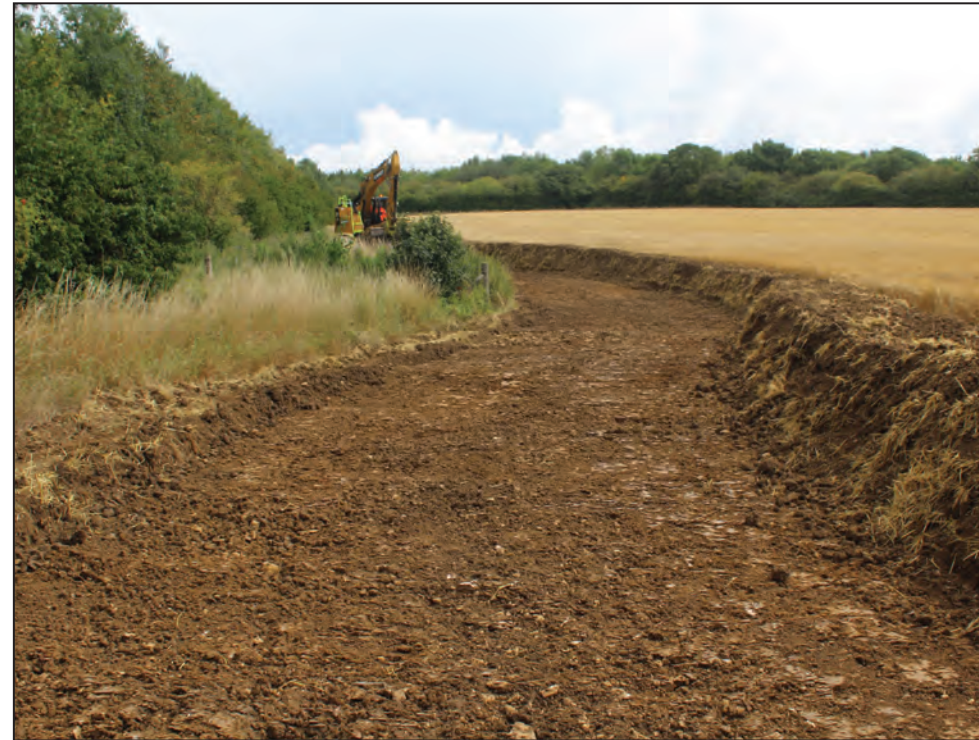
Working shot of northern watching brief Area 1, looking east
