**ST MICHAEL AND ALL ANGELS CHURCH
BRINKWORTH
WILTSHIRE**

ARCHAEOLOGICAL WATCHING BRIEF

CA PROJECT: 2146
CA REPORT: 08020

MARCH 2008

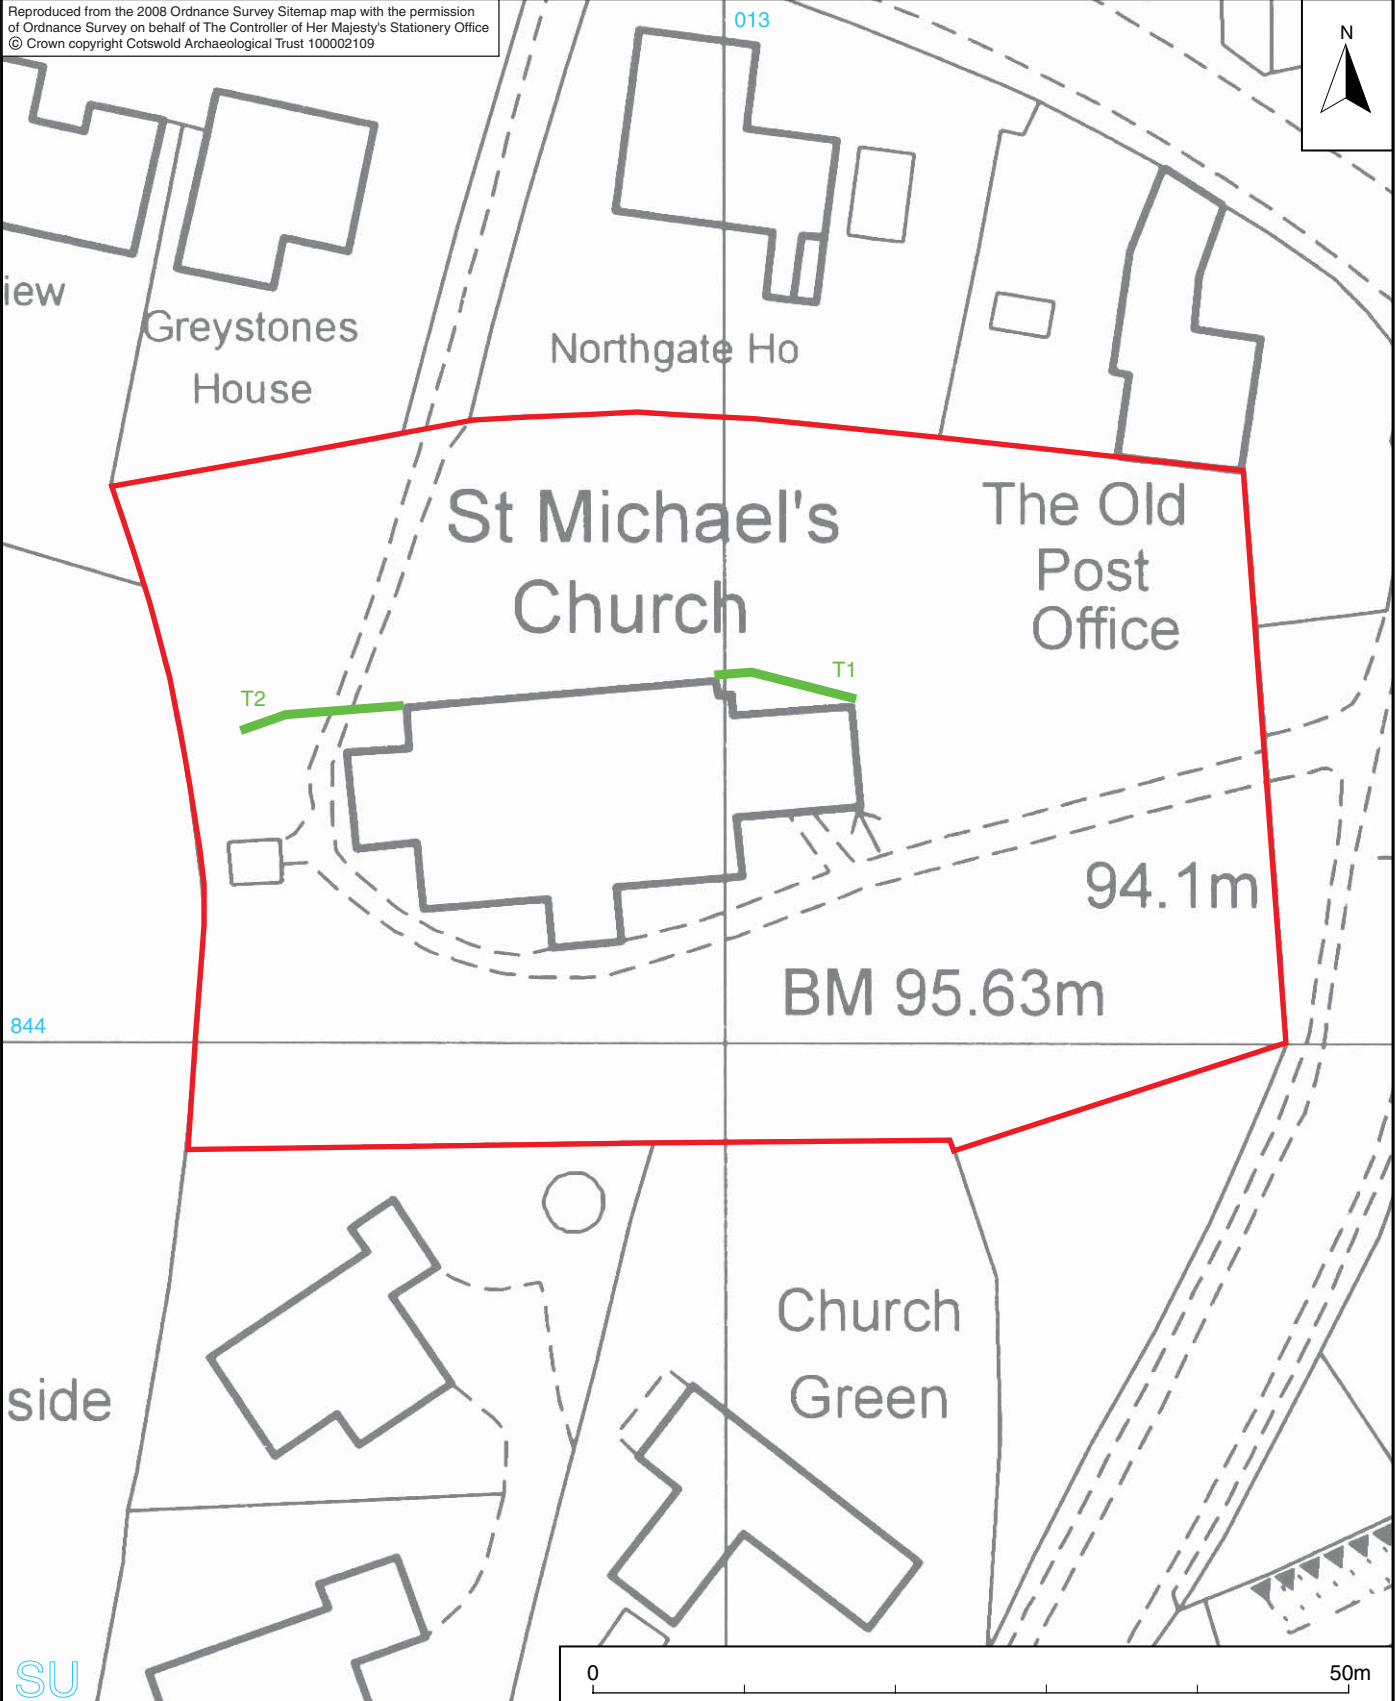
FIGURE TITLE
**The site, showing location of
 observed groundworks**

- 2.1 Graveyard soils 103 and 203, comprising mid grey brown sandy clays were identified in both trenches 1 and 2. Both of these deposits contained small quantities of disarticulated human bone. Deposit 103 was overlain by a dump of modern material (102), probably associated with the construction of an existing concrete drainage channel adjacent to trench 1. This was in turn sealed by topsoil 101. Deposit 203 was overlain by subsoil 202 and topsoil 201.
- 2.2 No other features of archaeological interest were observed during groundworks and, despite visual scanning of spoil, no artefactual material pre-dating the modern period was recovered.

- 3.1 The excavation of the drainage trenches revealed probable *in situ* graveyard soils within trenches 1 and 2. No intact burials were encountered in these trenches, probably due to later re-working of the soils. Where small quantities of disarticulated human bone were disturbed, they were retained at the church for safe keeping and subsequent re-burial by Brinkworth PCC.
