Oakengrove  
Shire Lane  
Hastoe  
Buckinghamshire

*Historic Building Recording*

CA Project: MK0312

September 2020

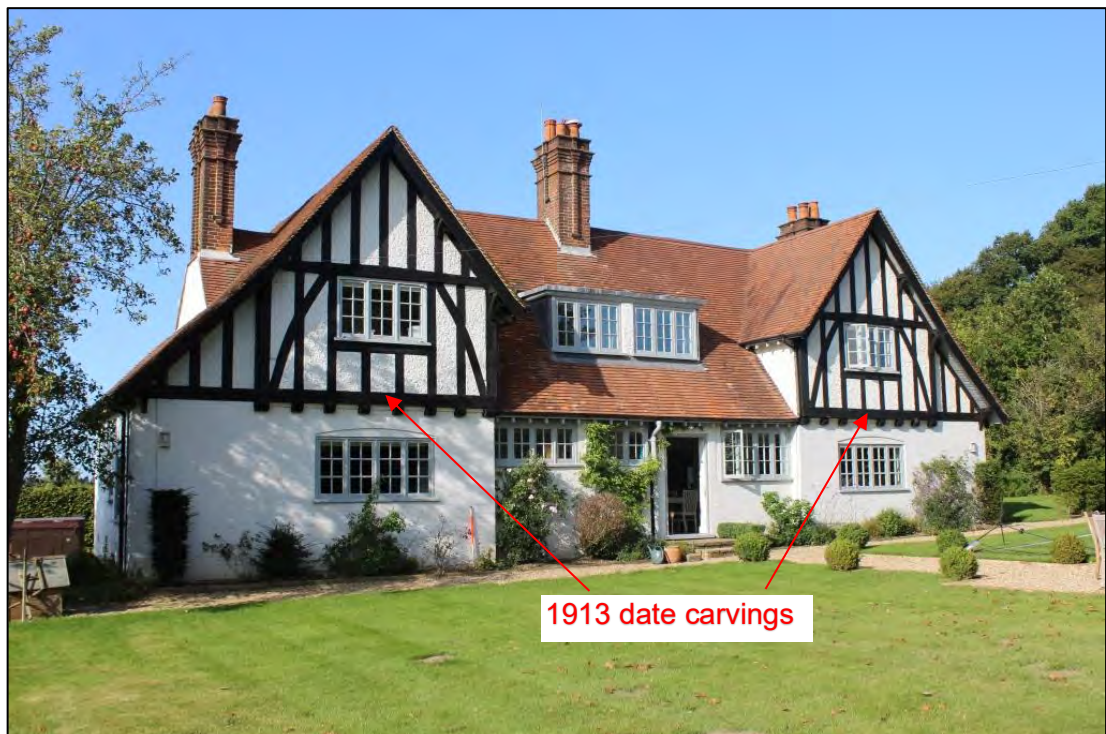
4.2. The building's eastern elevation (Photo 1) is clearly intended to represent its principal façade. The elevation fronts onto an area of gardens that separates the building from Shire Lane from where the building would commonly be appreciated by those using the lane. The eastern elevation exhibits many architectural features that mark the building as a design by William Huckvale such as the timber framed gables, jetties, tall chimneys and dormer windows.

Photo 1: Eastern elevation

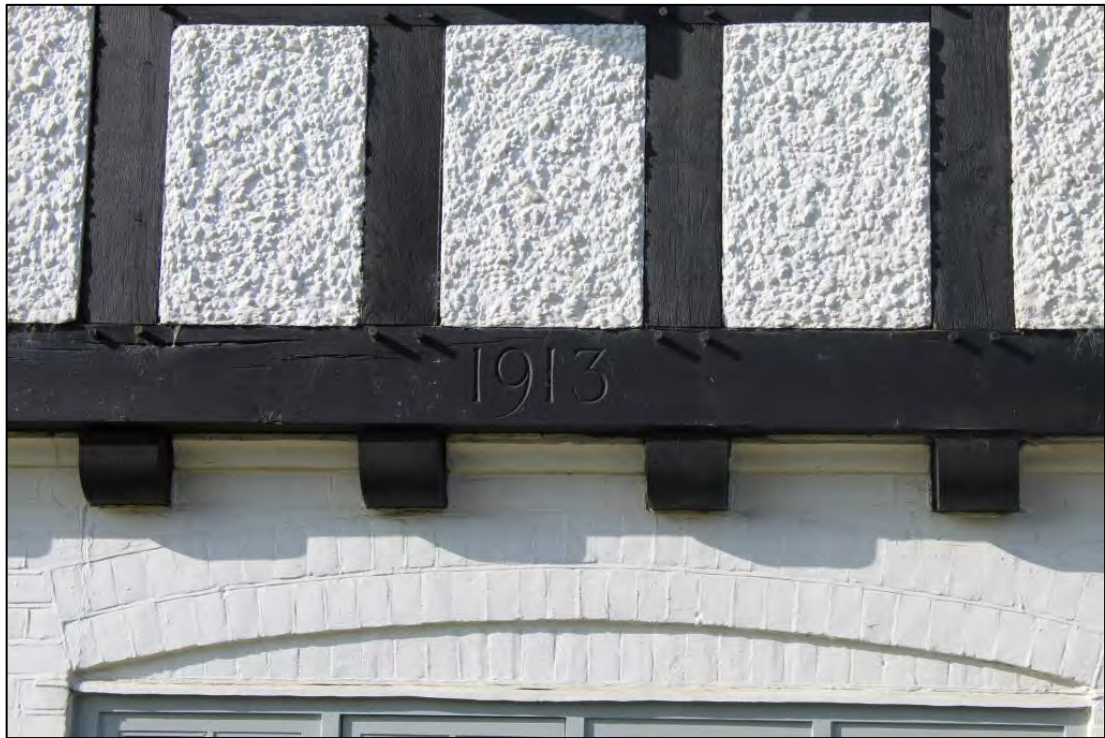
4.3. A date of 1913 (Photo 2) is carved within the wall plates of both the northern and southern timber-framed gables, further evidencing the building's prior configuration as two separate cottages. The carved dates of 1913 contradict the evidence presented on the 1924 OS map which records the Site as it was prior to the construction of the building (Fig. 4). However, it is documented that the association between the Rothschilds and William Huckvale came to an end following the outbreak of the First World War and subsequent death of Lord Rothschild in 1915 (Dacorum Borough Council 2018). Furthermore, Huckvale died in 1936, aged 88 so the construction of the cottage would have occurred very late in his lifetime had it been built after 1924. Consequently, based on the evidence presented, the date of 1913 is considered to be a more reliable indication of the building's construction date.

**Photo 2: Carved date on northernmost gable end of eastern elevation**

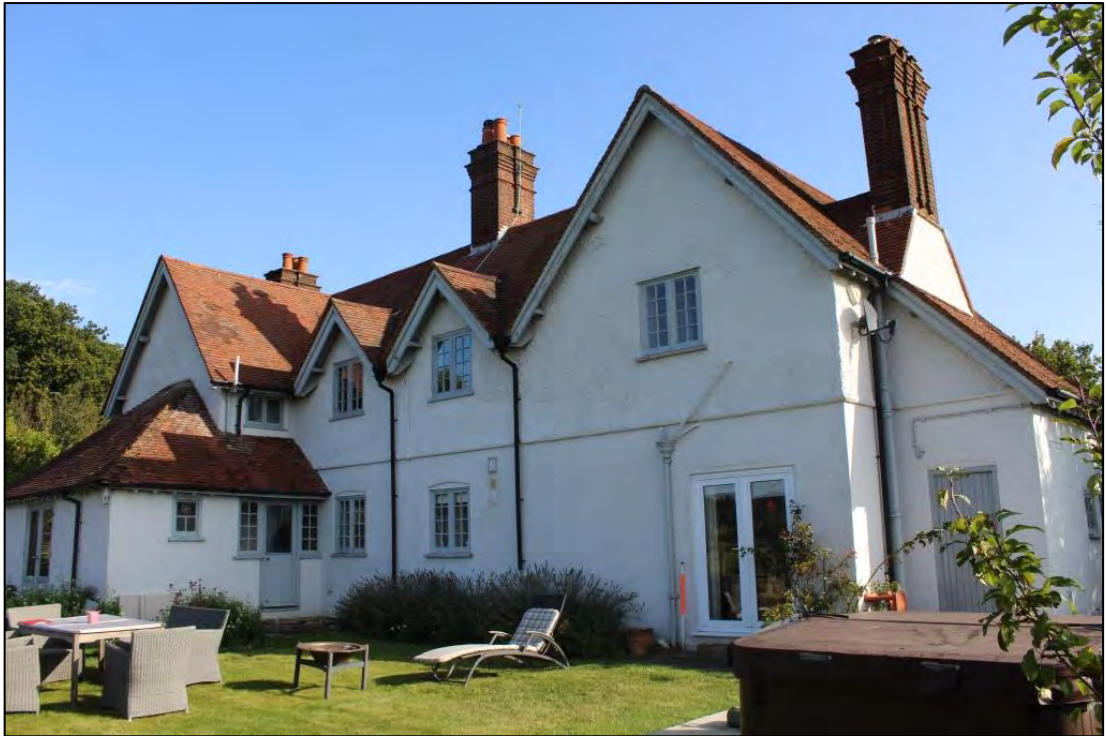
4.4. The western elevation of the building (Photo 3) portrays a more utilitarian character, devoid of many of the architectural flourishes of the principal façade. Furthermore, the elevation evidences several examples of alteration and reconfiguration, principally concerning the size and placement of windows and doors. The southernmost gable incorporates three infilled apertures (Photo 4) where a combination of three former windows or doors have been supplanted by a pair of Upvc doors. Whilst the predominant brick bond throughout the building is stretcher, this is disrupted in areas where alteration has occurred, such as described above.

Photo 3: Western elevation

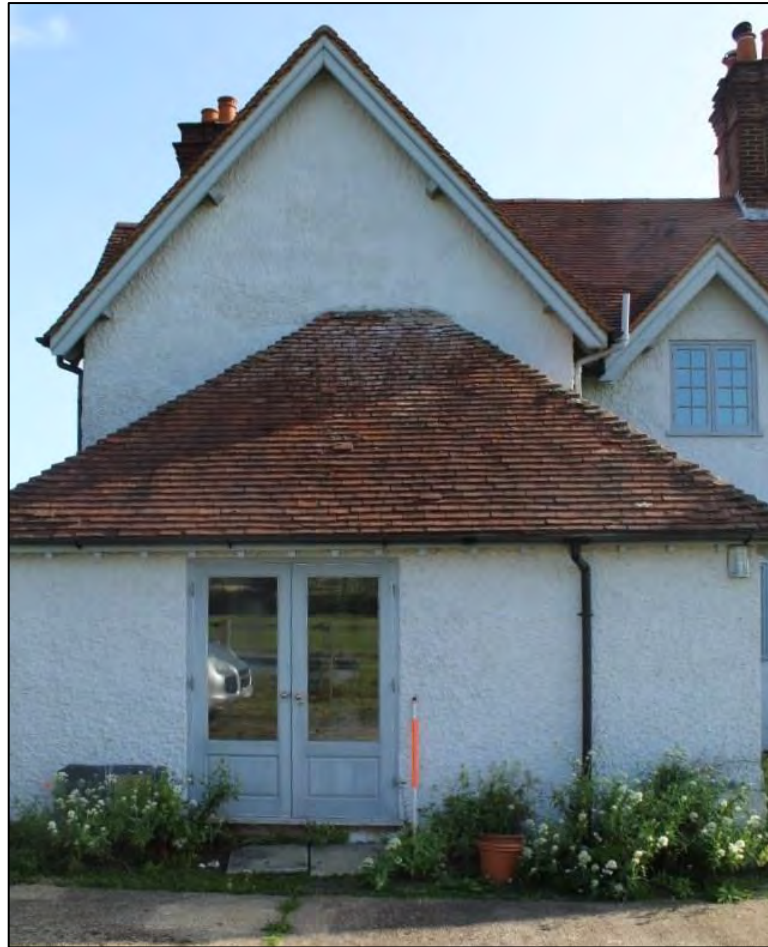
- 4.6. The northern extent of the western elevation (Photo 6) incorporates a shallow two storey projection with a further, single storey projection that returns eastwards and incorporates a doorway access to the building within the southern elevation of the projection. The single storey projection incorporates clay roof tiles that match those used on the principal, two-storey portion of the building. The western elevation of the projection incorporates a pair of glazed, timber doors that were installed by the present owners of the building (P. Tye, 2020, personal comment, 18 September), where previously the wall incorporated a window in the same position. The upper portion of the elevation is blind, incorporating pebble dash render.

**Photo 6: Northern extent of western elevation**

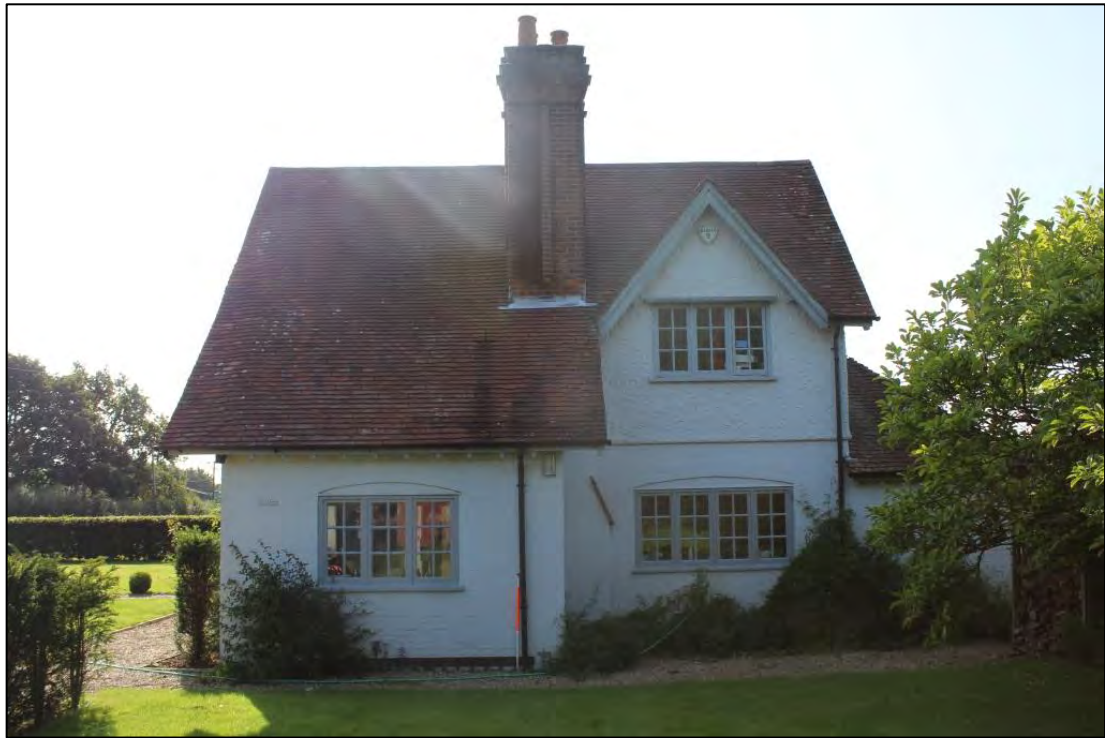
4.9. The northern elevation of the building (Photo 9) incorporates a gable to the western extent whilst the eastern extent incorporates a catslide roof. Little alteration is evident to the principal two-storey portion of the elevation where windows appear to represent

the likely configuration when the building was constructed, although the window units themselves may have been altered or replaced over time.

**Photo 9: Northern elevation**

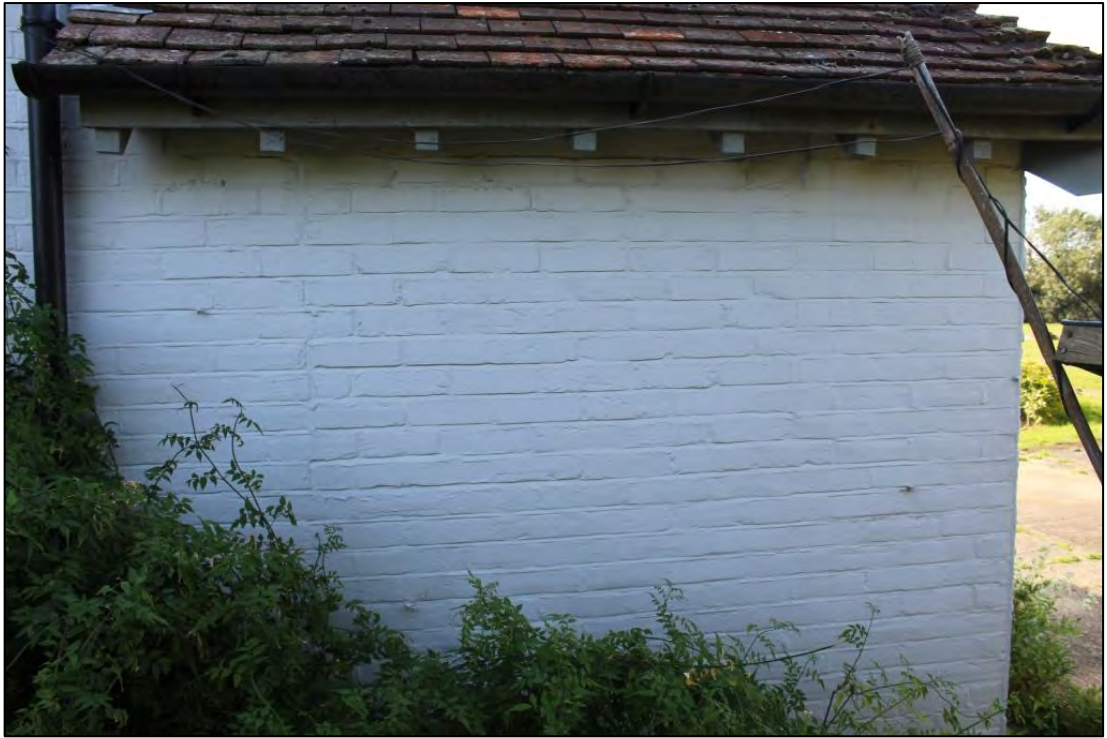
- 4.10. The western extent of the northern elevation (Photo 10) encompasses a blind portion of the single-storey projection. The junction between the single-storey projection and the two-storey portion of the house incorporates brickwork that is knitted in and apparently not of later date. This adds to the weight of evidence that the single-storey projection was likely constructed during the first phase of the building. A redundant lintel below the eaves indicates the probable position of a former aperture (Photo 11), further evidenced by inconsistencies in the brick bond beneath it.

**Photo 10: Northern elevation of single-storey projection**

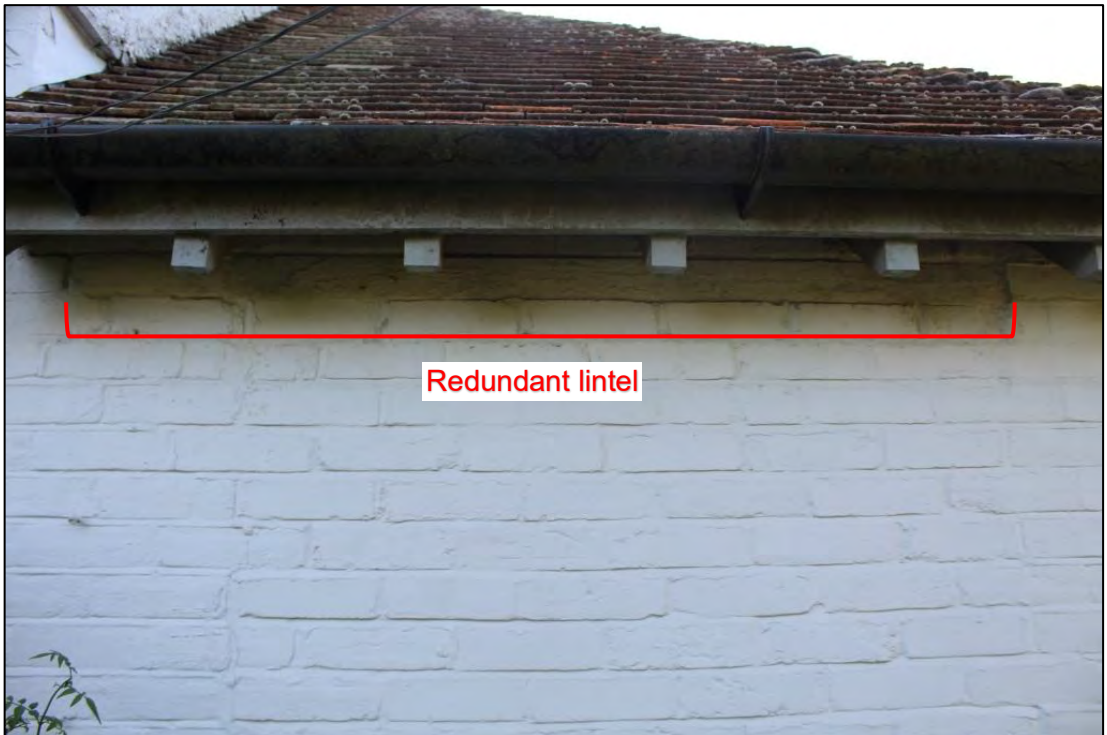
**Photo 11: Detail of redundant lintel within northern elevation**

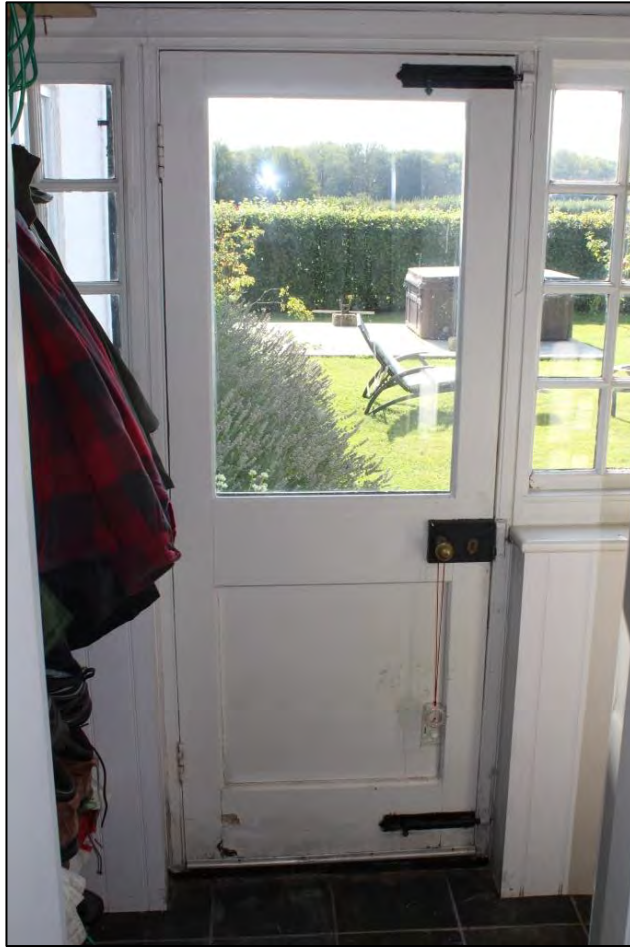
- 4.12. The southern extent of Room 1 (Photo 13) incorporates a single doorway that leads to Room 2. Room 2 functions as an enclosed porch with direct access to the rear garden (Photos 7 and 14). Room 2 was likely created as a result of infilling a former external porch by installing the door and flanking windows. The former external outlook of the space is evidenced by exposed brickwork and segmental arch head above the door to Room 1 (Photo 15). Furthermore, an exposed soil pipe is routed

Photo 14: Room 2, looking south

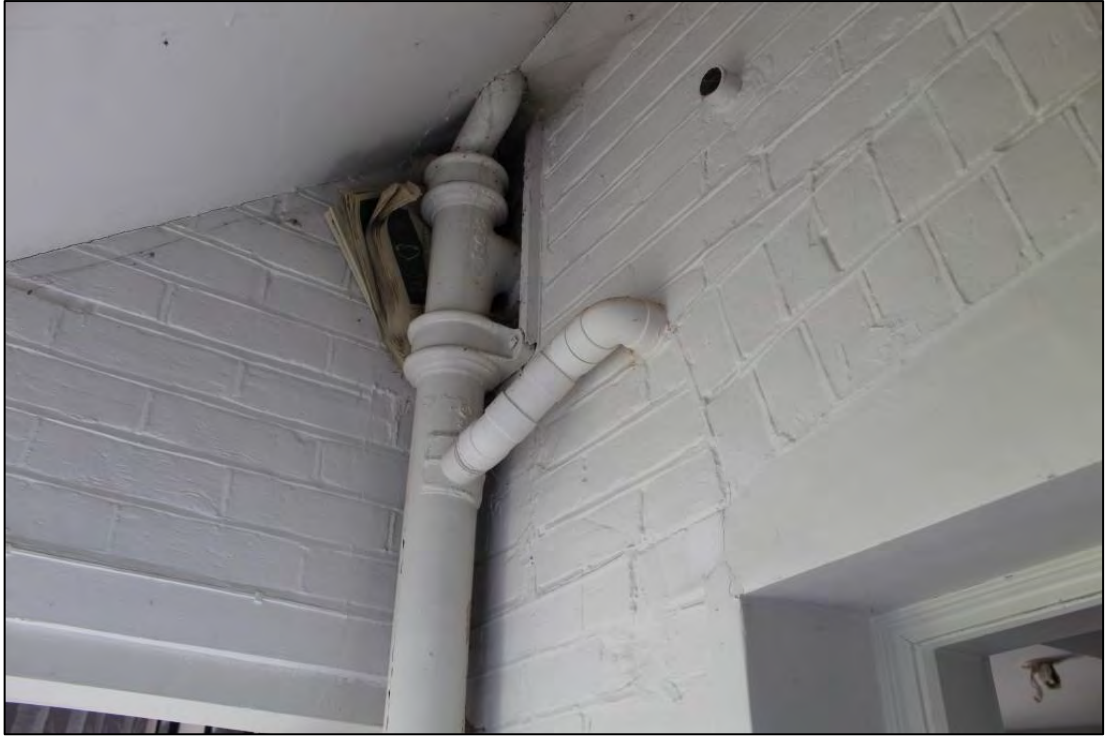
within the north-western extent of the Room (Photo 16), adding further weight that the room was once an external space.

**Photo 16: Exposed soil pipe in Room 2**

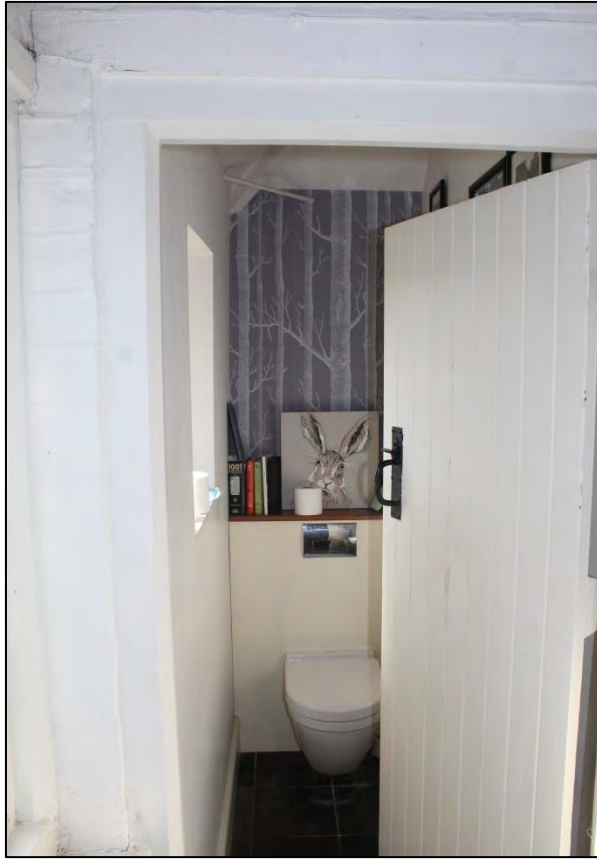
- 4.13. Room 3 is accessed directly from Room 2 and incorporates a WC (Photo 17) with a single window aperture in the southern wall of the room. Accounting for the aforementioned analysis of Room 2, it is likely that Room 3 has always incorporated a WC and was formerly accessed as an 'external' room, via the now enclosed space of Room 2. The timber plank door is also characteristic of an externally facing doorway to the former outhouse.

**Photo 17: Overview of Room 3**

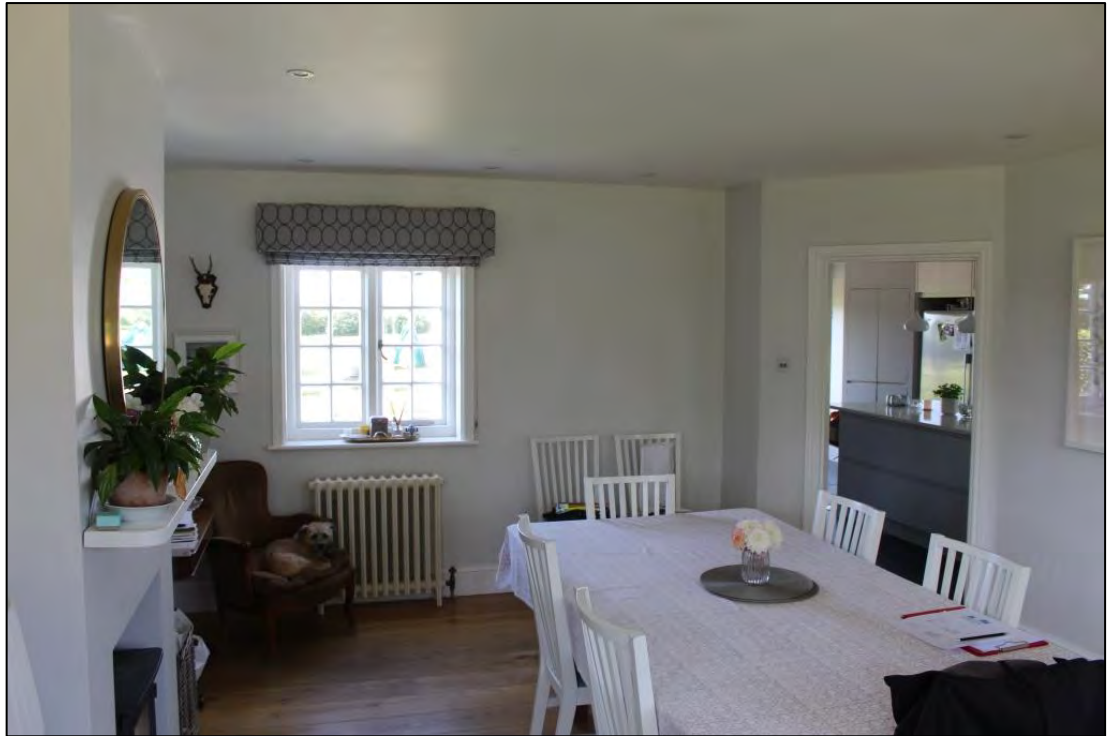
- 4.14. Room 4 (Photo 18) encompasses a much altered space that was formerly partitioned into a corridor, separate rooms and a former staircase (P. Tye, 2020, personal comment, 18 September). The former staircase would have served the northernmost cottage when the building functioned as two separate dwellings, however, no trace of the former staircase remains visible. Presently, the room incorporates a single, open plan circulation space that is used as a dining area. The western wall of the room incorporates a two-light casement window with 20th/early 21st-century fixtures (Photo 19).

**Photo 18: Overview of Room 4, looking west**

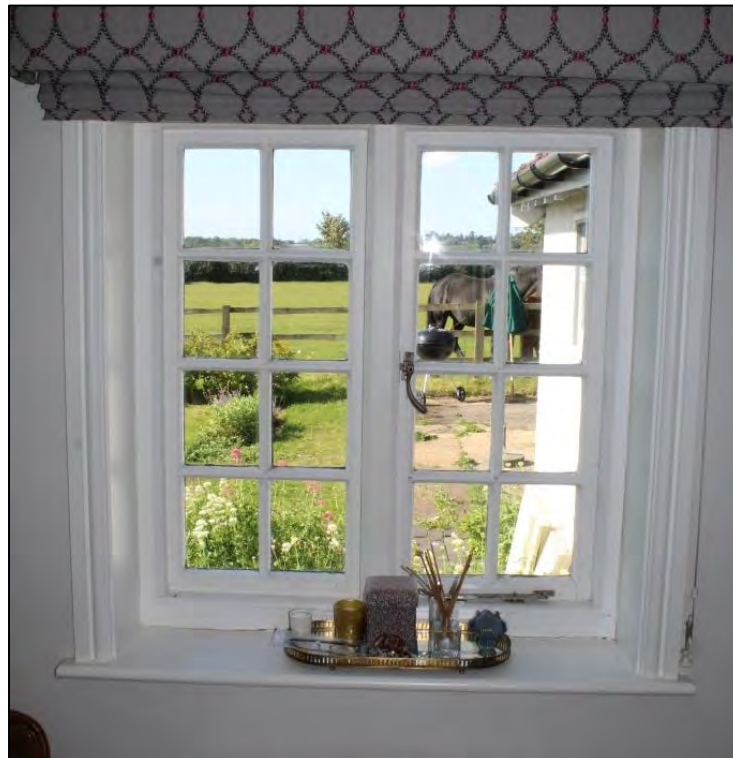
**Photo 19: Detail of window within western wall of Room 4**

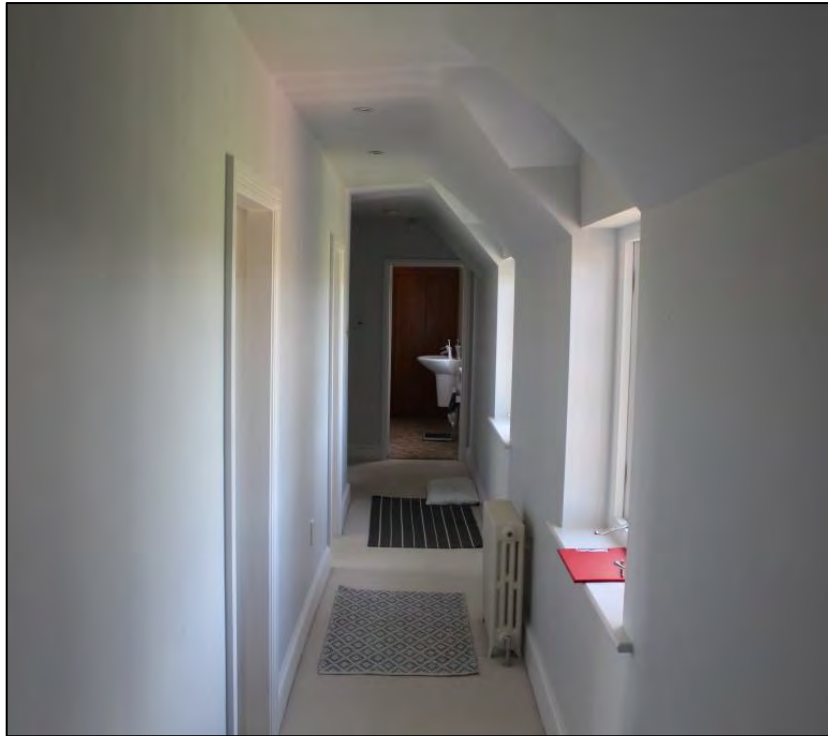
- 4.16. The first floor of the building is accessed via a staircase in the southern half of the building, likely in its historic position, which leads to a landing area (Room 6) aligned along the western extent of the building (Photo 21). Room 6 would have formerly incorporated a partition approximately halfway along its length at the time when the building comprised two separate dwellings. However, as all visible surfaces have been redecorated in the intervening years, no evidence of this partition remains. Room 6 incorporates two timber casement windows with modern fixtures.

**Photo 21: Overview of Room 6**

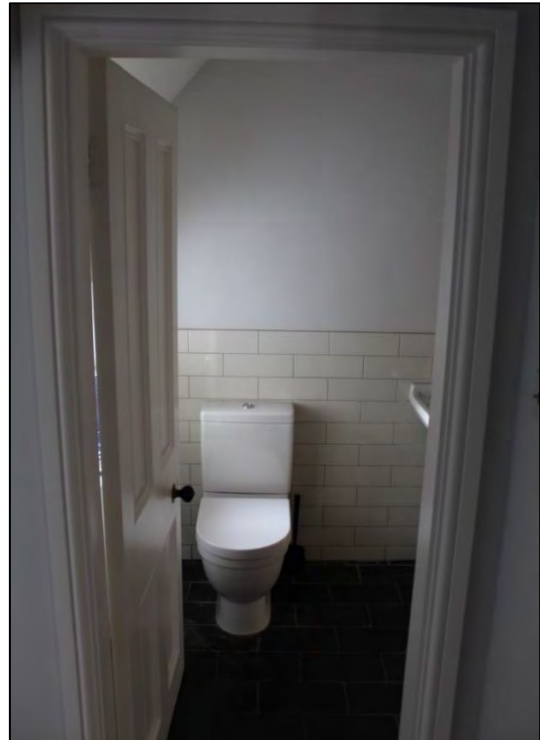
- 4.17. Rooms 7 and 8 comprise two separate rooms divided by a modern stud wall partition. Room 7 (Photos 22 and 23) incorporates a shower and WC with a single, obscured, two-light casement window within the southern wall (Photo 24).

**Photos 22 and 23: Room 7**

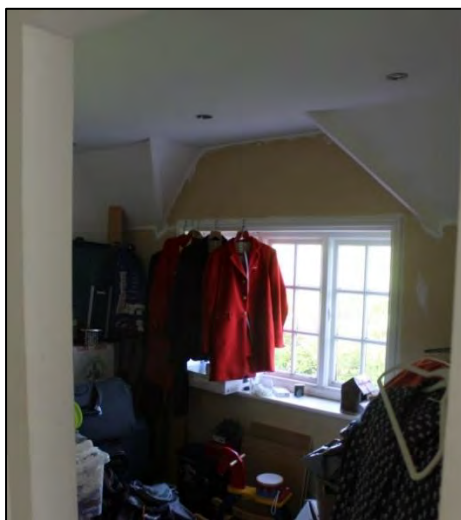
- 4.18. Room 8 (Photos 25 and 26) is formed of stud wall partitions and functions as an annex/en-suite to Room 9. The room incorporates a three-light timber casement window within the northern wall. The configuration of Rooms 7, 8 and 9 appears to have been altered over time. Rooms 7 and 8 were likely a single room originally with direct access from Room 6. Room 8 appears broadly intact, however, the stud wall separating it from Room 8 may have been slightly truncated or else represents a wholly new replacement wall.

**Photos 25 and 26: Overview of Room 8**

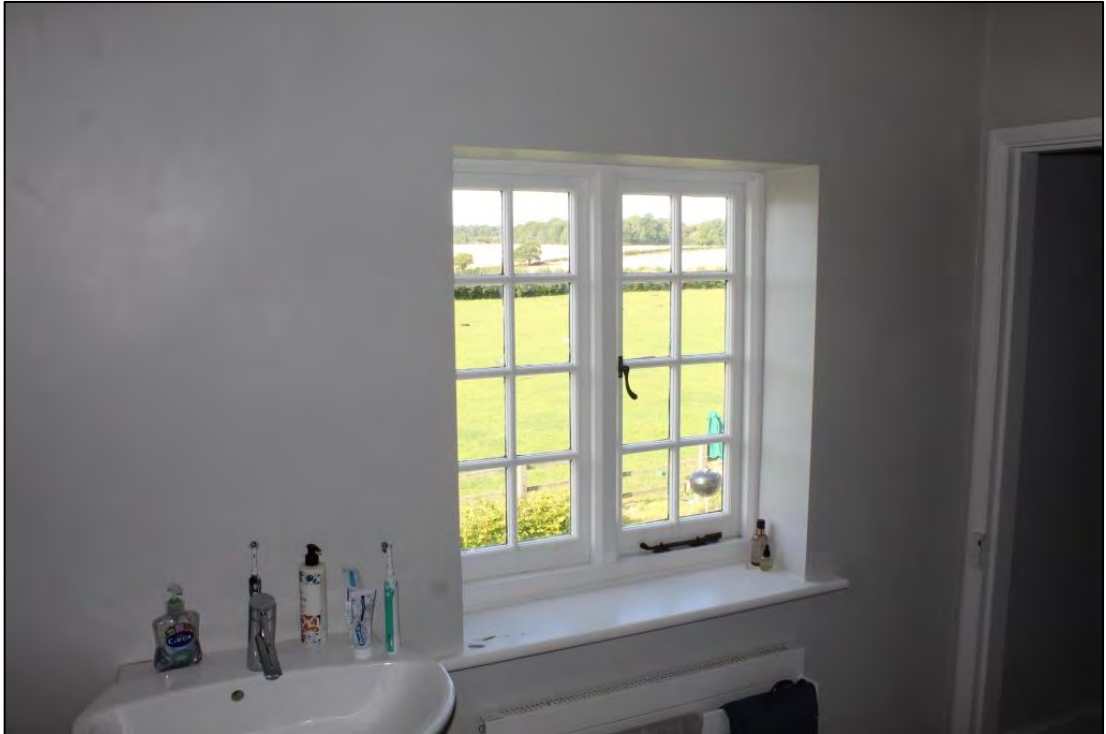
- 
- 4.19. Room 10 (Photo 27) is situated at the southern extent of Room 6 and presently incorporates a modern bathroom suite. A single, two-light timber casement window is situated within the western wall of the room.

**Photo 27: Overview of window within Room 10, looking west**
