**Land off Gascoyne Way
Hertford
Hertfordshire SG14 1LH**

*Programme of Archaeological Monitoring
(Watching Brief)*

CA Project: MK0113
CA Report: MK0113_1

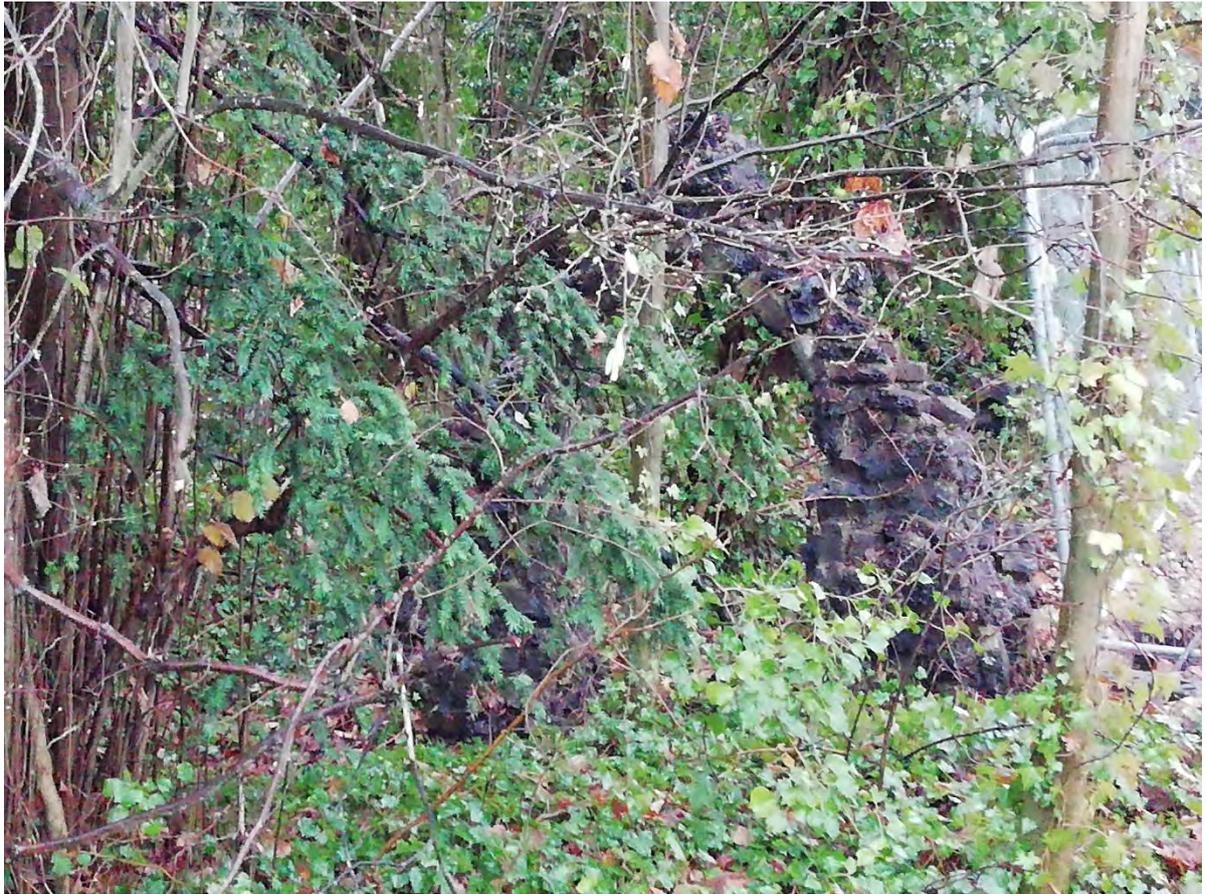
Plate 1: Surviving part of former brick / stone arch

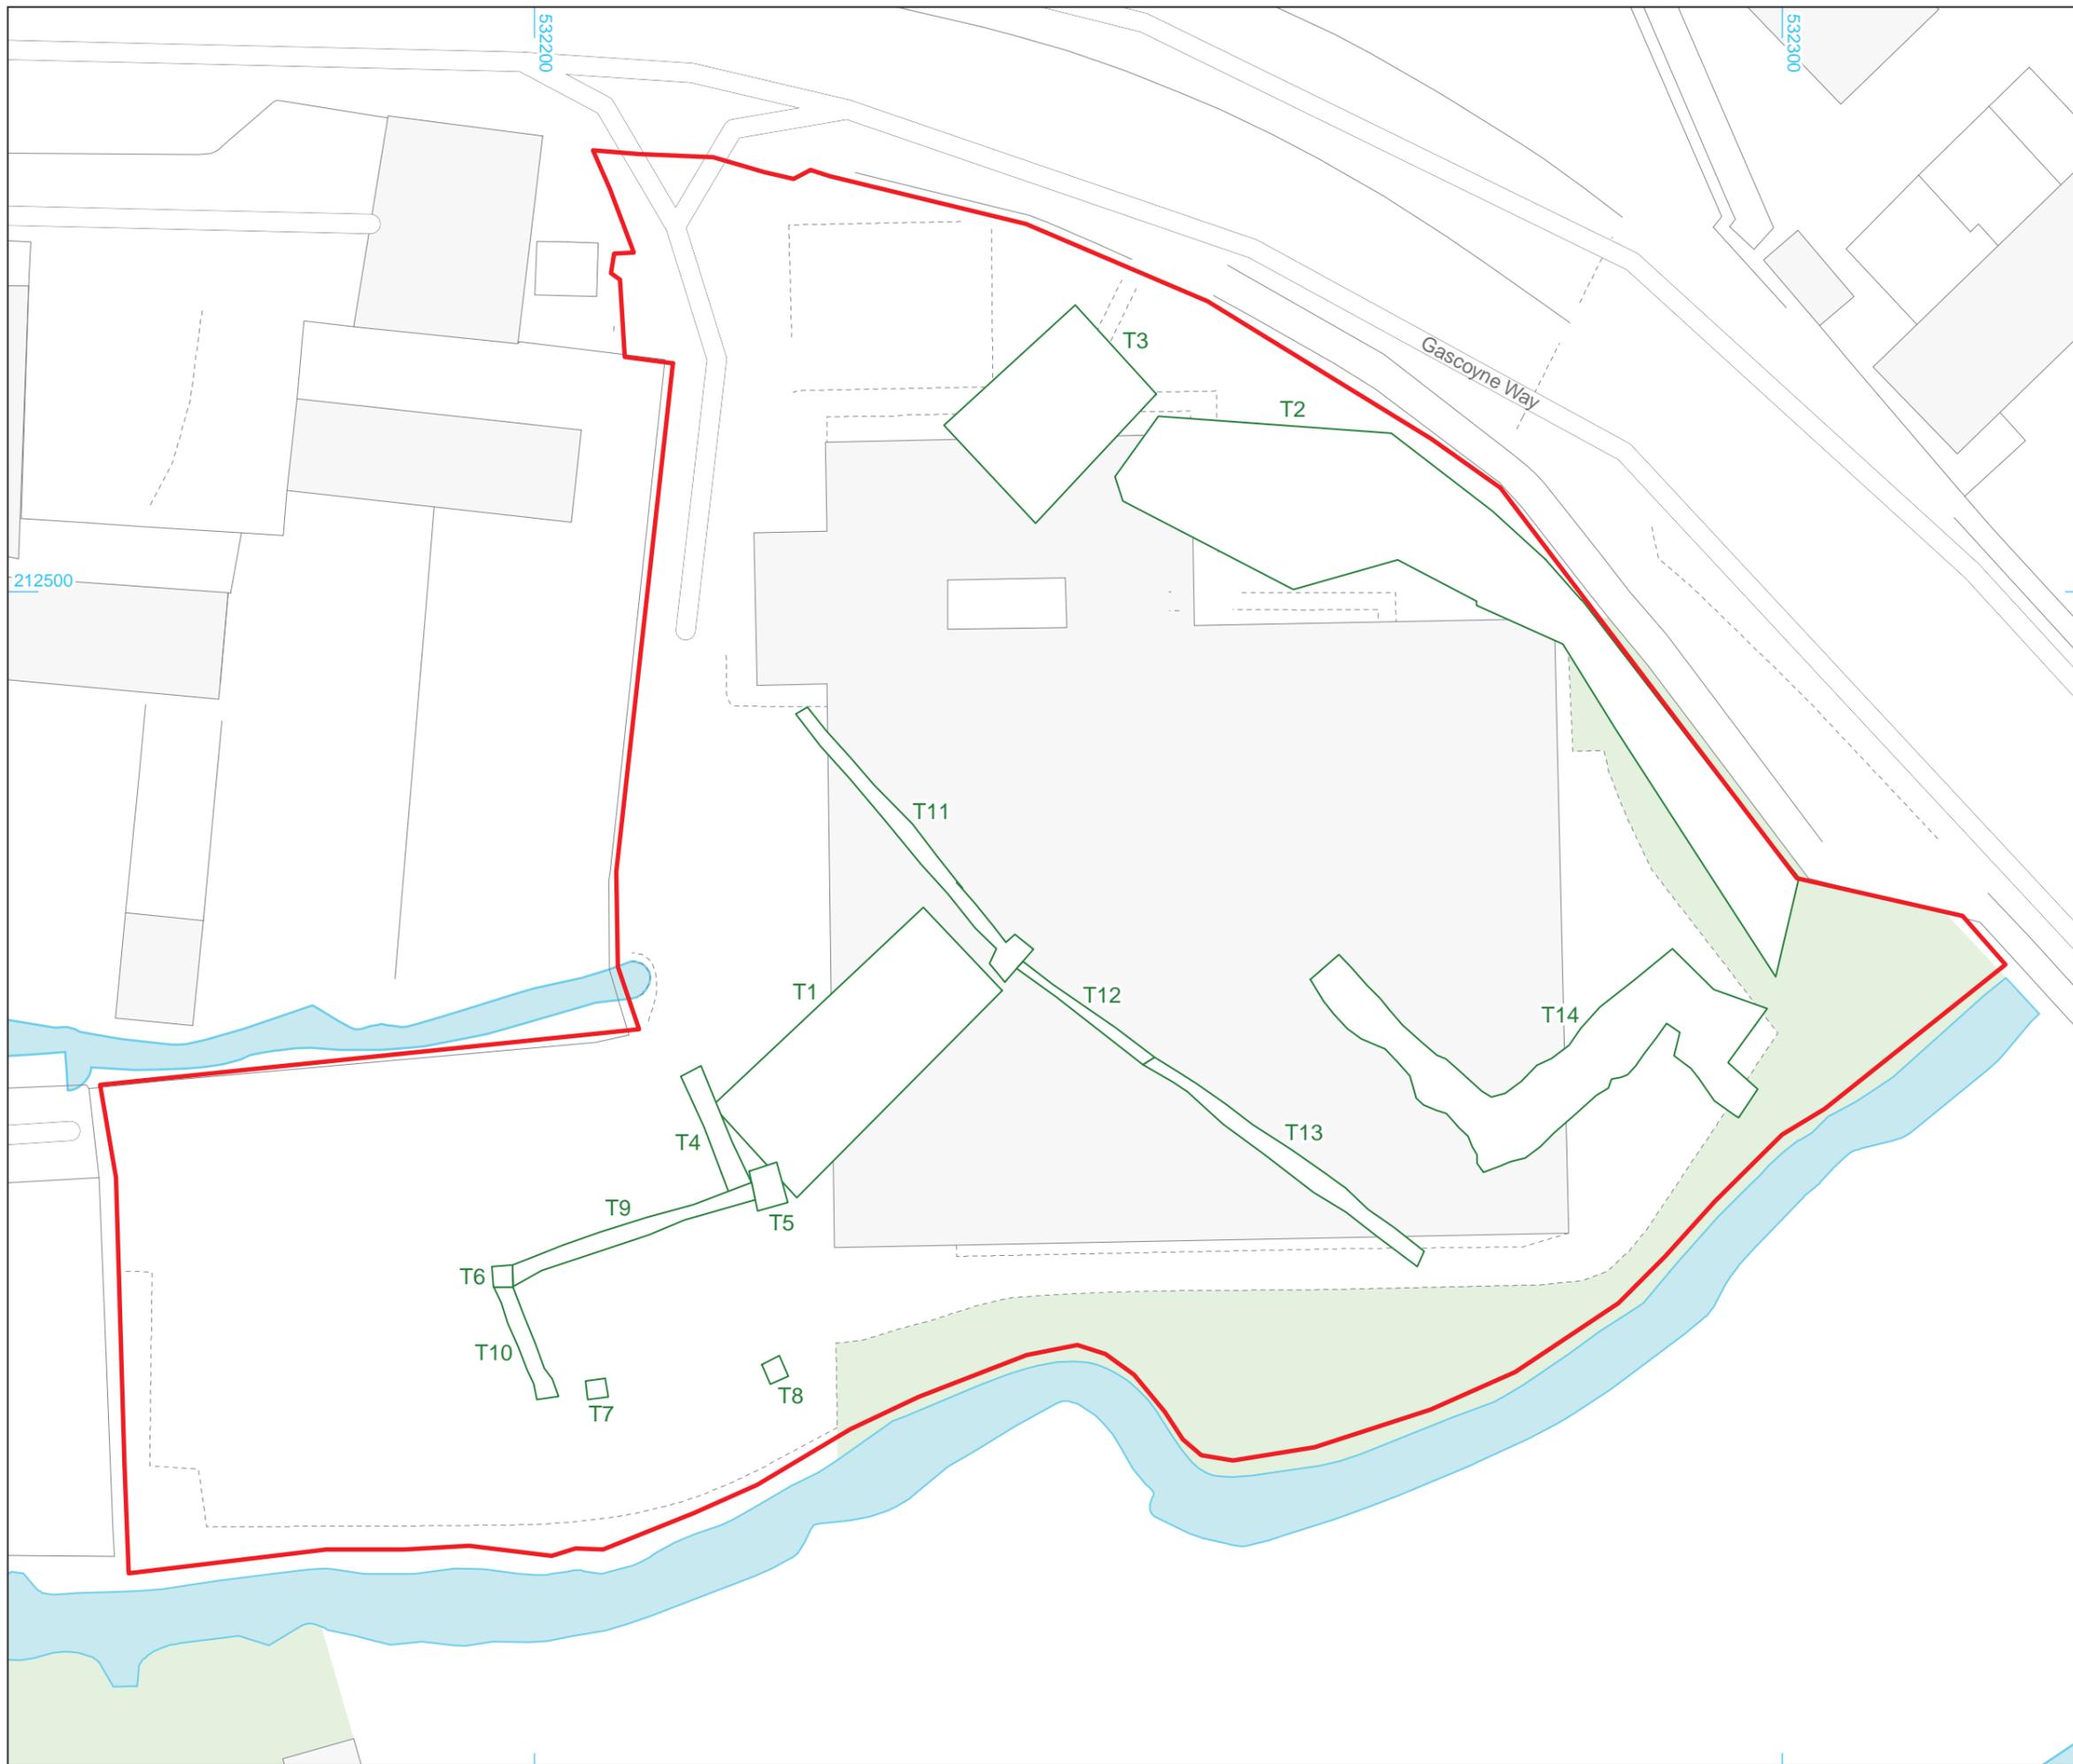
FIGURE TITLE
 Trench plan

- 4.1 The fieldwork followed the methodology set out within the WSI (CA 2019). Communication issues, however, at the commencement of the project meant that CA were not on site to monitor the initial removal of the floor slab and foundations of the previous development. An archaeologist was present during all other intrusive groundworks including the excavation of attenuation tanks, the ground reduction for the piling mat, and the drainage works (Fig. 2).

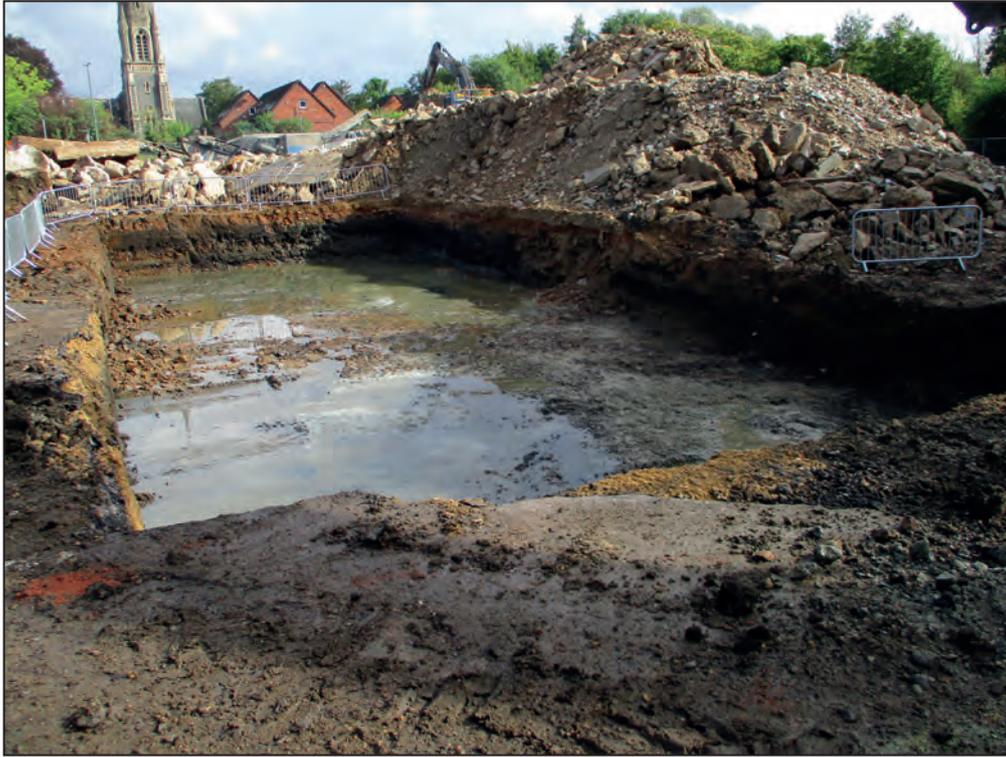
Attenuation tank in Trench 1, looking east

- 5.4 Trench 1 was a rectangular trench, measuring approximately 23m by 10m, excavated for the installation of an attenuation tank in the western half of the site. The natural geology (105) was encountered at a depth of 1.4m bpgl across the south-western half of the trench. Evidence for past fluvial activity was observed within the north-eastern end of the trench. Here the mixed brown yellow sand and gravels dipped and were overlain by fluvial deposit (104) comprising mid grey blue sand and gravels, which in turn was overlain a second fluvial deposit (103) comprising mid grey blue silty clay.

- 5.5 The natural sand, gravels and fluvial deposits were sealed by a layer of possible buried topsoil (102) which comprised dark grey brown sandy silt and measured 0.3m thick. This was overlain by a 0.8m thick layer of made ground (101) comprising dark grey blue sandy silt followed by a 0.4m thick layer of brick rubble (100). Both of these are likely levelling for the construction of the recently demolished building.

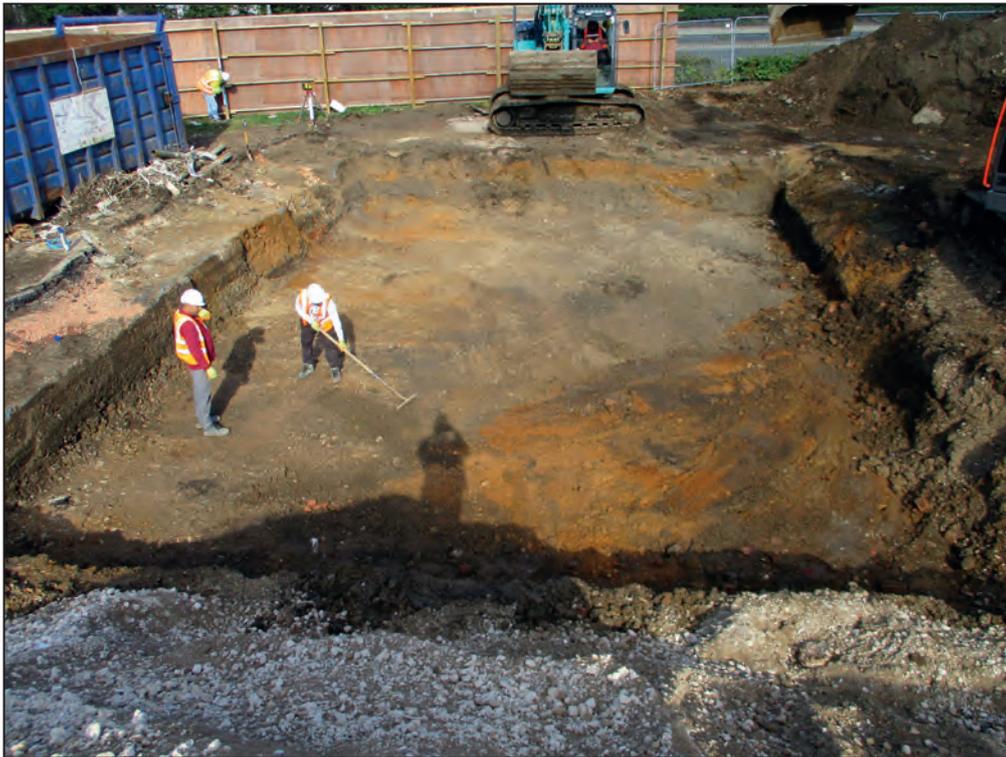
Attenuation tank in Trench 3, looking north

- 5.6 Trench 3 required the excavation of a rectangular trench for the installation of an attenuation tank in the north-west of site. The natural geology (301) was encountered at a depth of 1.4m in the north-eastern corner of the trench. Overlying this was made ground (300) comprising mixed dark brown grey sandy silt with patches of redeposited natural.

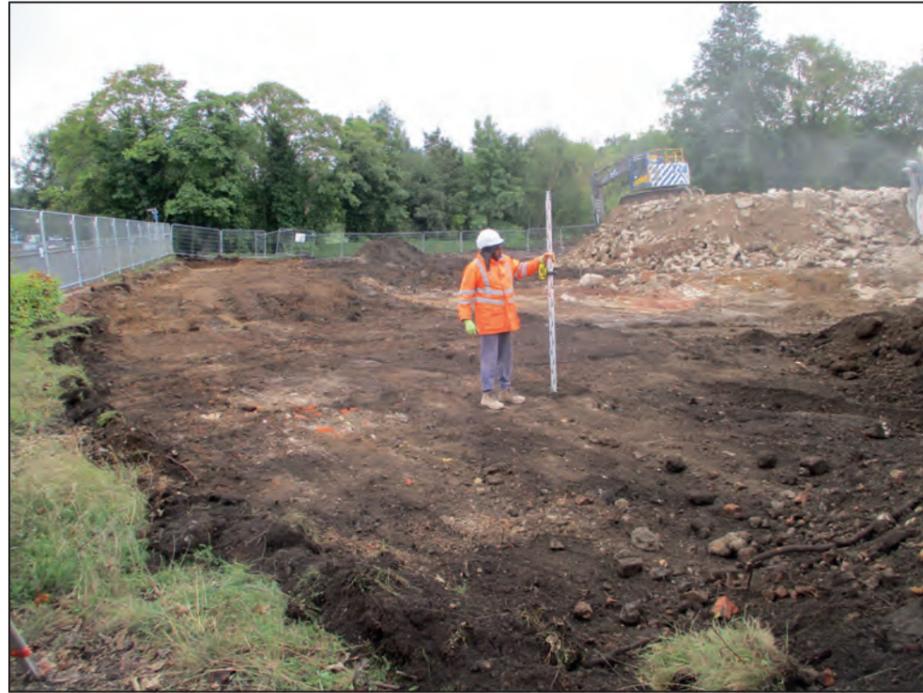
Ground reduction for piling mat: Trench 2, looking south-east

- 5.7 Trench 2 required the reduction of the ground level along the northern edge of the site for the installation of the piling mat. Excavations here did not extend below made ground deposits, which comprised mixed mid brown yellow sand and gravel in the east (201), and mixed dark brown grey sandy silt with patches of redeposited natural material in the west (202). These were likely deposited during the construction of Gascoyne Way in the 1970s. An underpass is present immediately outside of the site boundary here with a drop of several metres and it would have been necessary for much of this area to have been excavated for its construction. This made ground deposit was sealed by topsoil (200) measuring 0.25m thick.

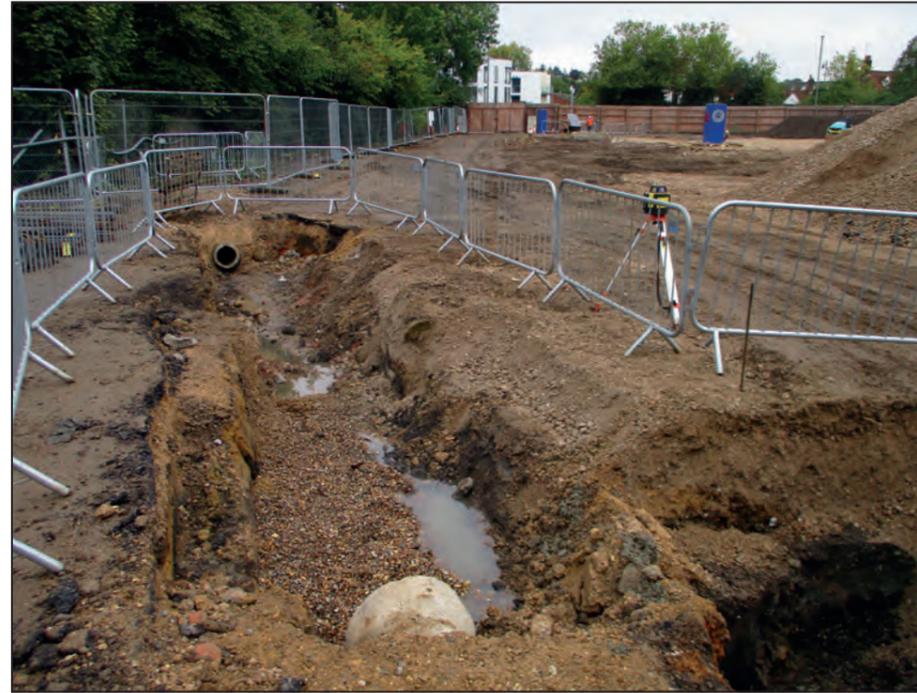
Pipe replacement: Trench 4

- 5.8 Trench 4 required the excavation of an existing pipe connecting the water courses to the north-west and south of the site. This did not extend below the drain backfill (402), comprising mixed mid brown grey clay with frequent stone and rubble, which measured 0.6m deep. This was overlain by a 0.15m thick layer of hardcore for the existing car park (401), which in turn was sealed by a 0.1m thick layer of tarmac carpark surface (400).

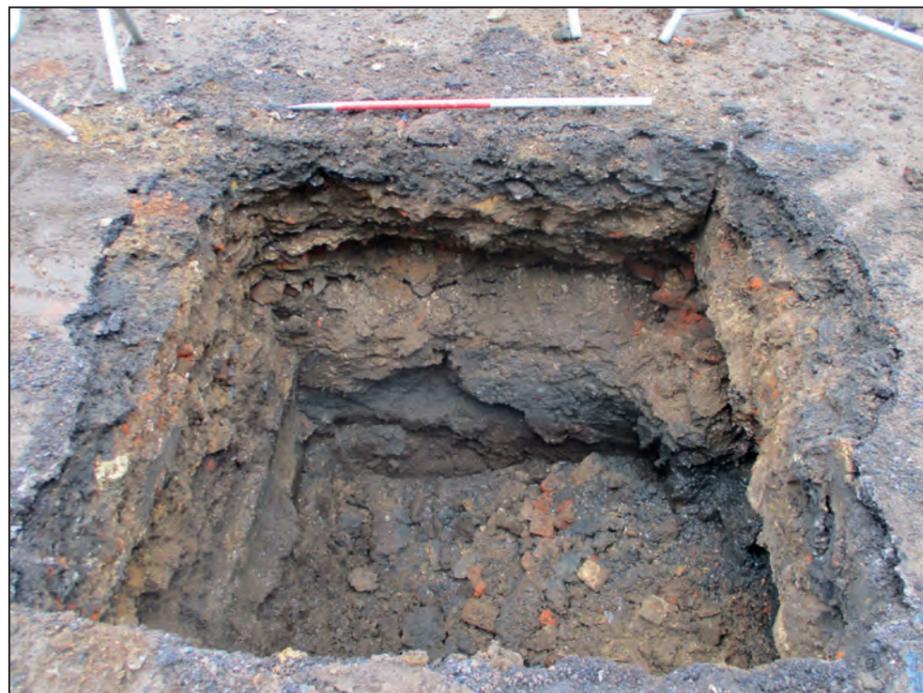
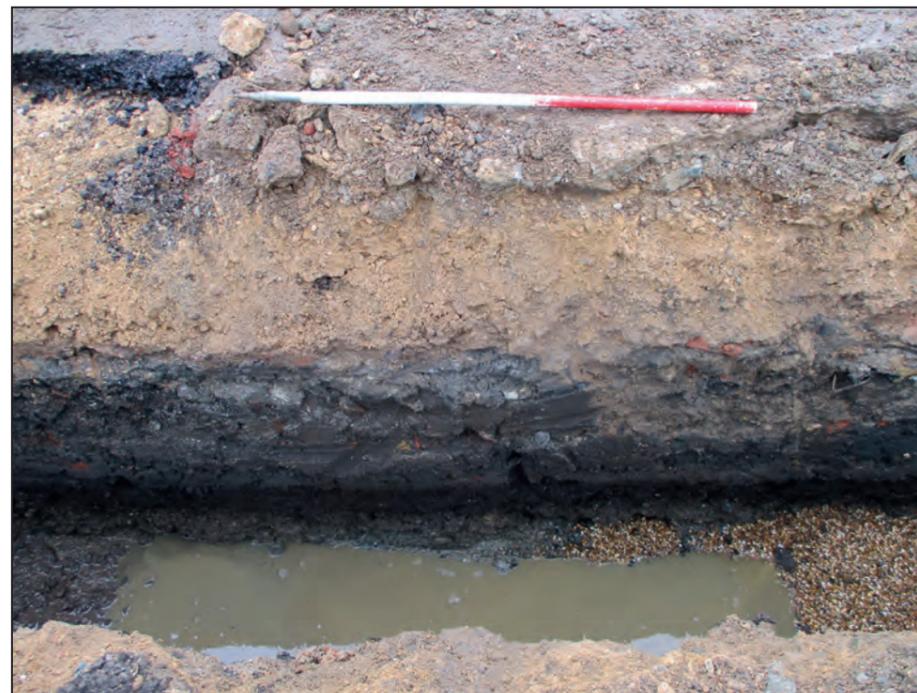
- 5.9 The drainage works monitored in the south of the site comprised four manholes and two connecting pipe trenches (Trenches 5 – 10). The level of the natural gravels deepened across this area from the north-east at 1.35m bpgl, to a maximum depth of 2.1m bpgl in the south-west. Within all the trenches the natural gravels were overlain by a possible buried topsoil comprising dark grey brown sandy silt and measuring on average 0.33m thick. Overlying this buried soil was significant deposits of made ground comprising dark grey blue sandy silt, followed by a mixed mid brown yellow silty sand and dark brown grey sandy silt. These ranged in depth from 0.7m in the northeast to 1.44m in the south-west. A layer of hardcore for the carpark sealed this made ground deposit, which in turn was overlain by the tarmac surface.

Manhole: Trench 6, looking north

Drainage run: Trench 9, looking north

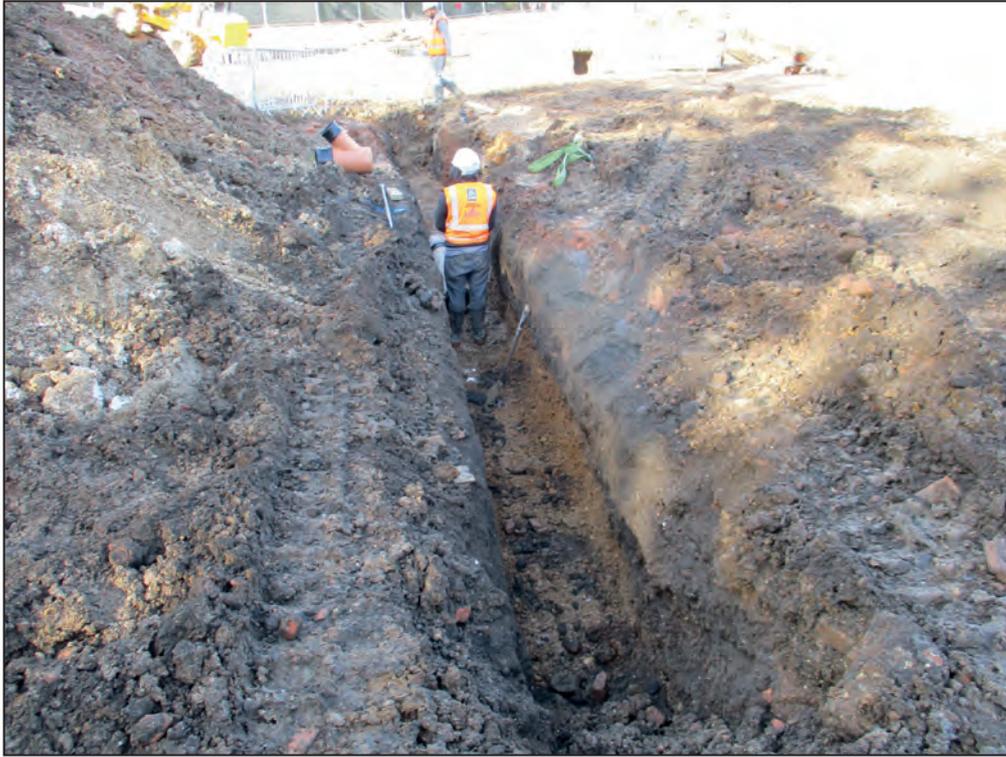
Trench 13, looking north

- 5.10 Trenches 11, 12 and 13 were part of a 70m long north-west/south-east drainage run across the centre of the site. The natural gravels were encountered at average depth of 1.24m bpgl along the length of these trenches. They were overlain by a c.0.87m thick layer of made ground comprising dark grey/brown sandy silt. This was sealed by a layer made ground comprising brick and concrete rubble measuring c.0.3m thick.

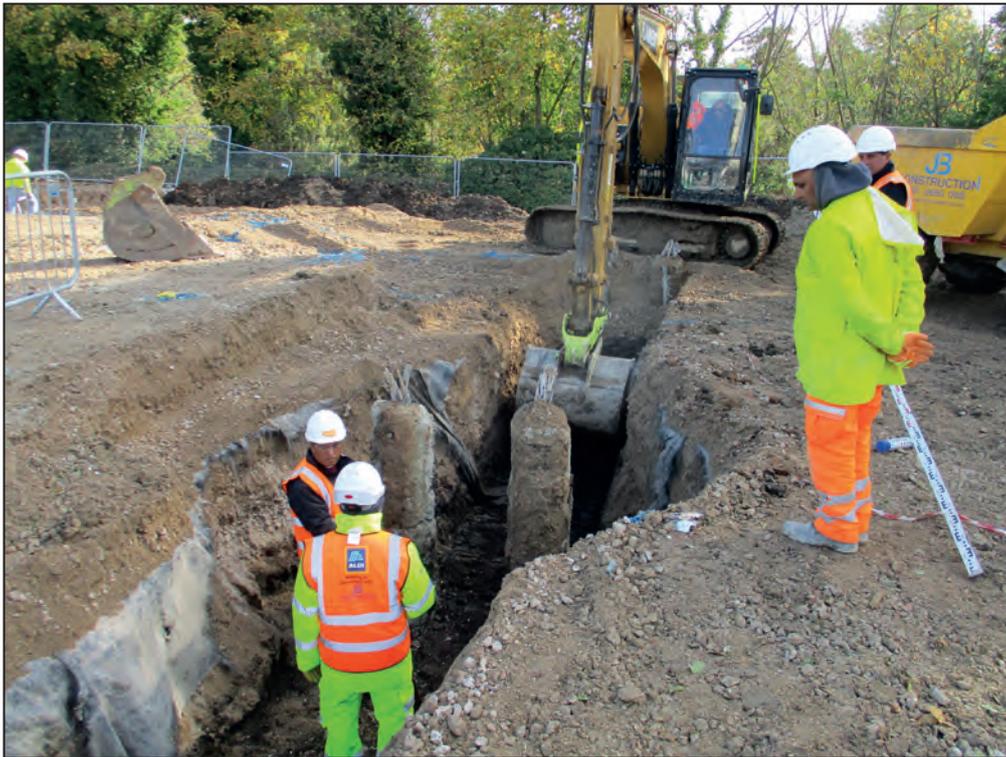
Trench 14, looking south-east

- 5.11 Trench 14 monitored part of the excavations for the piling cap. The natural substrate was not encountered in this trench, which was excavated to a depth of 2.1m. The earliest deposit encountered comprised made ground (1402), of dark brown grey sandy silt, measuring over 0.4m thick. This was overlain by a 0.4m thick layer of the brick and concrete rubble (1401), evident at the surface elsewhere on site. This layer was then sealed by a 1.5m thick layer of the concrete crush used for the piling mat (1400).
