**Wiltshire College,
Lackham Campus Agri-Centre Building,
Chippenham,
Wiltshire**

Archaeological Programme of Monitoring and Recording

CA Project: CR0195
CA Report: CR0195_1

April 2020

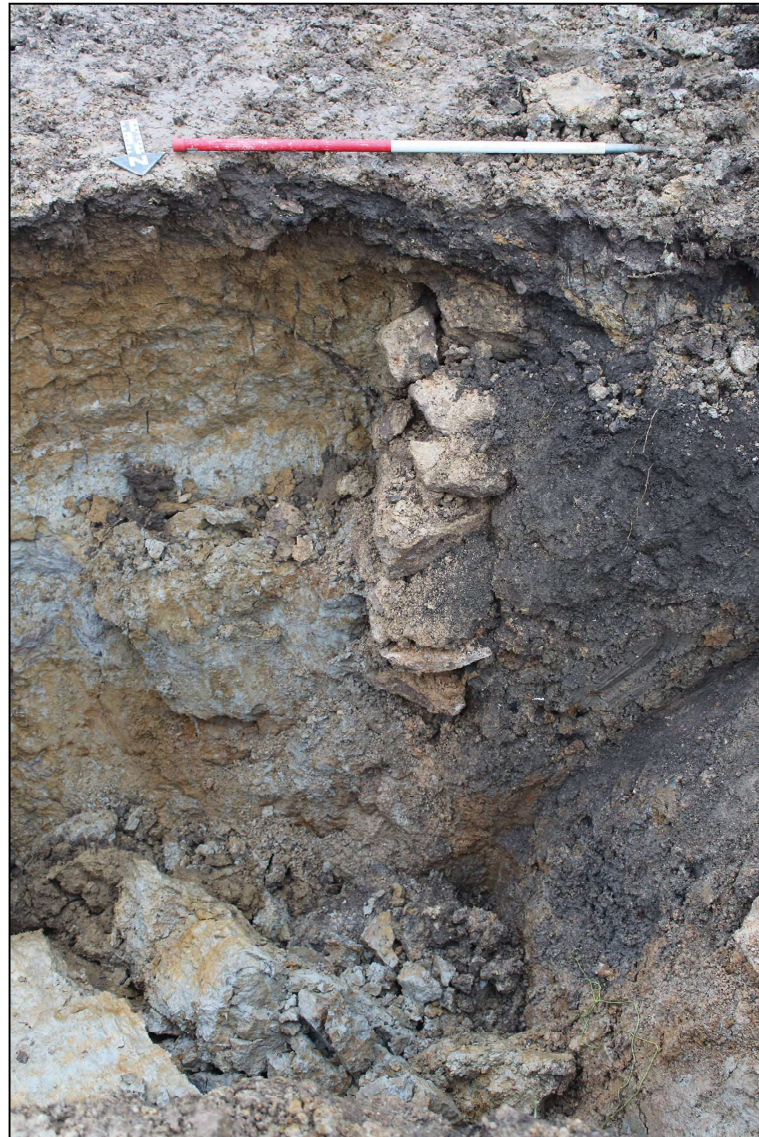
- 5.2. **Trench 2** recorded a stone lined soakaway **204**. It was only identified and recorded in section where it appears to have been lined with rough sandstone blocks and bonded with a gritty lime mortar. The soakaway was filled with a light grey/brown clay silt, which contained damaged unfrosted post-medieval bricks, it was 1.8m wide and 1m deep.

Structure 204, looking south (1m scale)

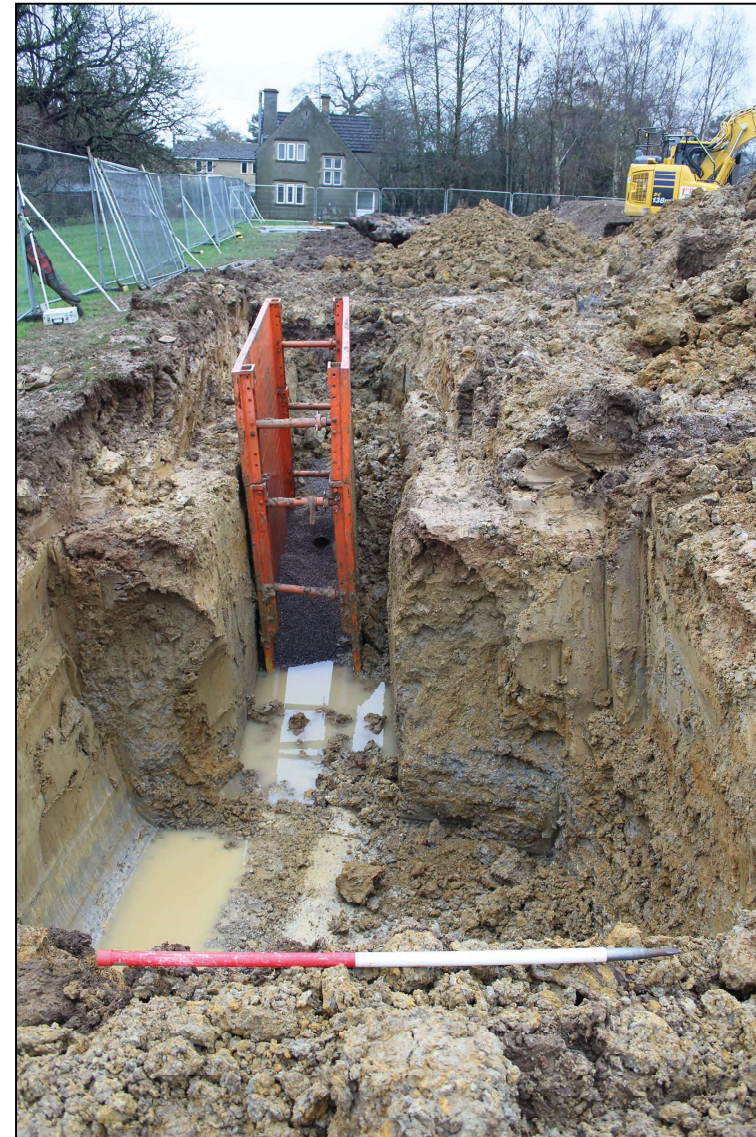
Trench 2, looking east (1m scale)

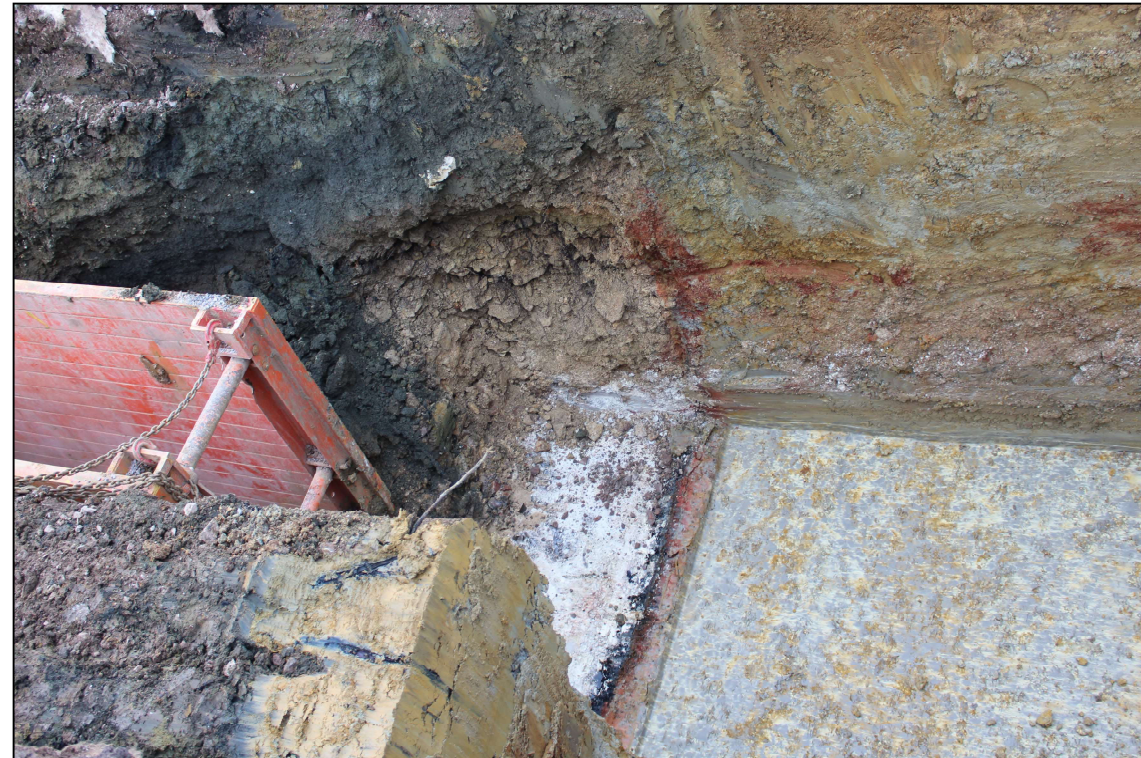
- 5.3. **Trench 3** contained a modern soakaway **306**. It was only identified and recorded in section and where the trench sides were so unstable it was impossible to do this with any accuracy. The soakaway appeared as a large cut feature, with redeposited chalk and crushed sandstone towards the base. The Soakaway was 7.5m long, a

minimum of 1m wide and minimum depth of 2.48m and may continue into **trench 14** as pit/soakaway **1404**.

Southern extent of soakaway 306

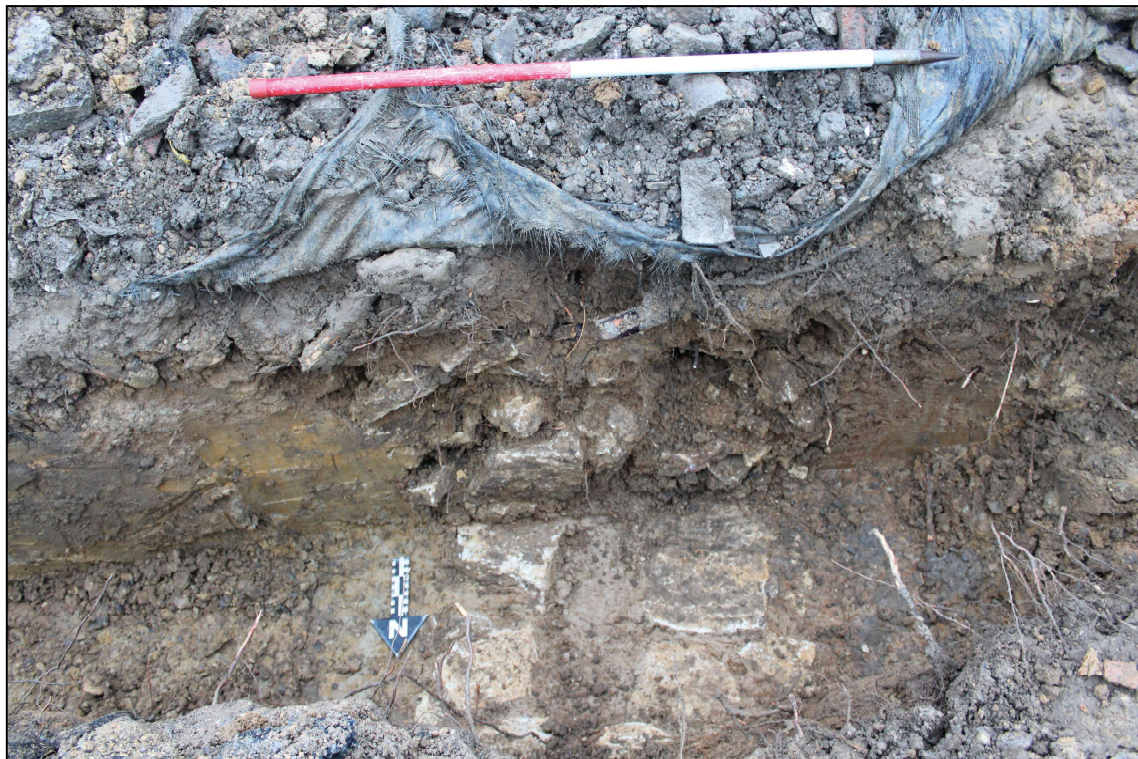
- 5.4. **Trench 4** recorded a north-south wall **402**. The construction trench was 0.98m wide and 0.11m deep. The wall **403** was constructed of roughly squared random coursed sand stone and bonded with lime mortar and clay.

Wall 403, looking south (1m scale)

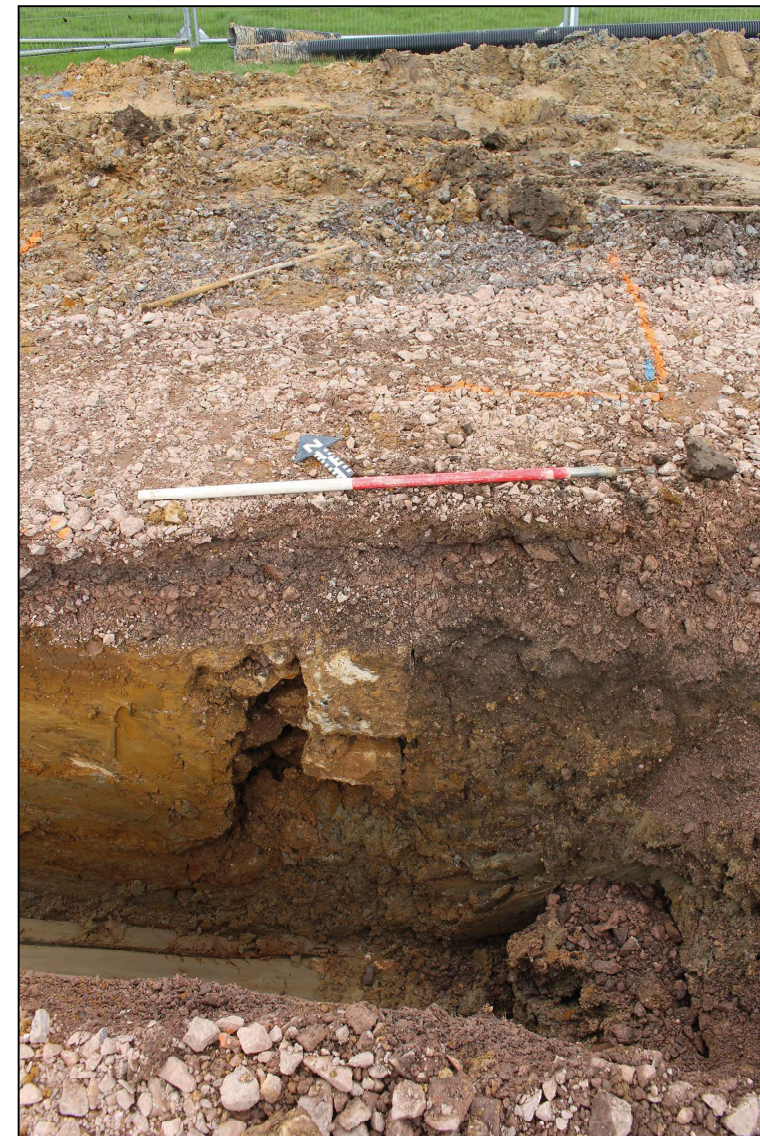
- 5.5. **Trench 14** recorded a contaminated pit or soakaway **1404**, and a dry sandstone lined soakaway **1406**. The western end of pit **1404** had gradual concaves sides and was only visible in section and is probably a continuation of Soakaway **306**. It was 4.7m long, a minimum of a 1m a wide and was at least 1.08m deep, the base was not reached. The upper fill **1404** was a green silty clay with modern CBM inclusions. The lower fill **1403** was a dark green/brown silt/clay. Soakaway **1406** was 1.6m long, 1.1m wide and 1.1m deep, and only part of the south-western and south-eastern edges were exposed. The edges of the pit appeared to be lined with a rough sandstone **1408**, which was constructed from irregular semi-rectangular sandstone brash blocks with no visible bonding. The pit was filled by **1407** a dark greenish black silty clay which contained post-medieval to modern pottery, which was not retained. The soakaway is very similar in form to **204** but would have been considerably larger.

Structure 1408, looking north-east (1m scale)

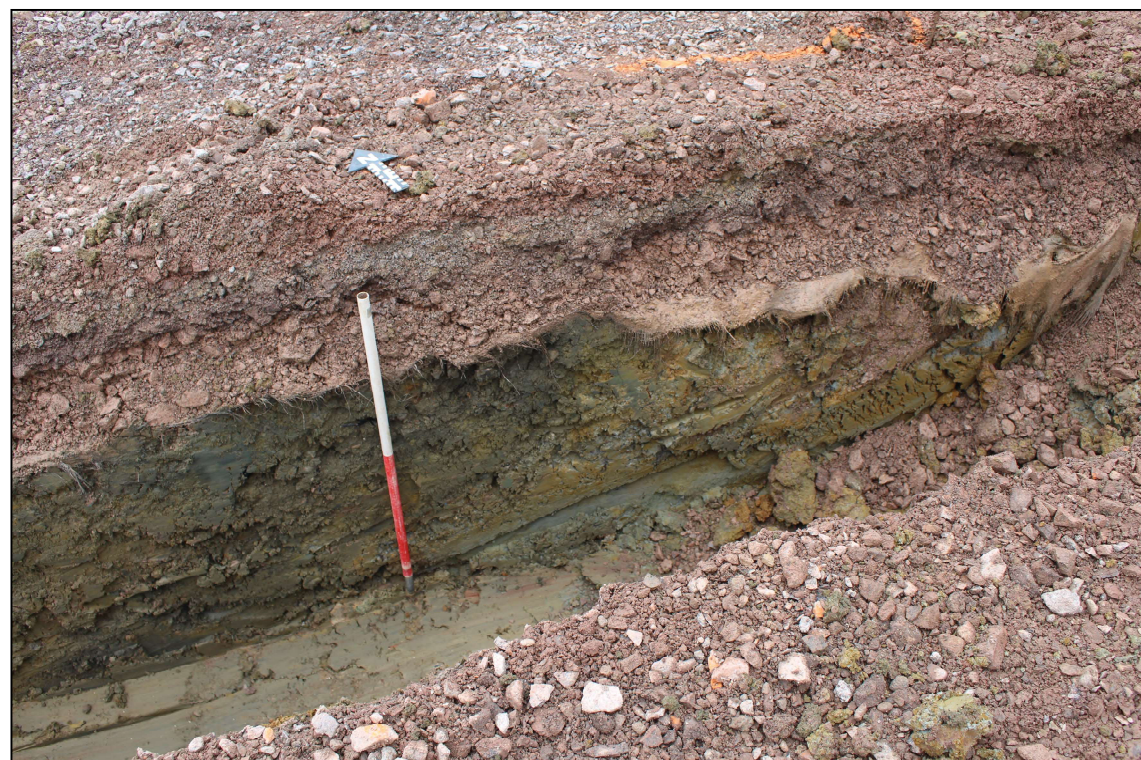
Part of Pit 1404, looking north-east (1m scale)
