# Anteroom Dodington House, Dodington

*Historic Building Recording*

CA Project: CR0381

CA Report: CR0381\_1

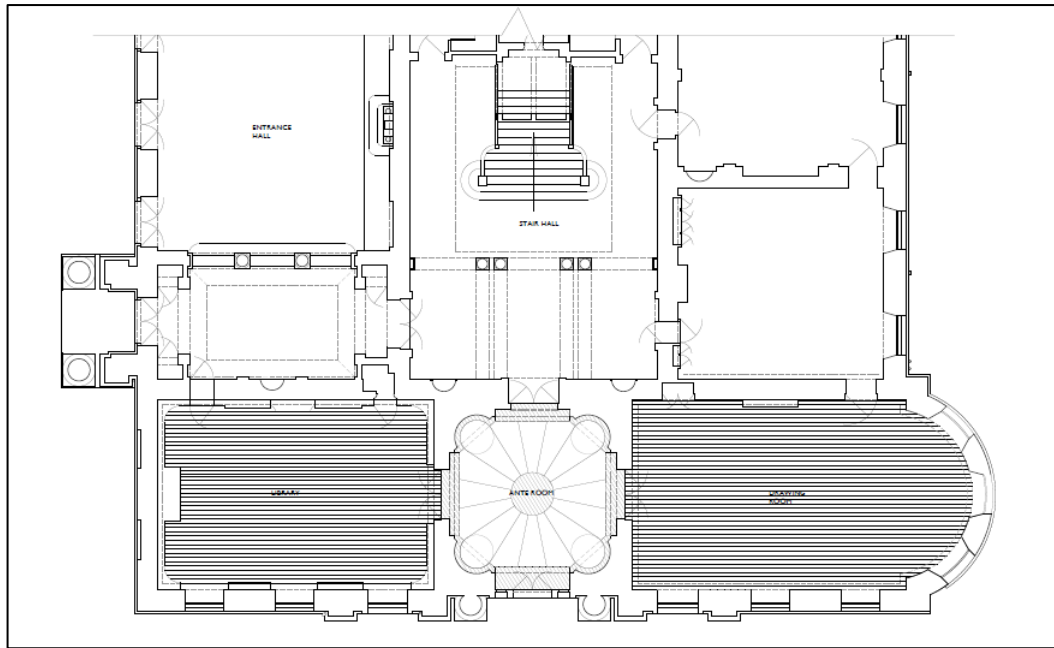
**Fig.2 Plan of the anteroom and associated areas of the building (courtesy of Lewellyn Harker Lowe)**

- 3.3. The room is square, but with curved half circle niches running floor to ceiling in each corner. The present floor arrangement is of oak floorboards running east-west as seen in Figs. 3, 4 and 5. The floorboards are laid in bands of three widths, increasing in width to the centre. The boards run seamlessly into the drawing room, whilst there is a flush oak threshold at right angles to the ante-room boards in the library and the boards in here do not correspond in alignment or width with those in the anteroom. The staircase hall floor is stone, and as such there is a stone threshold with the anteroom, flowing into the hall.

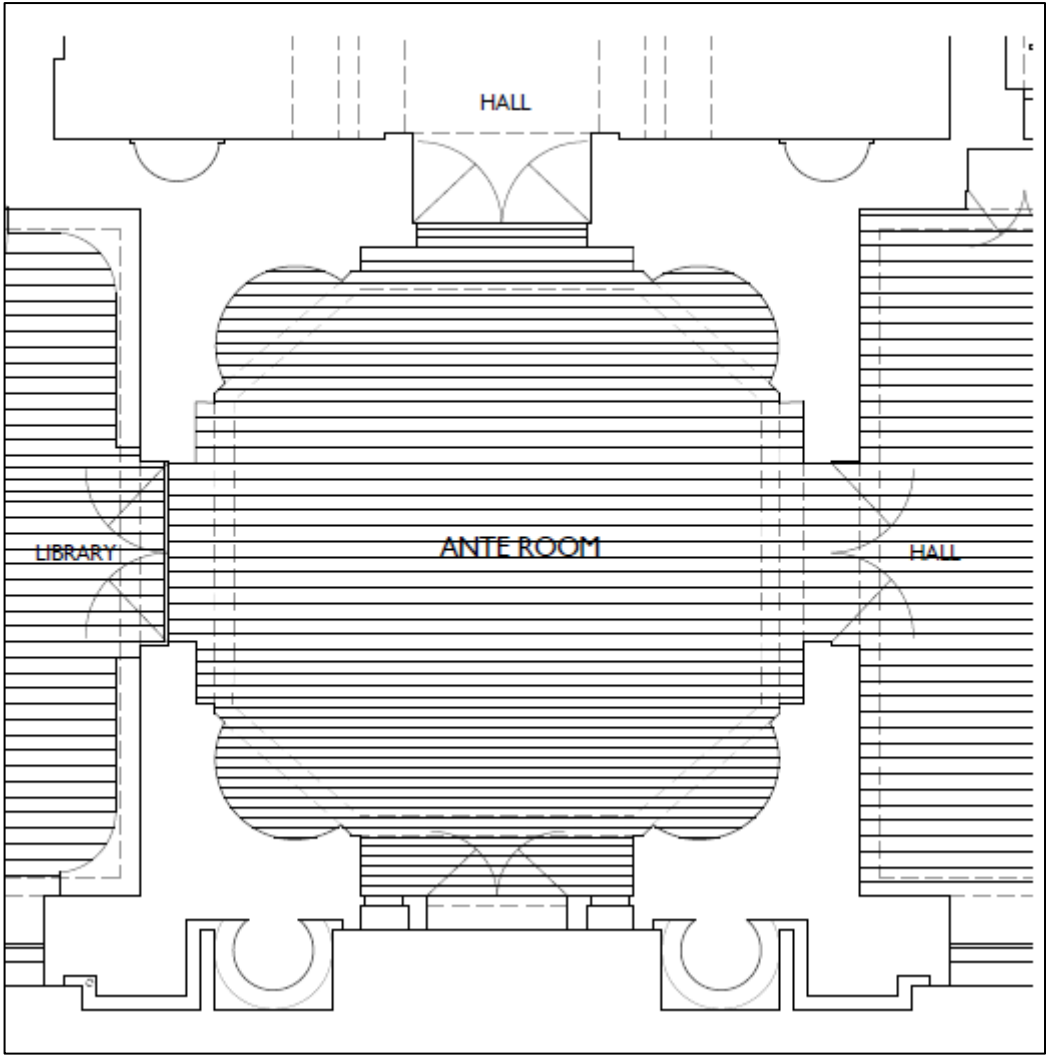
Fig.3 Representation of the floorboards in the anteroom (courtesy of Lewellyn Harker Lowe)

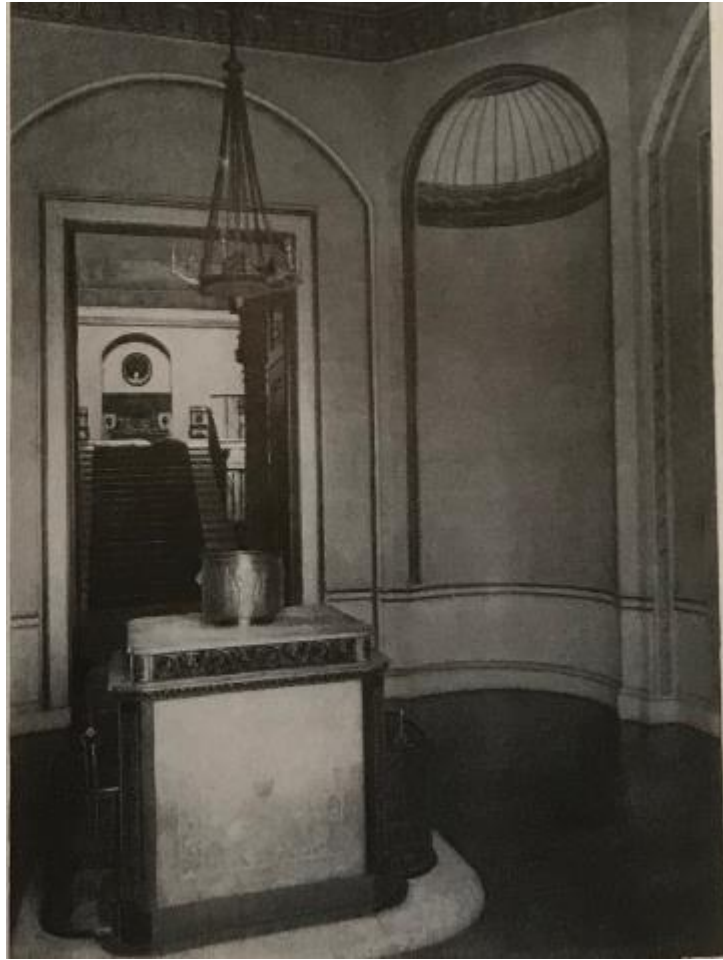
**Fig.6 Image of the stove in the anteroom (Architectural Review 1932)**

horizontally through the floor in the north-east corner where it rose to the roof (Fig.6).

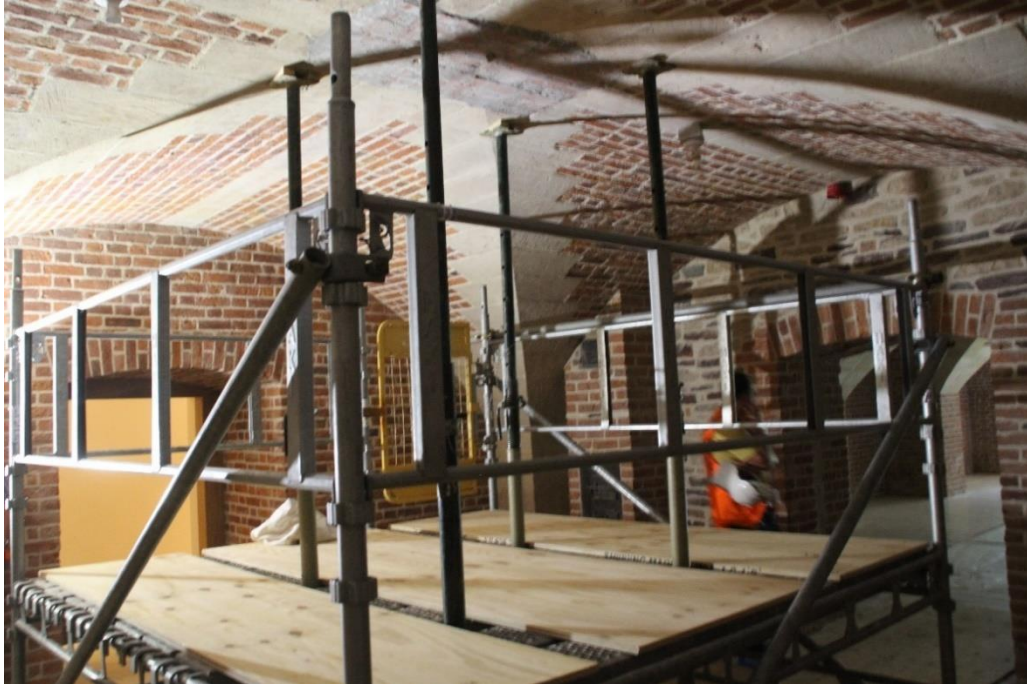
- 3.9. The groined vaulting is supported on limestone ashlar piers with the groin junctions formed of ashlar laid diagonally, as seen in Fig. 7. The rounded apex of the barrel vault is also ashlar with brick forming the bulk of the barrel. In the north east corner of the space is a what appears to be a small brick chimney stack with a stove insert. This must be related to the former stove placed above, the flue of which ran to the north-east corner of the room (i.e. above this stove and stack) and rose up the house to the roof. It is possible this feature assisted with obtaining the draught drag

- 3.10. The boss area of the groined vaulted has been removed, presumably when the stove and hearth were removed, and bricks inserted as infill, as seen in Fig.7.

**Fig.7 View of the barrel groin vault basement beneath the anteroom, view taken looking north-east**

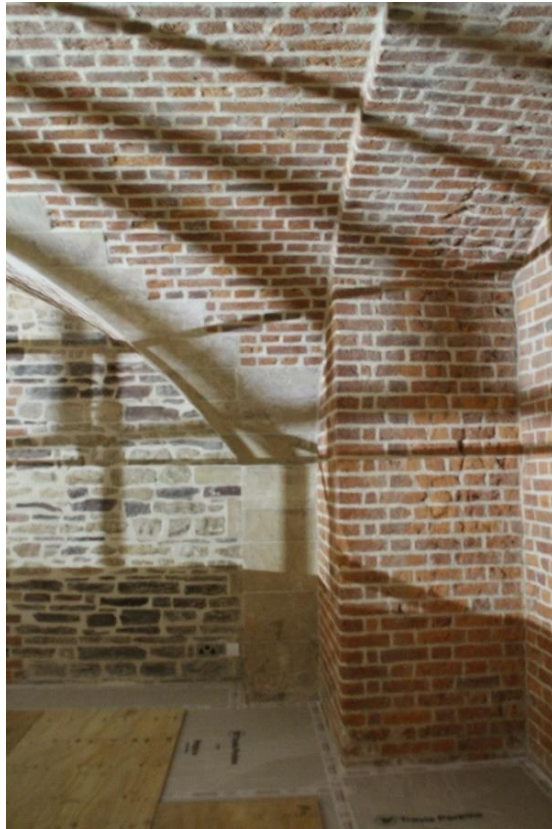
**Fig.8** View of the south-west corner showing the vault corner piers

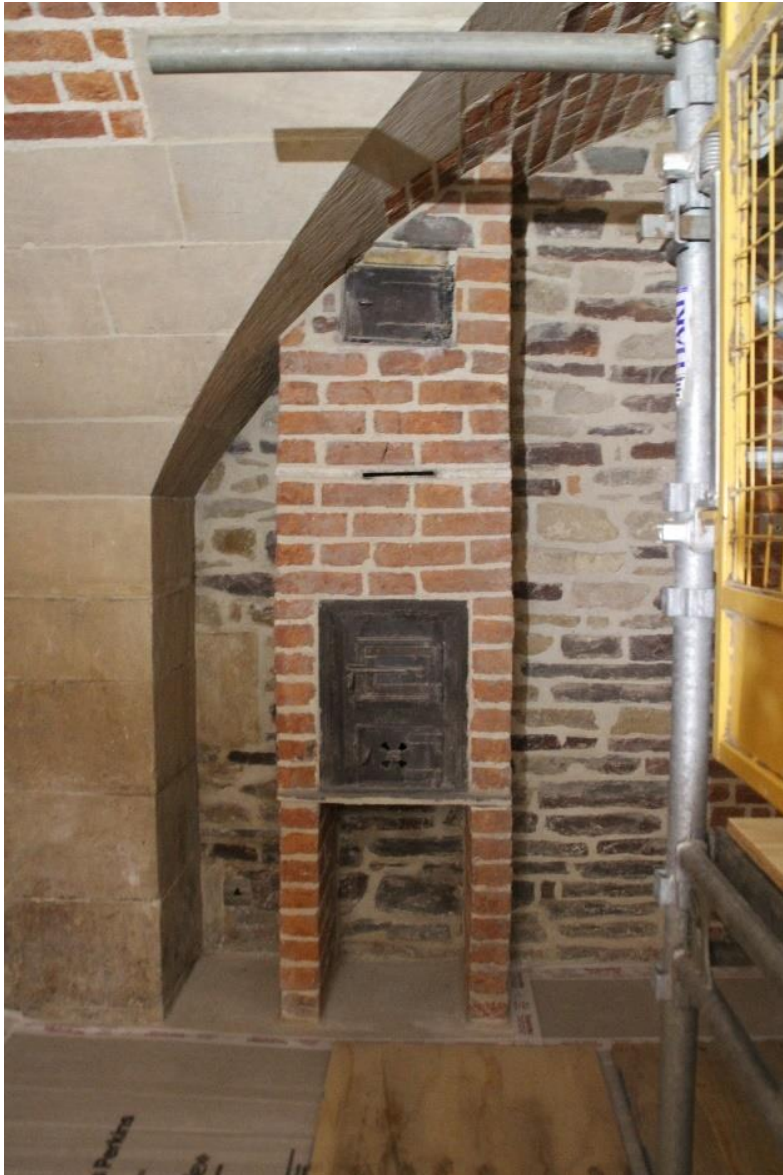
**Fig.10** View of the small chimney and inset stove within the north-east corner

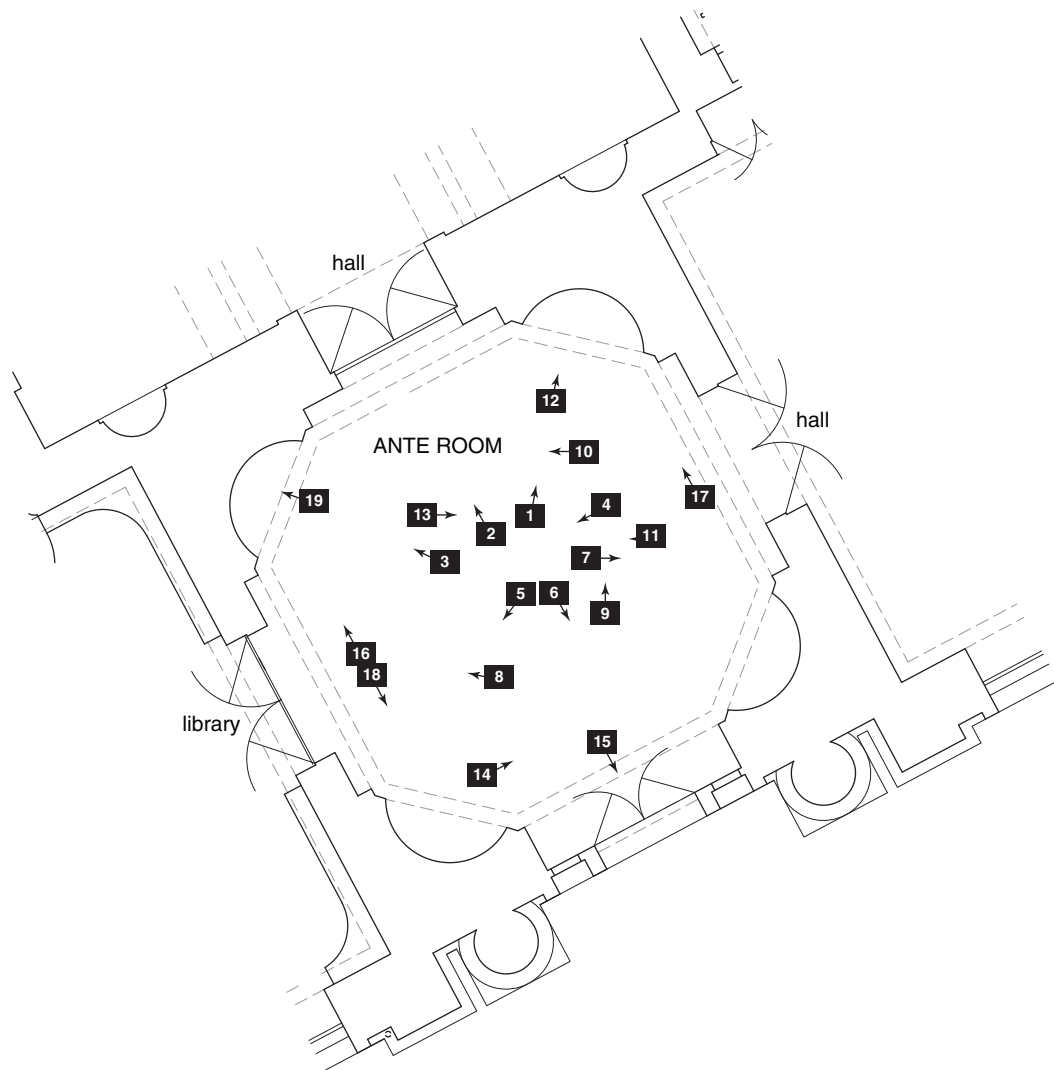
11

4.1. A plan of the room has been produced with photo location points, as per Fig.11.

Indicative plan of anteroom with  
 photograph location points

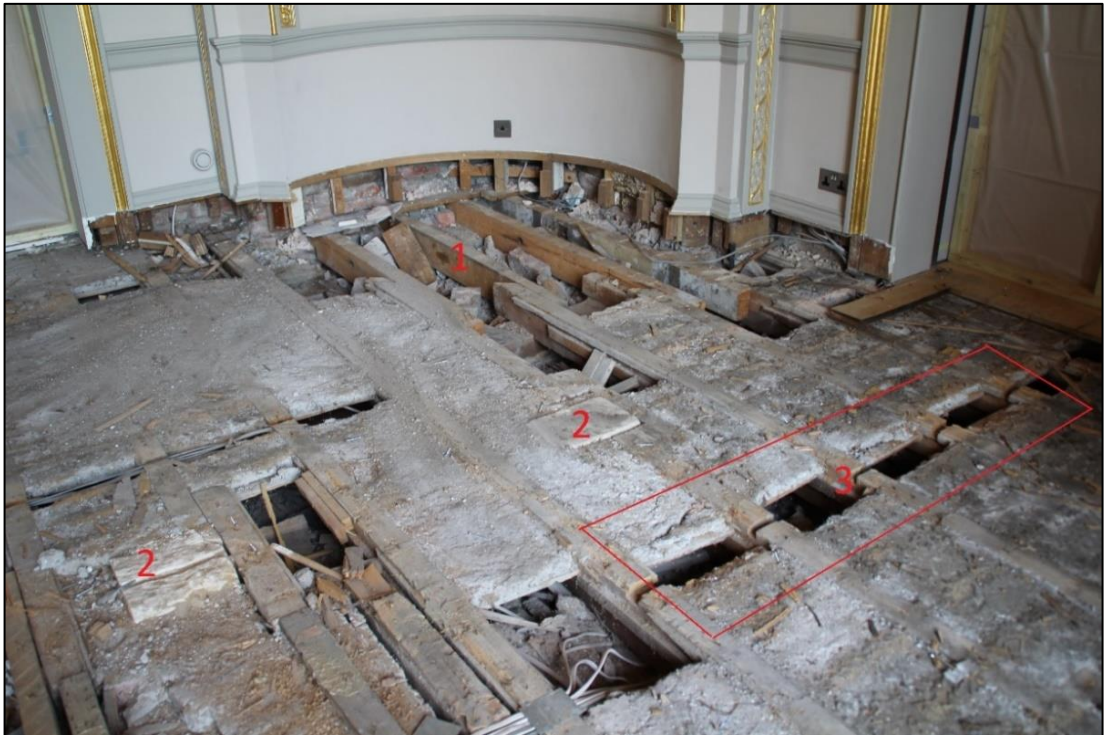
- 4.5. Photo 1 shows the north-eastern corner of the room. The room was clearly built as a square, with the rounded niches created via a curved timber structure fixed into the corners. Former areas of intervention are seen in (Photo 1, 1), where new joists have been pieced in to the corner section. This is where the former flue pipe for the stove was located and thus its removal probably occasioned this intervention. Two of the ashlar blocks noted above are seen (Photo 1, 2). Towards the drawing room door is an area where pugging has been clearly removed and the joists heavily notched, presumably to accommodate pipework which is no longer present (Photo 1, 3).

**Photo 1**      **View of north-east corner of the room**

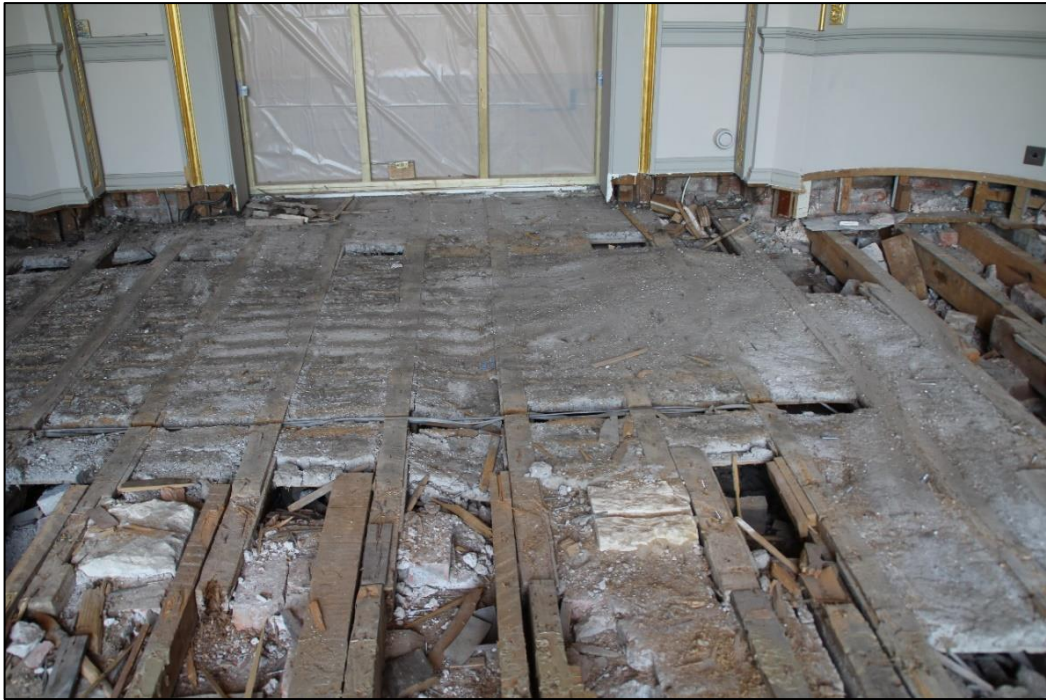
- 4.6. Photo 2 shows the northern middle section of the floor, nearest the doorway to the staircase hall. Again areas of untouched pugging are seen, with other areas of disturbance with removal and infill, mainly related to the area around the removal of the stone hearth to the former stove. The addition of additional 'sister' overlapping joists are evident where joists have been added to the central area where the hearth stood.

**Photo 2** View of central northern portion of room

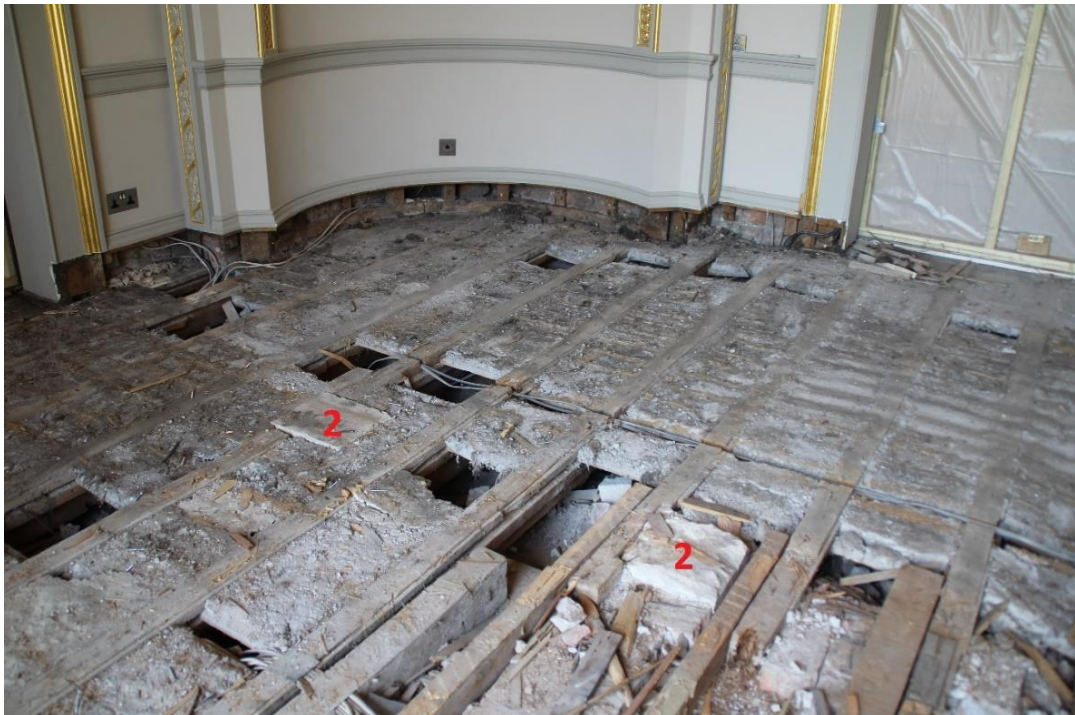
- 4.7. In Photo 3 the north-west corner of the room is seen. This again shows large areas of historic joists and pugging, along with disturbed areas and additional joists added within the former hearth. Of particular note here again is the regular spaced ashlar padstone blocks (Photo 3, 2).

**Photo 3** View of north-west corner of room

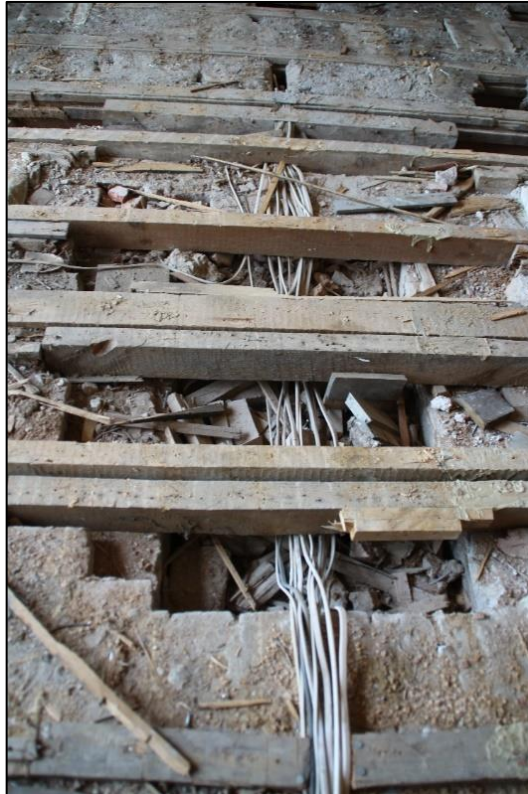
- 
- 4.8. The central section with the hole formed of the former hearth is seen in Photo 4. The opening is formed of brick, and has been filled with rubble and office. Sister joists have been added to provide support for the floor above.

**Photo 4** View of central stove void as found following removal of floorboards

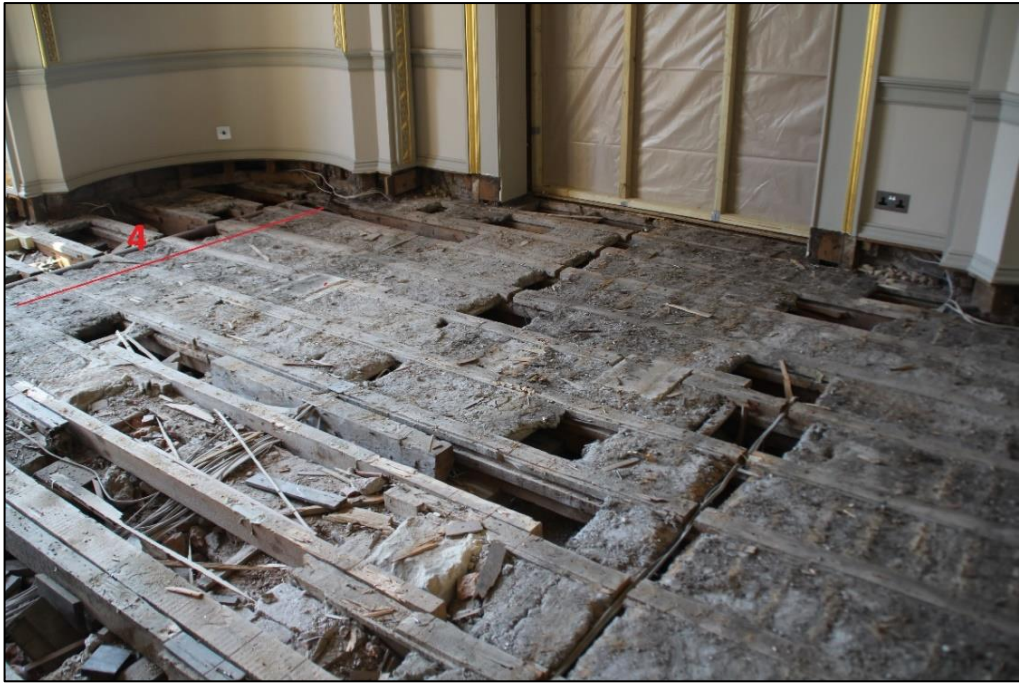
- 4.9. Photo 5 overlooks the south-west corner of the room, showing the central section and looking towards the doors to the library and the curved niche corner. A heating pipe has been inserted along the length of the southern section of the room which has required notching the joists to accommodate it (Photo 5, 4)

**Photo 5** View of the south-west corner of the room

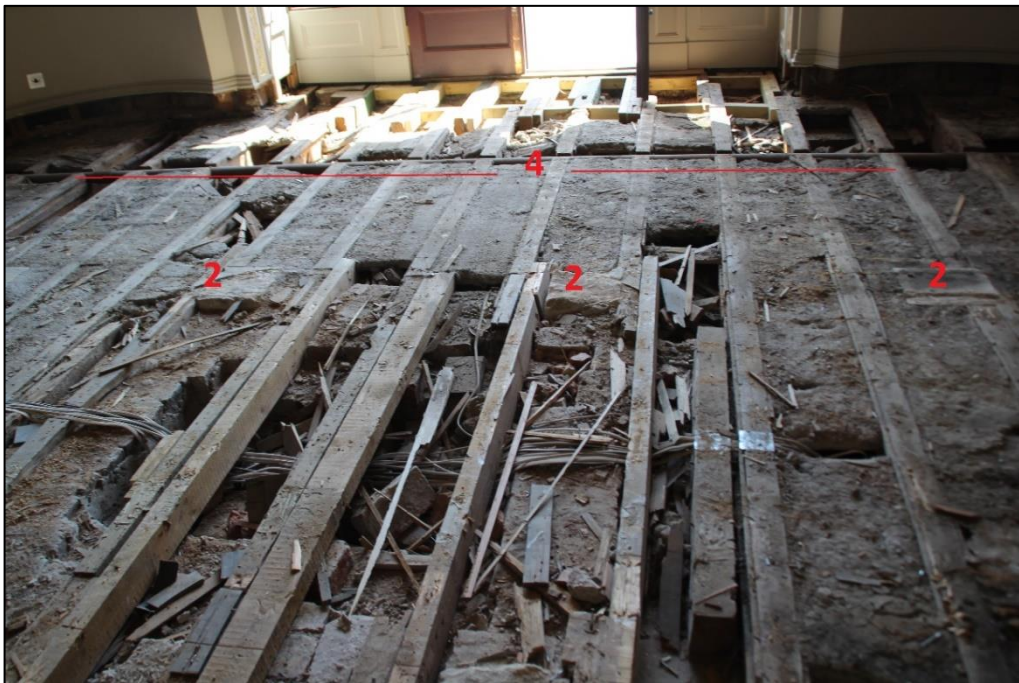
4.10. Photo 6 faces the external door and the south terrace. New joists are seen within the entrance area, and the metal heating pipe traversing the room is also evident (Photo 6, 4). Three of the four southern ashlar blocks are also seen (Photo 6, 2).

**Photo 6** View of the central south portion of the room overlooking the garden terrace

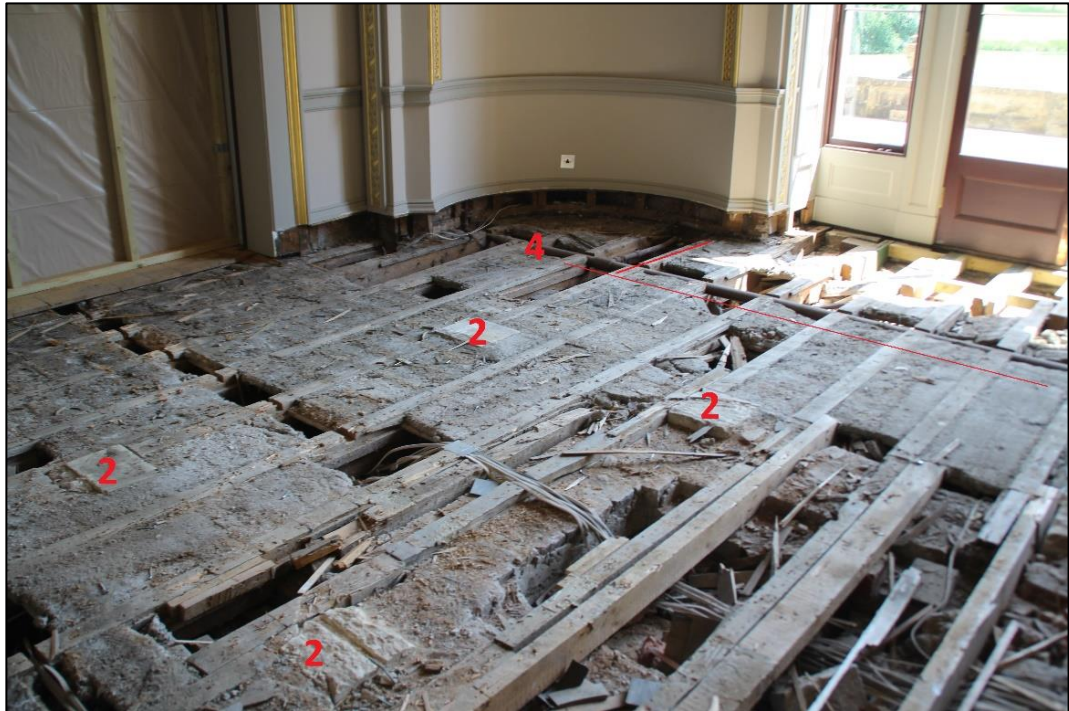
- 4.11. Photo 7 completes the overall 360 review of the room and faces towards the south-eastern corner of the room. The heating pipe branches off at right angles into the corner brick work (Photo 6, 4), and again alteration, notching and removal of pugging is seen in the area of the pipework. The pipe work appears to come from below, and then proceed up the walls behind the two southern niches. However no pipework was seen in the basement below, so it is presumed the extant pipework flows from the floor substructure under the library and drawing room.

Photo 7 View of the south-east corner of the room

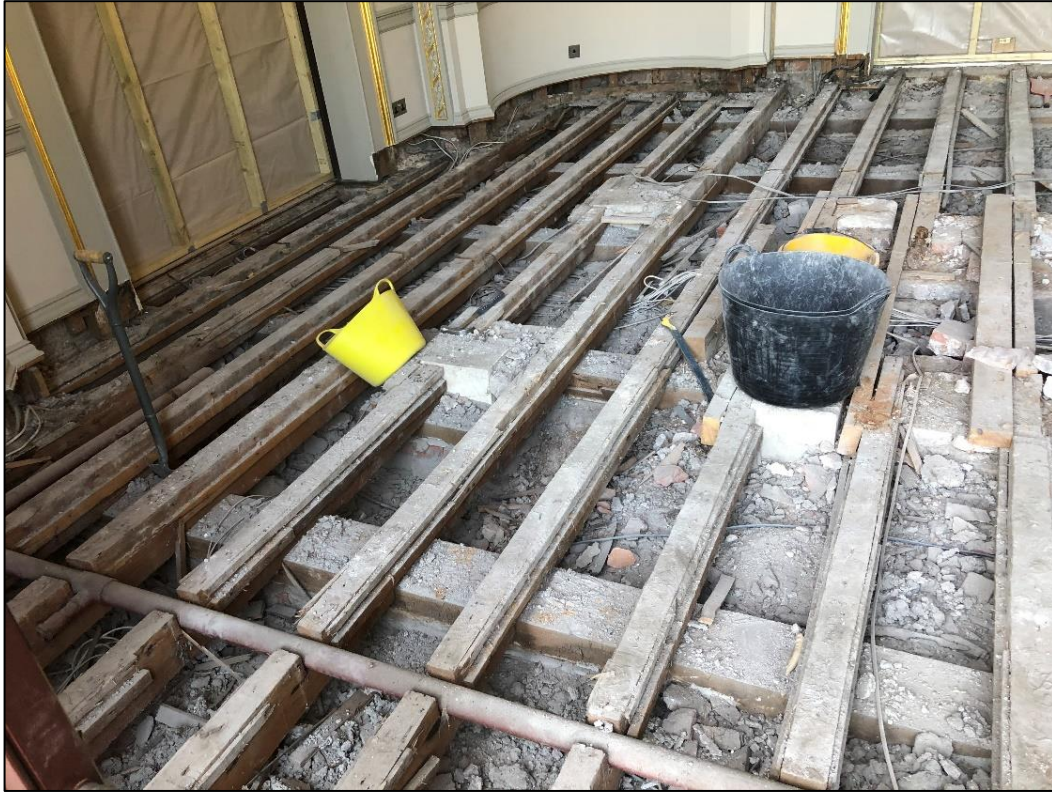
- 4.13. The top layer of infill, pugging and extraneous pipes/cables were then removed to reveal the joists and more of the substructure. What emerged at this point was the existence of six brick low brick structures supporting oak timber bearers (c.180mm x 110mm) spanning the room east-west. These brick and timber 'beams' form the support for the joists of the suspended floor and lie built either across or along the barrel vaults beneath (depending on the orientation of the vault).
- 4.14. Photo 8 illustrates the western half of the room with the piers and bearers supporting the joists which are still in situ. At this stage rubble is being removed

**Photo 8**      **View of the central western area of the room**

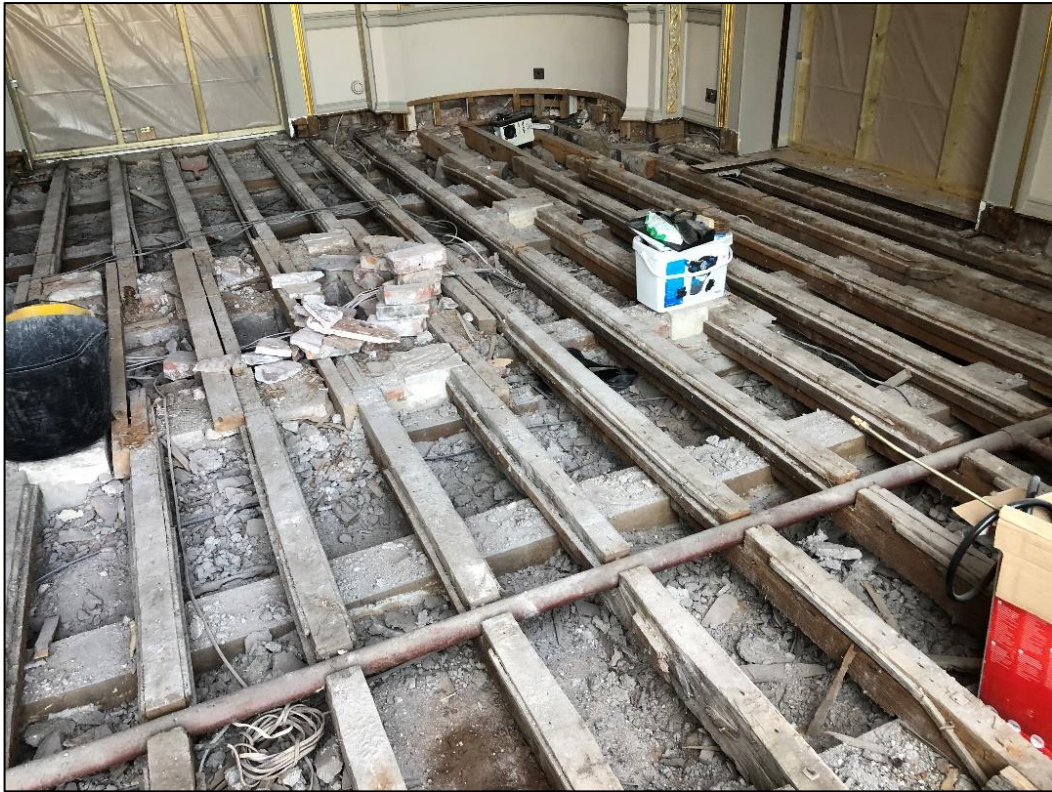
- 4.15. Photo 9 illustrates the eastern part of the room and Photo 10 the northern portion adjacent to the stair hall doorway. In both cases the same arrangement of joists clasped on to horizontal brick and timber beams is seen.

**Photo 9** View of the central eastern area of the room including the stove void

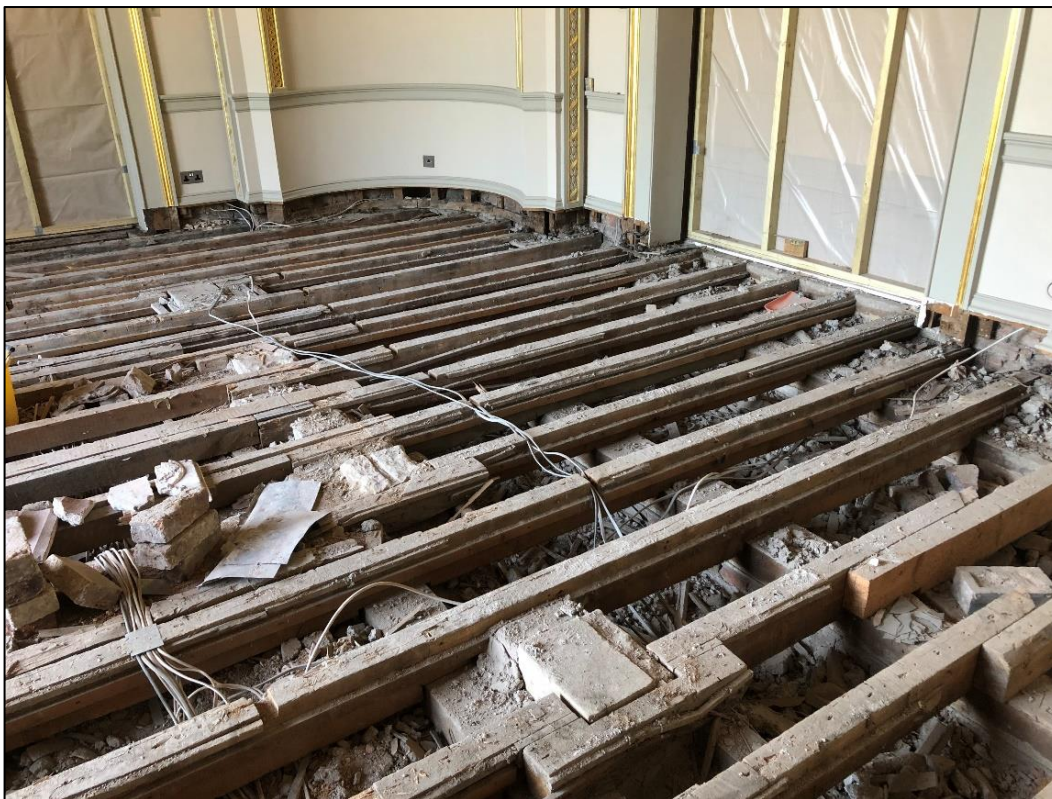
**Photo 10** View of the northern half of the room looking west

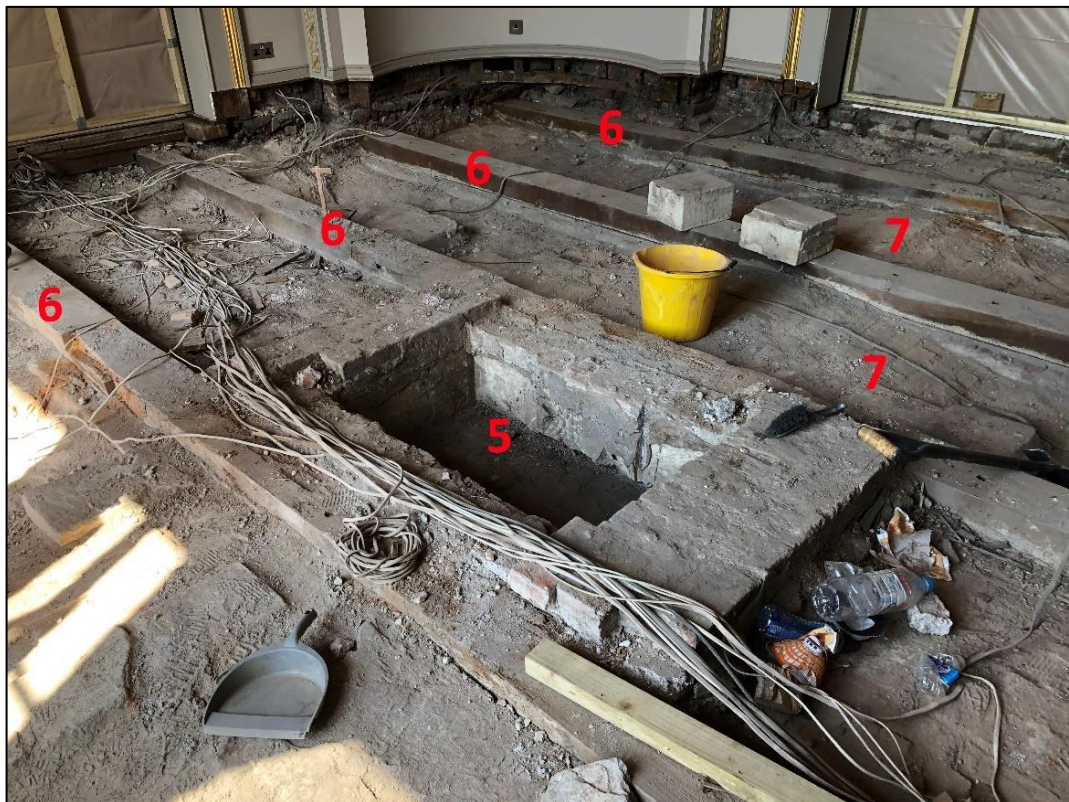
- 4.16. Following removal of the floor timbers and further infill, more of the floor structure and its relationship to the vault is revealed.
- 4.17. Photo 11 shows the former floor opening where the stove was installed (and which is bricked up in the vault below). It is lined with a mixture of brick and ashlar (Photo 11, 5). The lateral brick beams can also be seen in better detail still topped with their oak bearer beams (Photo 11, 6). The top of the curve of the barrel vault below can be seen (Photo 11, 7). Whilst the curve of the vault is quite shallow, the corners, which form the groins, slope down to meet the brick piers below. These areas are quite tightly packed and levelled off with infill and the brick structures are built up from them, as illustrated in Fig.15.

**Photo 11**      **View of the western half of the room looking north-west**

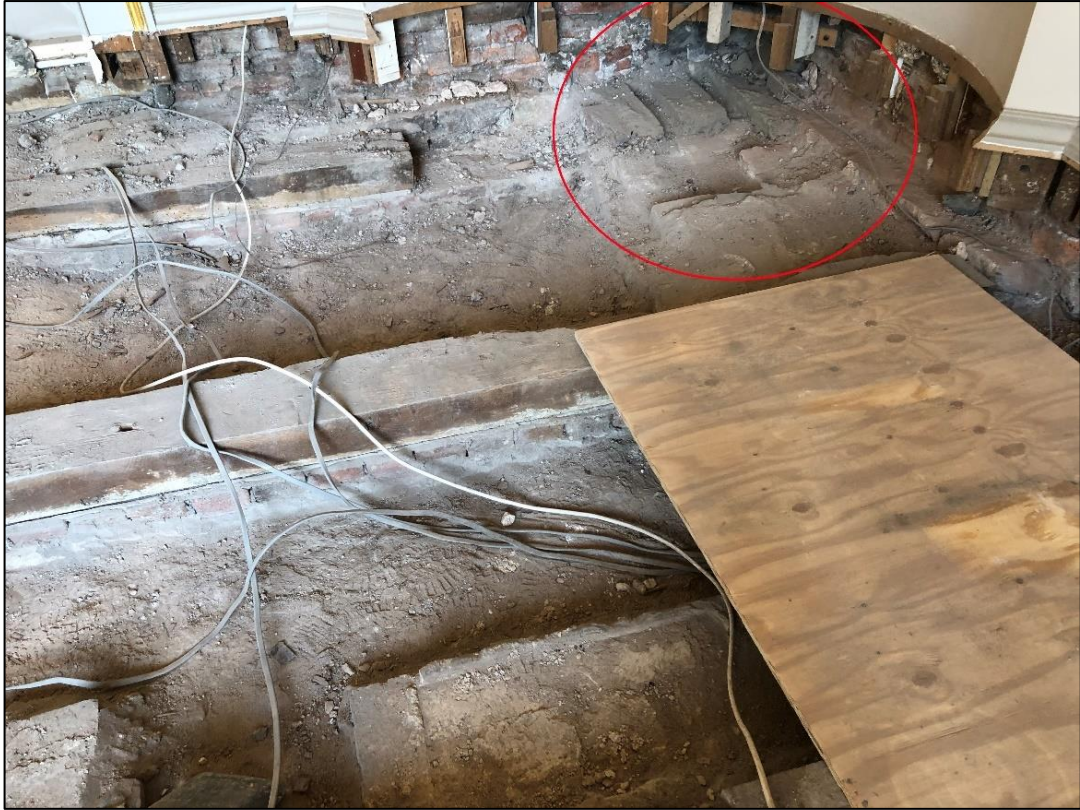
- 4.18. Particularly large pieces of infill are seen in the north-east corner where the former flue from the stove was located and areas of soot blackening are seen near the junction of the floor and wall, as circled in Photo 12.

**Photo 12**      **Detail showing the infill in the north-east corner**

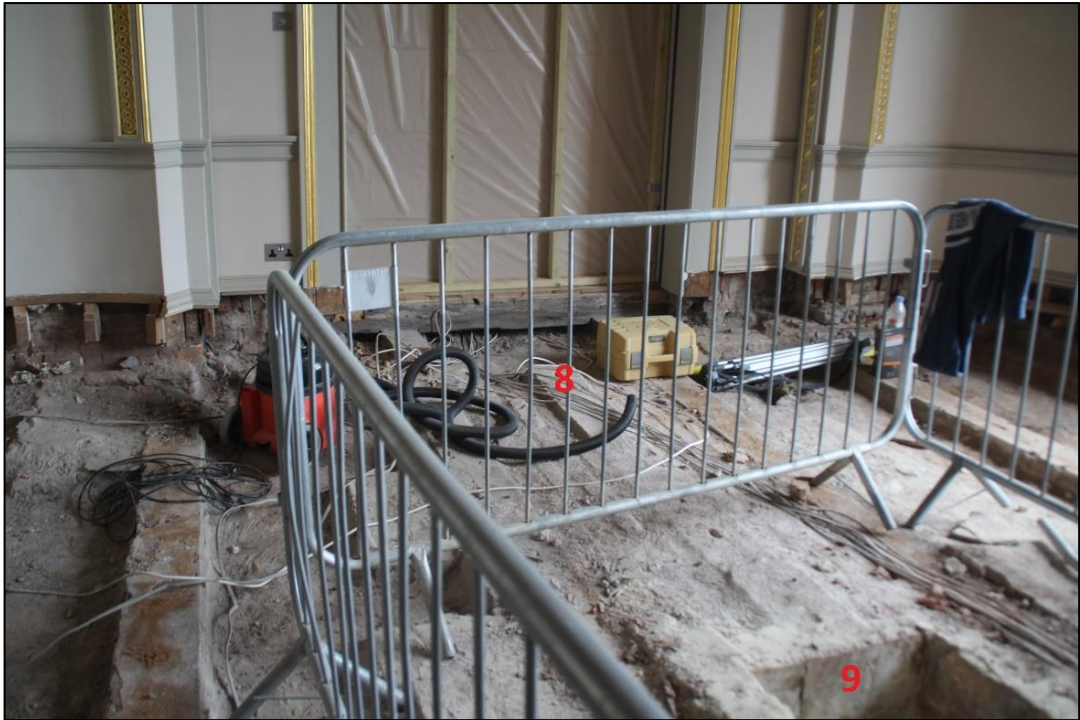
- 4.19. Further removal of infill and the timber beams reveals more of the vault structure below, this includes the line of ashlar blockwork that runs along the apex of each barrel; though it is clear that whilst the finishing in the vault below was conducted to a high standard, above some of the blocks have not been squared off or aligned (as seen in Photo 13, 8). Such an approach would be acceptable given the floor substructure was not on display and as such a lack of finishing saved time and energy. The removal of the timber bearers from the brick structures shows that they were laid on a bed of a lime-based mortar.
- 4.20. The opening in the centre of the vault which accommodated the stove appears to be original to the vault structure as the ashlar work at the ridge terminates with a keystone at the opening as seen in Photo 13, 9.

**Photo 13**      **View of the central eastern section of the room**

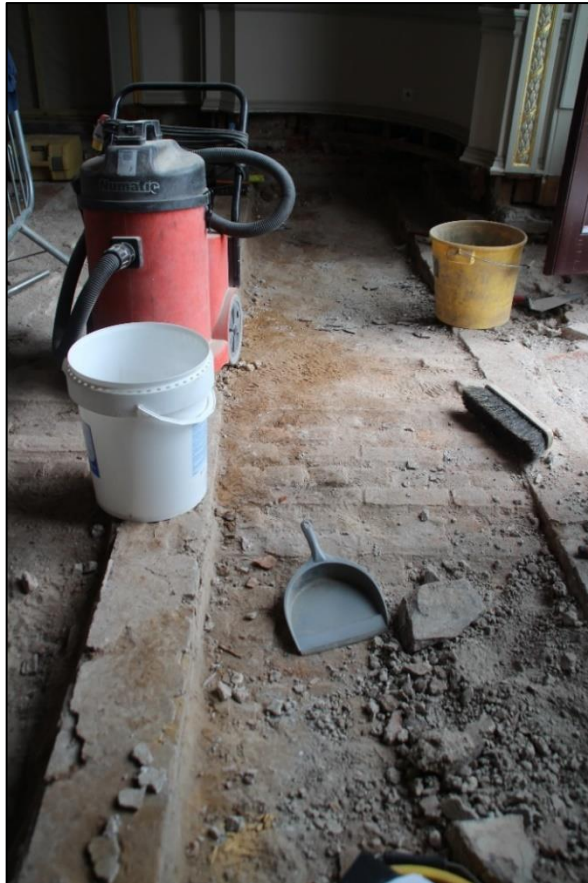
4.21. Photo 14 shows how the barrel vault structure has emerged with the removal of infill. The rubble stone found at the threshold of the external door is Pennant, which indicates that the foundations of the external walls were formed of Pennant stone, some of which is seen interspersed with brick and Bath stone in the basement below (Photo 15).

**Photo 14**      **Detail showing apex of the barrel being uncovered**

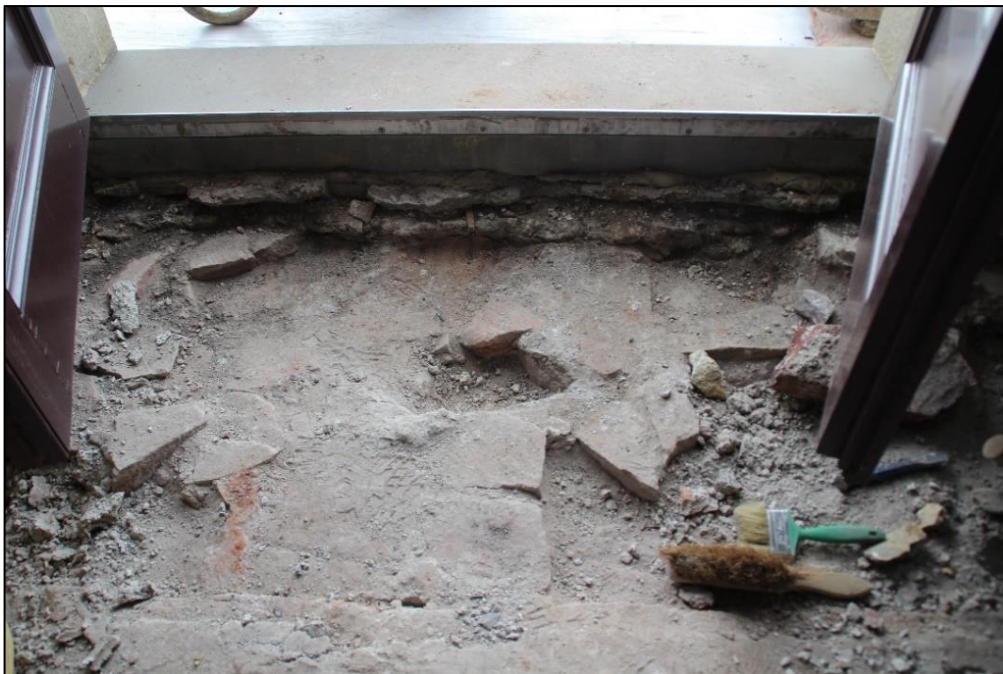
**Photo 15**      **Detail of the floor and outer wall substructure with Pennant stone by the garden entrance**

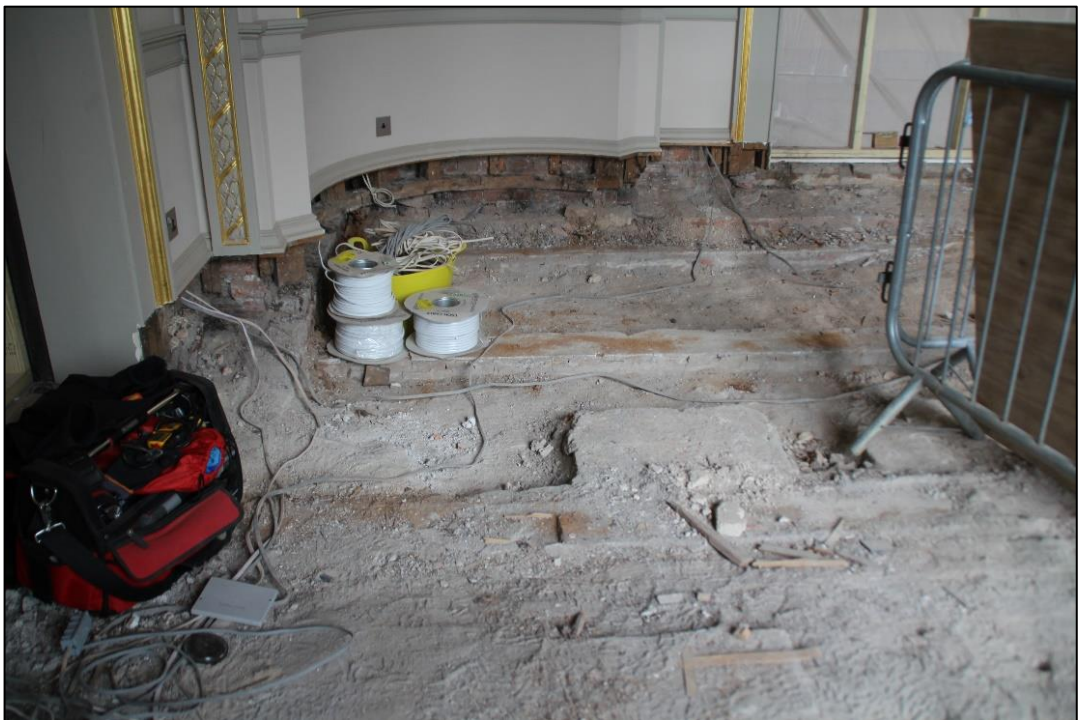
- 
- 4.22. Photo 16 features the north-west corner and part of the western area of the room, and it illustrates the relationship of the floor structure to the curved niches at the corners, with the timber work being built off the brick perimeter walls. It also illustrates the general arrangement of east-west brick piers, unfinished ashlar work from the barrel below, and the remaining infill which forms a relatively flat surface from which the new stone floor is to be built up.
- 4.23. Photo 17 illustrates the same view for the north-eastern corner, and Photo 18 for the south-western corner. Photo 19 shows a detail of the corner joinery and its interface with the masonry behind and underneath it.

**Photo 16**      **View of the north-west corner**

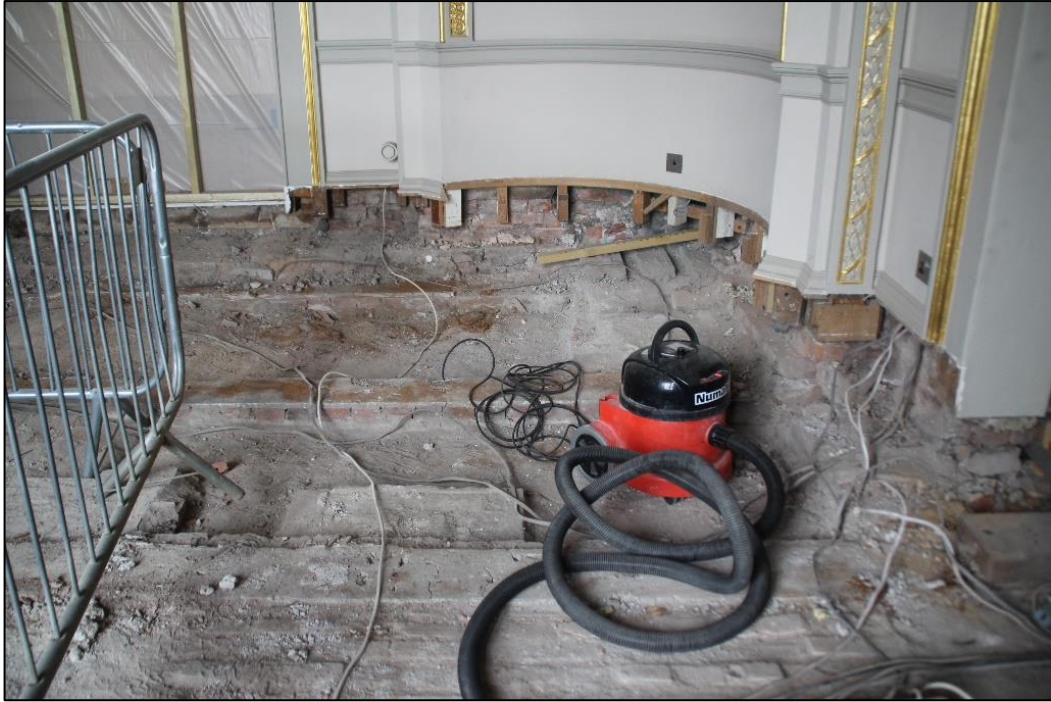
**Photo 17**      **View of the north-east corner**

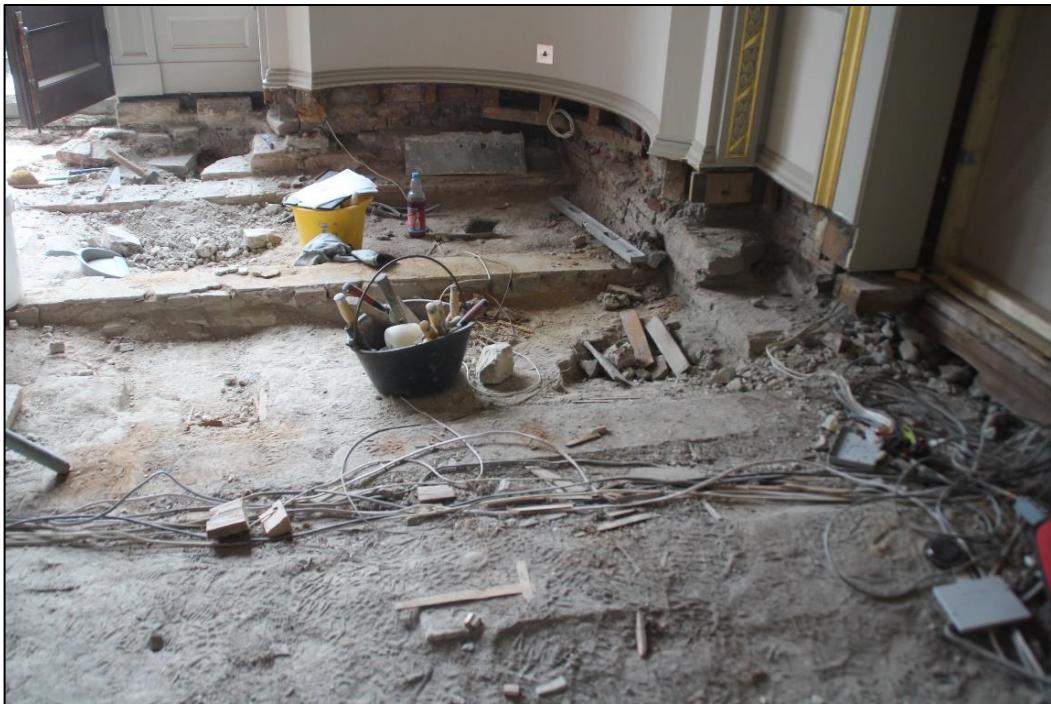
**Photo 18**      **View of the south-west corner**

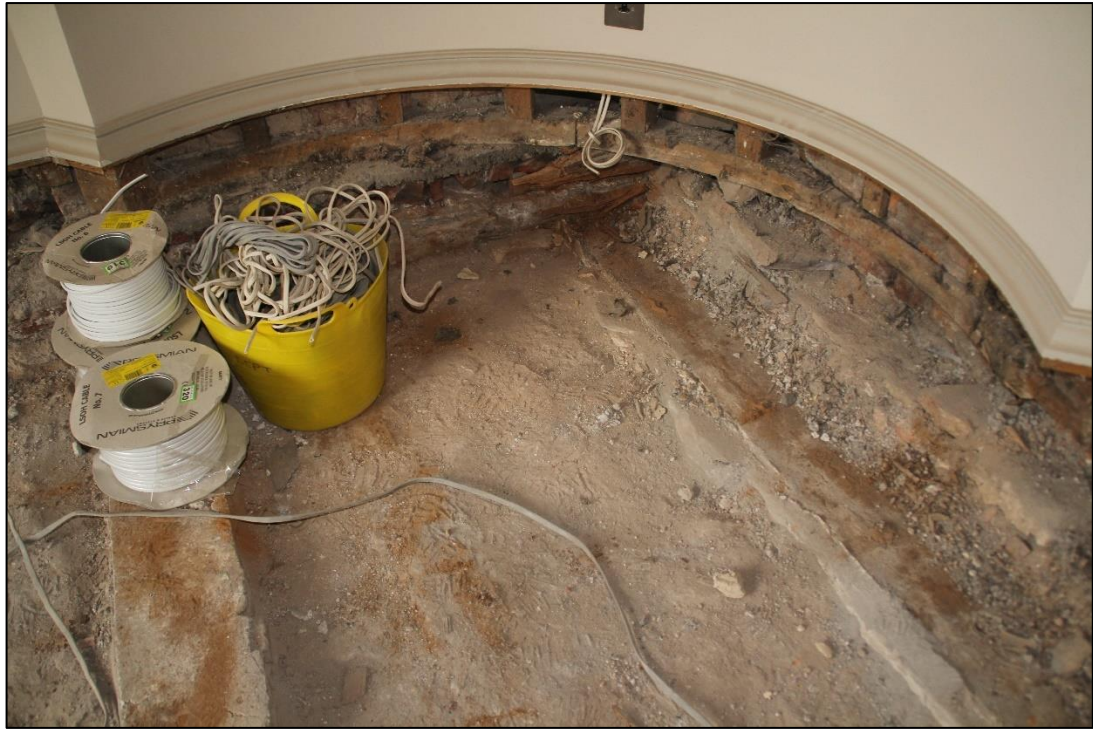
**Photo 19** Detail of the north-east corner showing illustrating niche joinery and interface with brick piers running across the room
