# Anteroom Dodington House, Dodington

*Historic Building Recording*

CA Project: CR0381

CA Report: CR0381\_1

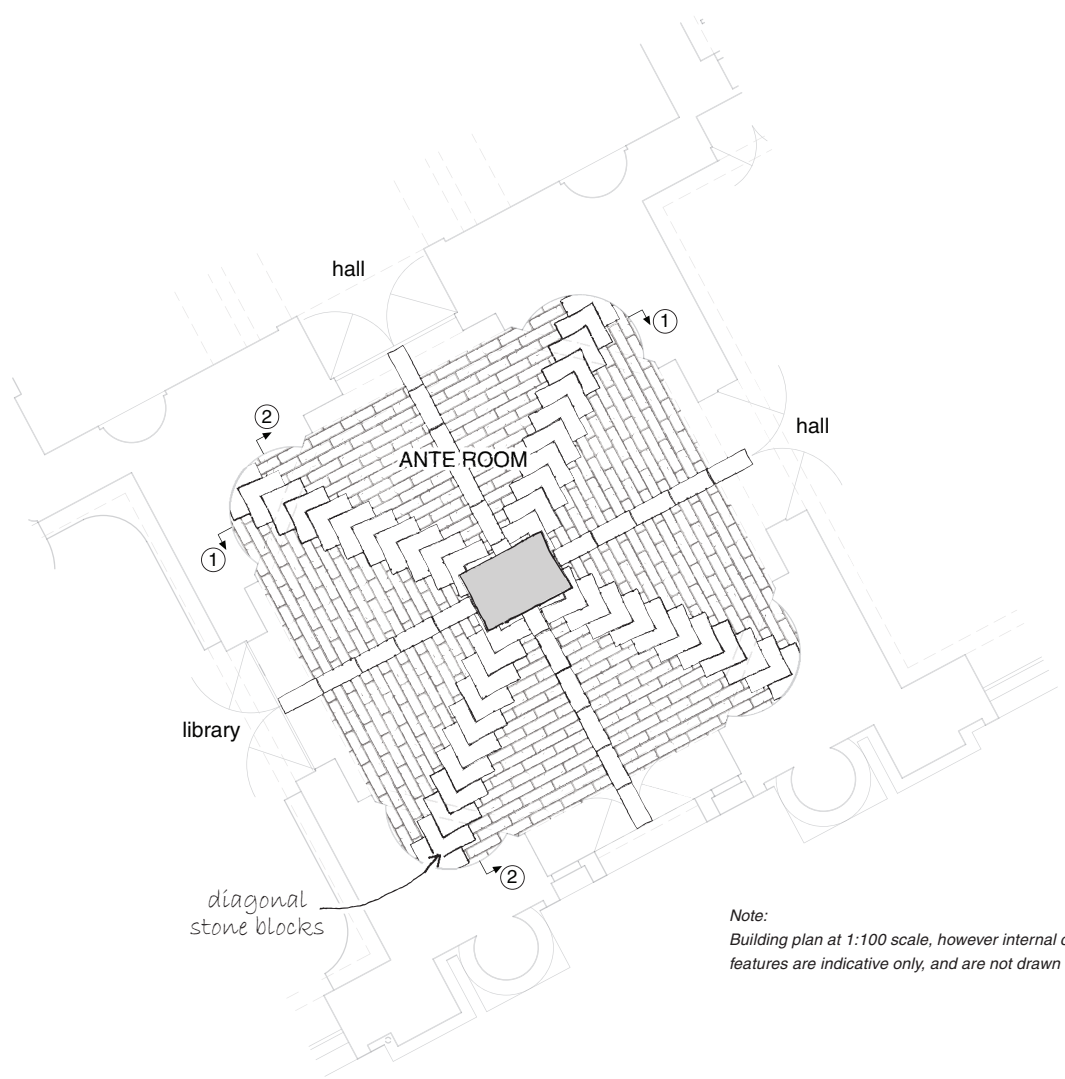
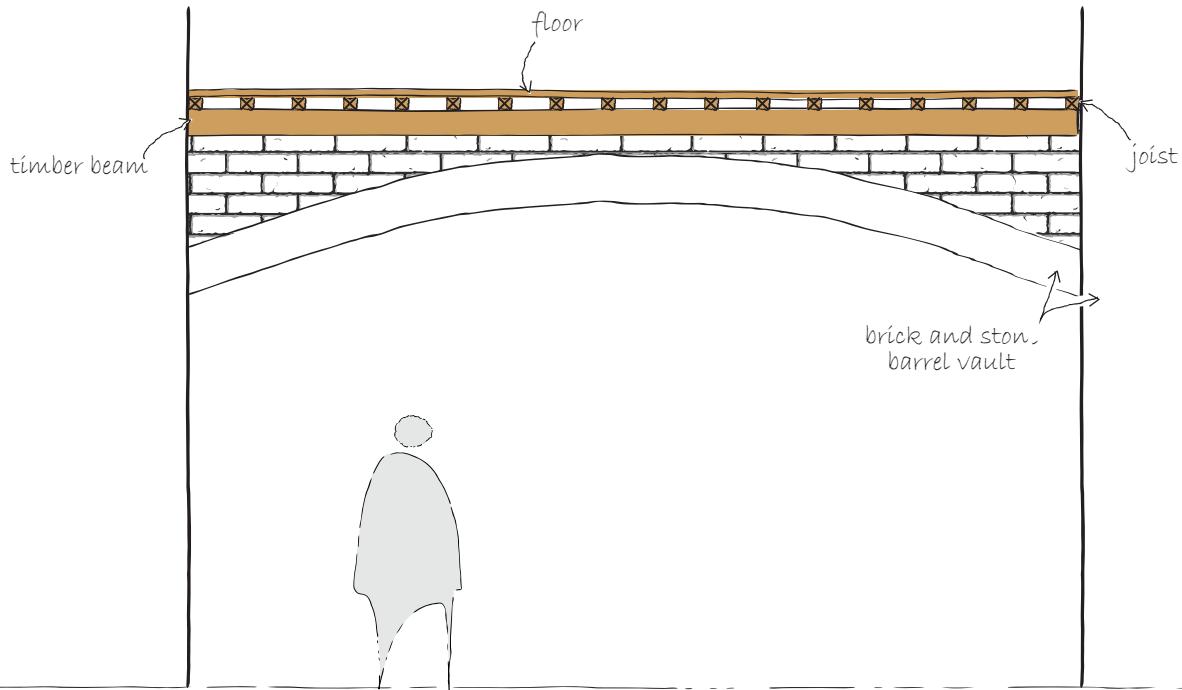
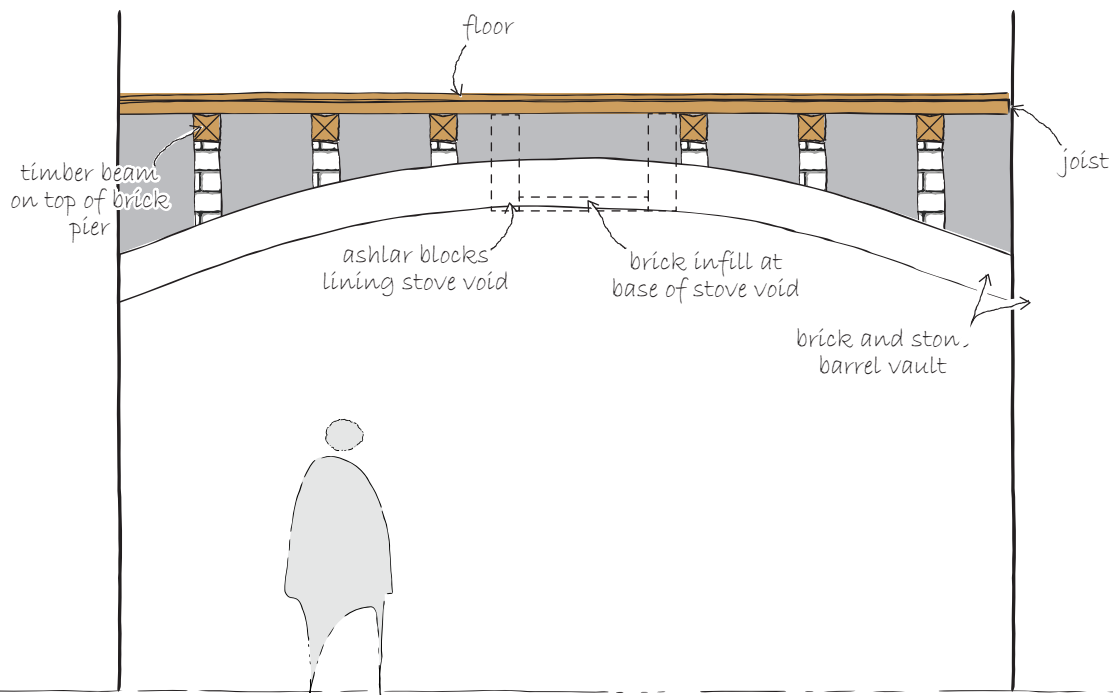
FIGURE NO.  
**15**

- 4.16. Following removal of the floor timbers and further infill, more of the floor structure and its relationship to the vault is revealed.
- 4.17. Photo 11 shows the former floor opening where the stove was installed (and which is bricked up in the vault below). It is lined with a mixture of brick and ashlar (Photo 11, 5). The lateral brick beams can also be seen in better detail still topped with their oak bearer beams (Photo 11, 6). The top of the curve of the barrel vault below can be seen (Photo 11, 7). Whilst the curve of the vault is quite shallow, the corners, which form the groins, slope down to meet the brick piers below. These areas are quite tightly packed and levelled off with infill and the brick structures are built up from them, as illustrated in Fig.15.
