Aldi Foodstore Newton Abbot Devon

*Historic Building Recording and
Archaeological Watching Brief*

CA Project: 880272

CA Report: 17727

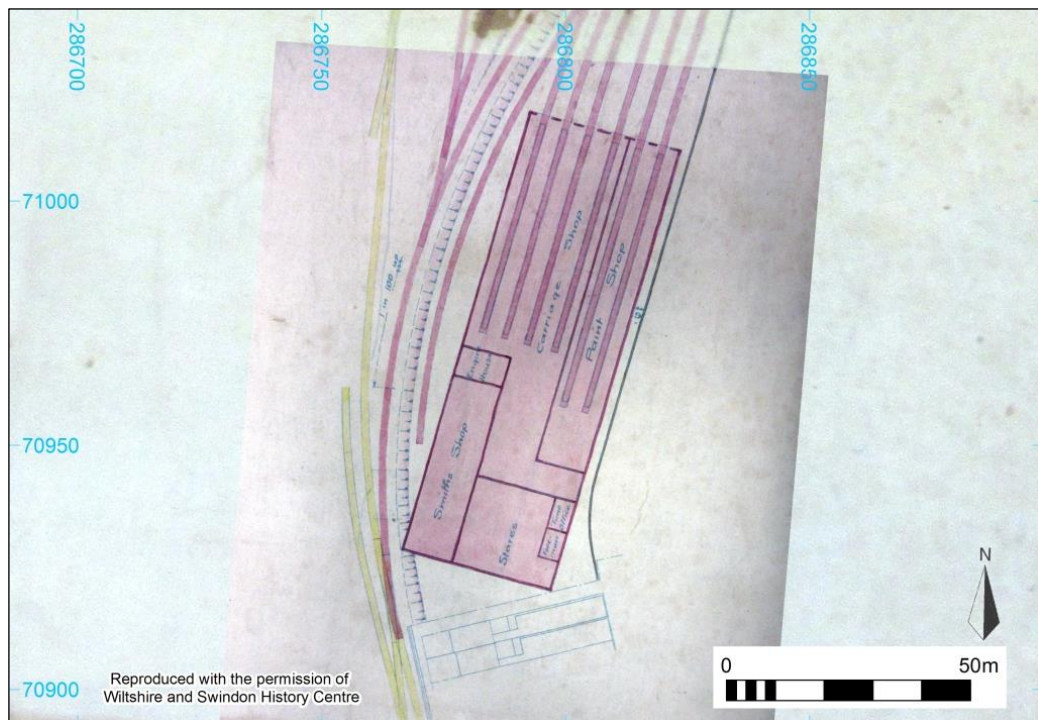
Fig. 2 1892 plan of the carriage shed (Building A); note that the extension to the south (Building B) is not shown at this time.

- 4.10. A plan dated 15 June 1892 shows a series of alterations to the Newton Abbot Station and shows Building A (see below for more detailed description) as built (WSHC ref 2515.410.0241 ms: Fig. 2). The plan implies that the internal layout was the same as the extant building with the exception of a few walls and doors which have since been added. An insurance plan dated 7 January 1893 (WSHC ref 2515/403/1617; not reproduced) depicts the shed within the Site and records it as the *Carriage Repairing*

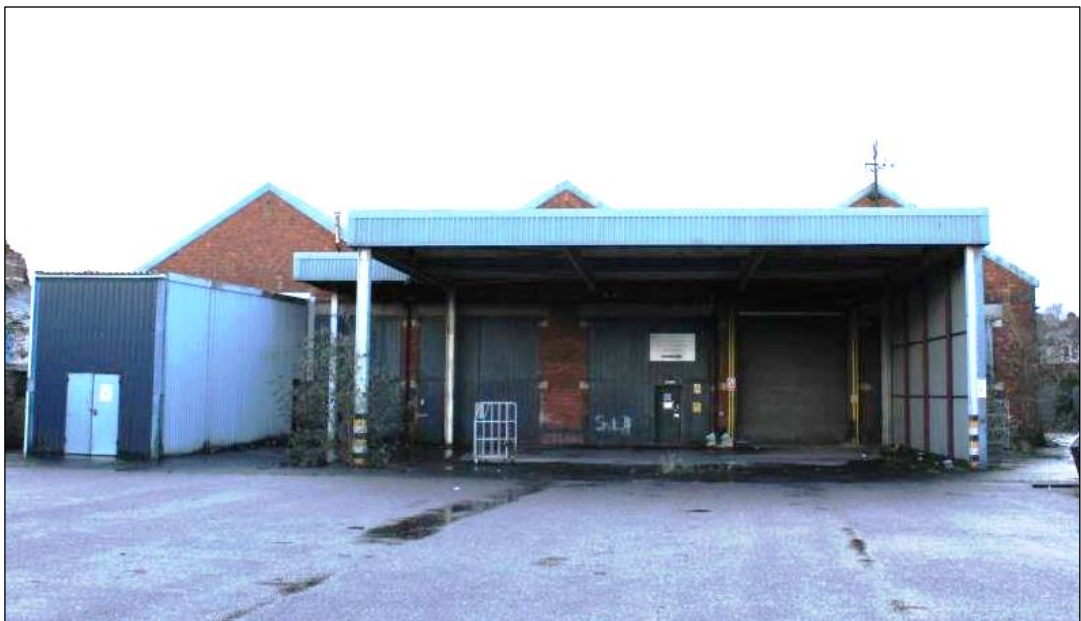
Photograph 1 General view of the north Elevation

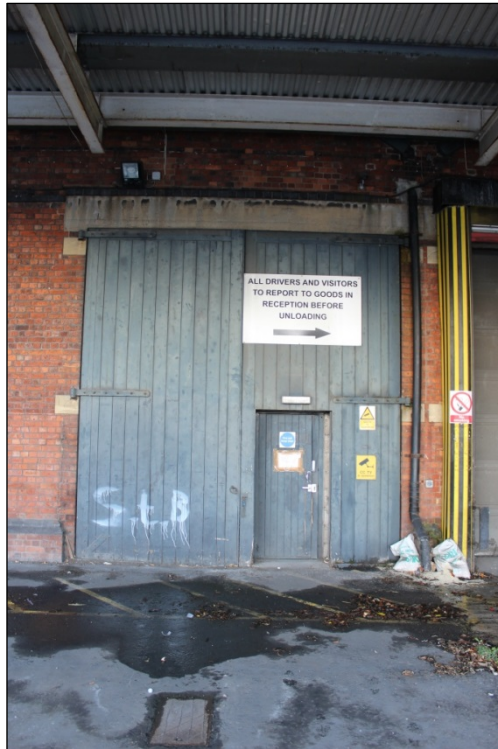
- 5.2. An examination of the interior of the door shows that the carriage door has been boarded up on the inside with the pedestrian door still accessible. This implies that the pedestrian door is a later insert. At mid-height and the top of the door, on both sides is an ashlar stone, which appears to have been a decorative and functional feature as the hinges are attached to it (Photograph 2). These stones are on the side of the metal roller door (Photograph 3) implying that there was formerly timber door at this location, which was replaced by the modern metal roller door.

Photograph 2 Sample of the former carriage doors now blocked up on the interior with a pedestrian door inserted and stone dressing

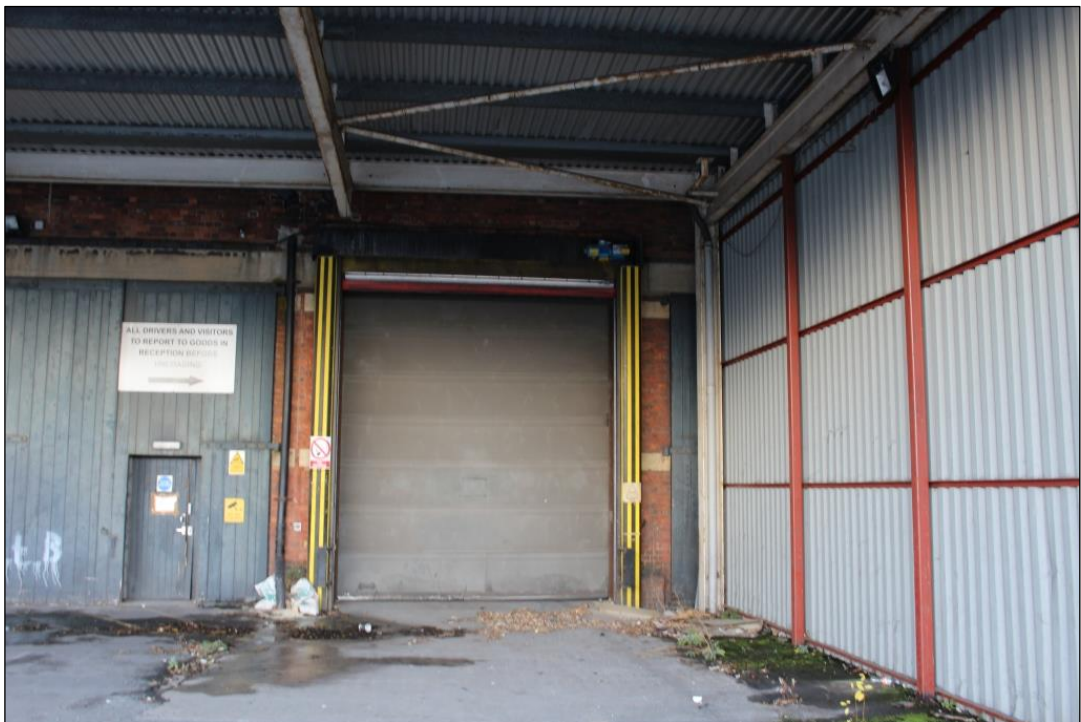
Photograph 3 Later inserted metal roller door with the remains of the stone dressings still in place

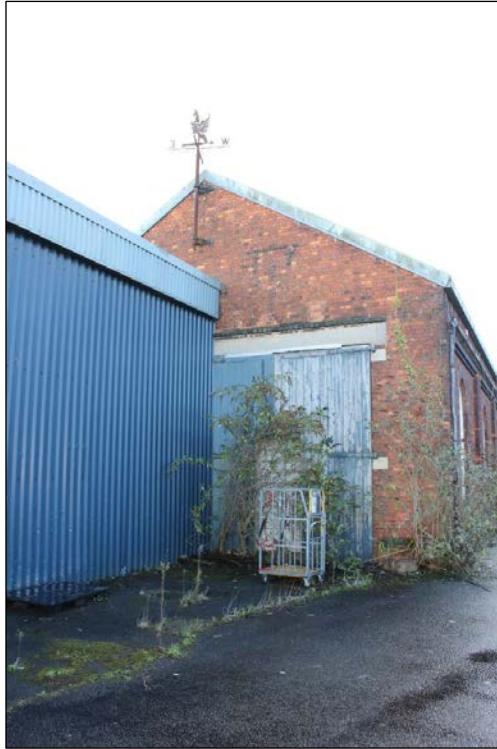
- 5.3. At the apex of the western most gable is a weather vane with a Pegasus design (Photograph 4).

Photograph 4 Western edge of the north elevation with the overlapping of the later canopy and Pegasus weather vane

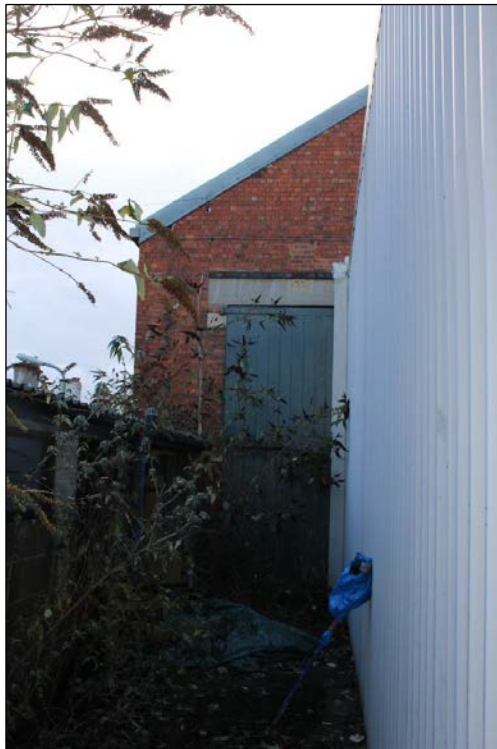
Photograph 5 Eastern extent of the north elevation with the overlapping container and timber door

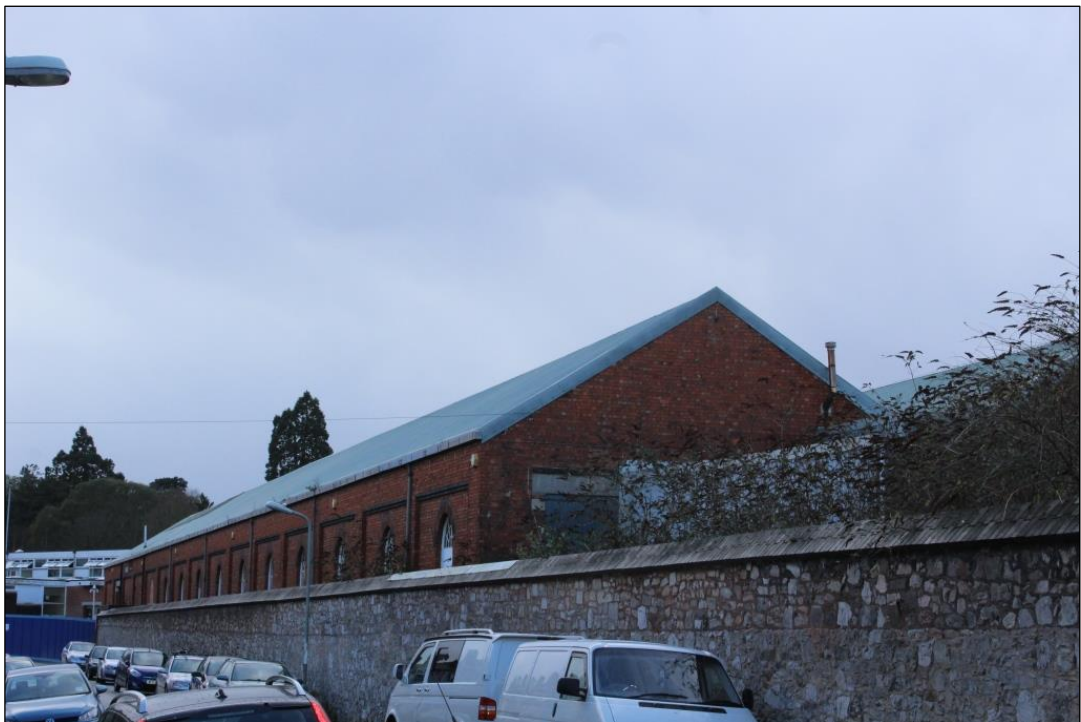
-
- 5.4. The east elevation is predominately obscured by the stone walling which demarcates the property boundary and the modern boarding which was erected by contractors for safety reasons and was inaccessible during the Site visit (Photograph 6). Along the elevation are a series of recessed walling with two courses of engineering (possibly Staffordshire Blue) bricks in a stepped design forming the top (Photograph 7). Within the ten northern most are arched windows with an arched brick lintel and decorative arched band in dark grey/blue engineering brick above.

Photograph 6 General view of the east elevation with the stone boundary wall

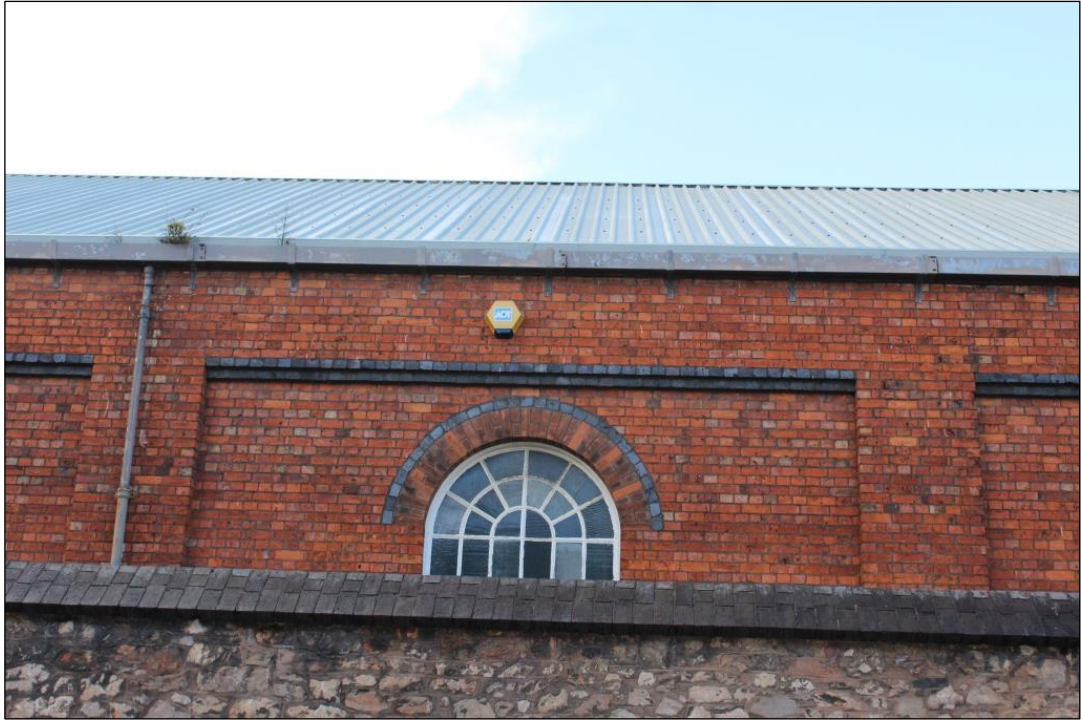
Photograph 7 Sample of the recessed walling with an arched window

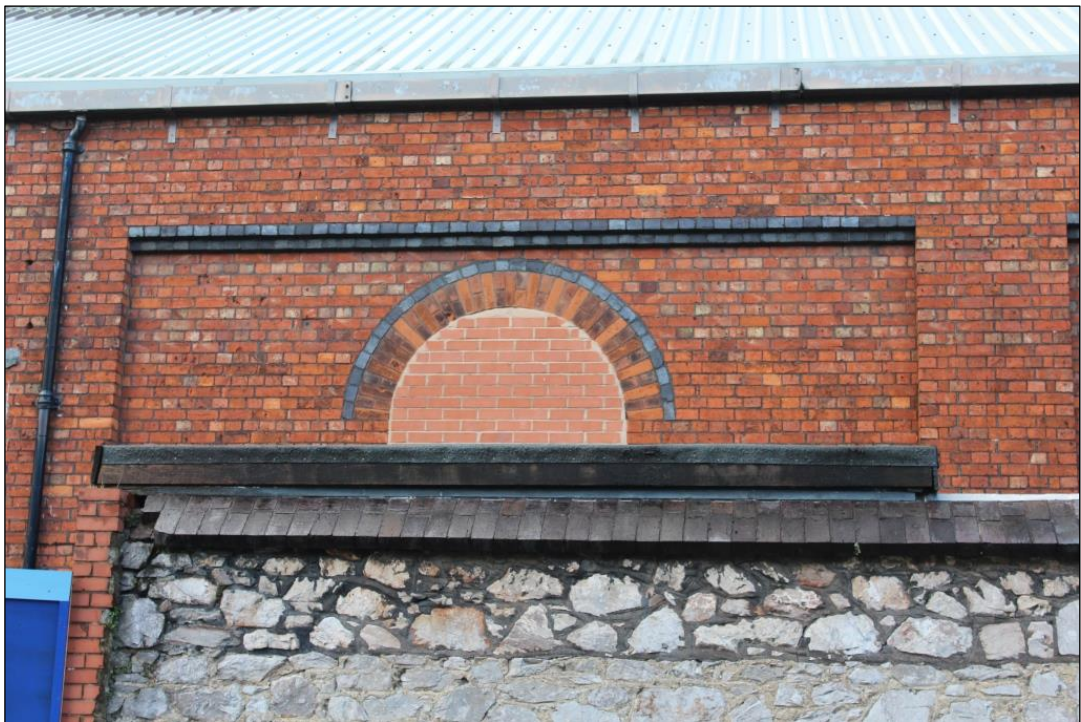
- 5.5. At the southern extent of the row of windows is a bricked in arched window with a porch beneath (Photograph 8). This indicates that the porch was added at a later date and the window was bricked in to allow it. The appearance of the brick infilling would indicate that it was a recent change as they are smooth and have minimal tarnish, particularly when compared with the brick for the building. It was not possible to determine if there were any features in the southern-most recess (Photograph 9). There was a large modern door set into the entirety of the adjacent recess, with two small segmental-arched windows in the third recess and a modern square-headed window in the fourth recess from the south.

Photograph 8 Bricked in arched window in the eleventh recess from the north with a porch beneath

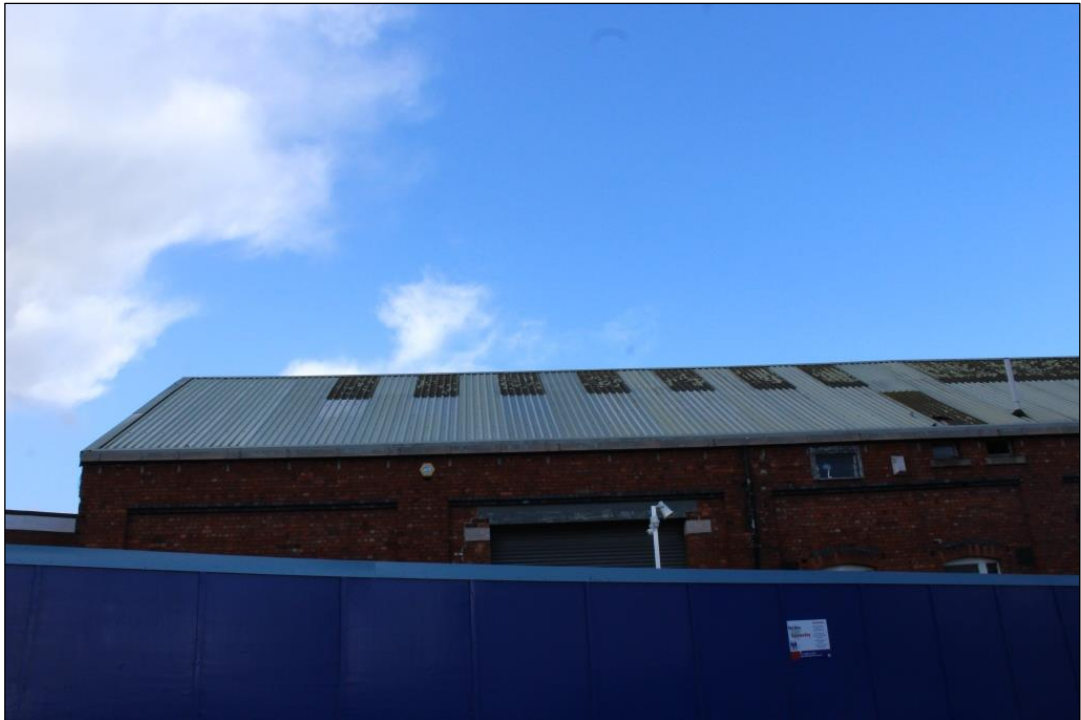
Photograph 9 Southern section of the east elevation with modern boarding prevent views

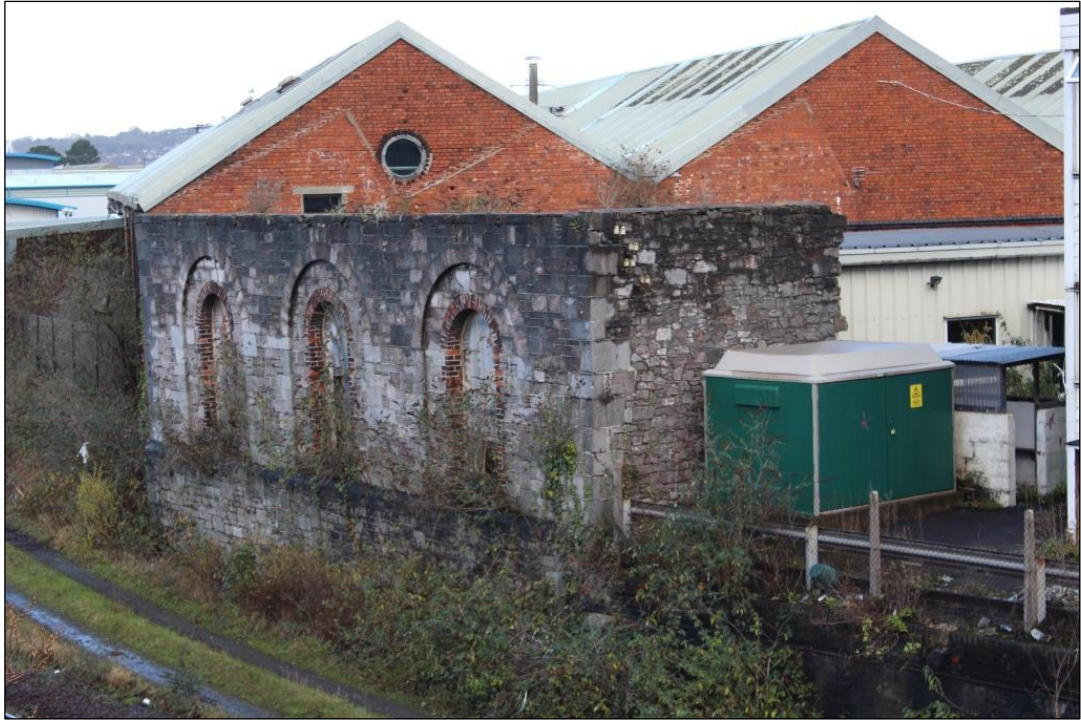
- 5.6. As with the east elevation, the south elevation could only be seen in part due to adjacent building form. In this instance the adjacent buildings prevented the ability to view the elevation in its entirety. The south elevation is formed of three gables, with the remnants of the former roof line of Building B, visible on the western most and central gable (Photograph 10). As with the east elevation there are a row of three recessed wall sections, one for each gable.

Photograph 10 View of the south elevation from the adjacent railway bridge showing the three gables and remnants of the former roof of the adjacent structure (Building B) and circular window in the western gable

- 5.15. The form of the roof structure can be seen from where it butted on to Building A (Photograph 10). This appears to have been a classic saw tooth structure, designed to allow the circular window in the gable of Building A to be retained. No other features of this structured survive.

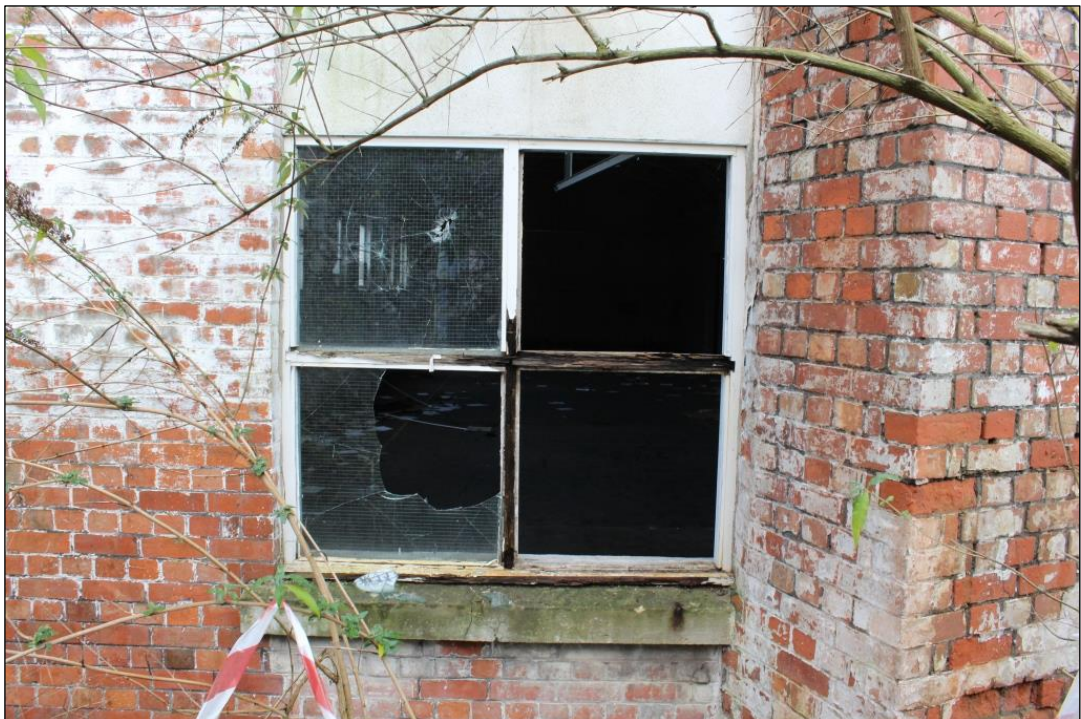
- 5.7. Within the centre of the western most gable is a circular window, with a square head window with a concrete lintel offset at the base of the gable and two square-headed windows with brick lintels at the lower part of the wall (Photograph 11).

Photograph 11 Sample view of the window within the lower part of the west gable

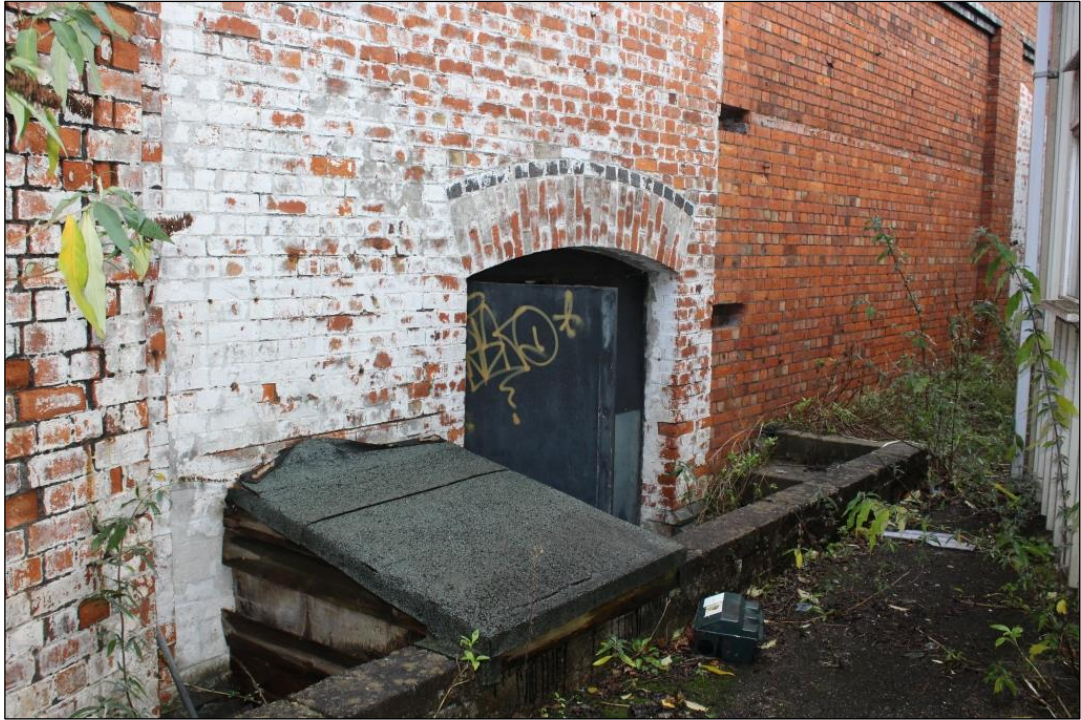
- 5.8. Within the centre gable is a segmental-arched door with the western part of the recessed walling having the remnants of white paint (Photograph 12). Between the western and central recess and in the centre of the western recess is a buttress set at an angle with the western side larger (Photograph 13). The reason for the irregular shaped buttress is unclear; however, the removal of the former stone structure would imply that they are a later addition and positioned as such to correlate with later development within this part of the Site. The eastern most recess was obscured by the adjacent modern building which has been connected to the carriage shed via an opening at this point.

Photograph 12 Central recess with the door and steps leading to the exterior of the building

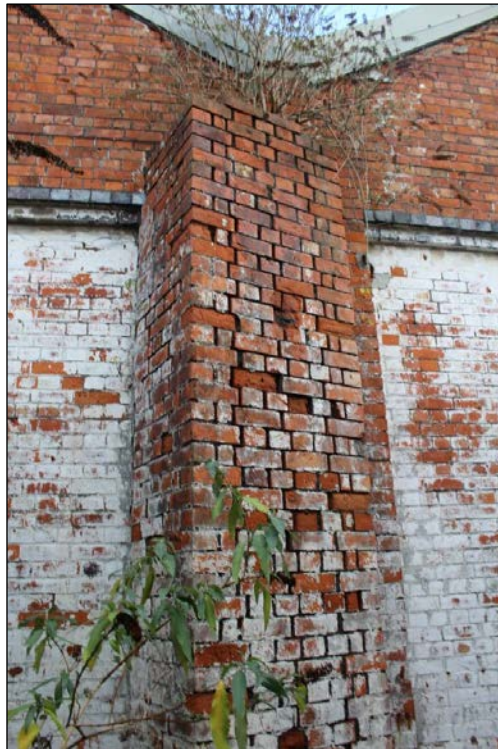
Photograph 13 Sample view of the irregular buttress located in the centre of the west recess and between the west and central

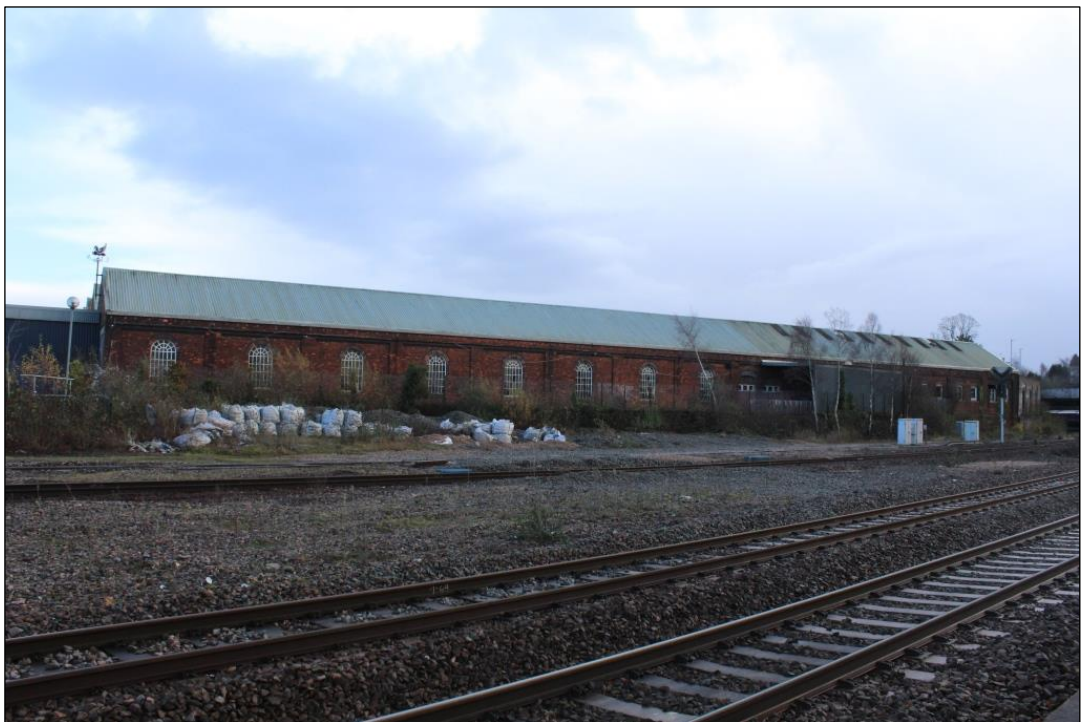
5.9. The west elevation fronts onto the railway tracks. The elevation is similar to the east elevation with a series of recessed sections, with the eight northern recesses

Photograph 14 General view of the west elevation taken from the Station car park

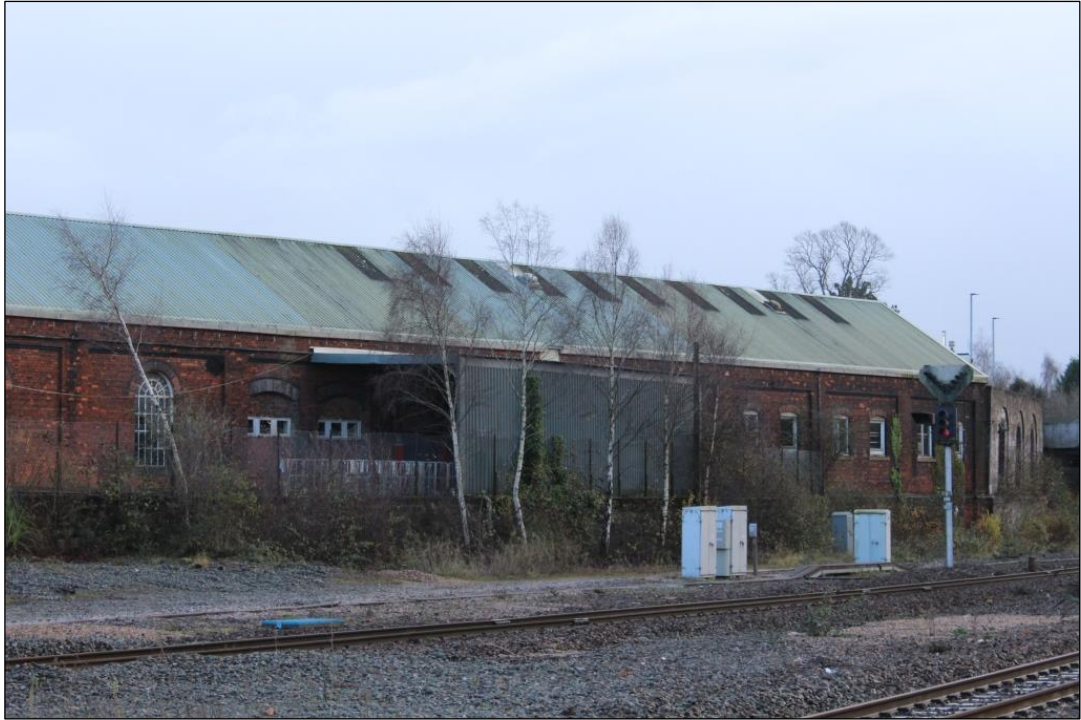
containing long arched windows (Photograph 14). Off centre, to the south is a corrugated sheet canopy which is open on the northern side (Photograph 15). The recessed wall sections continue under the canopy with two segmental-arched openings in each which have been partially bricked in and windows and doors inserted (Photograph 16). The southern-most four recesses are to the south of the canopy, with two segmental-arched windows in each (Photograph 17).

Photograph 15 View of the canopy off centre to the south on the west elevation

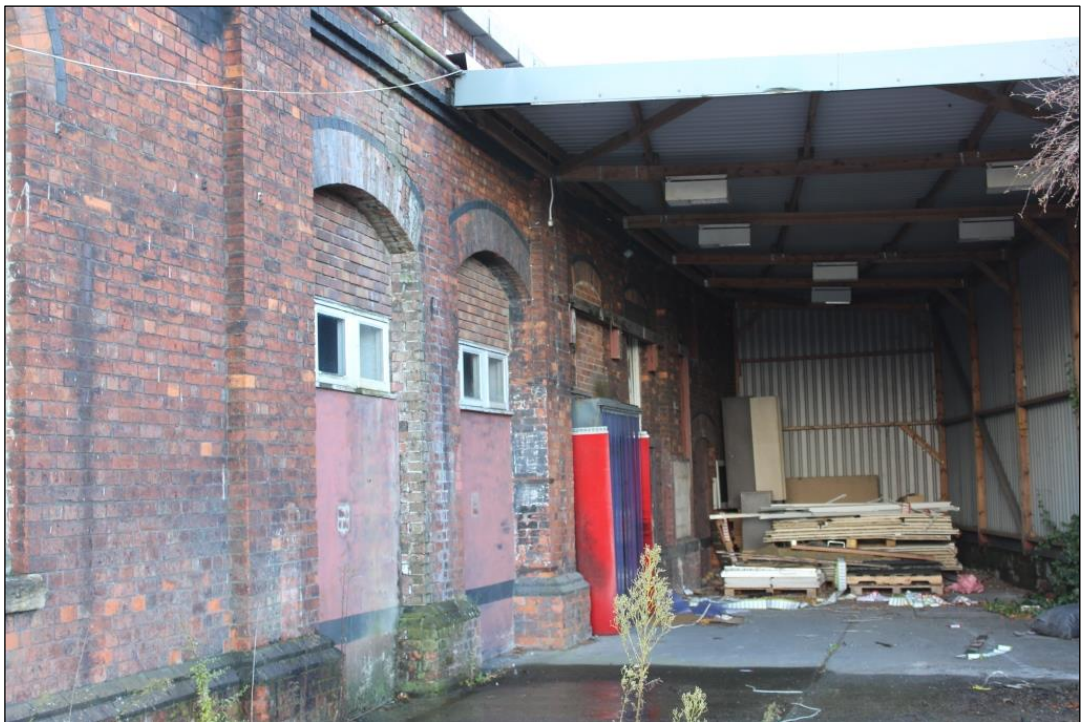
Photograph 16 Sample shot of the features continued under the canopy on the west elevation

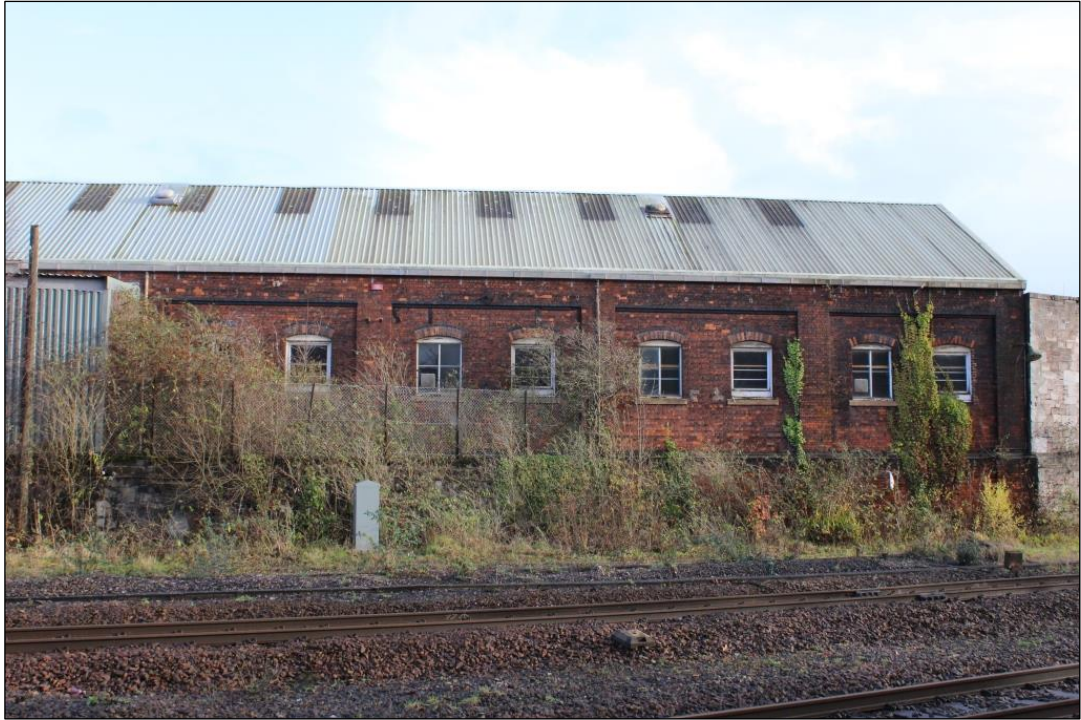
Photograph 17 View of the southern part of the west elevation

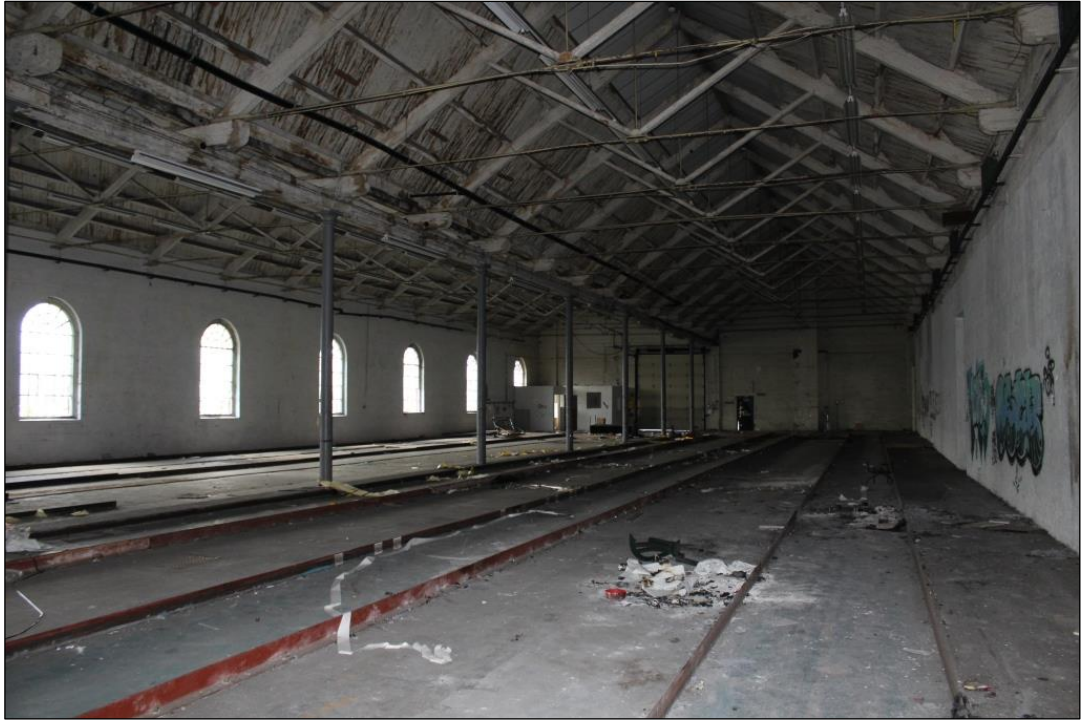
- 5.11. The interior of the building has been stripped of the majority of historic features and suffered a degree of vandalism. This section will focus primarily on key features, which are mainly concentrated within the northern part of the building in two large rooms (Fig. 4, Room 1 and 2). Room 1 is to the north and retains five sets of low metal uprights orientated north to south (Photograph 18 and 19), which appear to relate to the more recent use of the structure as a store and may be the remnants or storage racking bays. Along the centre of the room is a row of metal, most likely cast iron, pillars set on a raised strip of concrete and which support the joint between the west and central roof sections. Between each set of tracks is a narrower strip with concrete infilling at either end. The dividing wall between room 1 and 2 is set along the joint between the central and east roof section with a bricked in doorway in the centre. There are three sets of tracks in room 2 which do not extend the full length of the room but would have previously (Photograph 20).

Photograph 18 General view of room 1 looking to the north-west with the row of pillars and bricked in north wall and pedestrian door

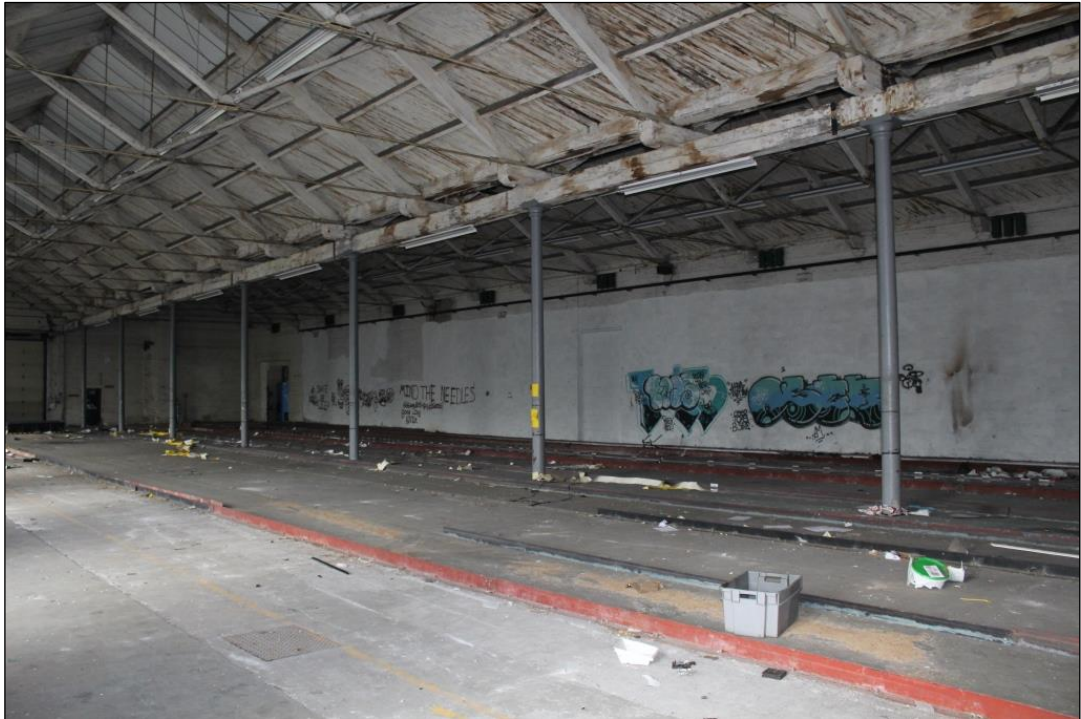
Photograph 19 General view of the room 1 looking to the north-east

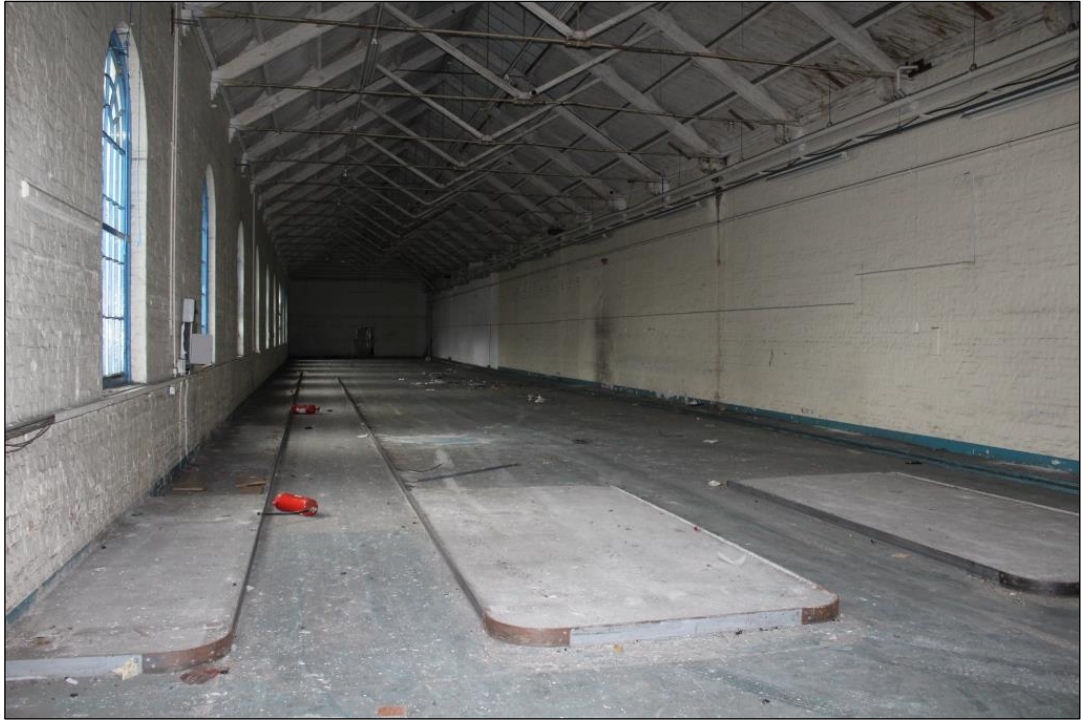
Photograph 20 General view of the room 2 looking to the south-west

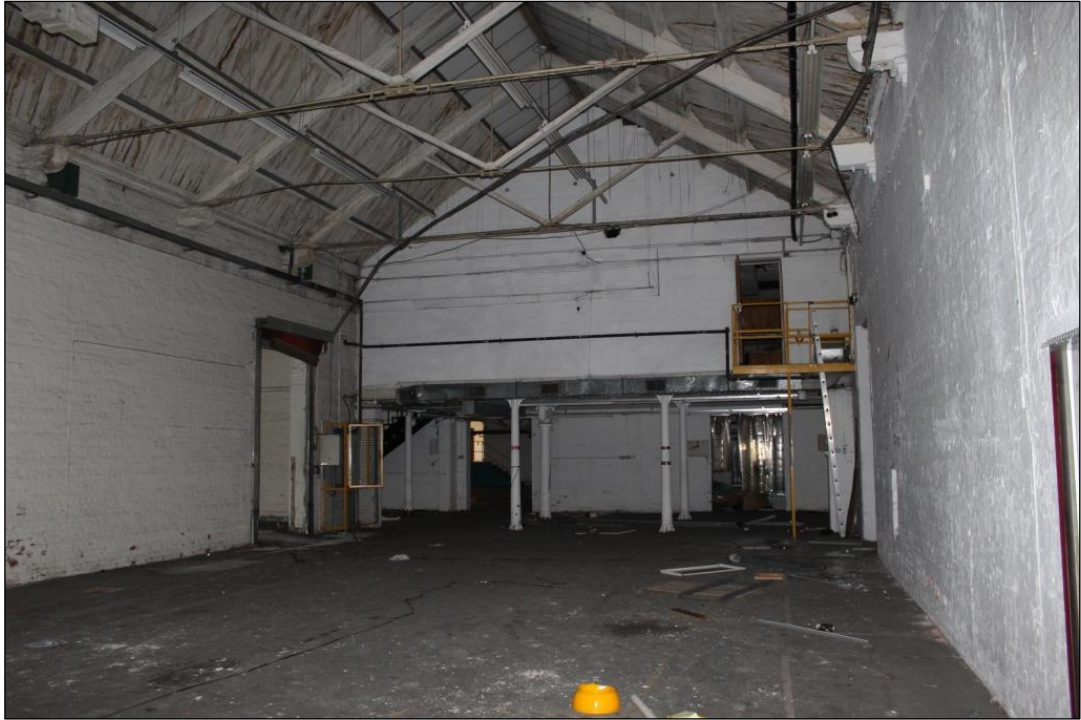
- 5.12. Within Room 3 to the south of room 1 and 2, there is a mezzanine at the southern extent which is accessed via a metal staircase in the south-east corner (Photograph 21). The mezzanine is supported on five pillars, four of which taper inwards to the top with capitals to connect them to the underside of the mezzanine. The south central pillar is the same size throughout and topped with a wide brace (Photograph 22). There are two additional pillars in room 4, which support the roof along the joint between the east and central sections (Photograph 23). Within room 5 there are a series of pilasters set between each window with a stepped base pattern (Photograph 24).

Photograph 21 Mezzanine in room 3 supported on pillars

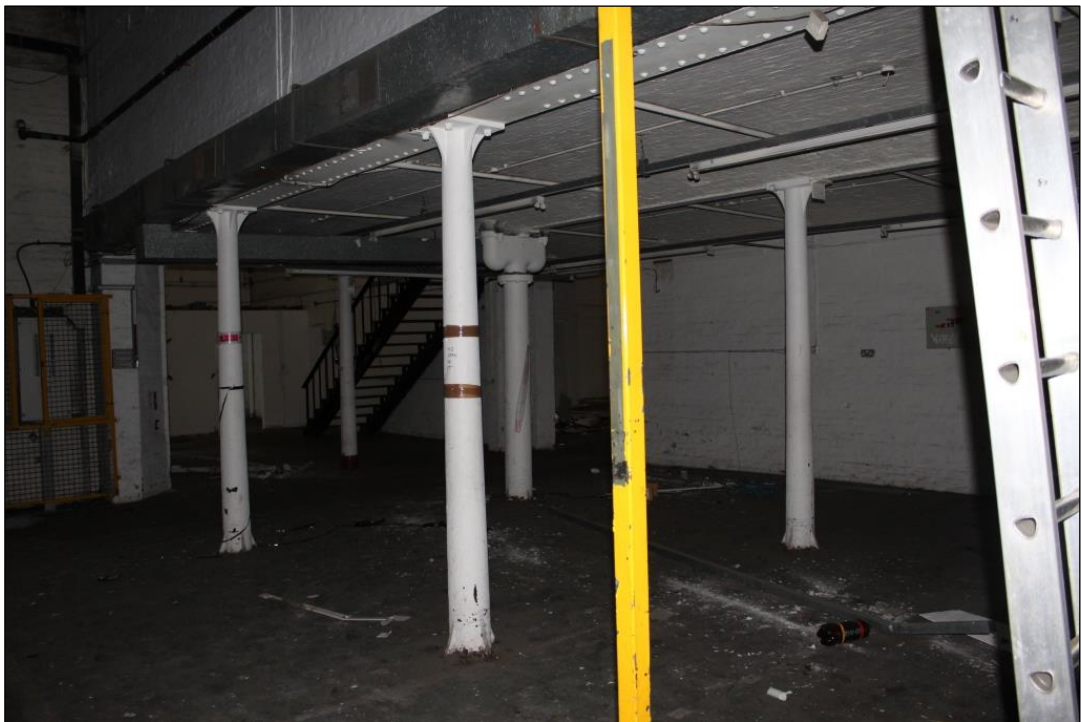
Photograph 22 Detailed view of the pillars supporting the mezzanine

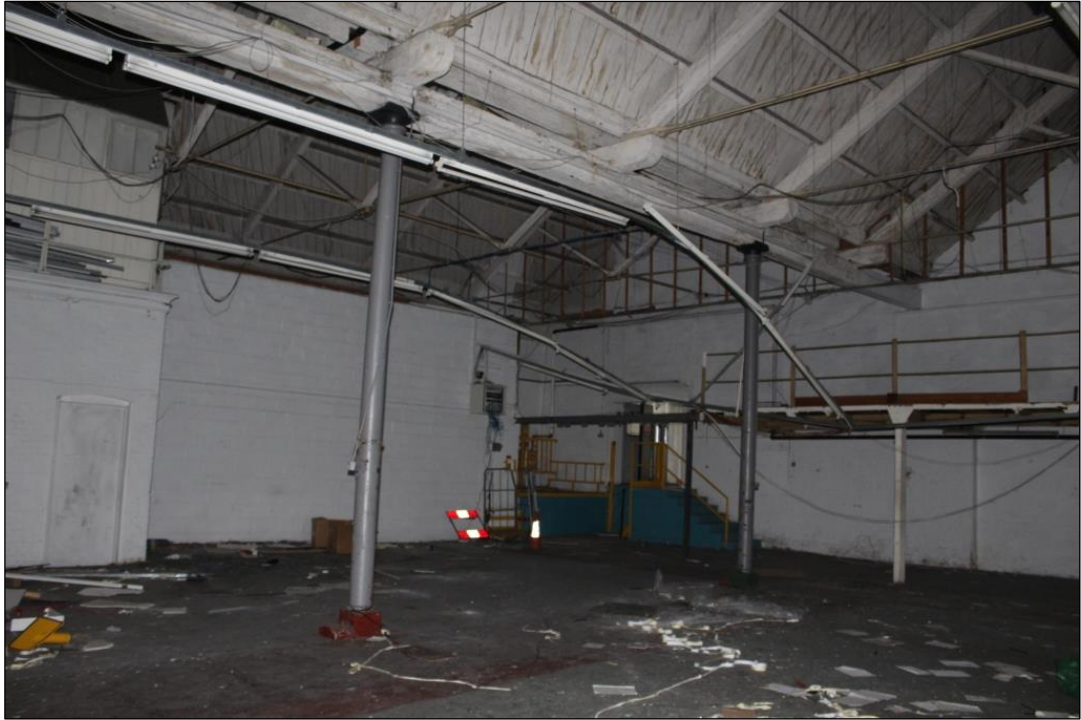
Photograph 23 General view of room 4 looking to the south-east

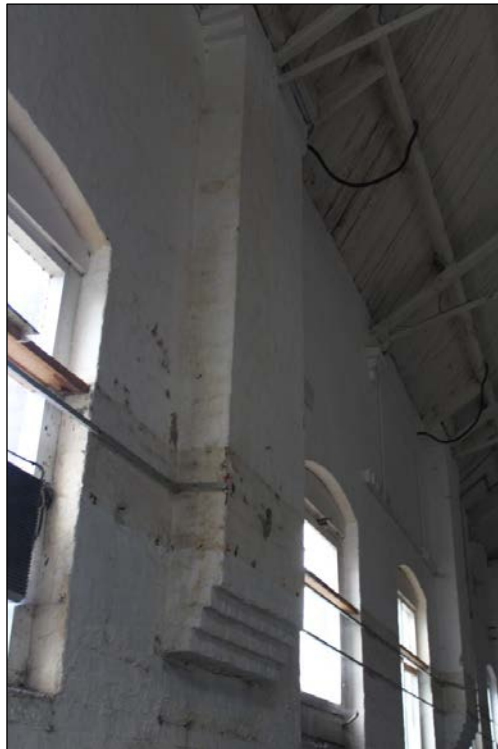
Photograph 24 Detailed view of the stepped base on the pilaster between each window in room 5

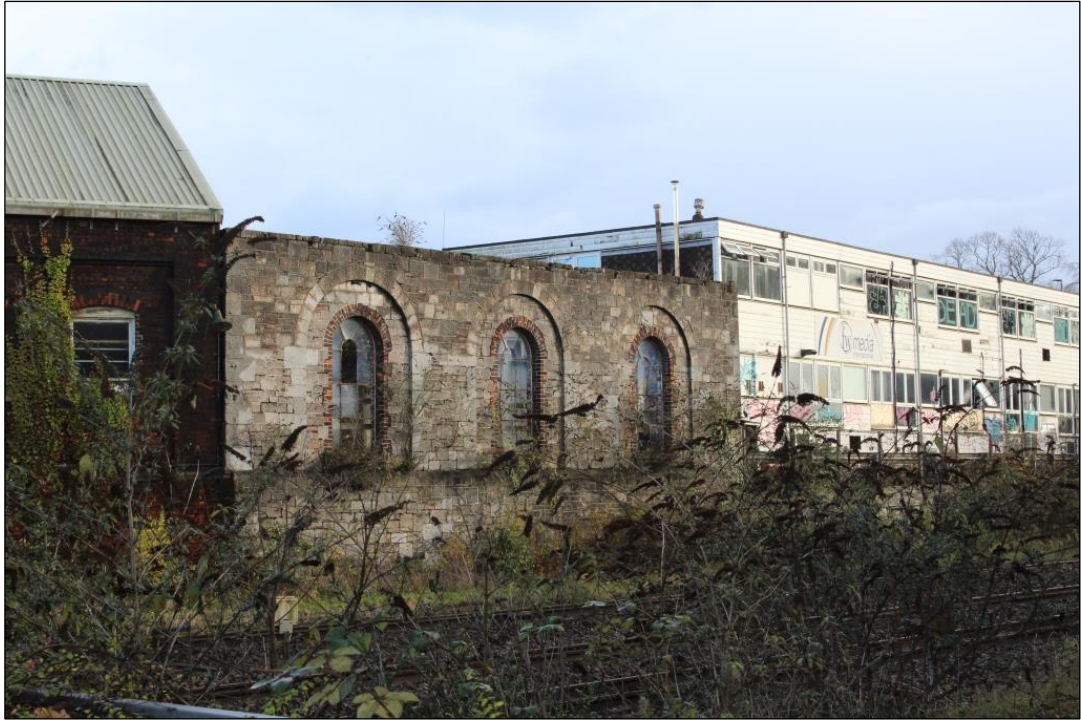
- 5.14. Building B comprises the remains of what appear to be an extension to Building A, which was located immediately south of the brick carriage shed, and consists of two sections of walling which would have been the west (Photograph 25) and part of the south elevation (Photograph 26). The wall and roof structure were clearly butted up to the existing carriage shed. The surviving elements are in stone with brick detailing. The south elevation is predominately obscured by a modern sub-station and does not appear to retain any features. As with Building A, the west elevation fronts onto the existing railway lines. The elevation has three large arched windows lined in brick with a recessed section of stone walling surround which is framed in stone dressing. The stonework, when viewed from the west (external facing) is of cut stone and conscientious positioning. However, when viewed from the east (internal facing), the wall appears to be constructed of uncut stones and in a rough design (Photograph 27). With the exception of the windows the west elevation retains no features.

Photograph 25 General view of the west elevation of Building B as seen from the Station car park with the three arched windows

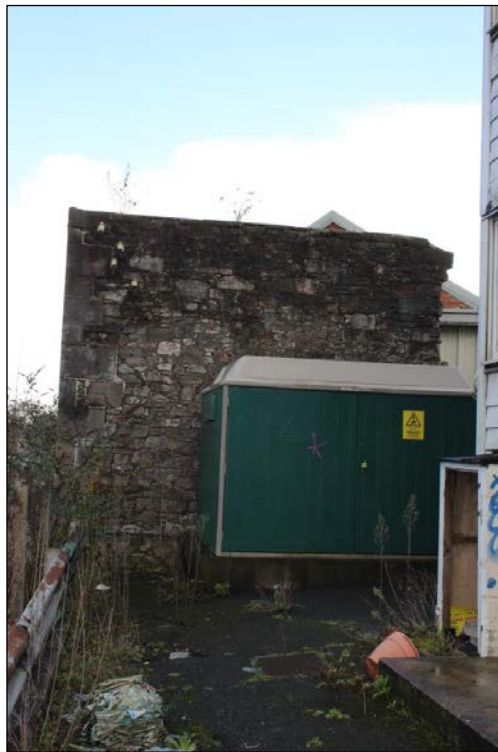
Photograph 26 General view of the south elevation of Building B with the sub-station obscuring a section of the elevation

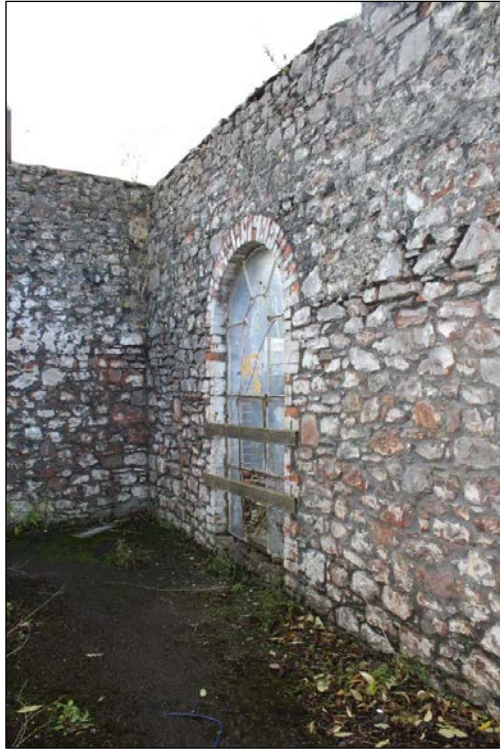
Photograph 27 Sample shot of the internal view of **Building B** with the rough-cut stone work

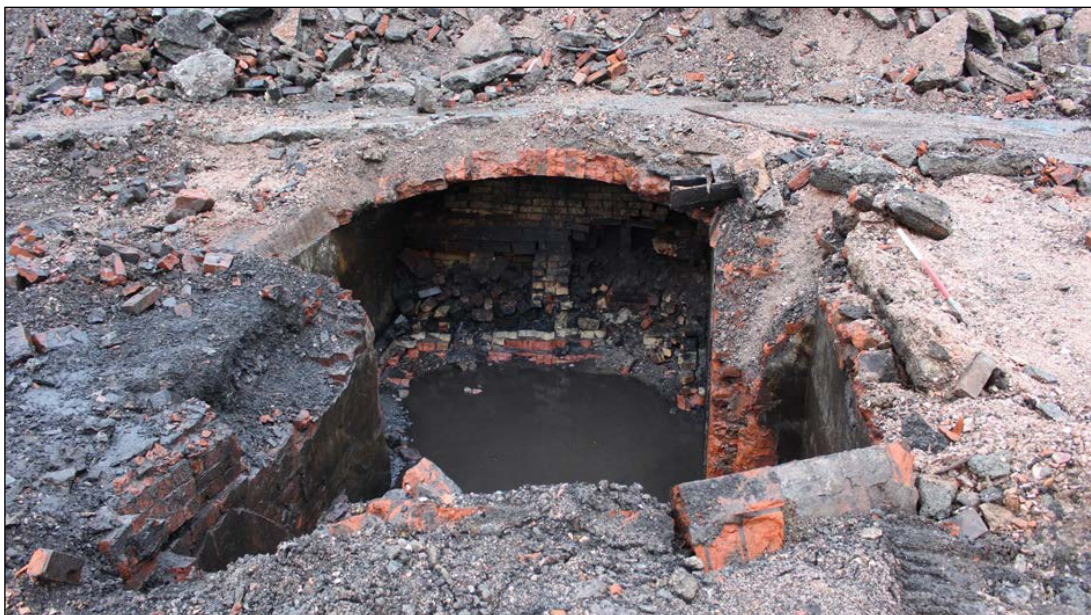
- 6.4. At the northern end of the shed, basement 105 (Photo 28) was identified with two sets of two furnaces (?) set into wall 107 on its northern edge. This wall was constructed of pale brown fire bricks, while the remainder of the basement was constructed of the same unfrosted red bricks as the shed and was lined with 10mm of cement. The basement measured c. 3.2m by c. 4.5m and was irregular in shape. It was apparent that the floor and steps had been largely removed during demolition.

Photograph 28 Basement 105 with furnaces in the background, facing north
