Aldi Foodstore Newton Abbot Devon

*Historic Building Recording and
Archaeological Watching Brief*

CA Project: 880272

CA Report: 17727

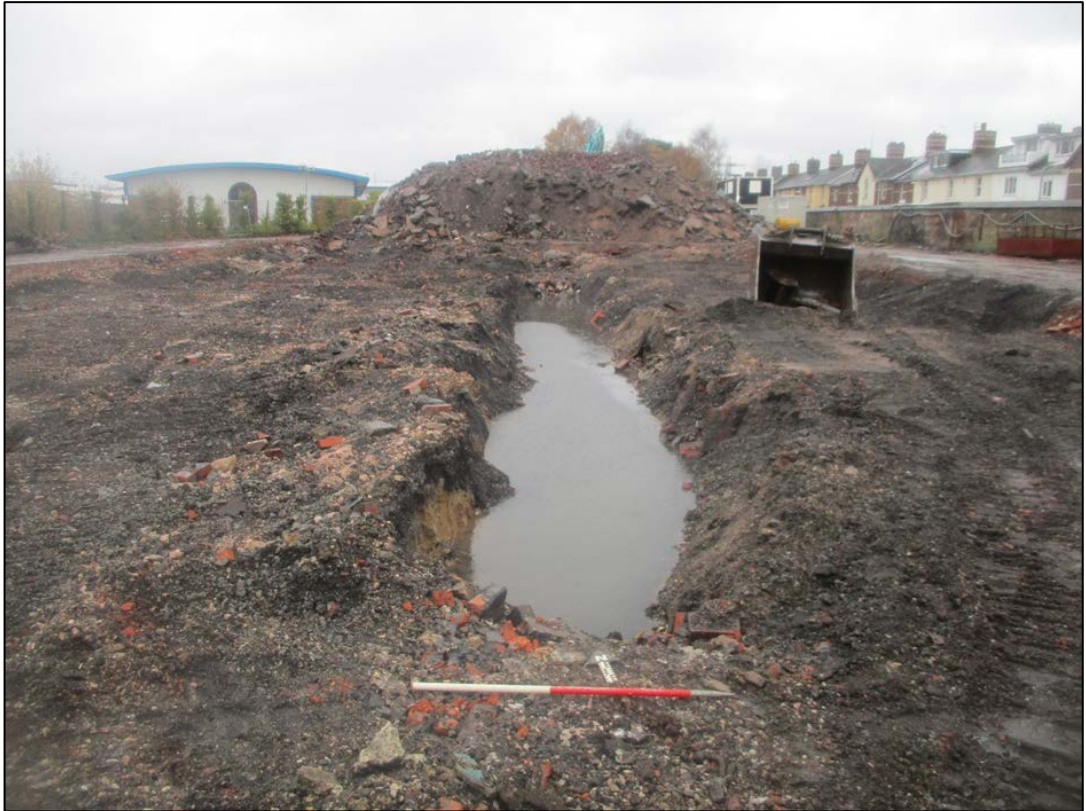
-
- 6.5. The robber cuts (102 and 109) of two inspection pits (Photo 29) were identified within the interior of the shed. These measured up to 40m in length and up to 2.6m wide. It was apparent that any interior masonry had been removed during previous demolition when the building was repurposed. These features had been backfilled with demolition material.

Photograph 29 Robber cut 102 of a former inspection pit, facing north
