Bodmin Jail Bodmin Cornwall

Archaeological Watching Brief

CA Project: 880210
CA Report:880210_1

February 2021

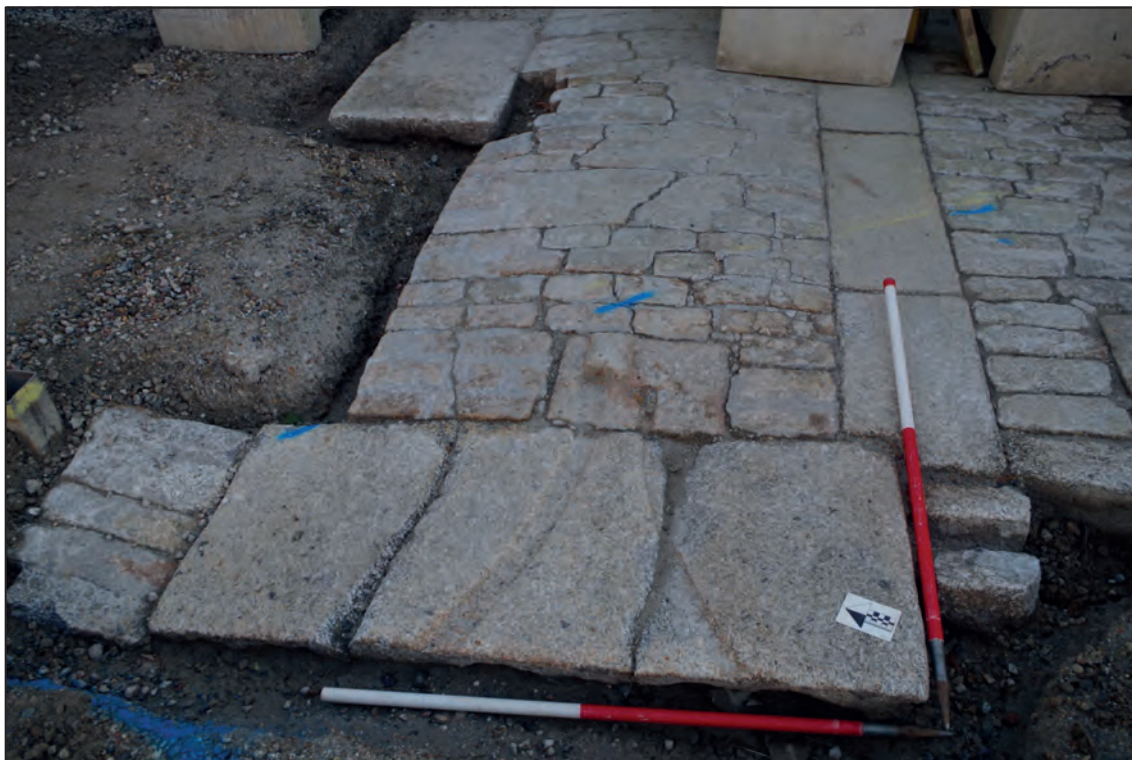
6

5.34. Trench 34 was located in the north-eastern part of the site, within the former main entrance to the jail, where the remnants of a granite flagstone floor surface (185) were identified (Fig. 6). This surface was exposed immediately beneath the existing gravel path and was constructed from large granite flagstones and smaller square-cut cobbles. Two square granite piers (192) were present to the north-west and south-east of the surface. Metal hinge plates were visible on the piers; the pattern of wear to surface 185 indicated that gates were supported on the hinges, and that these gates opened inwards. These are likely to have formed the easternmost of two pairs of gates that allowed access through the entranceway from Bodiniel Road into the Civil Prison (as evidenced by the remnants of a gate pier in Trench 11 to the south-west, and the depiction of four piers on the 1929 sale plan). A small area at the east of the surface appears to represent modern re-positioning and grouting (193) of the original cobbles (185).

Surface 185 comprising large granite flag stones and smaller square cut blocks, looking east (1m scales)

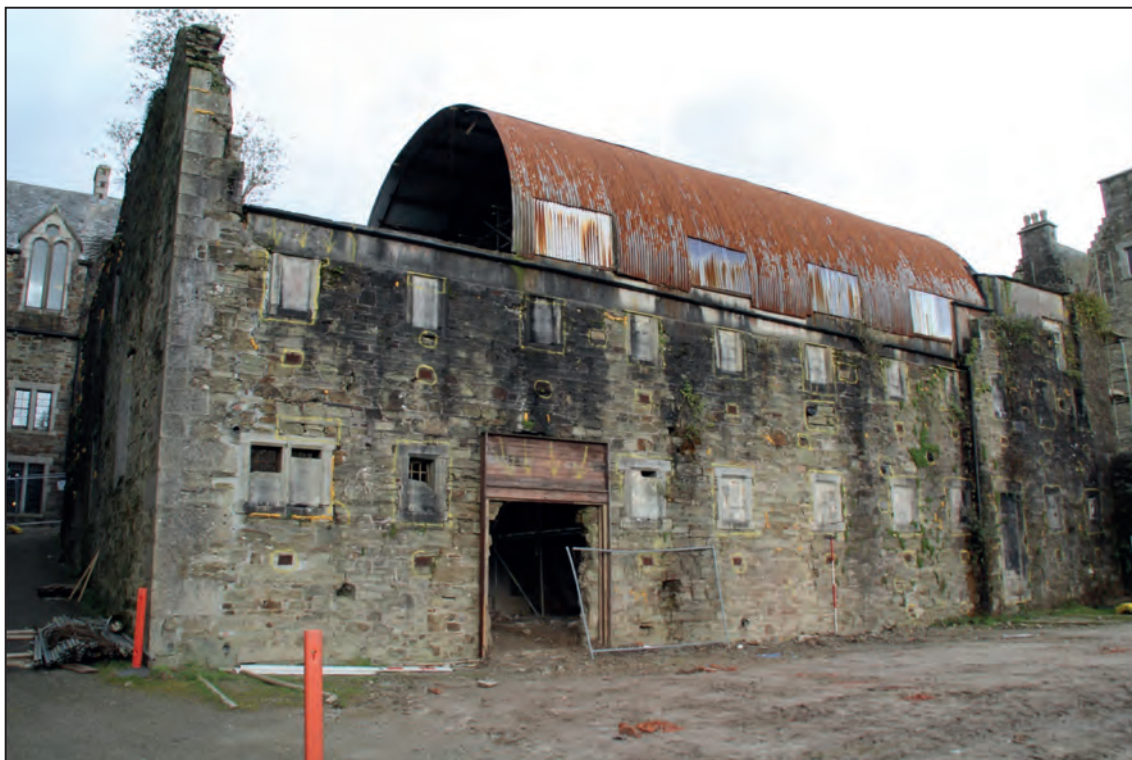
7

- 5.4. As part of the present works, the Naval Prison Hospital Block building (Fig. 7) was demolished. A detailed Historic Building Recording was undertaken prior to demolition (CA 2021) and basic recording of the above-ground remains (including the assigning of context and room numbers; Fig. 4) was carried out as part of the watching brief. Below-ground archaeological remains were investigated in Trench 12 and exposed in the northern parts of Trenches 13 and 15 to the south of the former hospital block (see below).

South elevation of the Hospital Block, looking north-east

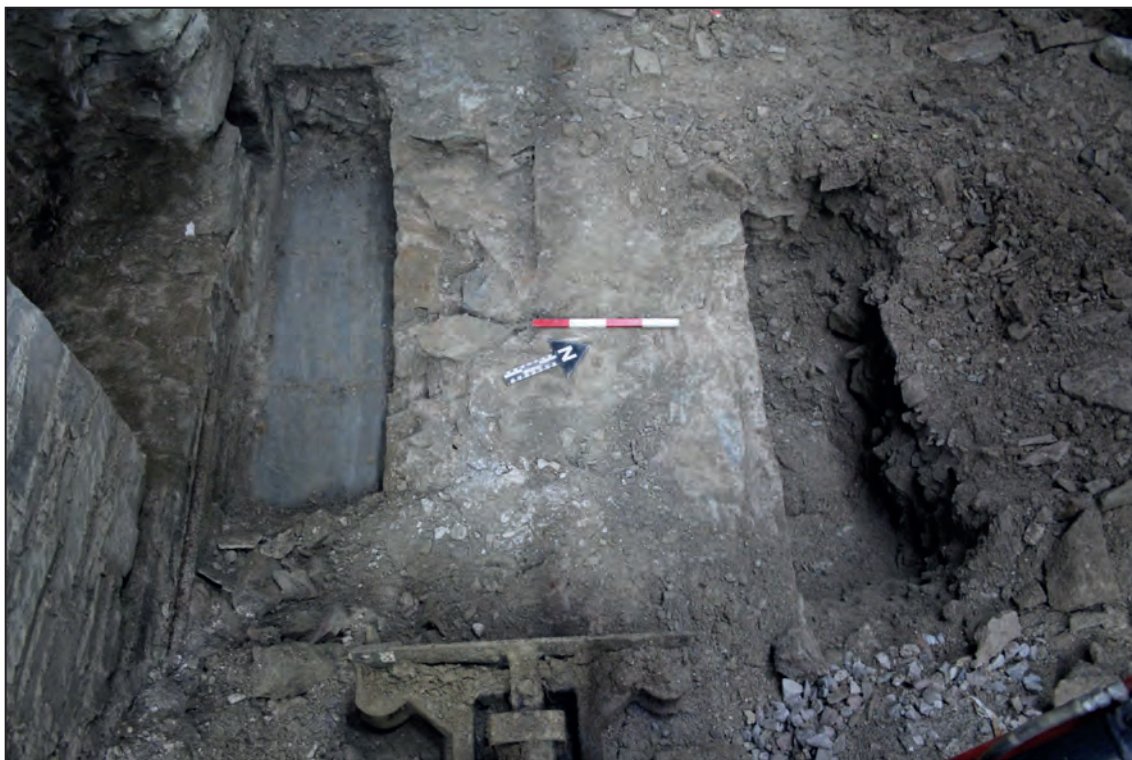
11

Wall 20011, with surface 20012 at the base of a gully between wall 20011 and extant wall 20010, looking north-west (0.4m scale)

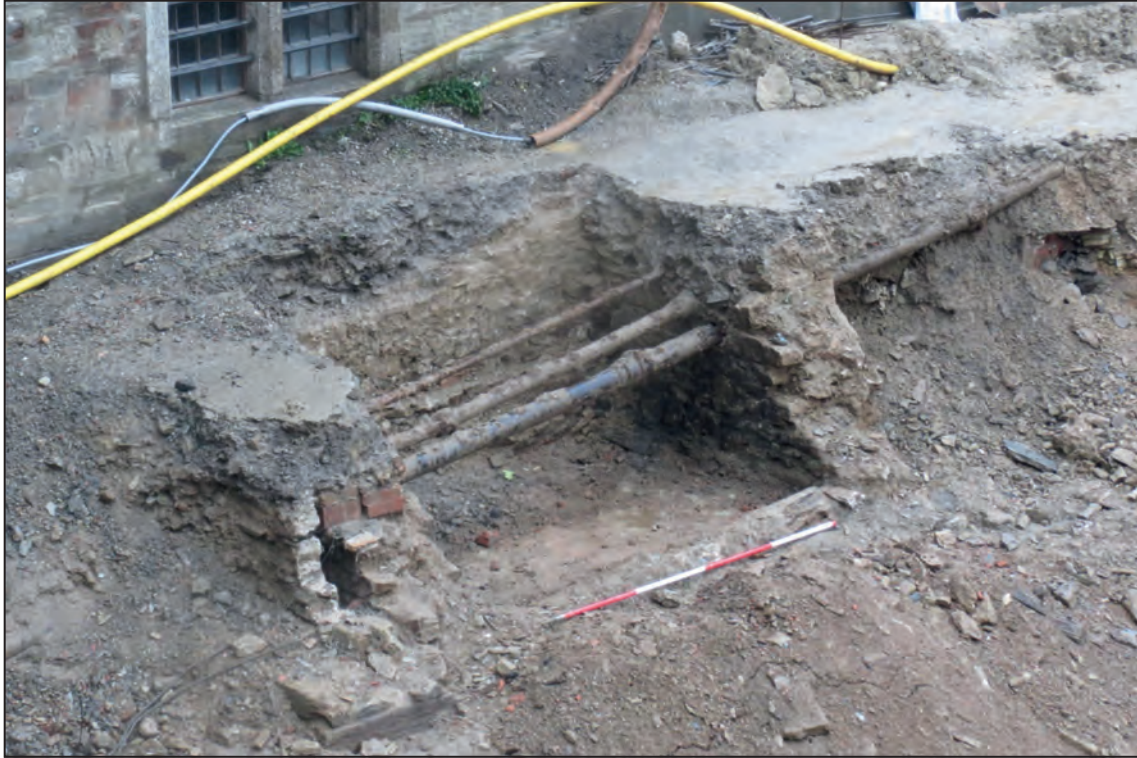
12

5.21. Trench 19 was located to the immediate west of Trench 11 and measured approximately 10m by 3.5m. A small rectangular mudstone and granite structure (230, Fig. 12) measured 5m by 2m with a height of 1.1m. Two stepped granite slabs (part of context 230), located on the south-eastern edge, possibly indicate a former threshold. Structure 230 had been truncated by modern services and infilled with a succession of levelling deposits. The original function of this structure is unclear. A similar structure was identified in Trenches 24 and 30 to the east of the Offices and Administration block of the Civil wing.

5.22. Structure 230 was truncated to the north-west by construction cut 241 for wall 243. This wall was located approximately 0.8m south of the Civil wing; its upper surface was flush with the present ground level. Wall 243 appears to have defined a space for service runs, similar to wall 197 in Trench 11 and probably a continuation of the same feature. A brick drain (245) and mudstone wall of unclear function (246) were also present in the trench. All structures and deposits were sealed by made ground 228.

Structure 230, oblique view, looking north (2m scale)

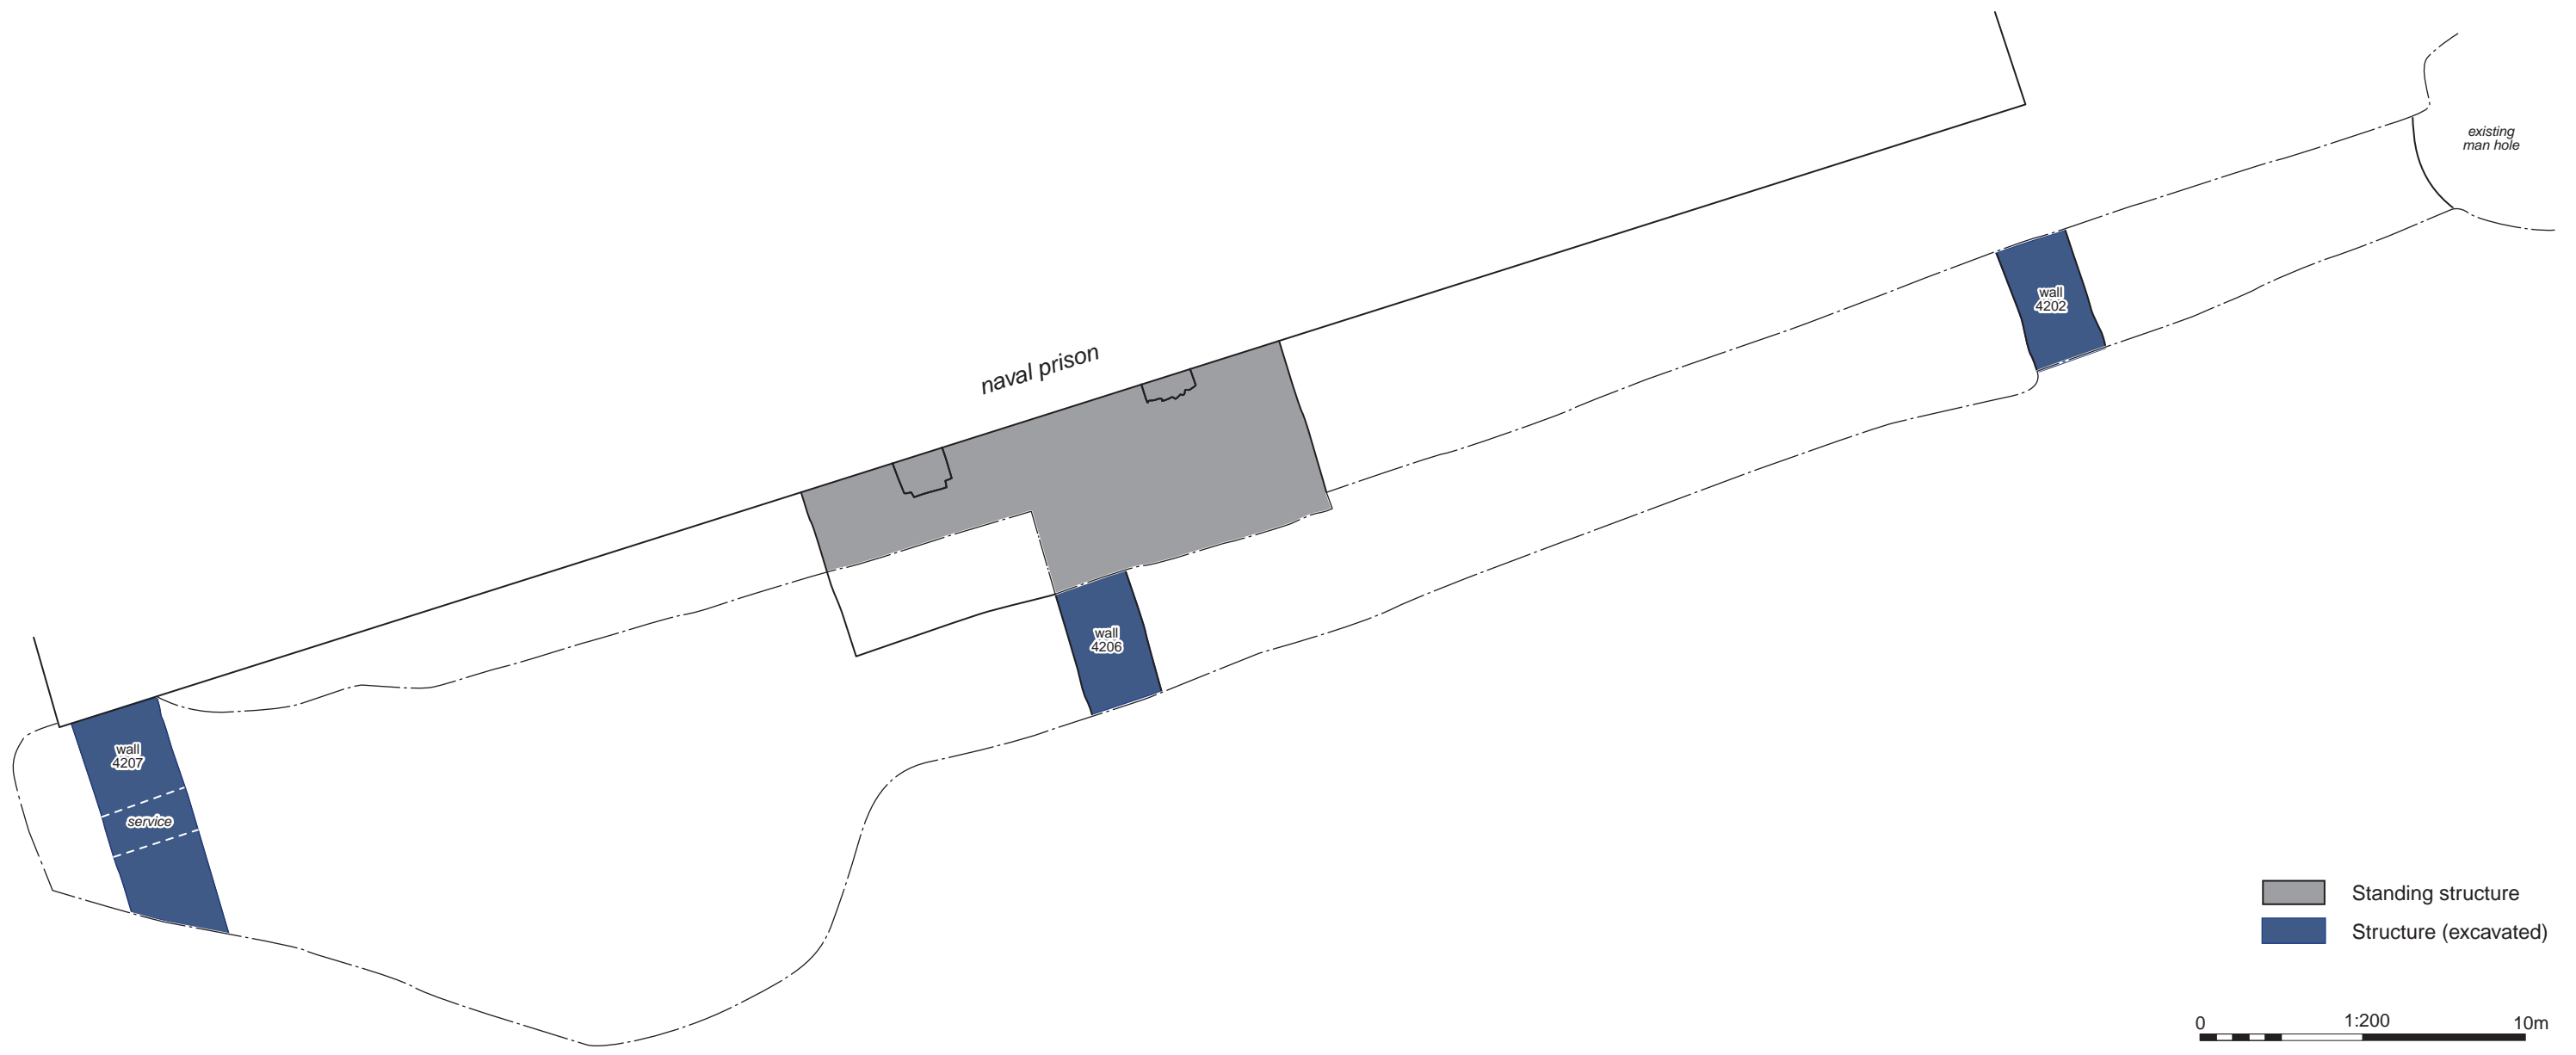
DRAWN BY	RW	PROJECT NO.	880210	FIGURE NO.
CHECKED BY	DJB	DATE	08/12/2020	13
APPROVED BY	LC	SCALE@A3	1:200

5.42. Trench 42 was located to the south-east of the Naval wing (Fig. 13). Three wall foundations were identified within this trench (4202, 4203 and 4207), all on the same alignment as the existing prison building. Each of the wall foundations were 0.55m in width, constructed of large stones and hard yellow lime mortar and were not fully exposed, continuing beyond the 2.60m maximum depth of the trench. Wall foundation 4202, at 0.72m bpgl, corresponded directly with the eastern wall of the Naval wing, although no relationship was observed between this wall foundation and the existing structure. Wall foundation 4206, at 0.75 bpgl, was only partially exposed but was located within the centre of the Naval wing porch. Wall foundation 4206 was also found to be overlain by the concrete footing of the Naval wing porch.

FIGURE TITLE
Trench 42: plan

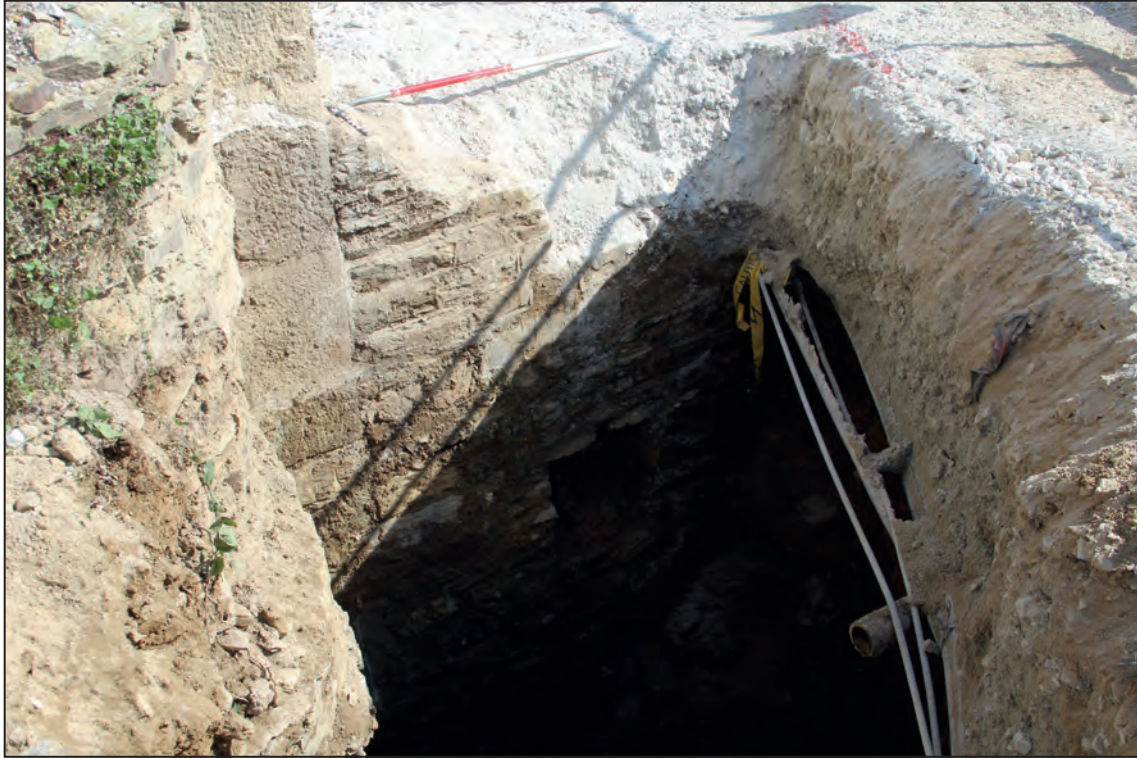
14

5.43. Wall 4207 (Fig. 14) was in direct alignment to the Naval wing's south-western edge and was observed to have been partially built over by the existing prison block (Fig. 13). The 1909 plan of the Naval Prison (Fig. 3) indicates that this wall separated the prisoners exercise yard to the west of the Naval wing from its entrance in the south-east (Fig. 14). The presence of a small 0.62m x 0.55m opening in the wall is thought to have been for services and was purpose-built into the wall rather than a later alteration.

South-west face of wall 4207, looking south-east (1m scale)

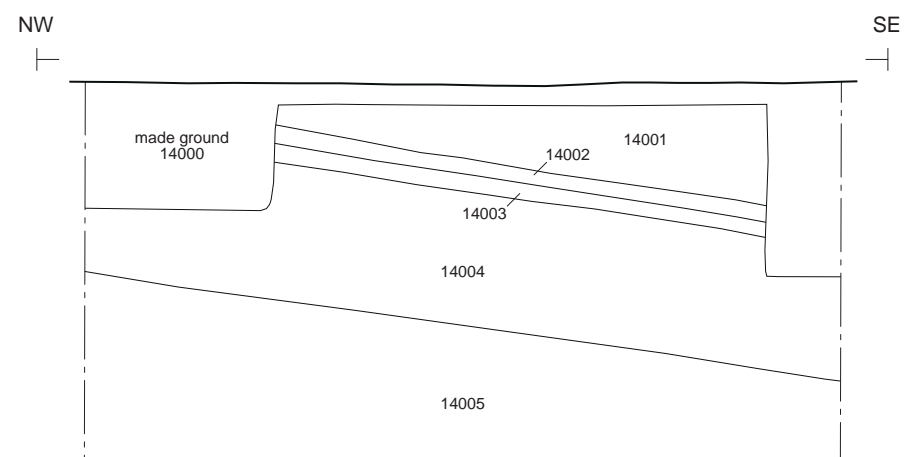
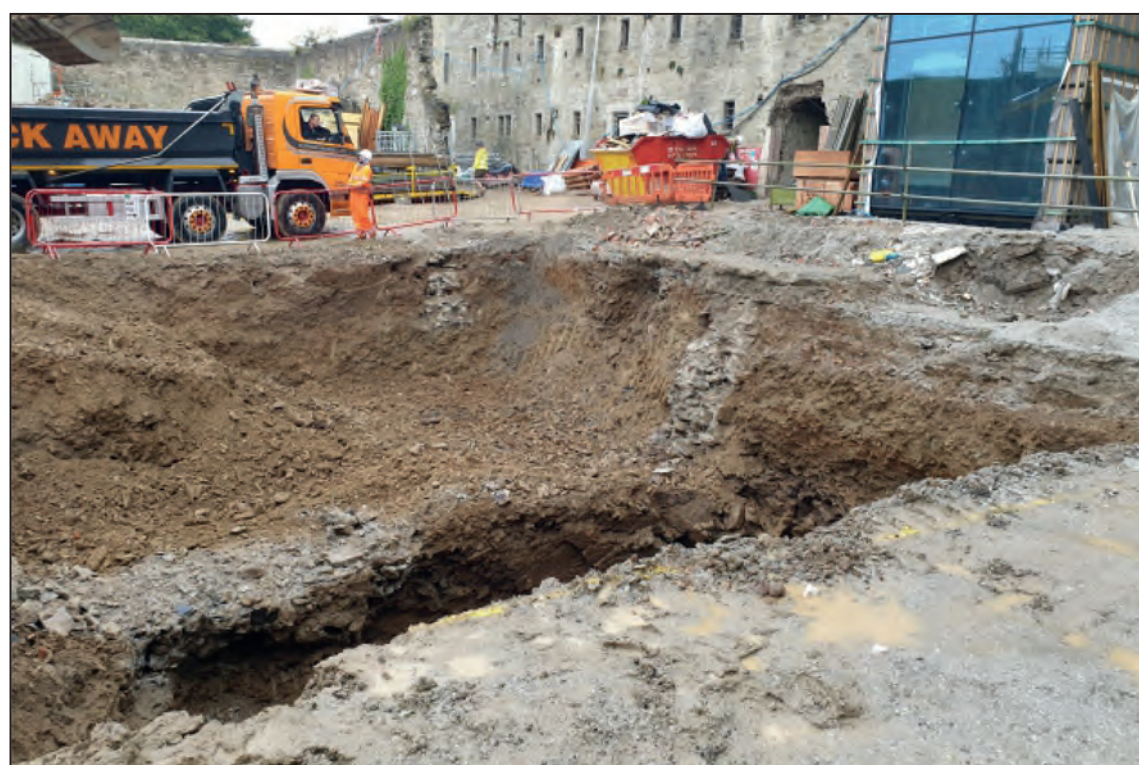
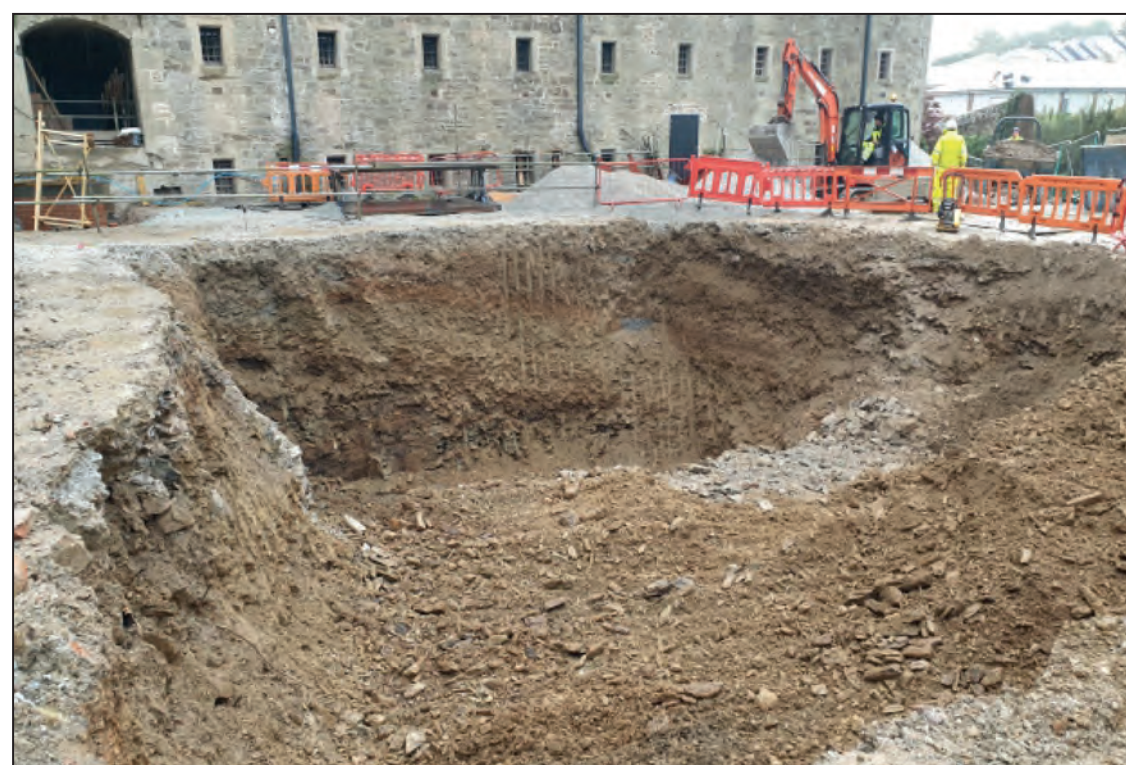
DRAWN BY	RW	PROJECT NO.	880210	FIGURE NO.
CHECKED BY	DJB	DATE	08/12/2020	15
APPROVED BY	LC	SCALE@A3	1:100

5.45. Trench 140 was located to the west of the Naval wing, in the eastern Exercise Yard. This trench, for the eastern attenuation tank, was approximately 12m x 10m and 5m deep, and exposed the original soil sequence underneath extensive deposits of made ground and stone-built wall foundations 14007 and 14009 (Fig. 15, Section BB). The original topography consisted of a gradual south-facing slope with bedrock 14005 overlain by a 1.9m-thick light to mid yellow silty clay 14004 with frequent mudstone fragments. This possibly represents a superficial geological deposit resulting from the erosion of the bedrock and was in turn sealed by a 0.2m-thick buried subsoil (14003) and 0.3m-thick buried topsoil (14002). The former topsoil was overlain by a 1.3m thick light yellow silty clay with frequent mudstone fragments (14001). Identified elsewhere across the central and western part of the site, this has been interpreted as a made-ground deposit associated with the construction of New Bodmin Jail in the mid-1850s. Both the walls and soil sequence were sealed by a 0.3m-thick modern made ground (14000).

5.46. The relationship between the two wall foundations and the surrounding deposits is unclear (groundworks were undertaken in this area without archaeological monitoring). Wall foundation 14007 was orientated north-west/south-east and was approximately 1.1m wide. Two short sections of the southern continuation of wall 14007 were identified in the sloping haulage road to the south. It survived to a depth of approximately 2.5m onto bedrock along its entire length. The wall was not related to any structures or boundary walls shown on the 1881 and 1907 Ordnance Survey maps. Its size and the fact that it is built onto and follows the sloping bedrock suggest that it may have been the former western boundary wall of the Georgian prison, although it could also have been a wall dividing the yard area to the south of the female wing in the New Bodmin Jail. The function of wall 14009 was unclear, although as it was much shallower than wall 14007 the two were unlikely to be related (Fig. 15). A Drill Shed was erected in this approximate location following the

Section BB

Trench 140 showing wall 14007 (centre) and 140009 (left), looking west

Trench 140, looking east

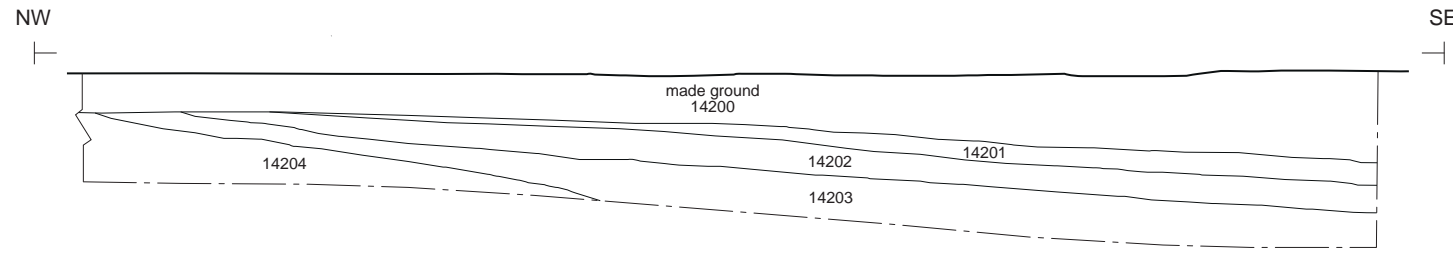
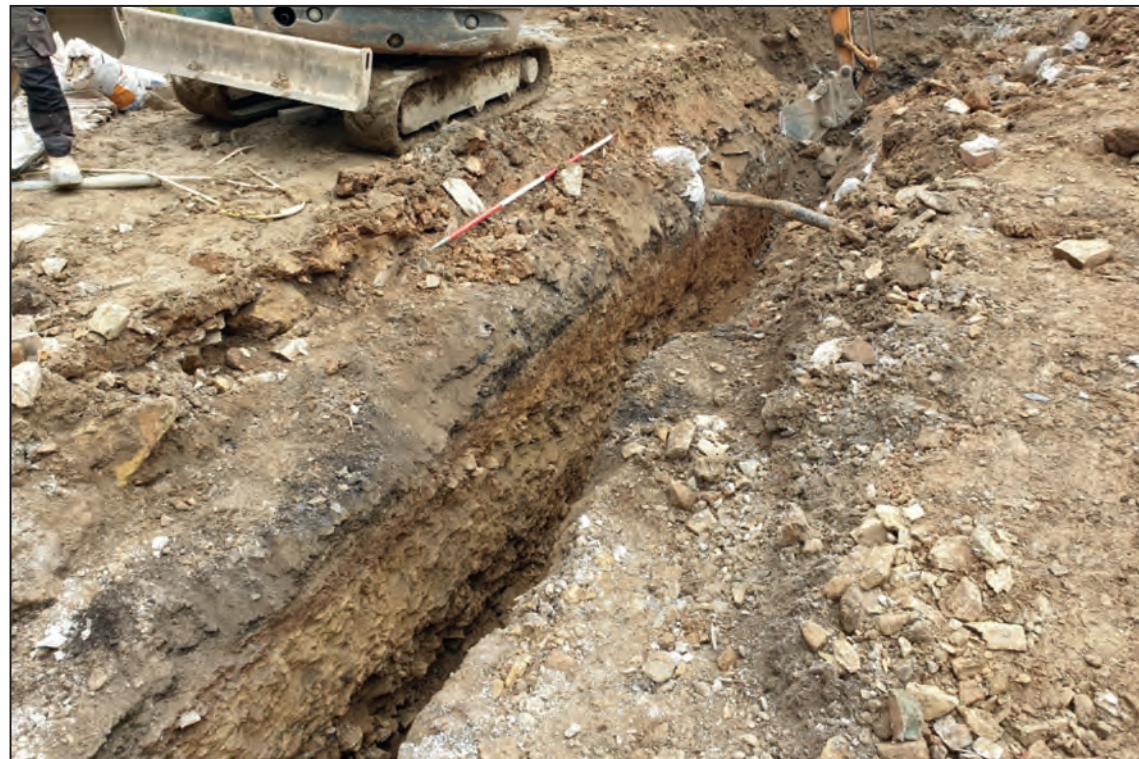
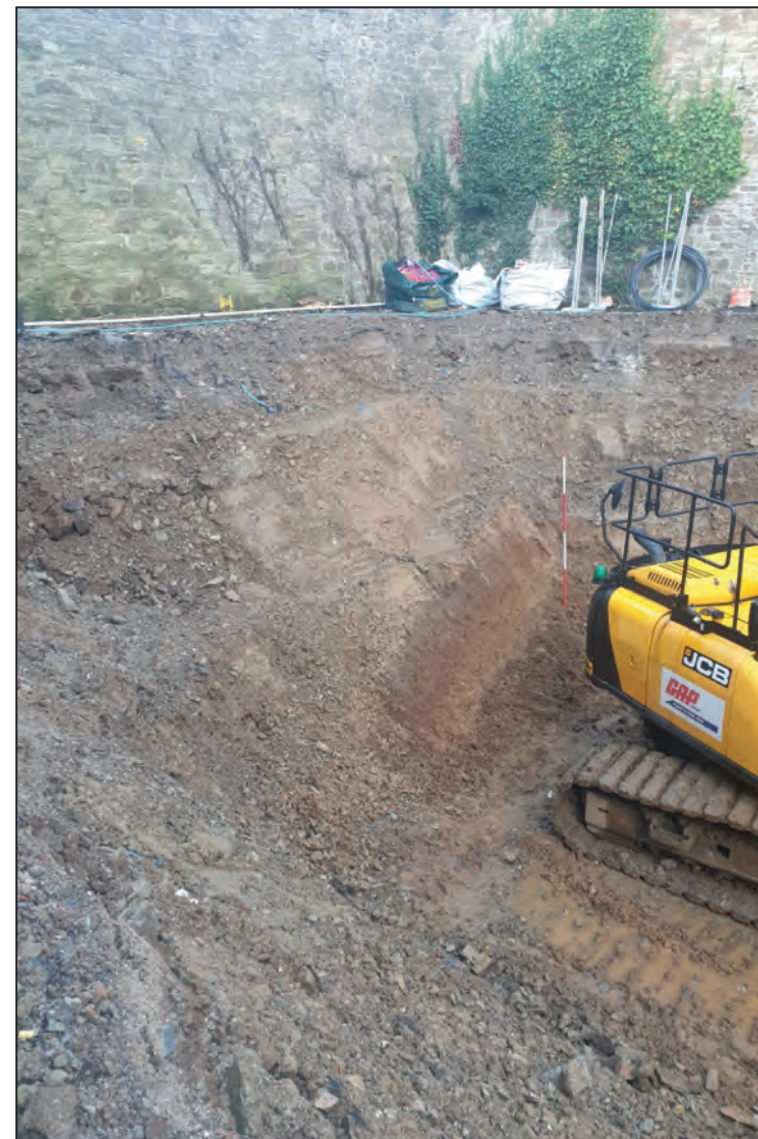
DRAWN BY	RW	PROJECT NO.	880210	FIGURE NO.
CHECKED BY	DJB	DATE	08/12/2020	16
APPROVED BY	LC	SCALE@A3	1:100

Section CC

Section DD

Trench 142a, looking south-east (2m scale)

Trench 141, looking north-west (2m scale)

FIGURE TITLE
Trenches 141 and 142a: sections

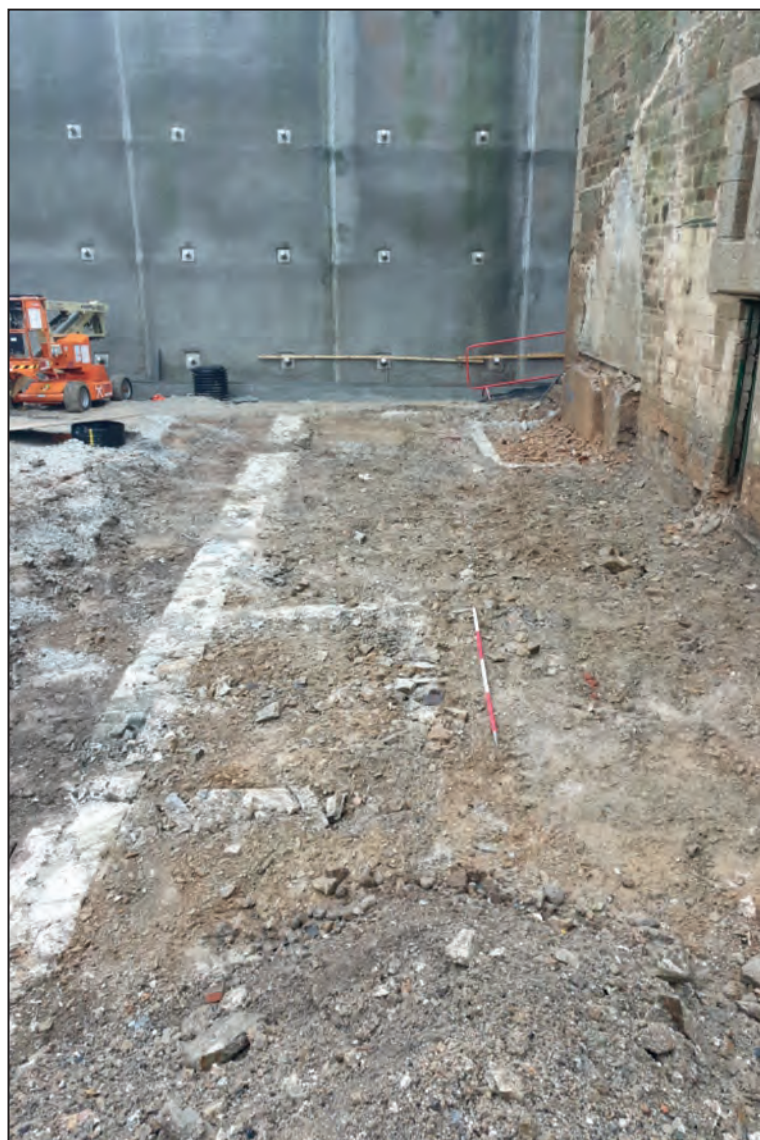
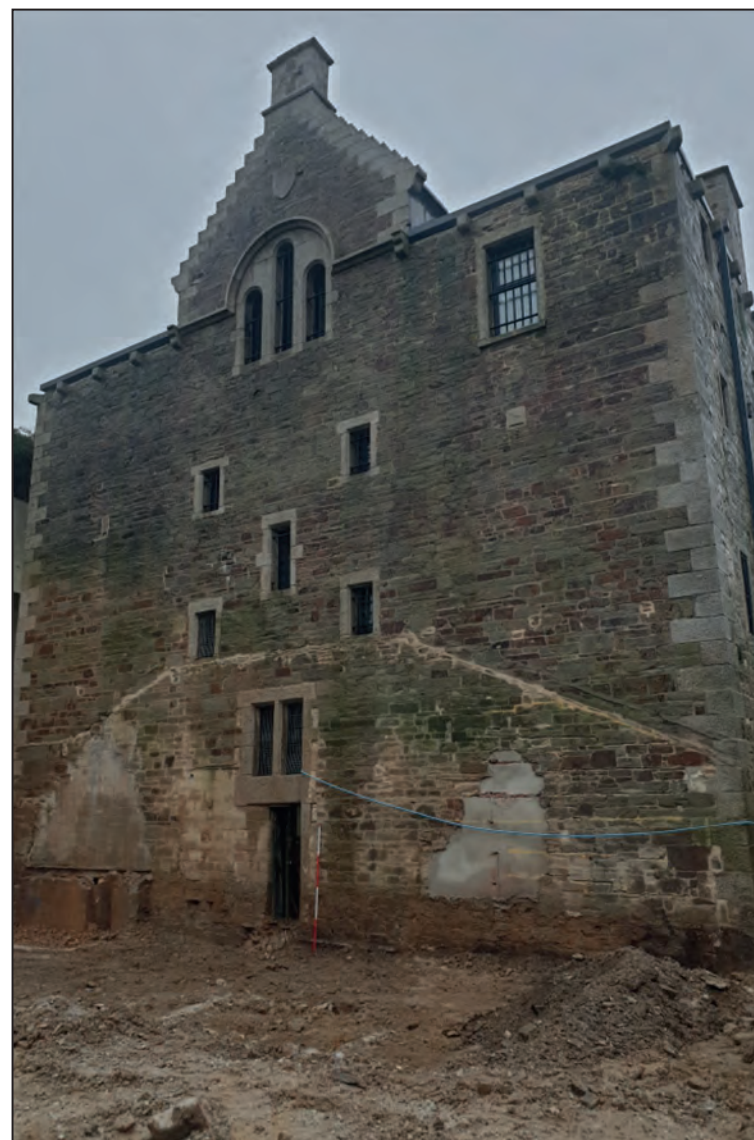
5.49. Trench 142b was excavated in the area between Trench 142a and the extant western end of the Civil wing. Stone-built wall foundations, 14206, were exposed, within construction cut 14205. These appear to have been associated with the Laundry building depicted at the western end of the Civil wing on the 1929 auction plan (Fig. 5). This building was a single-storey addition to the New Bodmin Jail (the roof scar is visible at the end of the Civil wing (Fig. 17)), extending the full width of the wing and comprising a 0.45m-wide external wall. Towards the southern end, a two-cell rectangular structure projected into the building. This was approximately 2.4m long and 1.4m wide. The exact function is unclear, but it could possibly be a latrine block or waste water disposal associated with the Laundry. No internal divisions or floor surfaces were present.

Trench 142b, showing wall 14206, looking north-west (2m scale)

Trench 142b, showing former laundry building, looking north-east (2m scale)
