Greystones Farm (shelter shed and yard) Bourton-on-the-Water Gloucestershire

Archaeological Evaluation

CA Project: 4067 CA Report: 15309

Greystones Farm (shelter shed and yard)
Bourton-on-the-Water, Gloucestershire

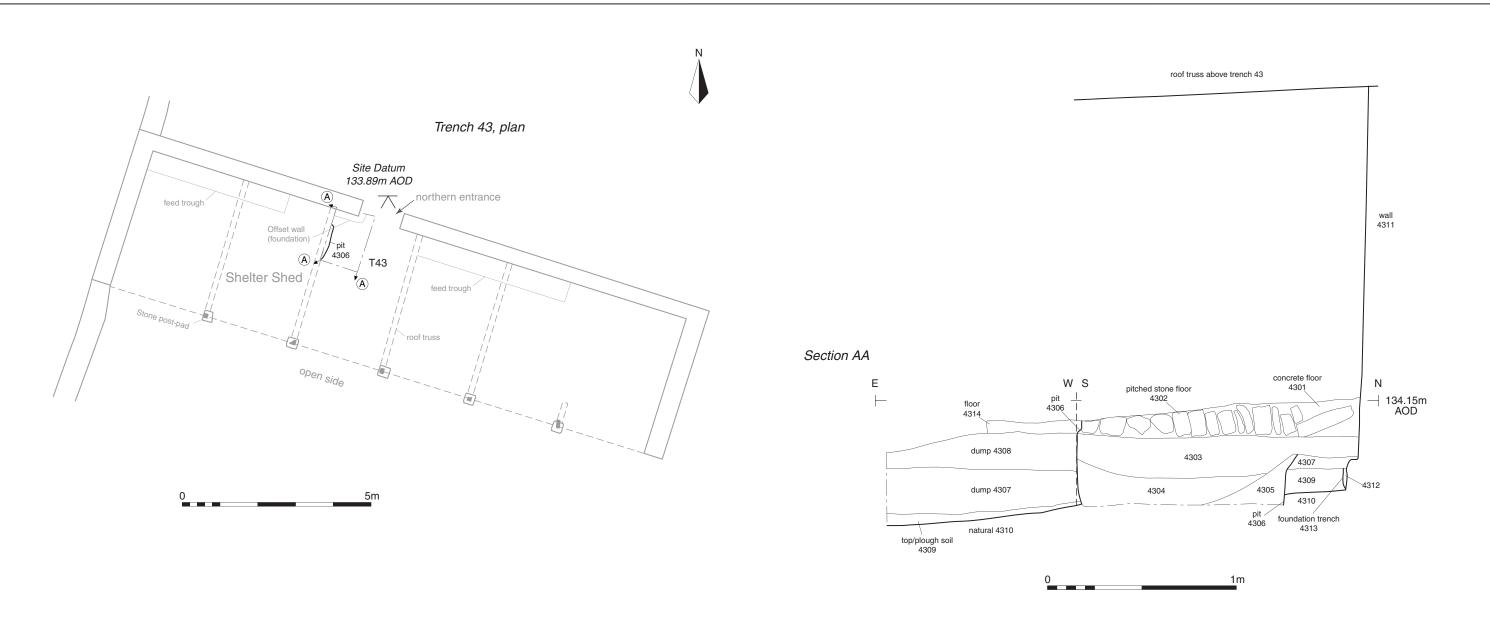
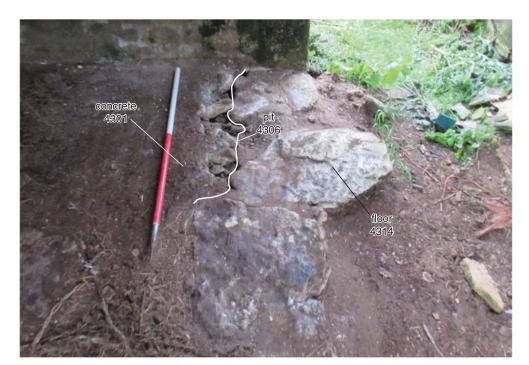
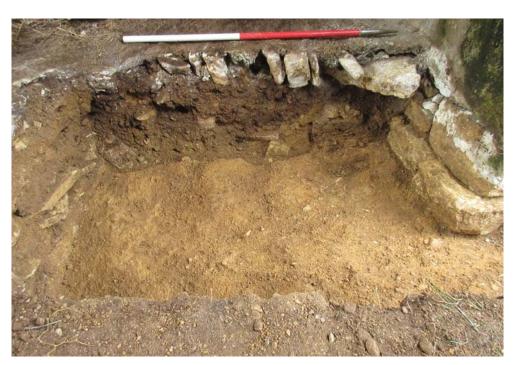
Trench 43: plan, section and photographs

- 5.3 Cutting deposit 4309, and founded upon the natural gravels, was north-west/south-east foundation trench 4313 for the northern wall of the Shelter Shed. The foundation trench clearly had an eastern terminus that did not cross the central doorway. The slight gap between the stone foundations and the construction trench cut it was filled by gravels 4312. The upper surface of the foundation course of wall 4311 was c. 0.05m above the surface of 4309 and there was no indication that it had ever continued east beyond the end of cut 4313.

- 5.4 Levelling deposits of sandy gravel and limestone rubble (4307 and 4308) were founded on the surface of the relic top/plough soil 4309 and sealed the offset foundation course for wall 4311. Irregular limestone paving 4314, which could be traced throughout much of the Shelter Shed, had been laid directly on levelling deposit 4308.
- 5.5 Square or rectangular pit 4306 cut through flooring 4314. The function of this pit is unknown as only 0.25m of it extended into the trench. However it was possible to trace the disturbance in the surface of floor 4314 for at least 1m west of the trench. The pit seems to have been intently backfilled with fills 4303, 4304 and 4305. A pitched limestone surface, 4302, was then laid on top of the fills, presumably to repair the hole in surface 4314. At a later date, concrete surface 4301 was laid over pitched surface 4302.

Trench 43, looking north-west (1m scale)

- 6.2 Foundation trench 4313 for the northern wall of the Shelter Shed cut former soil horizon 4309. The preceding building report (CA 2005) interpreted the doorway in the north wall of the Shed as a later addition. However, the evaluation has shown that foundation trench 4313 respects the current door opening, with the western extant of the foundation courses being tidy and well finished. This strongly suggests that this doorway is original to the building.

- 6.3 Deposits 4307 and 4308 overlie the stepped foundations to wall 4311 suggesting that they represent makeup layers associated with the original construction of the Shelter Shed. If this interpretation is accepted, then limestone flagstones 4314 could also be an original, or at least an early, internal floor surface. Pit 4306 and associated pitched limestone surface 4302 represent a later alteration within to the
