# Great Linford Manor Park Great Linford Milton Keynes

*Archaeological Investigation and Community Project*

*For*  
The Parks Trust

CA Project: 661033  
Site Code: GLMP19  
Accession Number: AYBCM: 2019.36

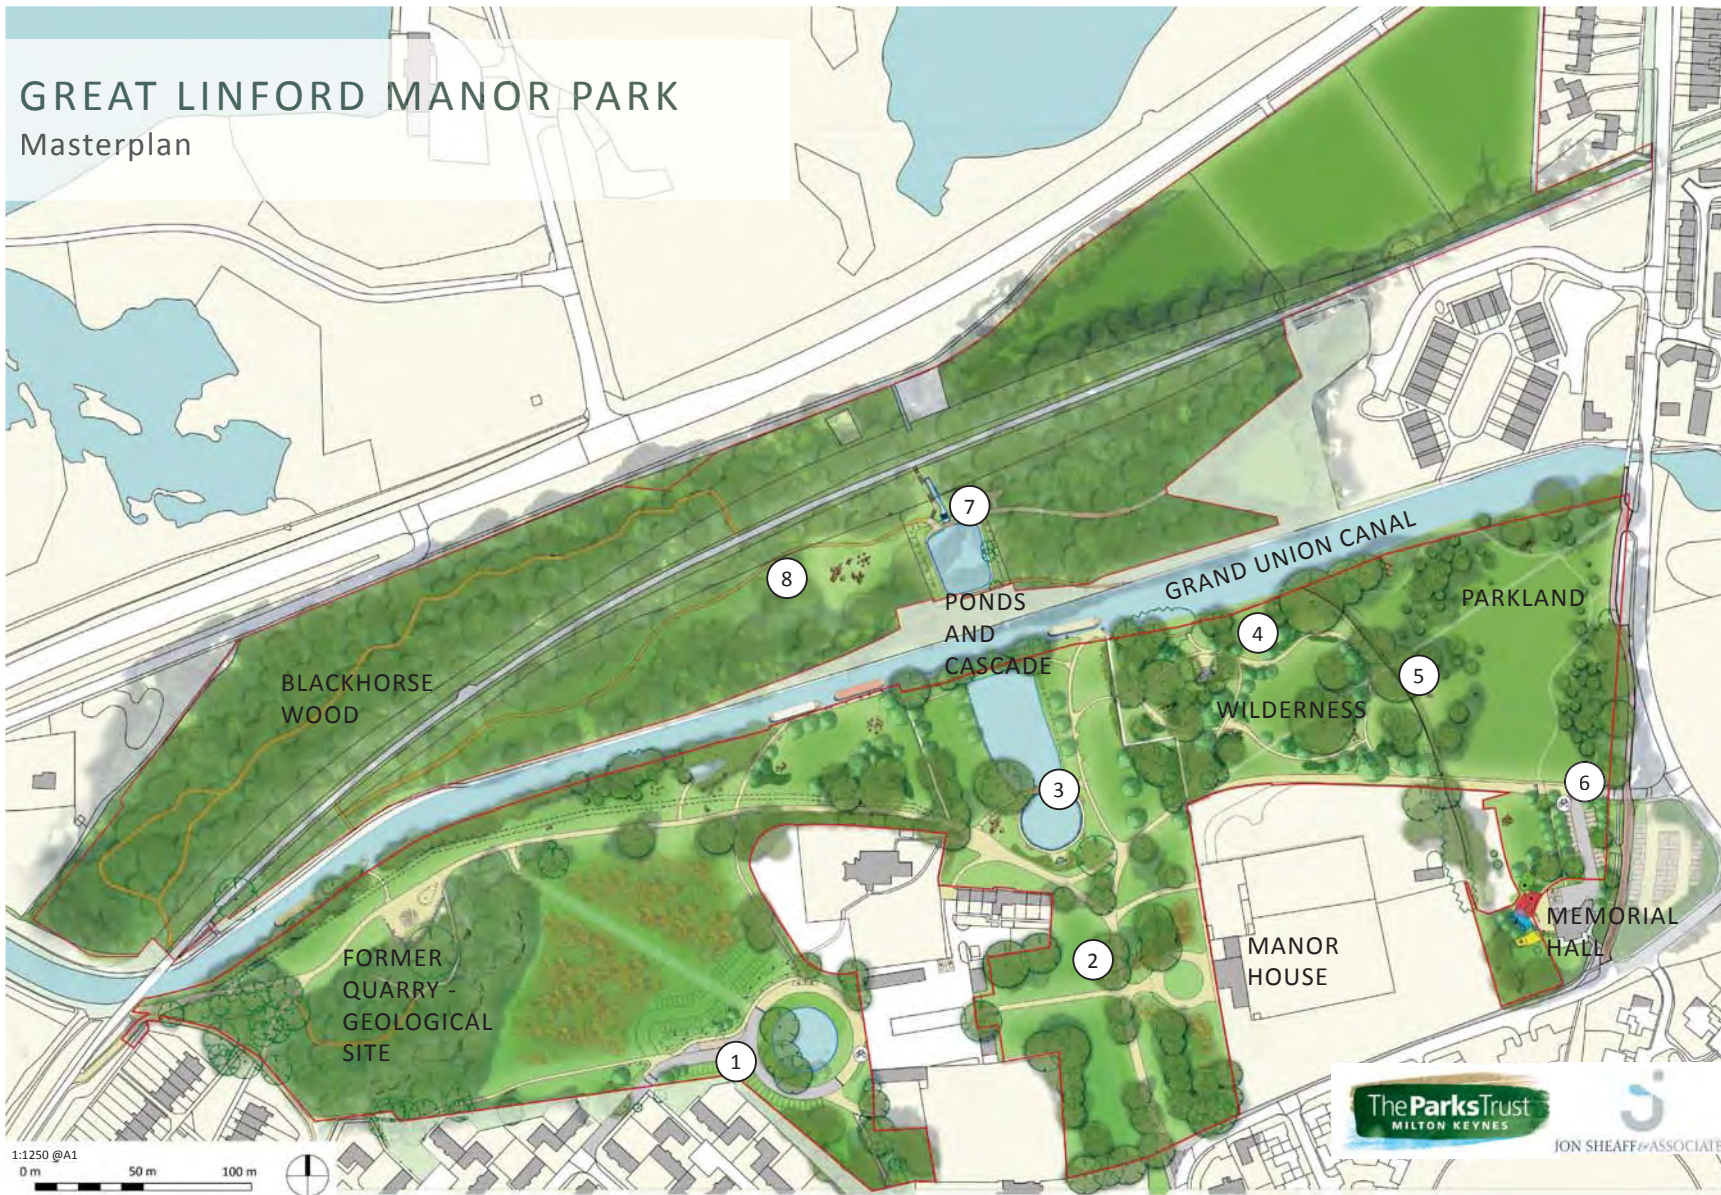
## Masterplan

- 1 WESTERN APPROACH  
Enhance arrival and sight lines into Manor
- 2 MANOR SETTING  
Re-define the Manor setting
- 3 WATER GARDENS  
Restore ponds, cascade and bridge
- 4 WILDERNESS  
Recreate the footpath network and interpret the Doric seat
- 5 HA-HA  
Restore and interpret the ha-ha
- 6 MARSH DRIVE ENTRANCE  
Re-organise entrance into park and enhance sense of arrival
- 7 CASCADE  
Restore the northern pond and repair the cascade
- 8 BLACKHORSE WOOD  
Play and ecological interventions

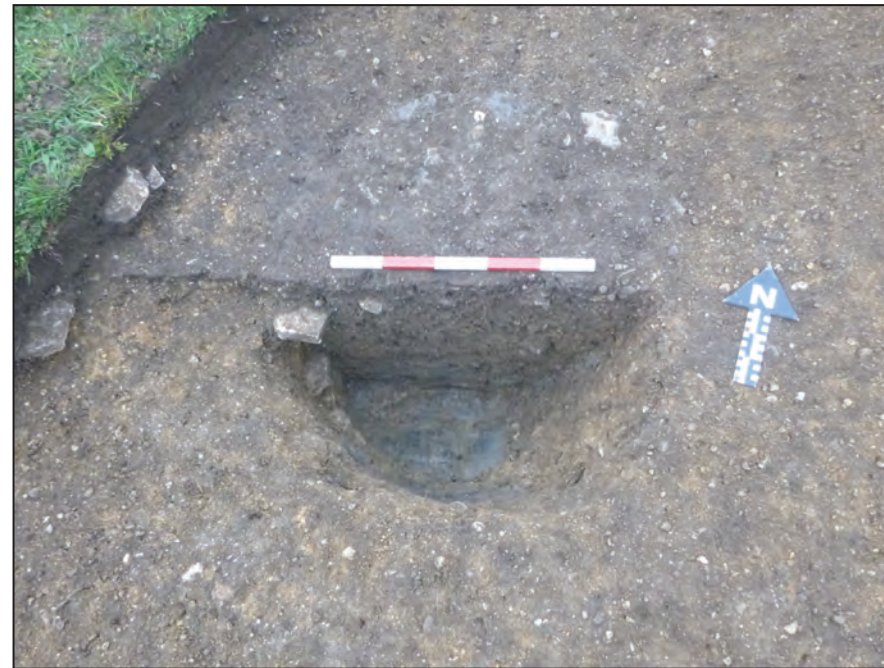
Pit 101, looking north-west (0.5m scale)

- 6.24 The fieldwork confirmed the presence of circular pit 101 near the southwest corner of the trench, measuring approximately 1.0m in diameter and 0.62m deep, with steep sloping straight sides and a concave base (Figure 3; Section AA). A basal fill 102 comprised mottled mid blue grey and yellow brown silty clay, containing oyster shell fragments and an iron nail of indeterminate date; this was sealed by an upper fill 103 of mid brown grey gravelly sand which contained no finds.
- 6.25 Despite the absence of direct dating evidence, it is possible that the pit represents the foundation cut for an ornamental sundial base dating to the mid- 20th century, which is clearly visible in aerial photographs of the site (see AHaCL 2013, Fig. 2.32).

9.4 In Trench 1, the likely foundation pit 101 of an ornamental sundial feature was encountered. The feature is visible in historic photographs dating to the 1960s, but it was hoped that its foundations may have remained in the ground when the feature itself was demolished. While no evidence was encountered for any parts of the original structural feature, the pit dimensions appear to correspond with the size of the sundial visible in the photographs.

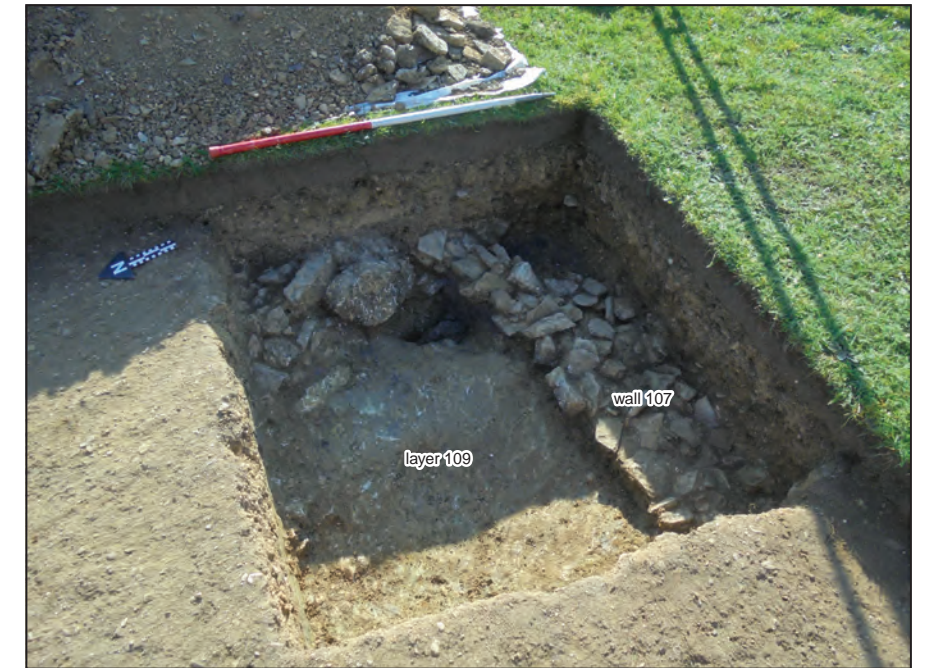
Stone alignment/possible wall 107, looking south-east (1m scale)

- 6.2 Trench 1 comprised a hand dug test pit measuring 4m x 4m, central to a circular grass feature immediately west of the manor.
- 6.3 In the southeast corner of the trench, parts of a possible L-shaped wall foundation (107) were encountered. These remains comprised rough, undressed limestone fragments of varying sizes (107), arranged above a dark grey blue clay layer (108) (Figure 3) which may represent a foundation supporting layer. Identical clay material was also observed as packing (106) between the stones. The individual stones and general construction method of the possible wall line were noted to be similar to that of the walls encountered in Trench 3 (see below).

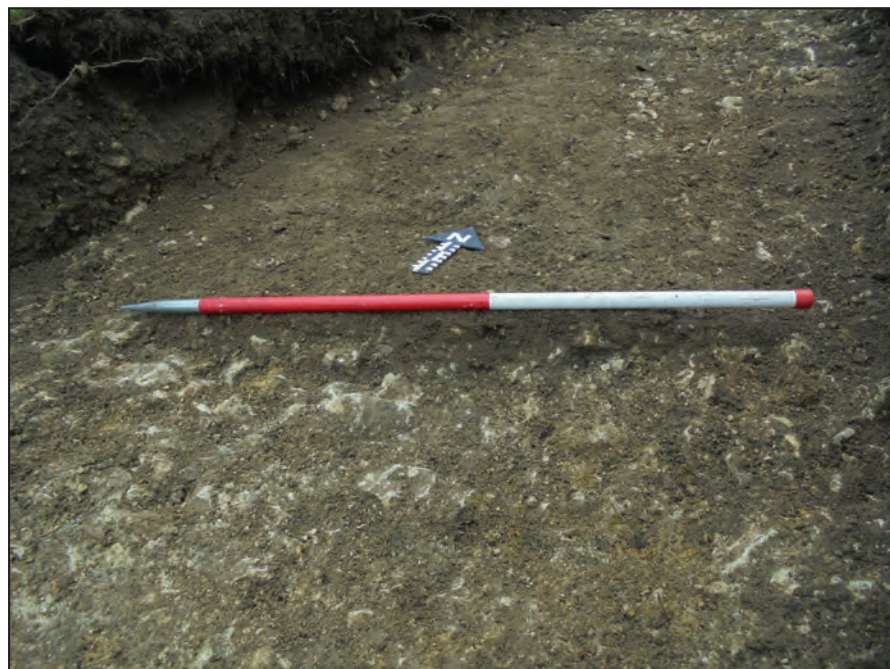
Ditch 202, looking north-east (1m scale)

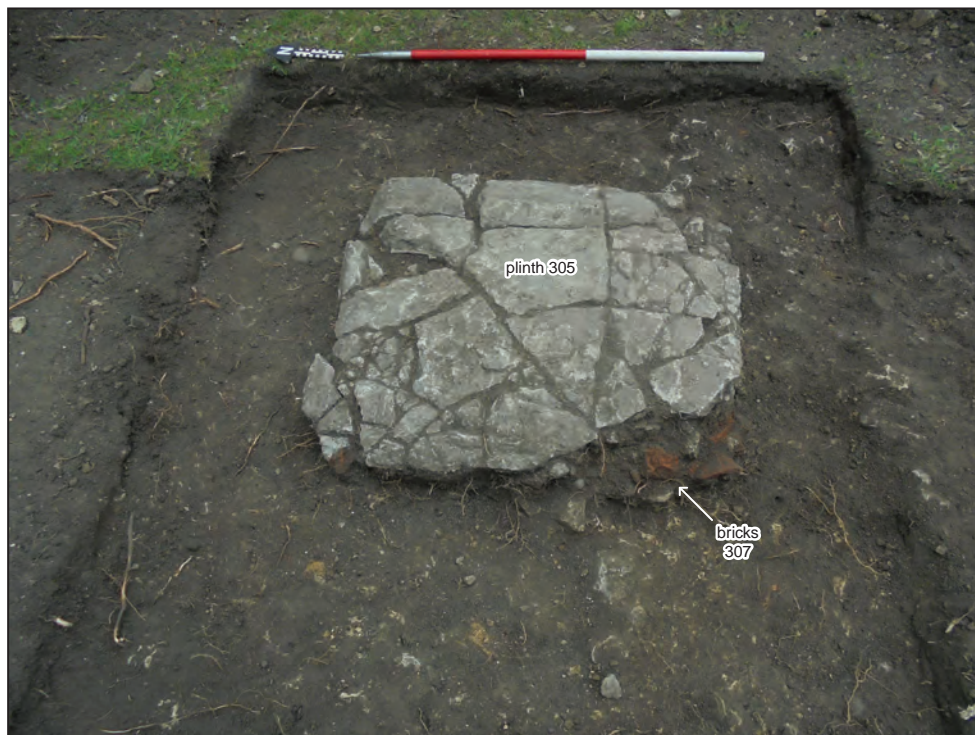
Possible ornamental feature plinth 305, looking east (1m scale)

- 6.13 The construction materials of the walls pointedly do not match those of the Doric Seat; on the contrary it appears that some of the limestone blocks were reused in the rubble layer (317) which forms part of the Seat's foundations (see below). It is possibly of some interest, however, that both are similar to the wall observed in trench 1 (see above). The Doric Seat (314) and a possible ornamental plinth (305) were also investigated in Trench 3 and are discussed below.

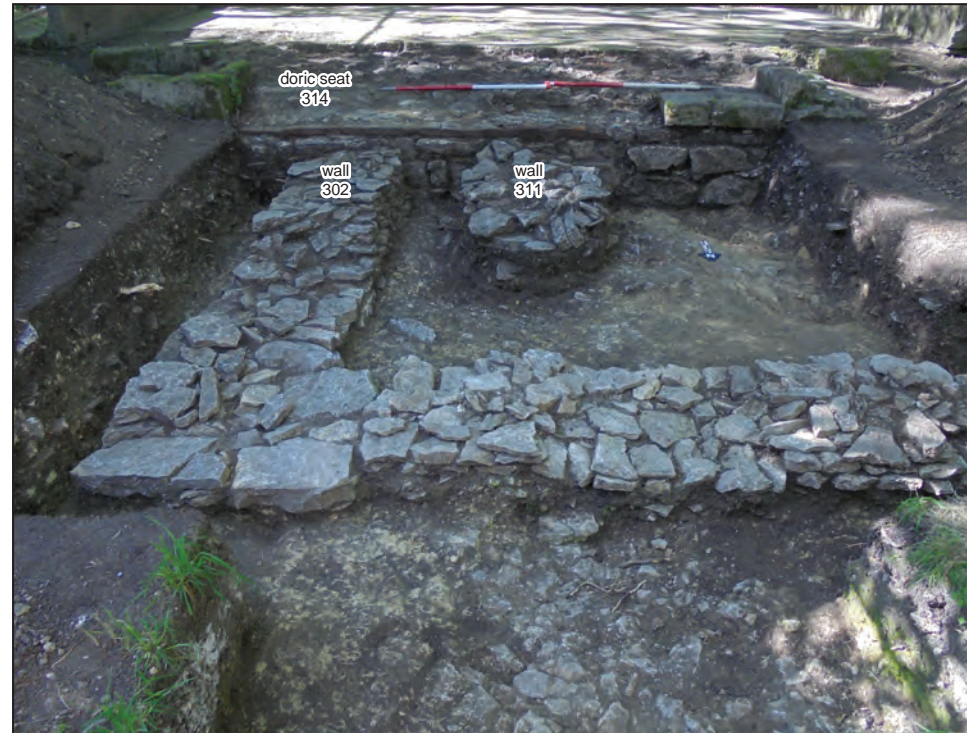
Section of Doric Seat 314 and walls 302 and 311, looking south (2m scale)

- 6.12 Within the presumed interior area of wall 302 a second, north-south aligned wall 311 was encountered during the Stage 2 extension of the trench (Figure 6; Section CC). This also appeared to be truncated by the foundations of the Doric Seat, surviving with a length of 1.10m by 0.80m wide and 0.45m in height. Its construction method and material are identical to those of wall 302, although their relative alignments do not readily suggest any obvious structural or functional interpretation. The foundation trench cuts 312 and 303 for wall structures 311 and 302 respectively

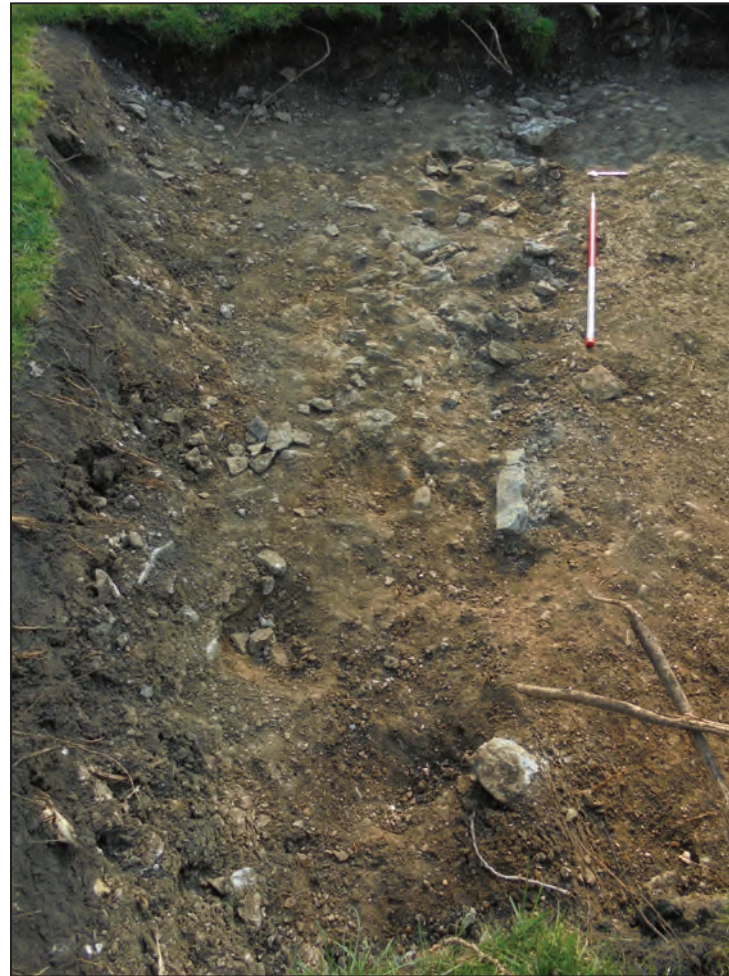
Possible wall 403, looking east (1m scale)

- 6.15 A possible robbed out wall foundation 403 was observed at the northern end of the trench on a northwest-southeast alignment. What remained of the feature measured approximately 0.95m wide, with a visible length of 4.70m although the line of the possible wall continued in both directions beyond the limits of the trench. A number of limestone fragments (405) very similar to those forming the walls in Trench 3 (see above) remain *in-situ* but they do not provide sufficient evidence to identify the original function of the possible wall.

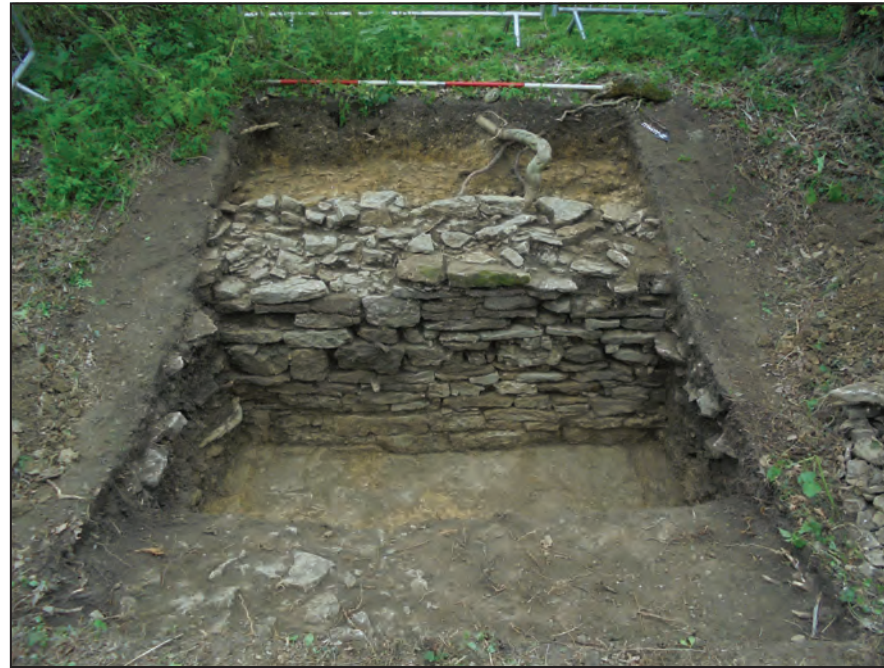
Ha-ha wall 702, looking south-west (2m scale)

- 6.23 Along the southwest side of the ditch, drystone retaining wall 702 (Figure 9; Section EE) was shown to survive to a maximum height of 1.13m, with a thickness of 0.60m. This was constructed from fragments of tabular limestone in uneven courses, with the fronting stones roughly dressed to create a more visually appealing surface. While it is clear that a section at the top of the wall has been lost, likely due to collapse caused by exposure and root damage over time, the main body of the structure appears to have survived well, protected by a layer of organic topsoil material (700).

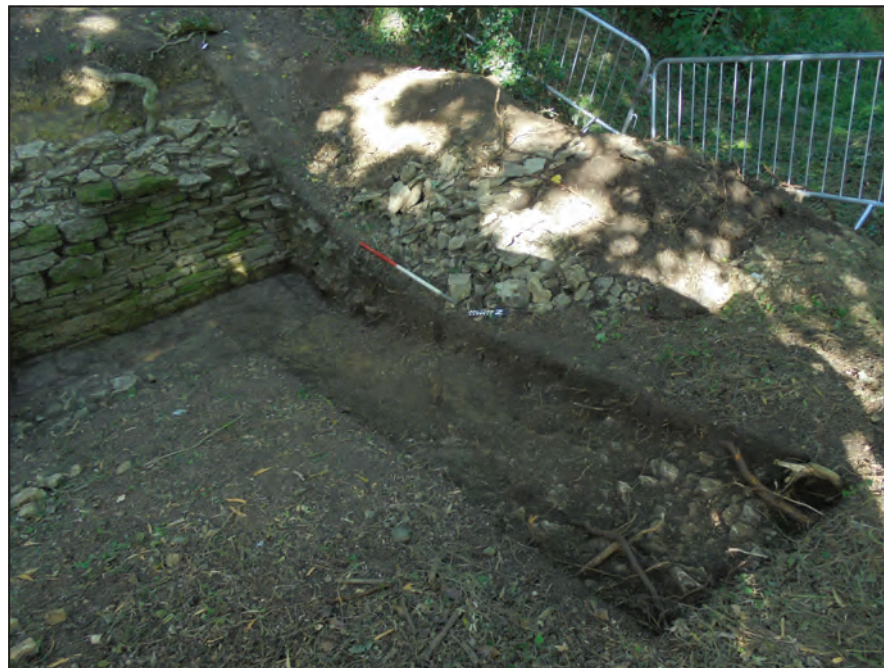
Section of ha-ha wall 702 and ditch 701, looking south-west (1m scale)
