**HAILES HOUSE  
HAILES, STANWAY  
GLOUCESTERSHIRE**

**ARCHAEOLOGICAL EVALUATION**

CA PROJECT: 2626  
CA REPORT: 08139

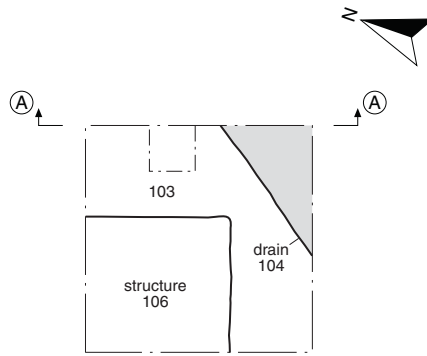
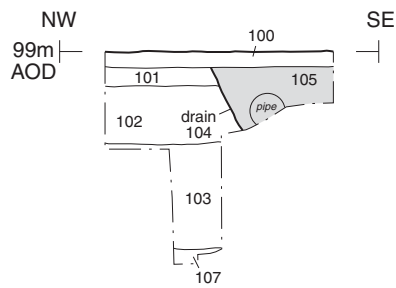
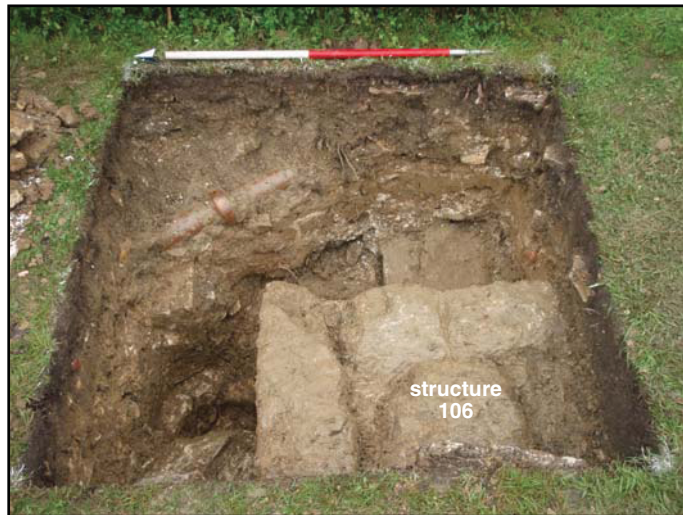
**Trench 1; plan, section and  
photograph**

- 2.2 The earliest deposit encountered in trench 1 was deposit 107 which was exposed in a sondage at a depth of 1.3 below the present ground level (bpgl). This deposit comprised clay silts with abundant limestone fragments and rare charcoal flecks from which no dateable material was recovered. It was sealed by a square or rectangular structure 106 which was poorly constructed from roughly hewn limestone blocks and rubble. The walls, which formed a right angled return, survived to a maximum of three courses in height (0.7m) and were bonded by clay. The structure was butted by make-up layer 103, comprising clay silts with abundant limestone fragments from which no dateable material was recovered.

- 2.3 Deposit 102 sealed the foregoing deposits. It comprised clays with abundant limestone rubble, from which 18th-century pottery was recovered. It was overlain by a heavily re-worked garden soil 101.

- 2.4 All the above deposits, with the exception of structure 106 and deposit 107, were truncated by the construction cut for modern ceramic drain 104, which was in turn sealed by modern topsoil, 100.

- 3.1 The evaluation has demonstrated that structural remains survive within the proposed development area at a depth of approximately 0.6m below the present ground level (bpgl). The full extent, date and function of limestone structure 106 remains undetermined due to its limited exposure within trench 1. However, the structure is sealed by make-up/ levelling deposits 103 from which 17th/18th-century pottery was recovered. Such evidence suggests that in all likelihood the structure was demolished during the documented landscaping of the abbey grounds in the post-medieval period and/or during construction of Hailes House itself.
- 3.2 The date of culvert 209 identified in trench 2 also remains undetermined, although again it is sealed by make-up/ levelling deposits from which 17th to 18th-century pottery was recovered and is therefore likely to be broadly contemporary with structure 106.

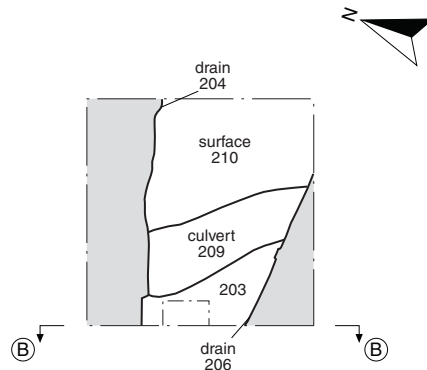
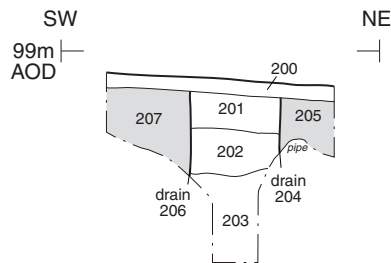
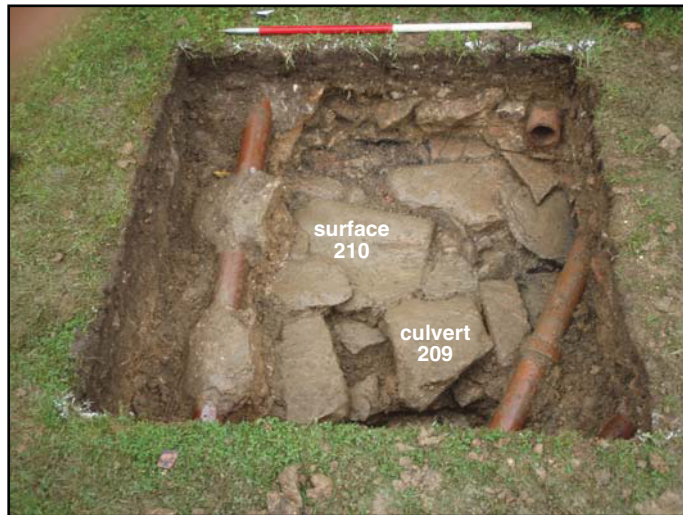
**Trench 2; plan, section and  
photograph**

- 2.5 The earliest deposit encountered in trench 2 was deposit 203, comprising clay silts with abundant limestone fragments and sparse charcoal flecks from which no dateable material was recovered. This deposit correlates closely to deposit 103, seen in trench 1, and may represent the same make-up event.
- 2.6 Deposit 203 was sealed by rough surface 210 which comprised of large, un-worked limestone slabs with no visible bonding material. This deposit was truncated by the construction cut for culvert 209 which was constructed from roughly worked

limestone slabs of variable size. Nineteenth-century pottery was recovered from the internal fill of this drain.

- 2.7 Both deposits 210 and 209 were sealed by limestone rubble 202 from which 17th-18th-pottery was recovered. This deposit correlates closely to deposit 102 identified within in trench 1 and may represent the same demolition event. It was overlain by a further post-medieval deposit, 201, which appeared to represent a heavily re-worked garden soil.
- 2.9 Deposit 201 was truncated by the construction cuts for modern ceramic drains 204 and 206 which were in turn sealed by topsoil, 100.
