# Drainage Works at Church Farm House Church End, Haddenham Buckinghamshire

*Archaeological Watching Brief*

CA Project: 661252  
CA Report: 661252\_1

April 2019

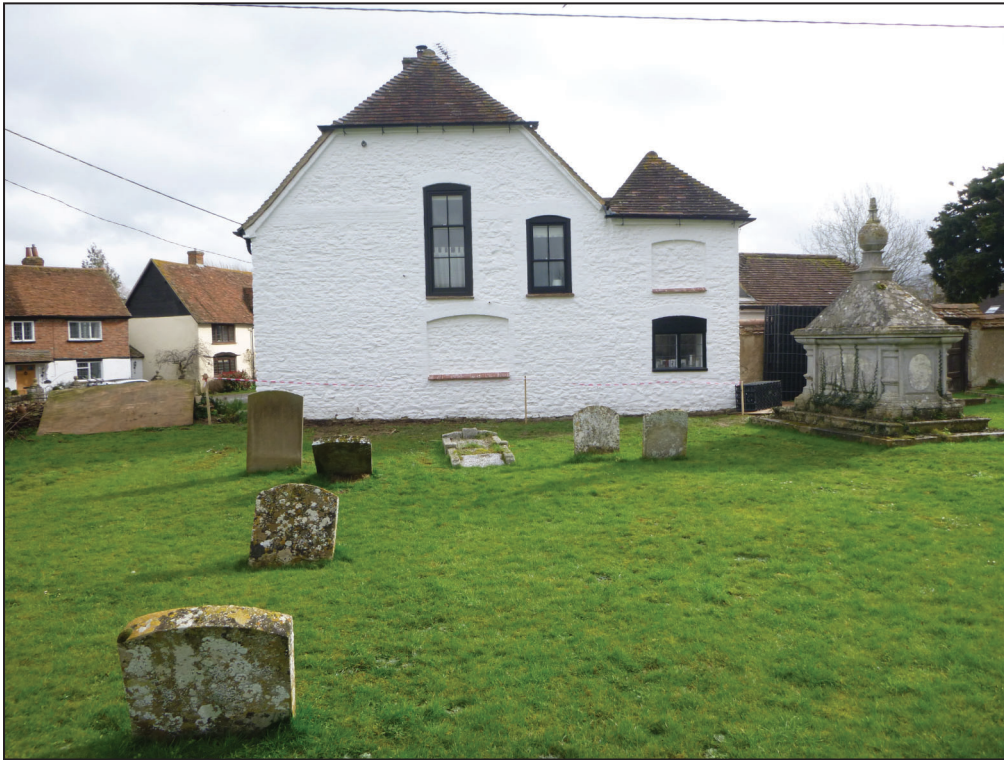
3

- 5.1 The natural substrate was not exposed within the drainage foundation trench. The earliest deposit, 102 was recorded at a depth of c.0.69m and c.0.73m below present ground level (bpgl). Layer 102 consisted of light brown/grey silty clay with mid-red/yellow stones, and may well be associated with the foundation layers of Church Farm House. Layer 102 was in turn overlain by a mid-yellow/brown clay silt deposit 101, which measured between 0.15m and 0.21m in thickness, and probably represents an earlier topsoil deposit within the churchyard. This was overlain by the modern topsoil layer, 100, which was c.0.48m thick.

Shot of trench and gable end of Church Farm House, looking east

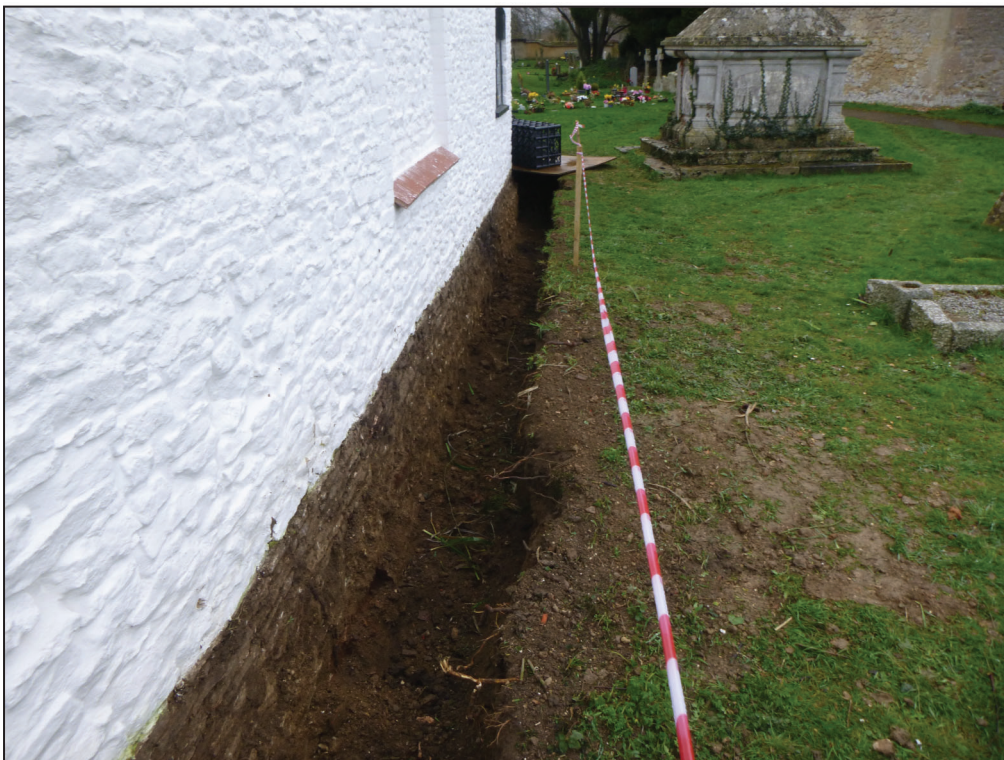
4

- 5.2 No features or deposits of archaeological significance were identified during the drainage groundworks. A few unstratified fragments of tile possibly dating between the 15th and 18th centuries were recovered from upcast topsoil along with several fragments of animal bone. None of these are of measurable archaeological significance.

View of drainage trench, looking south
