The Lampworks Jewellery Quarter, Birmingham

Historic Building Recording (Level 3)

CA Project: CR0549

January 2021

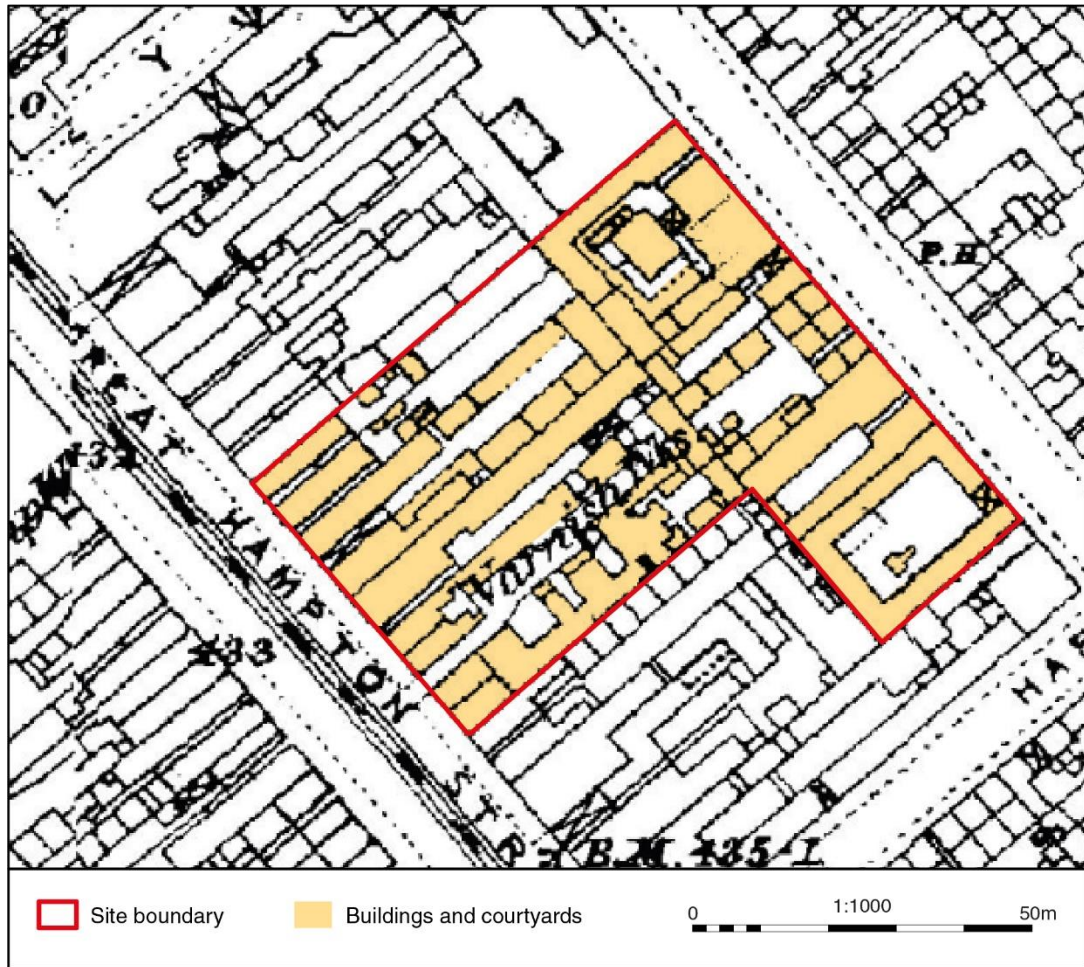
Fig.3 The 1890 Ordnance Survey (OS) map (enhanced to pick out buildings and voids).
 ©Crown copyright and database rights 2020 Ordnance Survey 0100031673

- 3.8. The 1st Edition Ordnance Survey of 1890 (Fig.3) illustrates how the Site has now become fully developed with linear ranges on the Great Hampton Street frontages, with uncharacteristically wider frontages to the Barr Street side. There are six back-to-back houses in the centre of the Barr Street frontage. Of note is the label 'Varnish Wks' for a range within the centre of the complex. The spatial arrangement is best seen in the map shown in Fig.3 which has been enhanced to illustrate the relationship between built form and voids (courtyards), and also how the internal courtyards were all accessed via passageways or carriage entrances (indicated with an X). The buildings have also all been extended to the roadside, some no doubt with shop frontages where the products of the workshops behind could be displayed and sold, others incorporate or amalgamate new build elements.

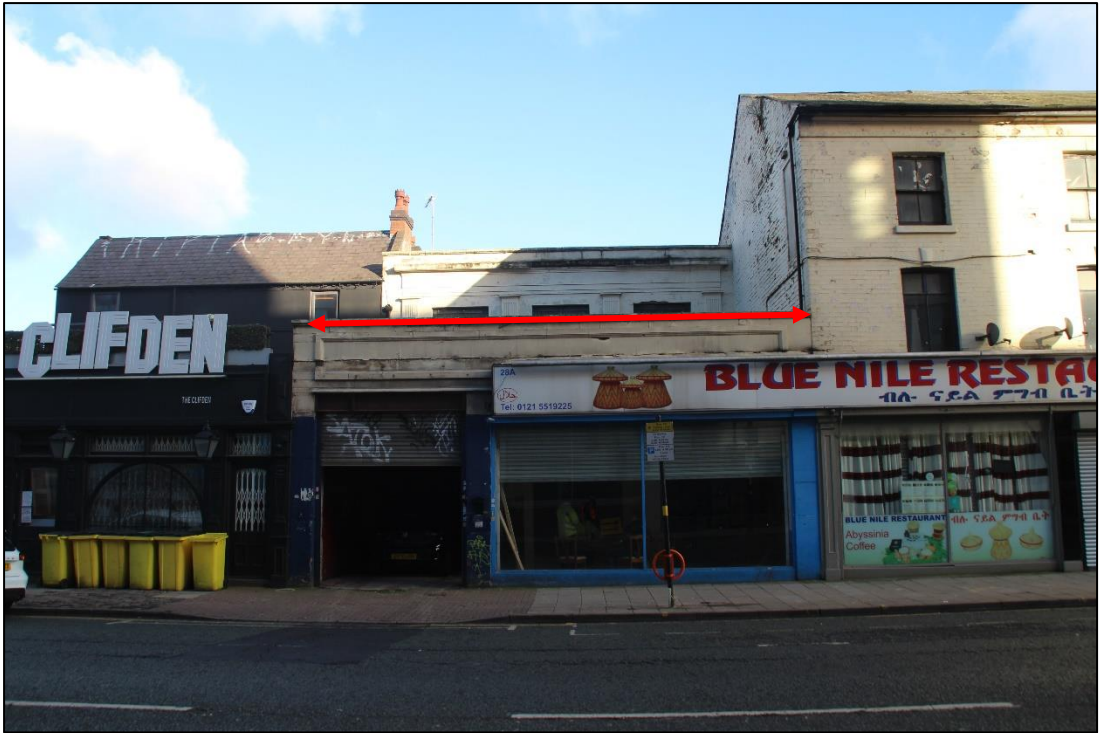
Photo 1: Principal (west) façade of No.33 Great Hampton Street, flat roof is arrowed

- 4.6. The Building is reached through the open plan frontage area of No.33 Great Hampton Street, which is formed of the one storey flat roof area as seen in Photo 1 below. To the rear of the flat roof area, the entire ground floor of the building behind (arrowed in Photo 2) has been opened out via the use of the structural steels illustrated in Photo 2. The brick rear façade of this building is extant within the rear area and forms a narrow corridor between No.33 Great Hampton Street and the south-west façade of Building 1 (Photo 3). This rear building is one of the oldest on the site, being present on the map of 1855 giving it a date of between 1818 and 1855. It is a rare example of the stepped back building line that was initially prevalent in this row, and which was altered in the later 19th century when Nos. 27-30 were built close to the street edge.

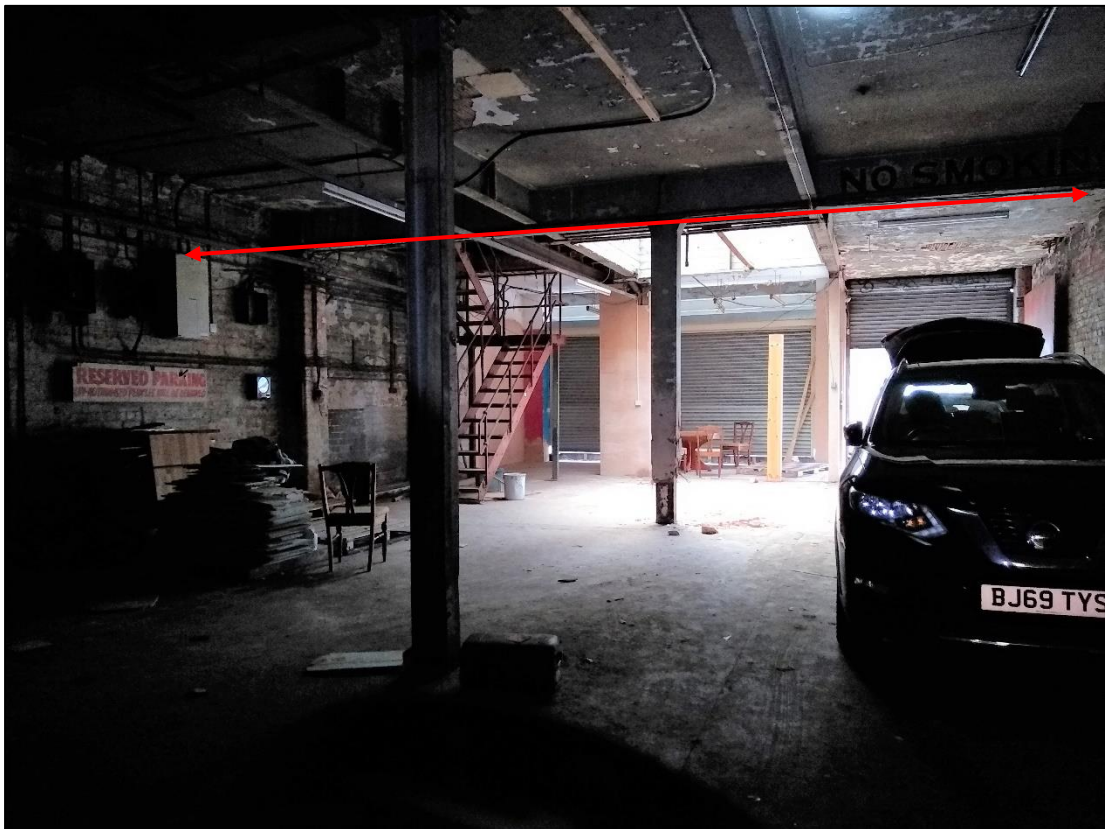
Photo 2: Interior of flat roofed section of No.33 Great Hampton Street (the beam supporting the main façade behind the flat roof is arrowed)

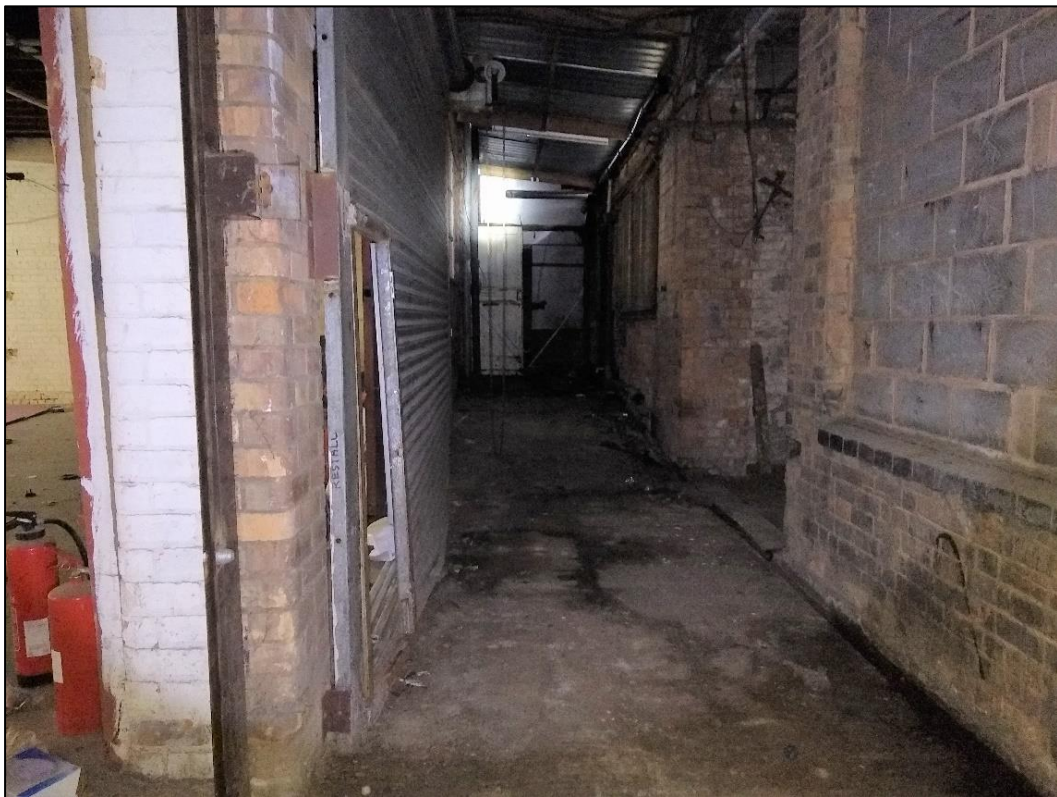
Photo 3: The corridor to the rear of No.33 Great Hampton Street (on right) between it and Building 1

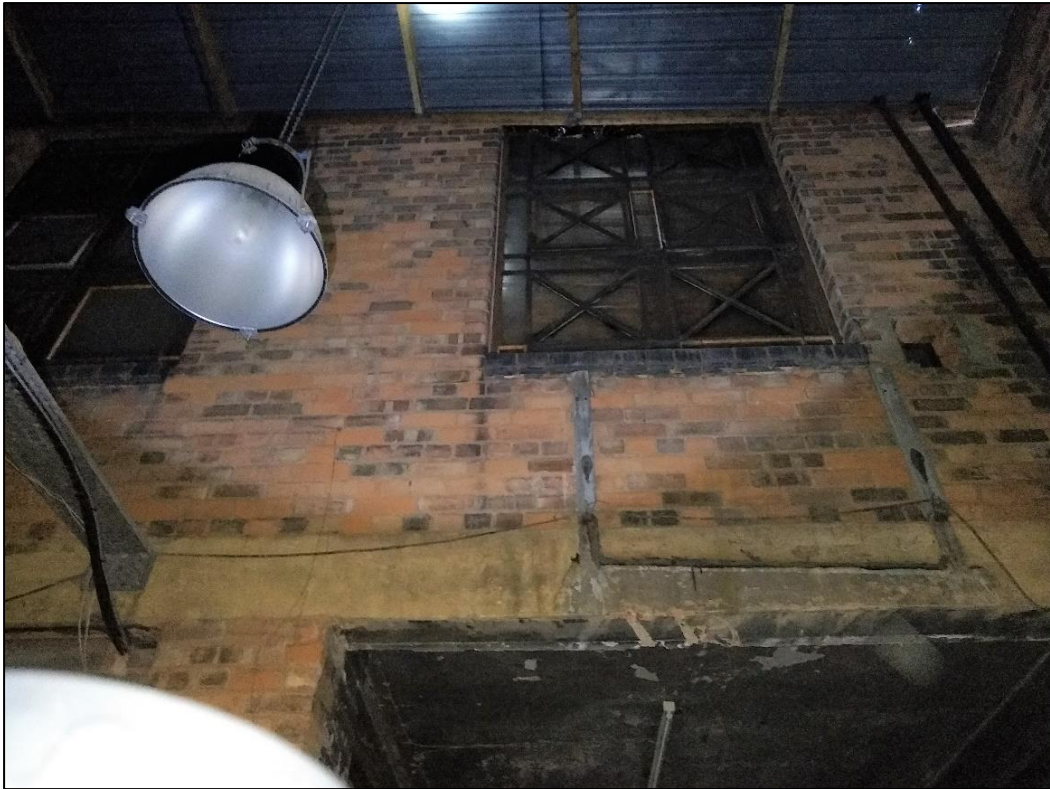
4.7. The rear façade of No.33 as seen in this internal corridor features large metal framed windows with criss-cross detailing and blue brick dressings at first floor level; the ground floor windows have been sealed with cement blockwork. These windows are industrial not domestic in size and character which suggests that the building was light industrial in nature from its inception. These windows match those seen in better condition on the front elevation, as seen in Photo 5. This front elevation also features fluted Neo-classical pilasters under a parapet with cornice detailing. As detailed above, what remains of the facades of this building evidence its early 19th century origins as one of the earliest surviving buildings on the site.

Photo 4: The rear façade of No.33 Great Hampton Street in the corridor, showing industrial window to upper floor

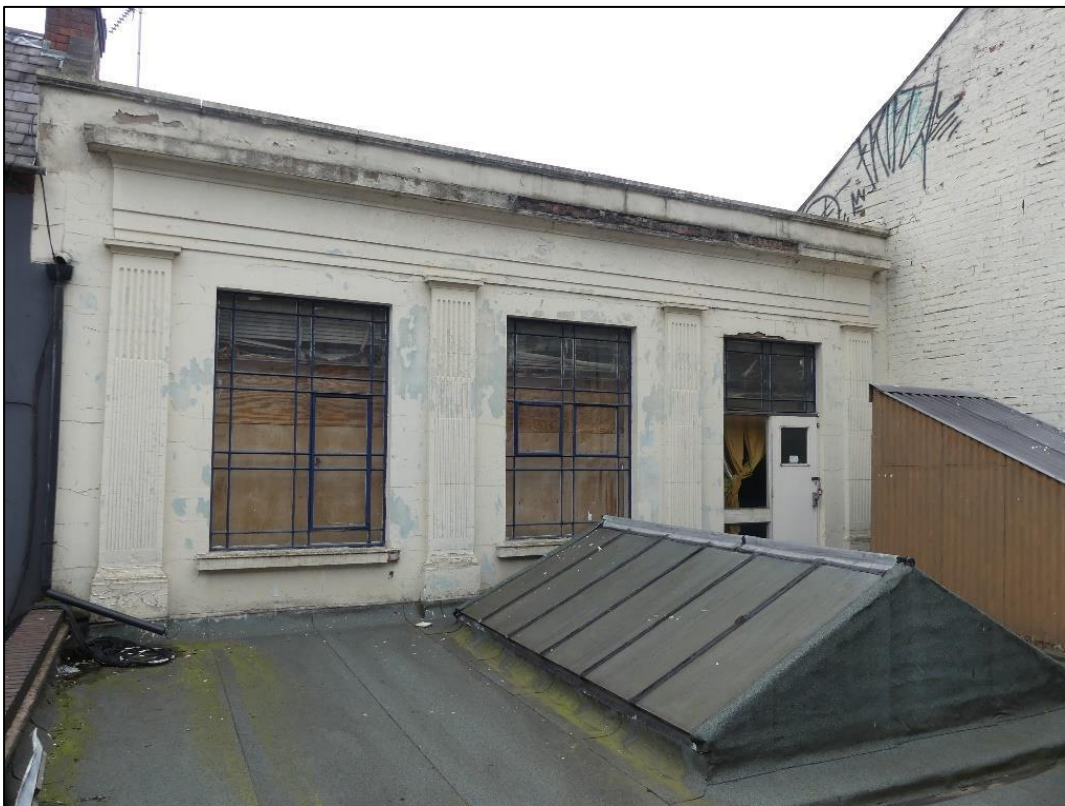
Photo 5: The flat roof element of No.33 Great Hampton Street, looking towards the original façade

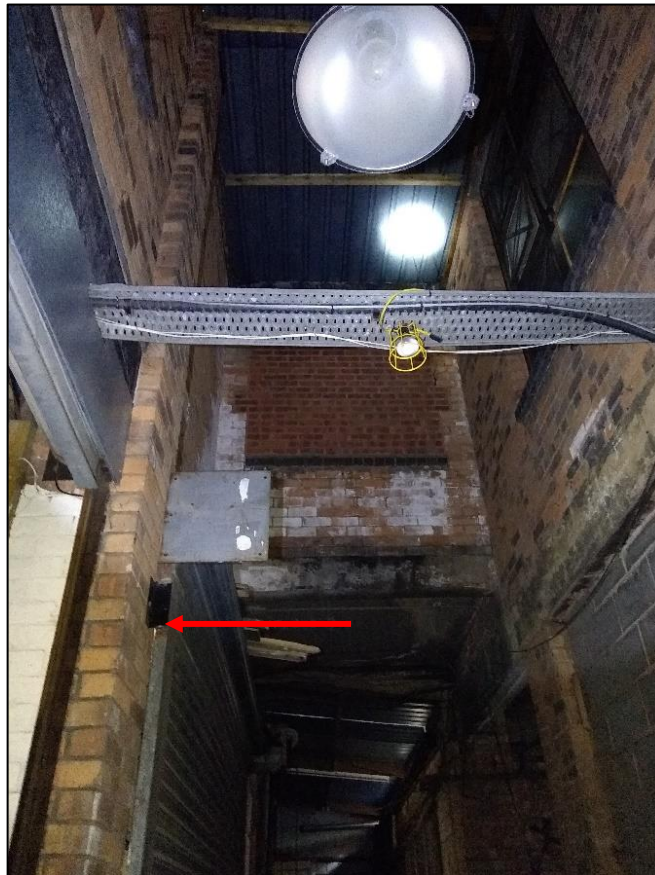
Photo 6: The first floor of No.30 Great Hampton Street seen from the corridor between No.33/30 and Building 1

-
- 4.8. The corridor is roofed in corrugated metal. At first floor level No.30 Great Hampton Street extends over the corridor as seen in Photo 6 and into the mezzanine structure of Building 1. Two newer openings supported on steels with roller shutters have been installed into the rear façade of No.30. The west façade of Building 1 (forming the left, or east side of the corridor and arrowed in Photo.6) is a newer addition, clearly built contemporaneously with the larger main building.

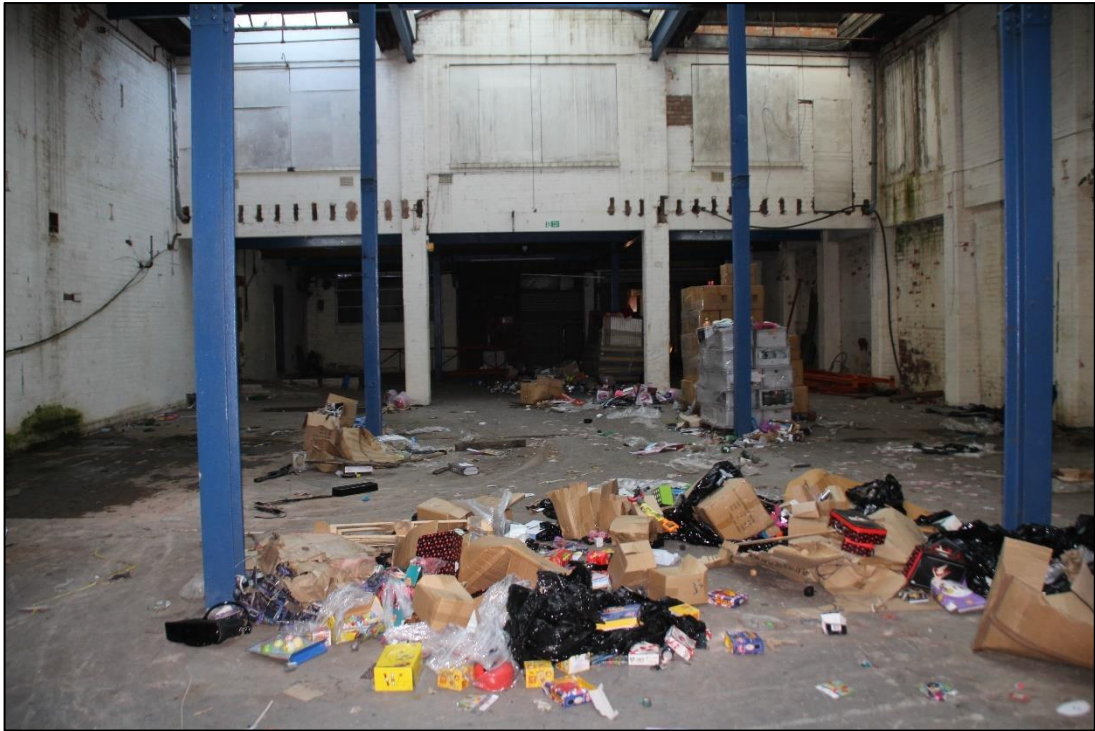
Photo 7: View looking west towards the mezzanine in Building 1

- 4.9. As can be seen on Fig.11, Building 1 is formed of two roofscapes; essentially these relate to two discrete sections of the Building, though both are open plan to each other at the ground level. The first section of roof (west) nearest Great Hampton Street is a building which forms a mezzanine to the main double height east part of the Building. This is seen best in Photo 7, which is viewed looking south-west towards Great Hampton Street and Nos.30 and 33. The mezzanine, which is supported on brick piers, features blocked-in windows, no doubt once overlooking the factory floor.

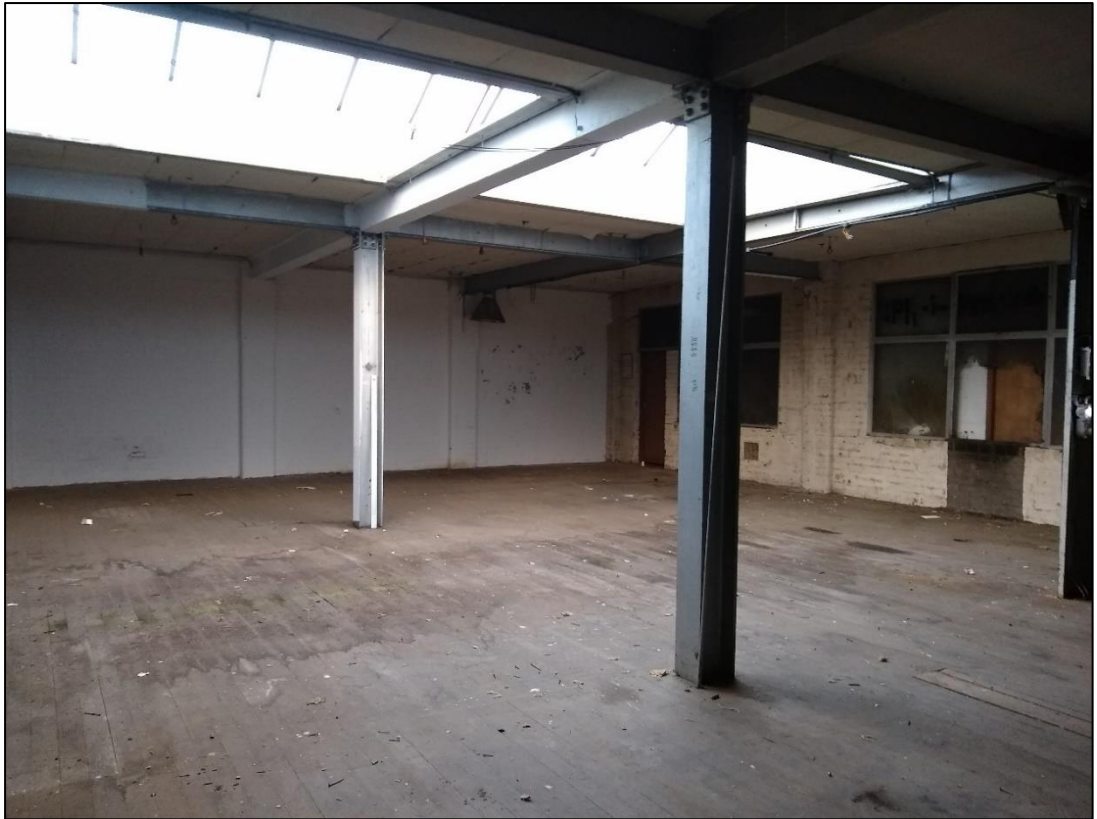
- 4.10. At first floor level the mezzanine is open plan with a steel frame, ridged roof light, timber floors and brick walls as seen in Photo 8. The blocked-in windows can be seen to the right of Photo 8, these would be the windows overlooking the factory floor.

Photo 8: The first (mezzanine) floor of Building 1, looking north-east

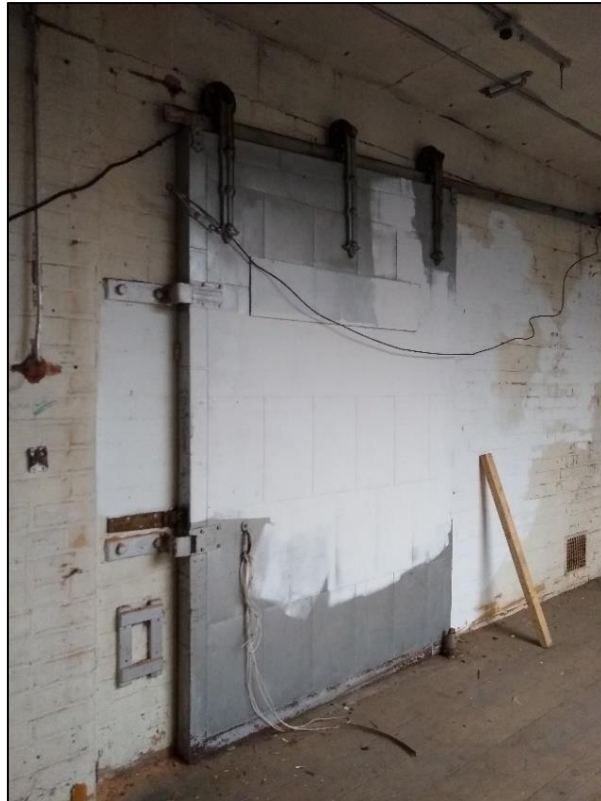
Photo 9: The large metal door between the first floor of Building 1 accessing No.30 Great Hampton Street

- 4.11. At the Great Hampton Street side of this mezzanine structure, a large steel door is seen, (bearing in mind this is the mezzanine level so essentially the first floor level) this overlooks the corridor between No.30 and 33 Great Hampton Street, and likely acted as a loading door to the spaces beyond (within the first floor of No.30 Great Hampton Street) given its size (Photo 9). A double set of similar doors are seen on the south wall of the mezzanine which provides access from the first floor of Building 3 (Photo 10). These have an interestingly substantial metal lock on them. The lock is marked Mather & Platt, Manchester, which was a fire protection business established in 1852 and operating under that name until 1938. The strength of the door material and the locks of these doors suggests they may well have protected an area for the manufacture and storage of high value or flammable goods, potentially precious metals though the link with Mather and Platt does point to them being fire doors..

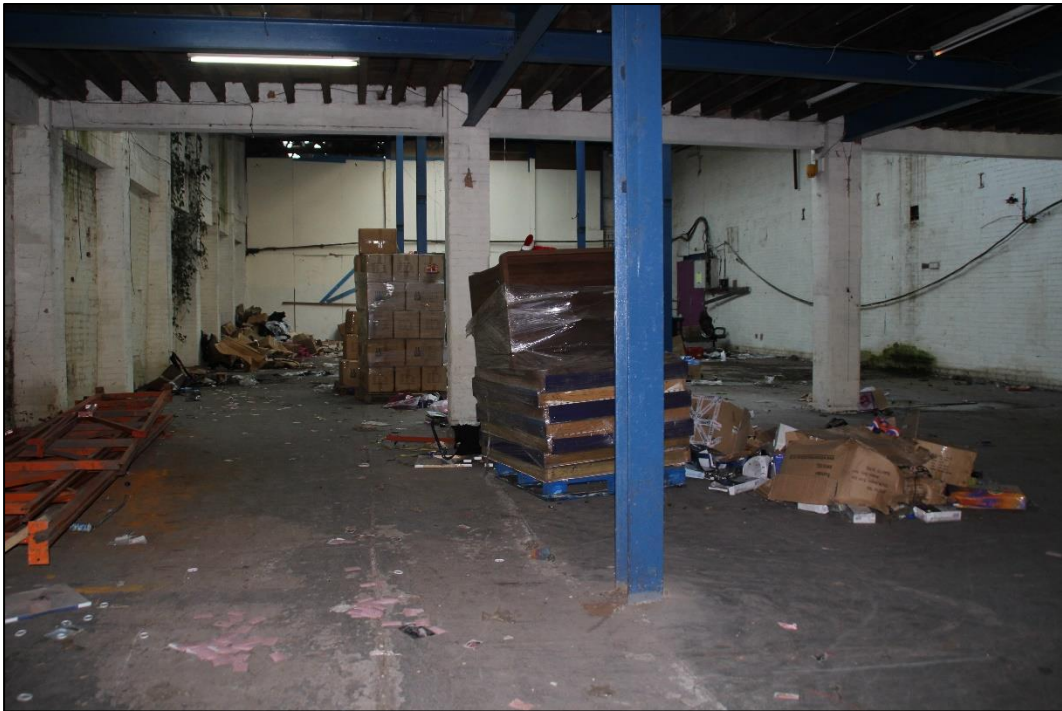
Photo 11: View looking east on the ground floor of Building 1

4.12. At ground floor level, the second section of the Building is an open plan double height structure built in a steel frame, with brick walls and a metal pitched rooflight that extends the full length of the section. In Photo 11 the building can be seen extending out from the mezzanine which covers the foreground. In Photo 12. this gives a long view along the right-hand flank of this structure showing the steel king post truss arrangement of the roof structure supporting the pitched rooflight. The wall at the far end in the photo appears to be of a temporary nature, such as Medium Density Fibreboard (MDF).

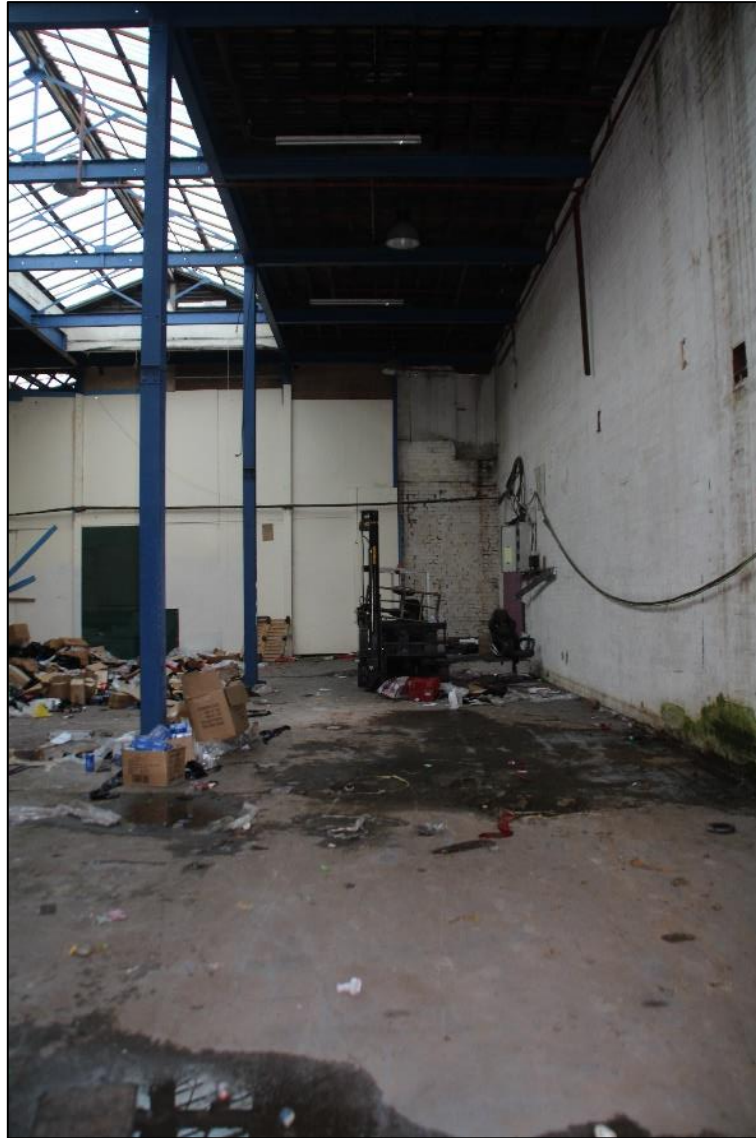
Photo 12: View looking east down the southern flank wall of Building 1

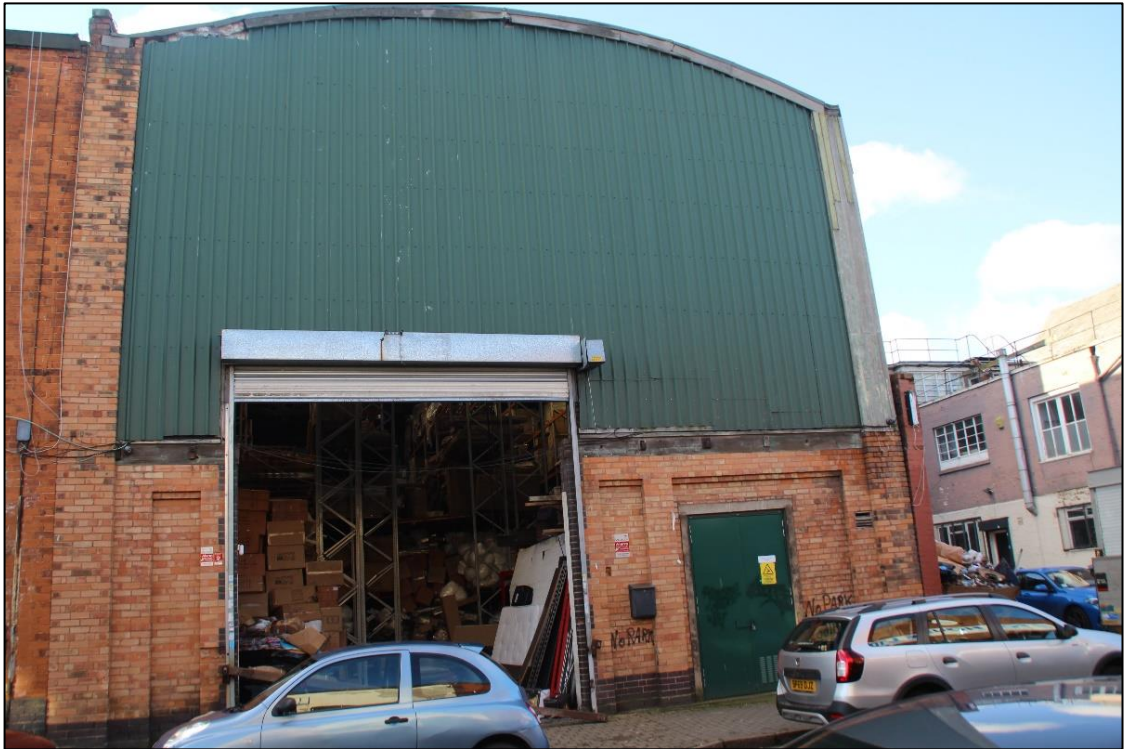
- 4.16. Its utilitarian façade on Barr Street supports the evidence that it is a 20th century warehouse or factory building and that it replaced what would likely have been workshop frontages on Barr Street. As can be seen in Photo 13. the building is built of brick and metal cladding, with a curved roof profile. It is possible that the

Photo 13 **Principal façade of Building 2 as seen on Barr Street**

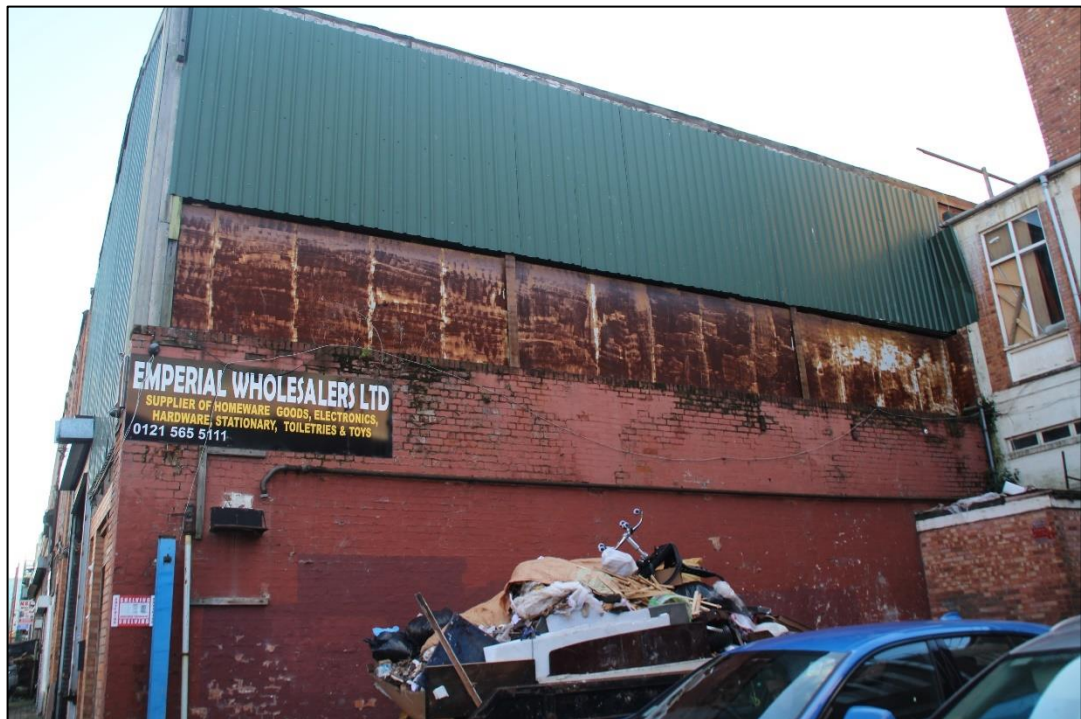
Photo 15 Southern (side) elevation of Building 2, looking north

4.17. The northern side elevation, as seen in Photo 15 also indicates that the modern upper parts of the Building were added onto a brick plinth formed of the lower walls of the original building.

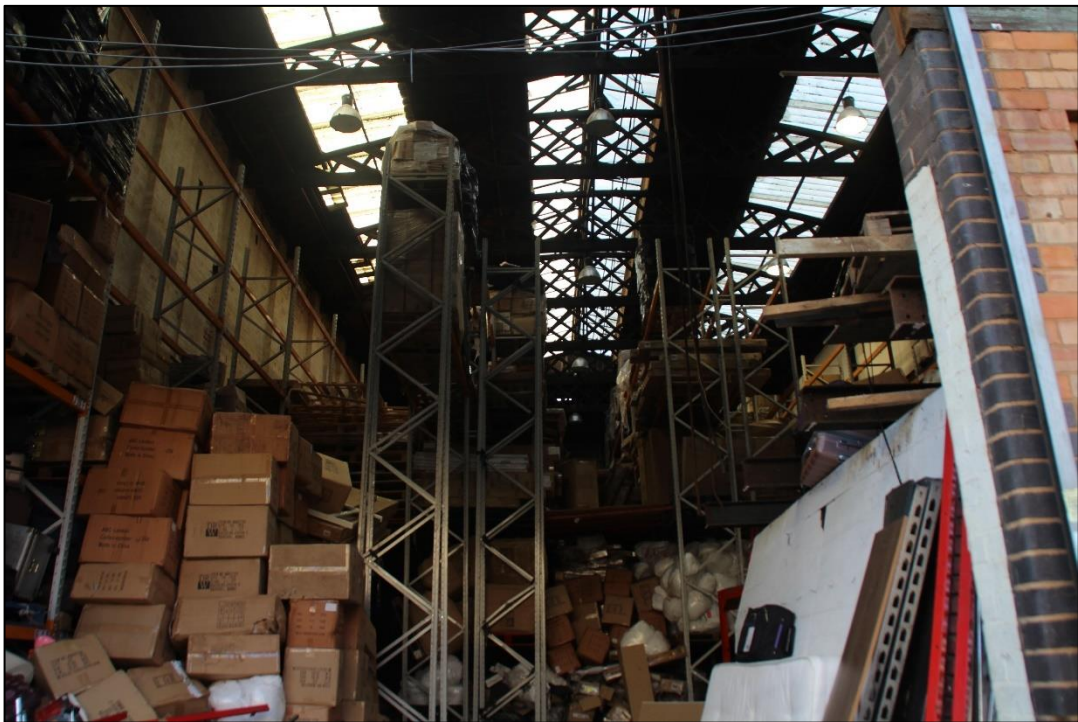
Photo 16 View of the Belfast roof truss of Building 2, seen from the entrance

-
- 4.18. Access to the interior of this space was severely limited by the amount of storage racks and stored items which impeded access and sight of the interior (Photo 16). It is clear however that the interior of the Building is one large double height open space extending to the party wall with Building 1 to its south. The walls of the southern side of the Building were visible and are plain brick with engaged piers. There is nothing to suggest these walls are historic, but rather constructed with the rest of the extant building.
- 4.19. The roof structure is formed of regular steel Belfast trusses which span the building north – south and over which there is a curved roof formed of linear runs of glazing, one central light with two flanking lights punctuated by runs of roof cladding. This can be seen in Photo 16. and in the roof forms on Fig.13.

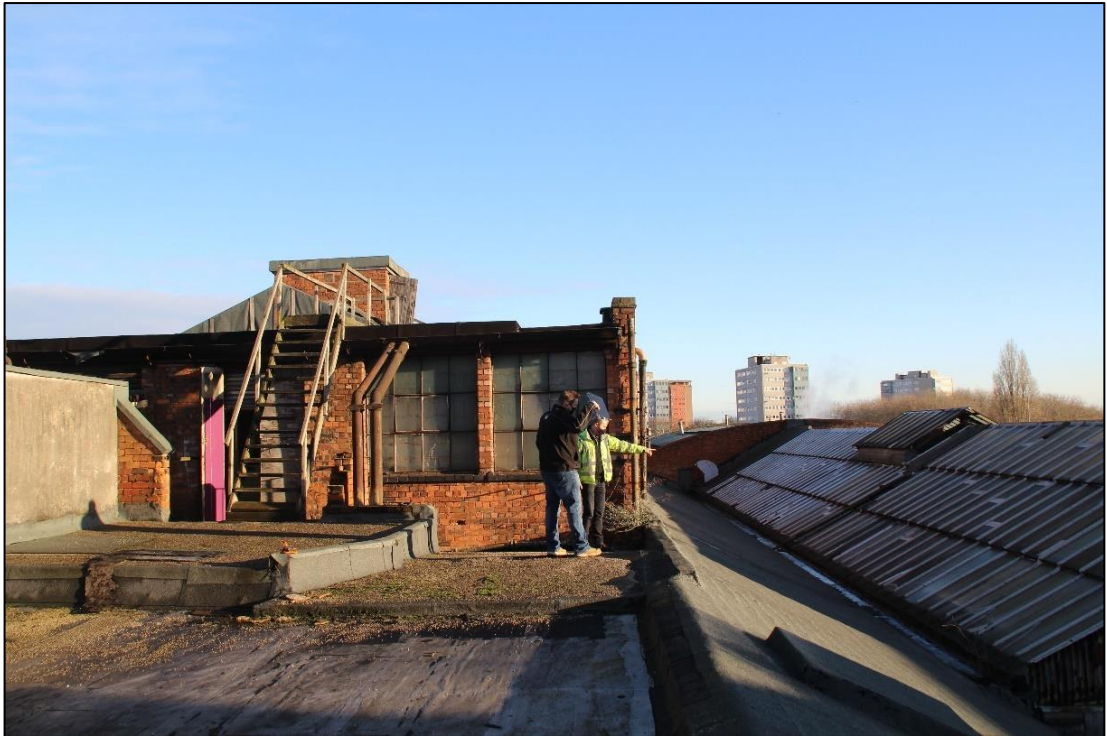
Photo 17 View looking east to the roofscape of Buildings 3 and 5

- 4.22. The Building is enclosed on all sides by the built form of the Site, and therefore has very limited external elevations; restricted to the glimpses of the south elevation as seen in Fig.15 above, and those seen from the flat roof of the building to the south, as seen in Photo 17 below that evidence metal windows and blue brick dressings. The roofscape was examined and photographed (Photo 18), and is formed of a flat roof structure with a central glazed atrium. The brick-built lift overrun is visible in the foreground.

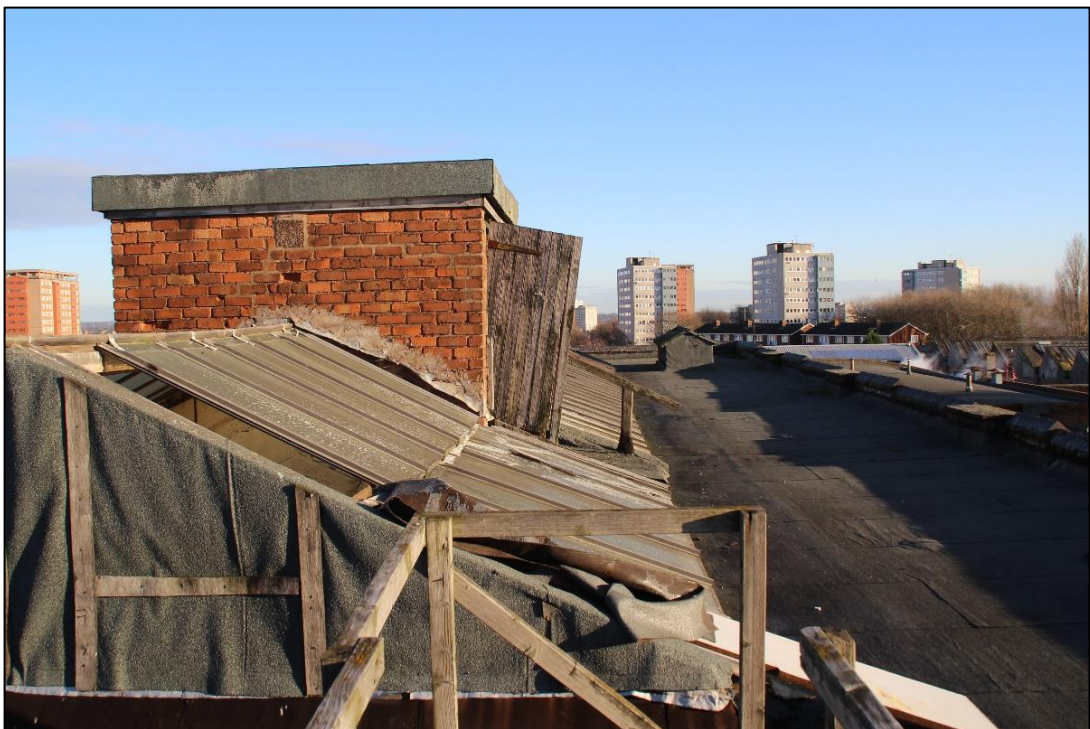
Photo18 Closer detail of the roof of Building 3

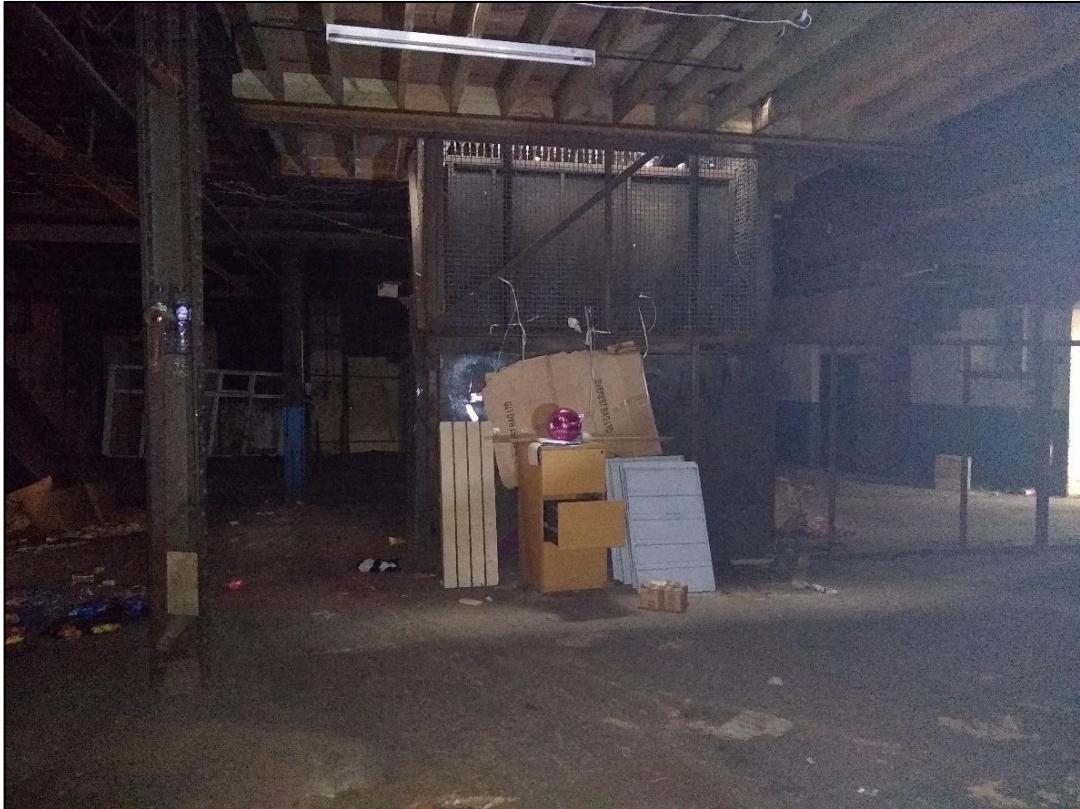
the lift within its cage enclosure at the western end of the space. The structure is formed of steel girder piers and beams which support the upper floors, which have timber joists and secondary beams. This arrangement is seen in Photo 19.

Photo 19 View looking west on the ground floor of Building 3

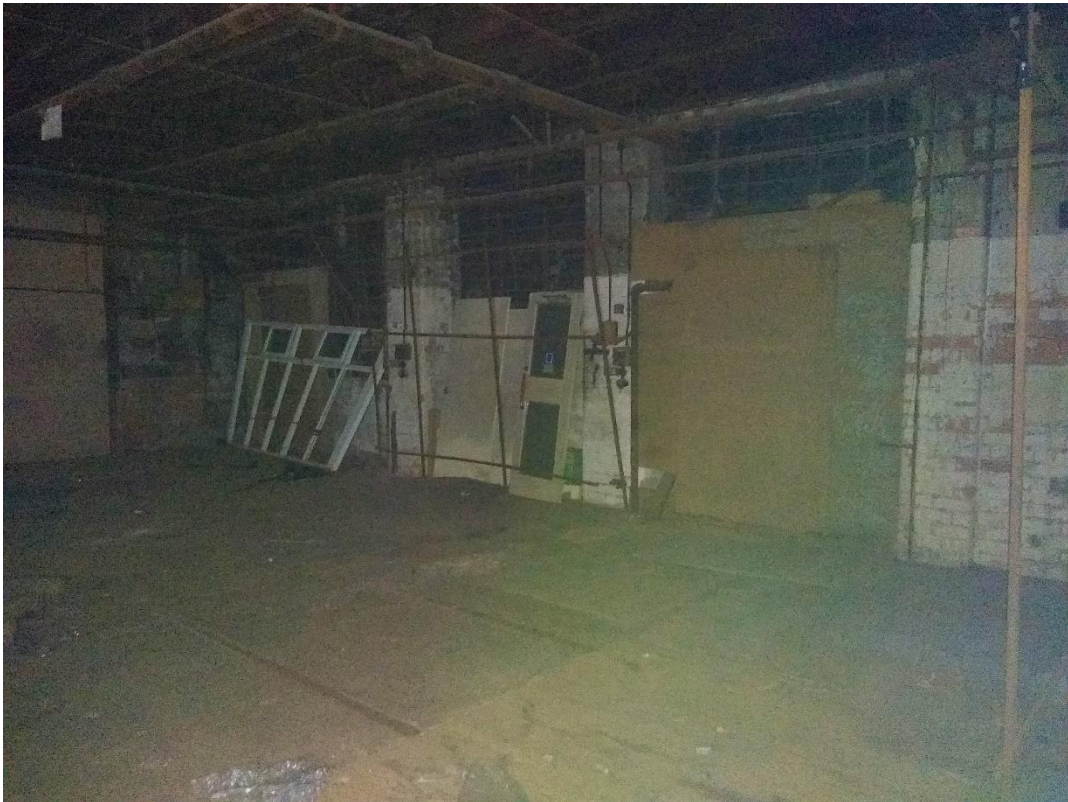
Photo 20 View of the rear (west) wall of Building 3 showing the large industrial windows fronting towards Great Hampton Street

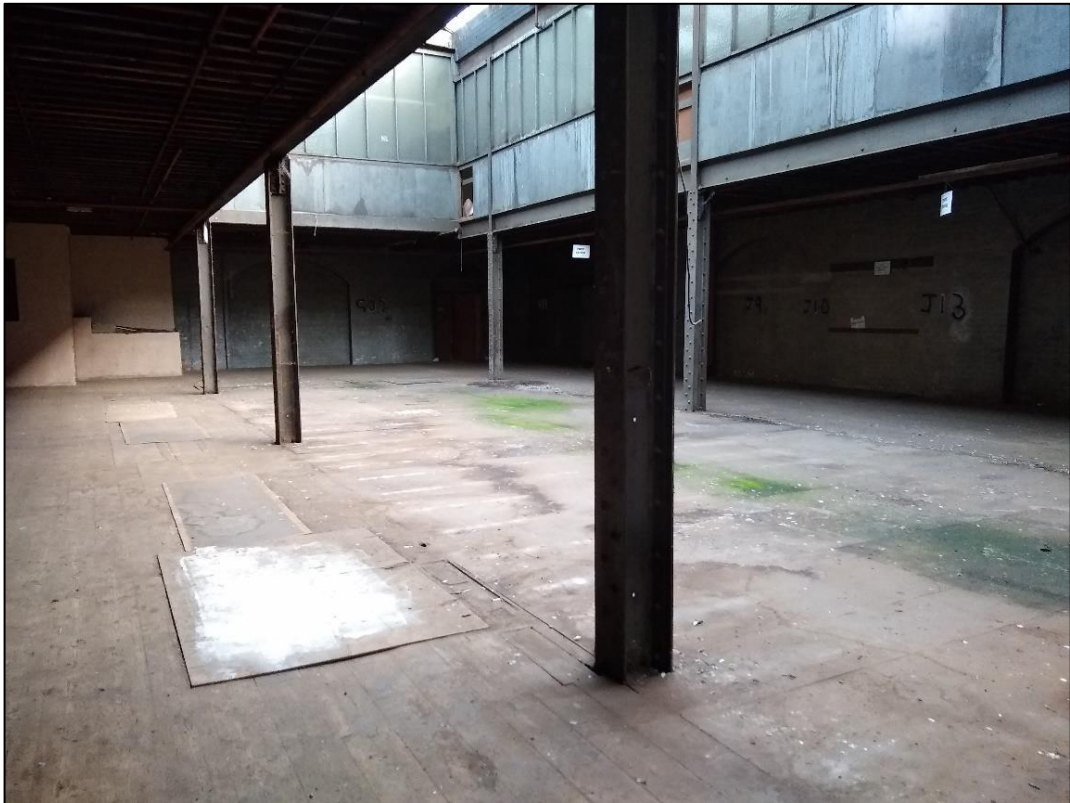
4.25. The first floor is accessed via within the western and eastern ends of the Building, the eastern end stairs being enclosed within the staircase vestibule. The upper floor is open centrally to the atrium lantern and features a steel frame structure supporting a partially glazed mezzanine floor which circumnavigates the internal atrium courtyard. This is illustrated in Photos 21 with the lift shaft illustrated in Photo 22.

Photo 21 **View looking east within the first floor of Building 3**

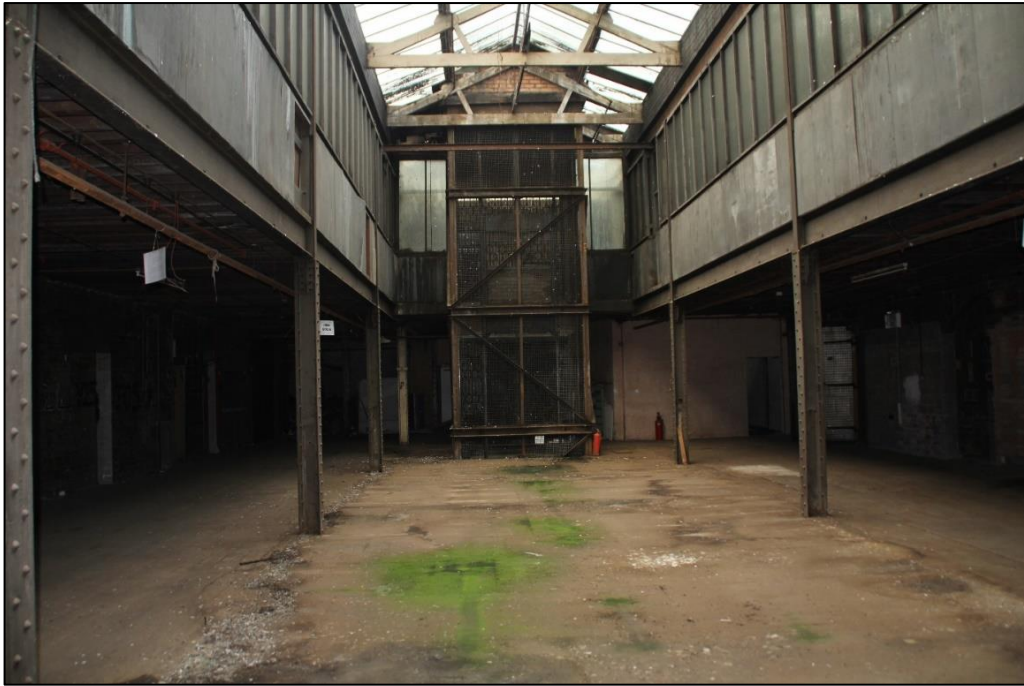
Photo 22 **View looking west towards the lift shaft of Building 3**

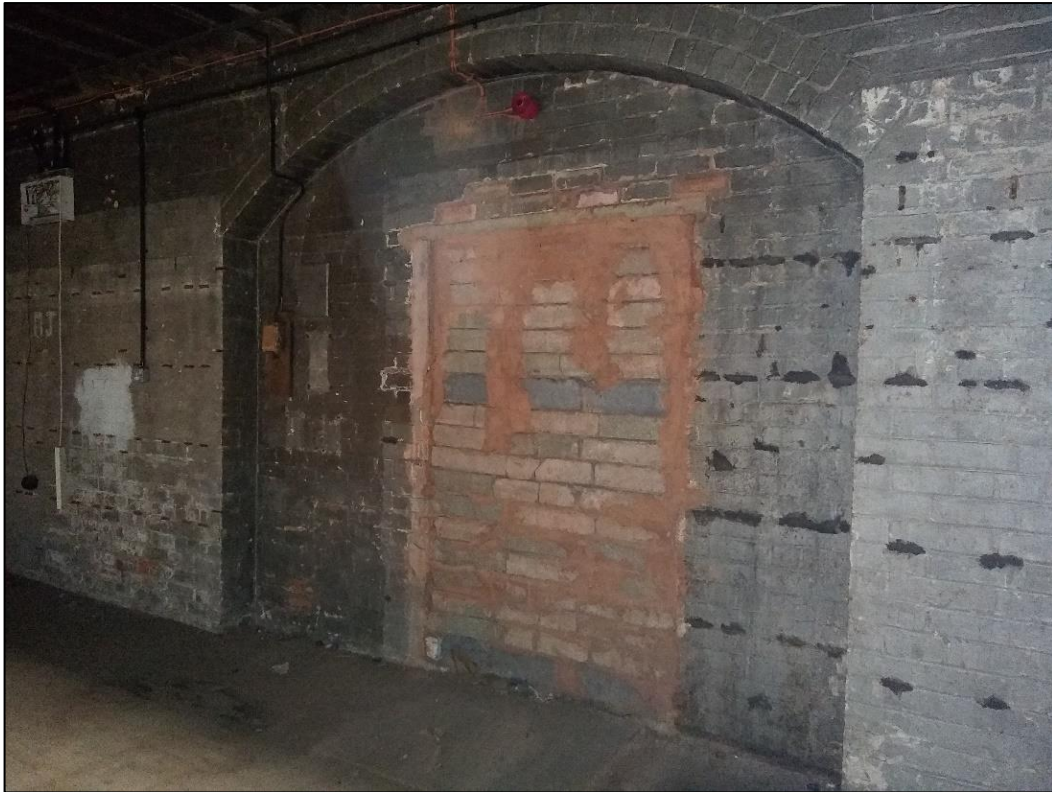
- 4.26. The floor in this area is timber, with some areas covered in a boarding material. The walls on both sides feature the blind arcaded segmental arches, some of which have been punctured with openings and then blocked with either brick or Concrete Masonry Units (CMU) as required. The western section of the Building has clearly (as on the ground floor) been subject to adaptation as the Building was amalgamated with adjoining parts of the Site. This is seen in Photo 23 where an opening to No.30 Great Hampton Street has subsequently been block up with brick.

Photo 23 View of flank wall in Building 3 with blocked up opening

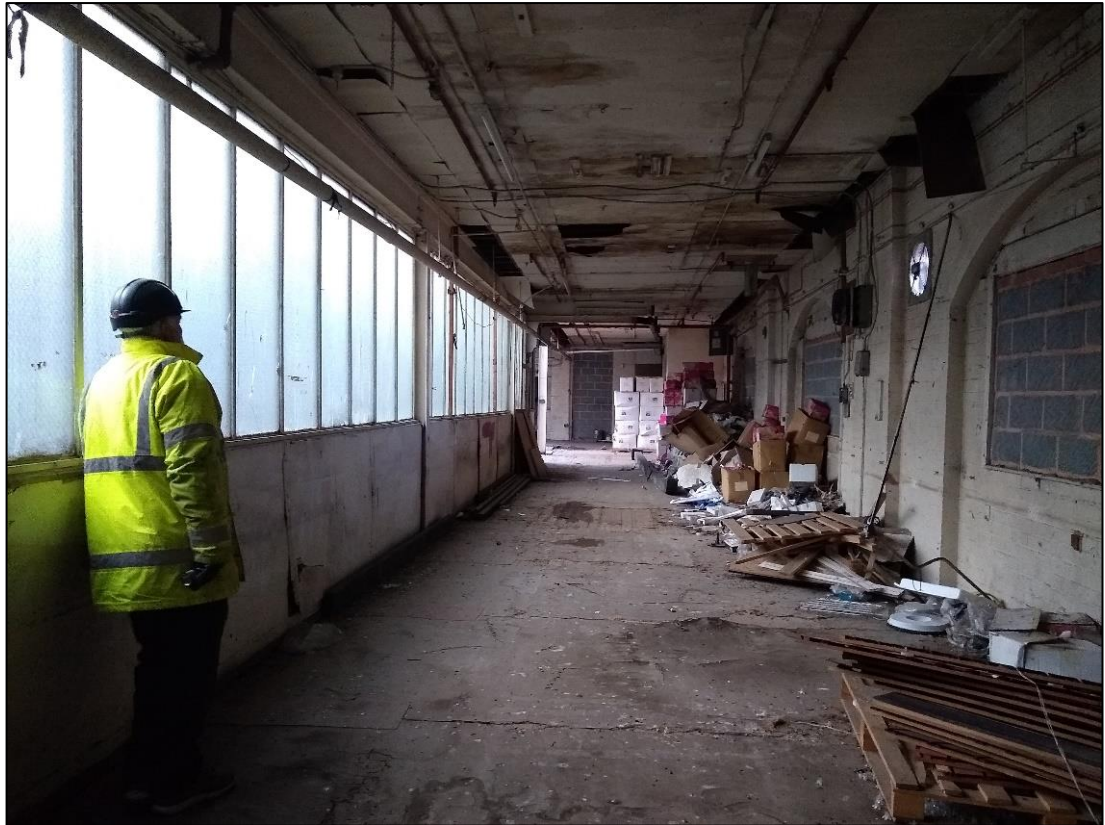
- 4.27. The second floor is formed of the mezzanine structure encircling the double height atrium. Glazed and panelled sections overlook the first-floor atrium area (Photo 24). The flooring is timber which appears to have been covered in an asphalt or similar covering over a thin board surface. This might indicate processes that involved fluids being conducted on this floor, perhaps the varnish works where splashing on the floor could be accommodate without damage. (Photo 25). The flank walls are brick with a blind arcade of arches, and again some of these arches have been punctured with openings and then subsequently closed again, evidencing the change from the Restall factory to individual units in the later 20th century.

Photo 24 **Second floor northern corridor in Building 3, looking west**

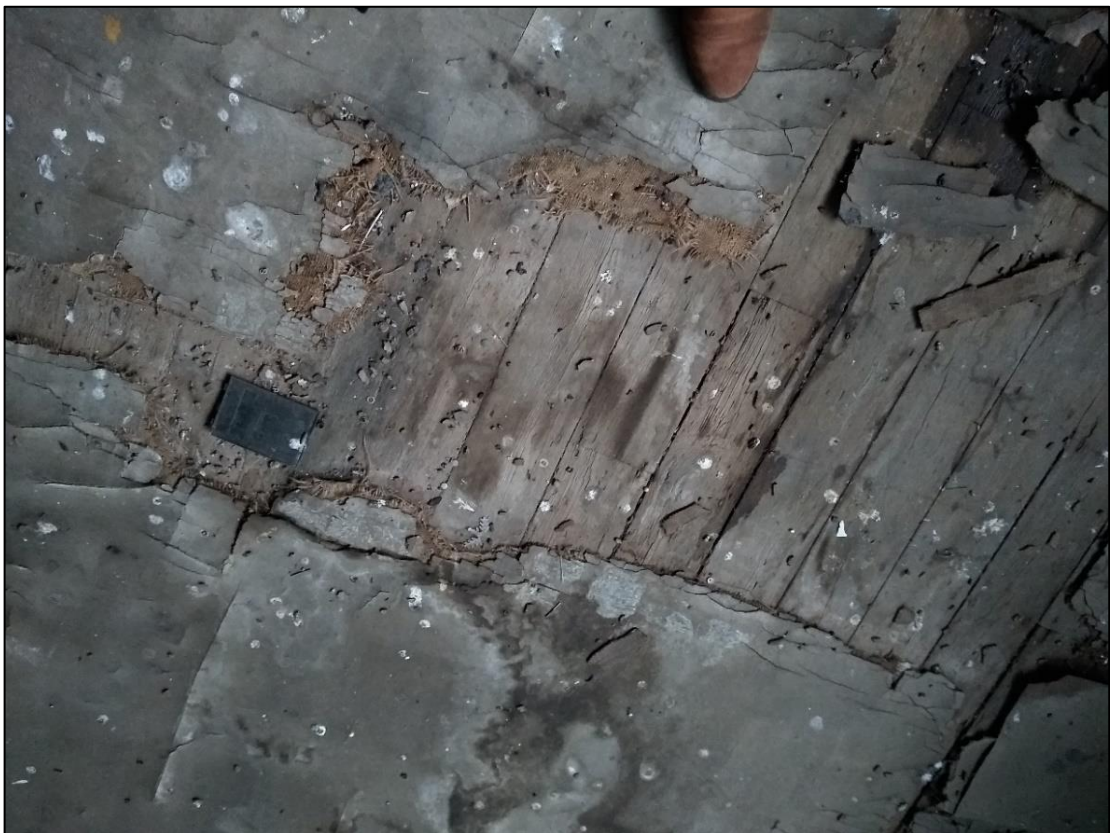
Photo 25 **View of the timber and asphalt floor, second floor of Building 3**
