The Lampworks Jewellery Quarter, Birmingham

Historic Building Recording (Level 3)

CA Project: CR0549

January 2021

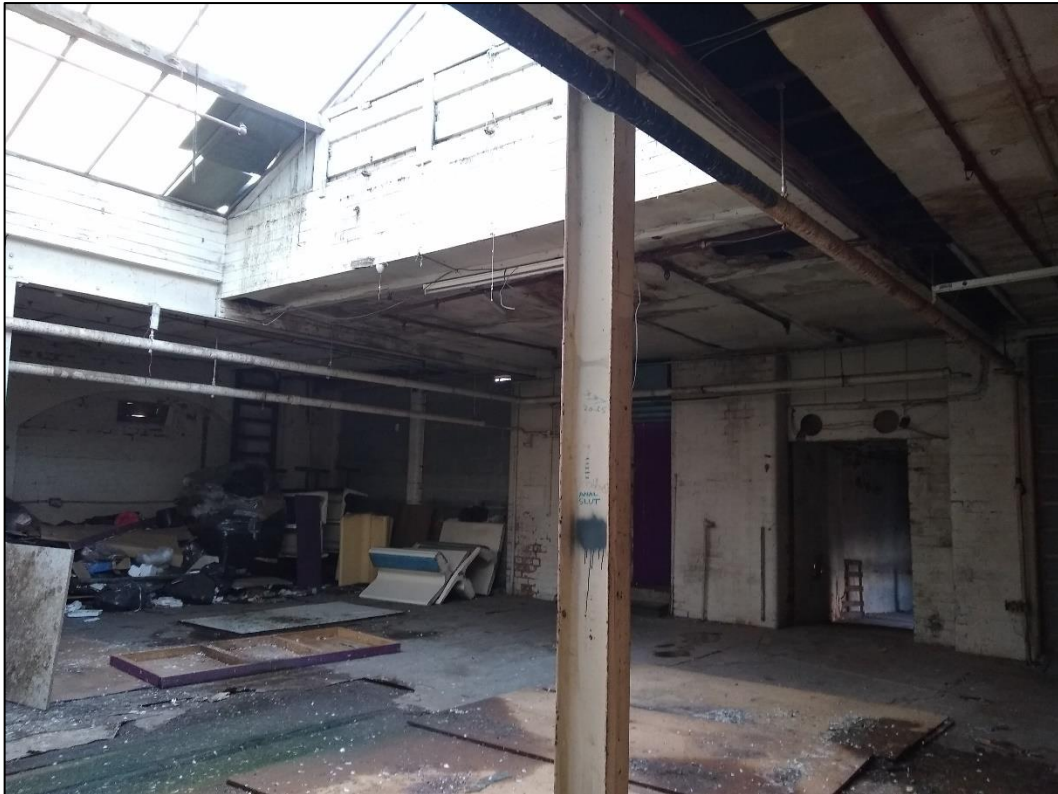
- 4.28. At the eastern, lift end of this floor are further openings to No.30 Great Hampton Street, with one opening, as seen in Photo 26, leading to a ramp down to the open plan upper floor of this building (Photo 27). From another angle, looking east, it is possible to see the lift shaft as it terminates on this floor and its interaction with the glazed roof lantern as seen in Photo 28. The lift itself is a substantial industrial structure of metal cage formation.

Photo 26 View of the second floor in Building 3 looking towards No.,30 Great Hampton Street

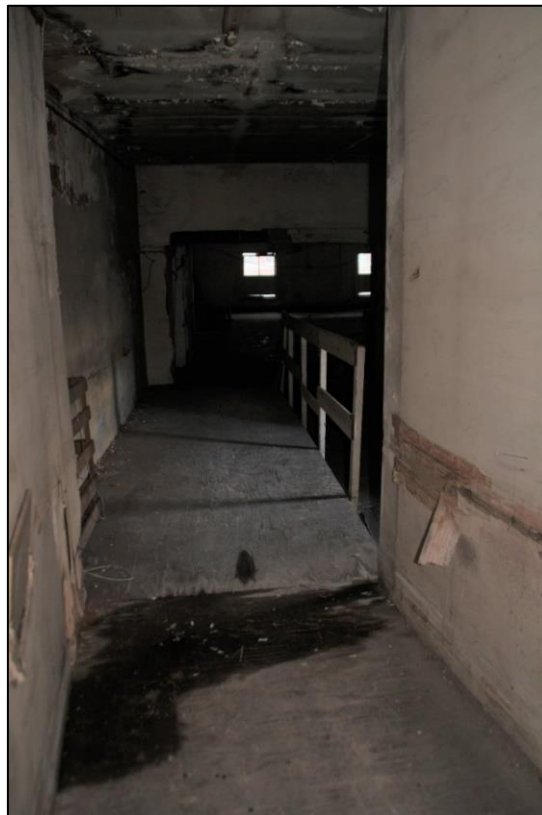
Photo 27 View of the ramp arrangement extending eastwards from Building 3 to No.30 Great Hampton Street

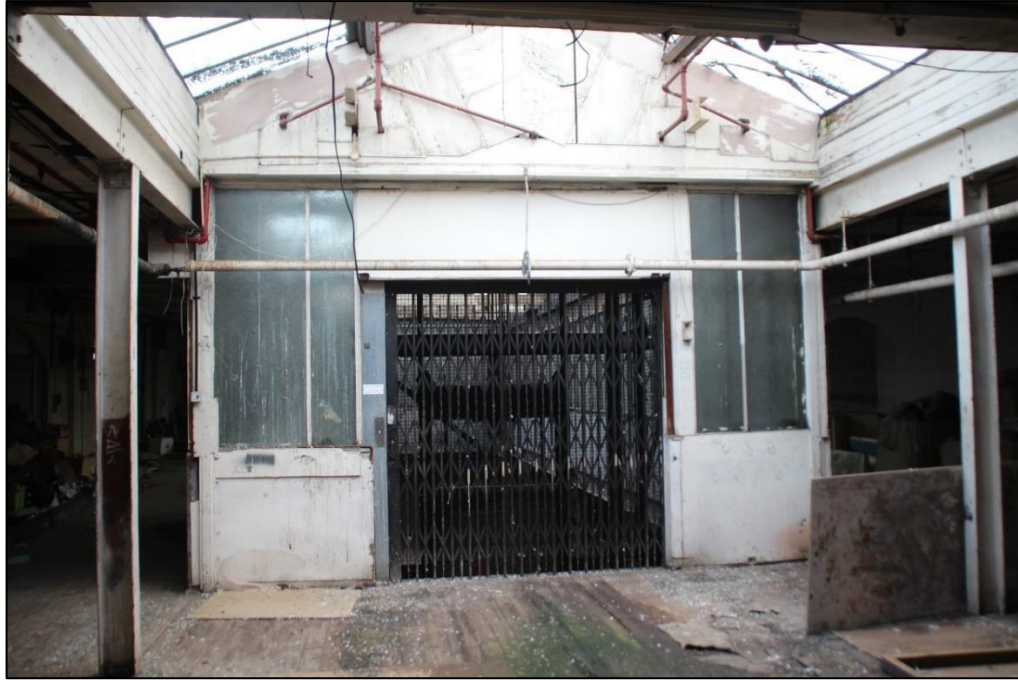
Photo 28 **View of the lift in Building 3 on the second floor**

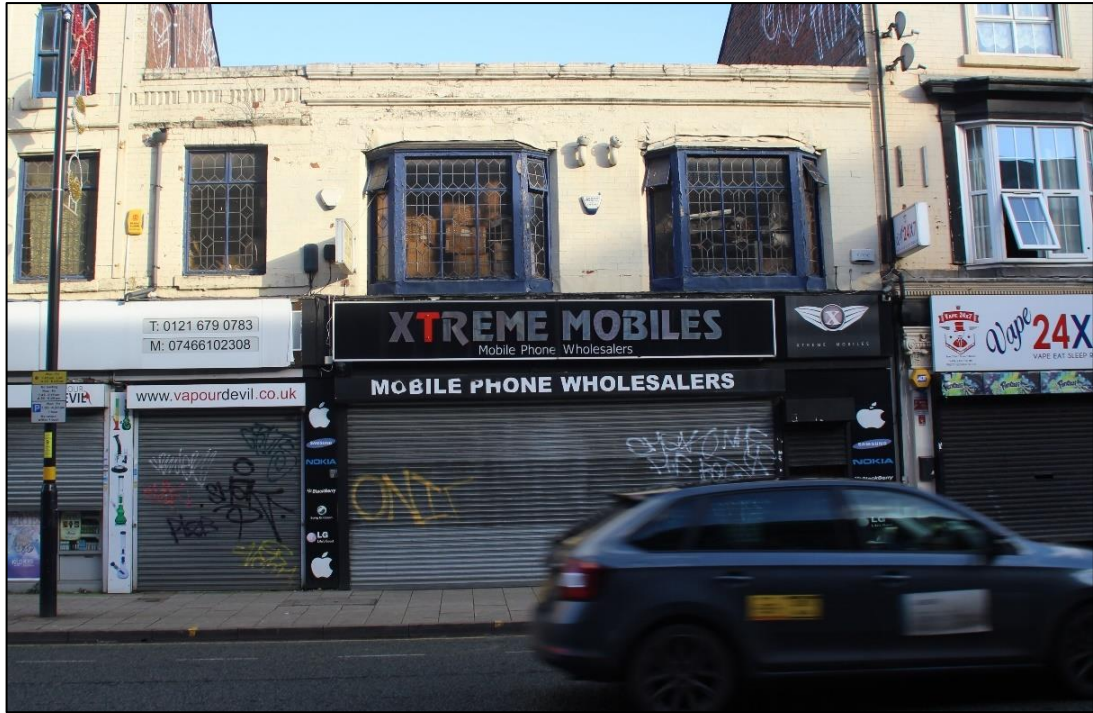
Photo 29 **View of No.27 Great Hampton Street**

4.33. This building (as seen in Photo 29 below) is a two-storey building with shop frontage, the composition and location suggests the shop front, despite its current appearance, was part of the original design, though the signage fascia has over time been enlarged so that it now cuts into the sill of the oriel windows above. These timber windows feature lead light detailing which is matched in a casement window to the left which has brick headers and sill. The lead light detailing, which is seen in the windows in all three buildings of this section, is difficult to date, but has an 'art deco' character which may suggest it was implemented in the early 20th century (possibly 1920's or early 1930's), perhaps after Frederick Restall Ltd took over the Site in 1912 and wanted to create a cohesive appearance to the shop frontages where his furniture was no doubt sold or displayed.

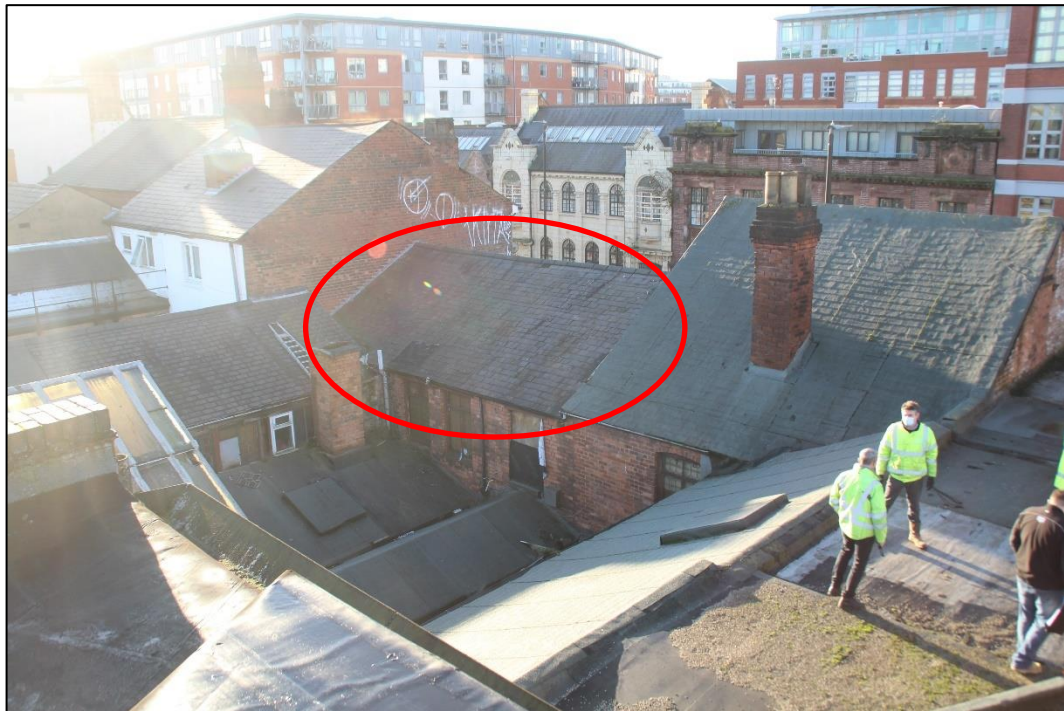
Photo 30 View of the roovescape of No.27 Great Hampton Street (circled)

- 4.35. The roofed rear yard areas of the building have been amalgamated into the ground floor of Building 5 and have been much altered. They are now accessed from Building 5 not No.27 and will be discussed in that section. Photo 30 shows the rear

elevation of the building from a vantage point on the roof with lead light windows matching the front elevation and shows a rear lean-to outrigger extension (with ladder on the roof slope) which was not accessed as part of this recording. The felt roofed rear areas of the building are also seen (to be discussed in Building 5's section).

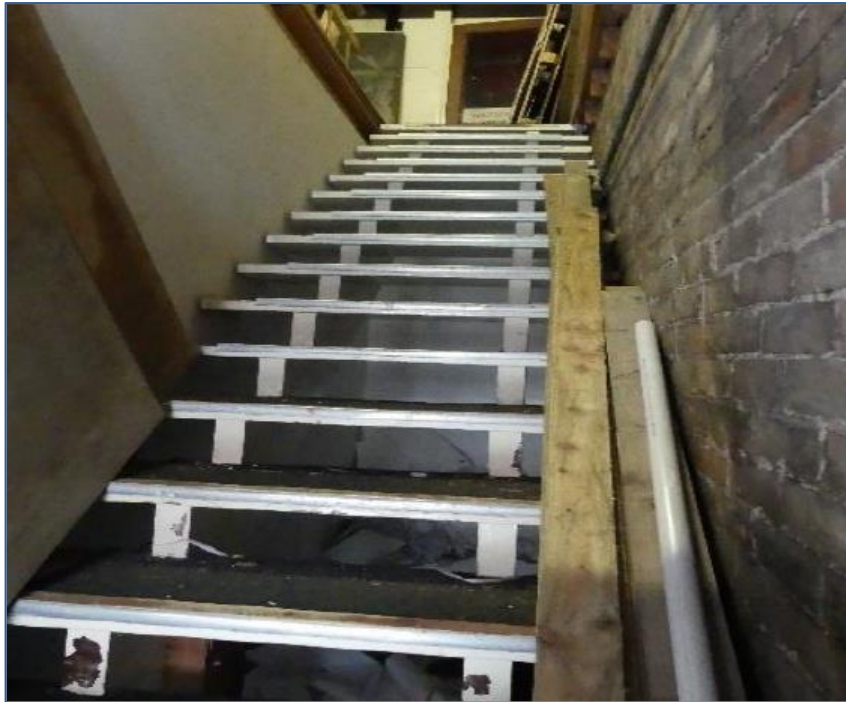
Photo 31 View up the staircase in No.27 Great Hampton Street

- 4.36. Internally the building has been much altered and features a new doorway to the right of the shop front which leads to a modern staircase which has been cut through the first floor (Photo 31). The first floor has been partly subdivided with ad hoc partitioning and steel beams as seen in Photo 32.

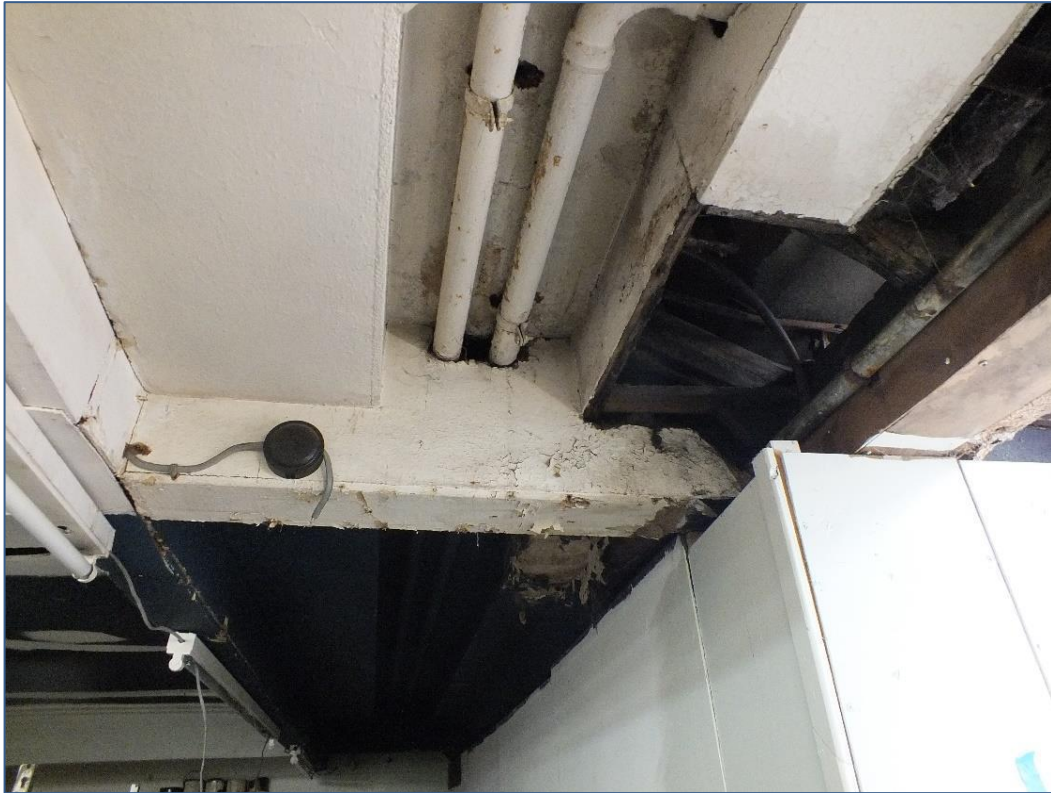
4.37. Remnant details of the historic interior structure can still be seen on the upper floor (Photo 33 and 34). The ground floor is now a shop which has obviously seen many alterations over the years, the walls and features of which are obscured by the shop fit out and stock (Photo 35). Access to this area was limited due to Covid-19 restrictions.

Photo 33 **View internal details, No.27 Great Hampton Street**

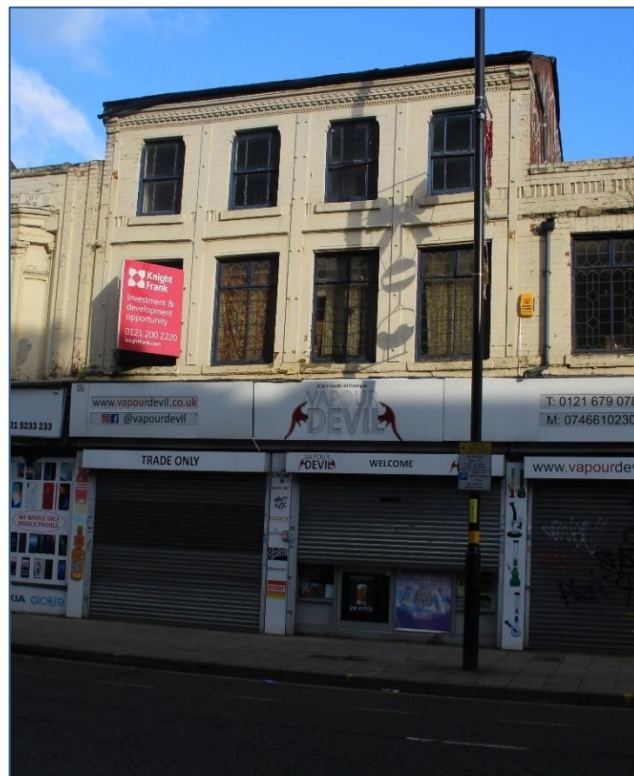
Photo 36 Front façade of No.28 Great Hampton Street

- 4.38. This building was constructed after 1855 and before 1890 as evidenced on historic cartography. It is a three storey four bayed building with painted brickwork and stone dressings as seen in Photo 36. The eaves cornice is deep and features dentils and other decorative details. The tall first floor windows have lead light detailing matching that of No.27 which suggests an overhaul of the windows when the buildings were both part of the furniture works in the 1930's. The ground floor is formed of a shop frontage which extends over the whole building at this level, with a deep shop fascia below a first-floor string course. The roof form is asymmetrical, dropping to two storeys on the rear elevation in a catslide style roof arrangement (Photo 37). Also seen in this image is what appears to be a blocked doorway and the efflorescence either side from the sealed flat roof structure. Thick bolted metal straps run vertically from the top of the second floor to the bottom of the ground floor, these very likely have a structural tying function, perhaps related to later phases of alteration in opening out the ground floor.

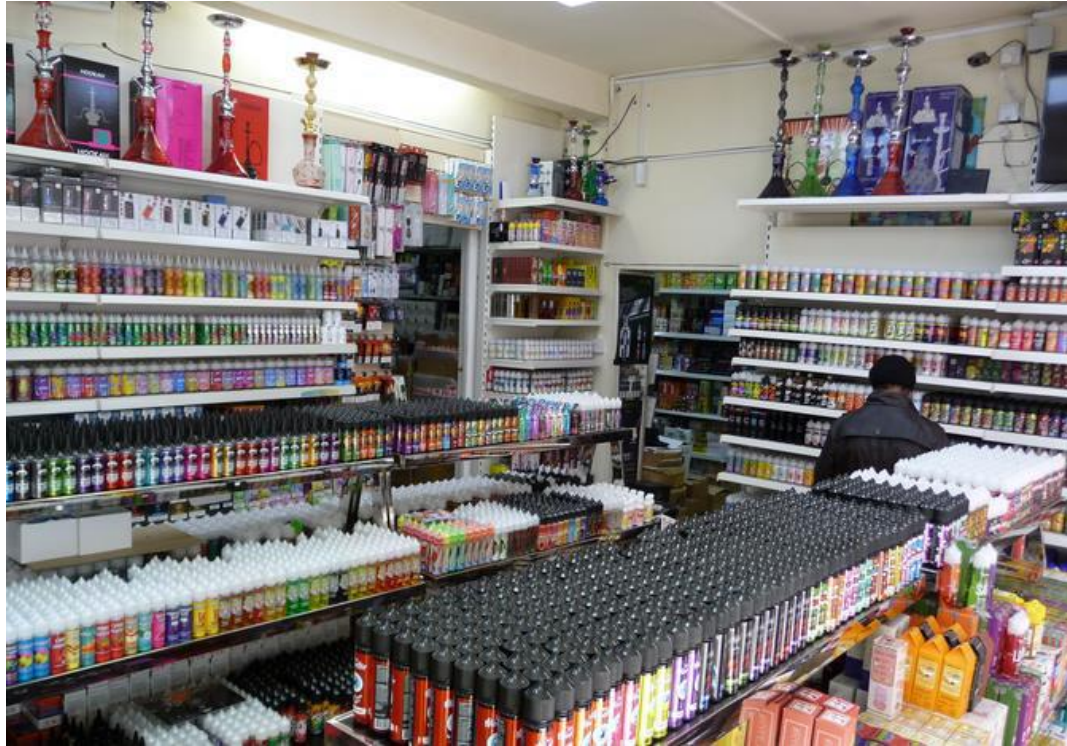
Photo 38 View of the ground floor interior of No.28 Great Hampton Street

-
- 4.40. Internally the ground floor premises of the building have been opened up into one retail space. Numerous alterations over the years combined with shop fitouts has obscured any original or historic detailing as seen in Photo 38.

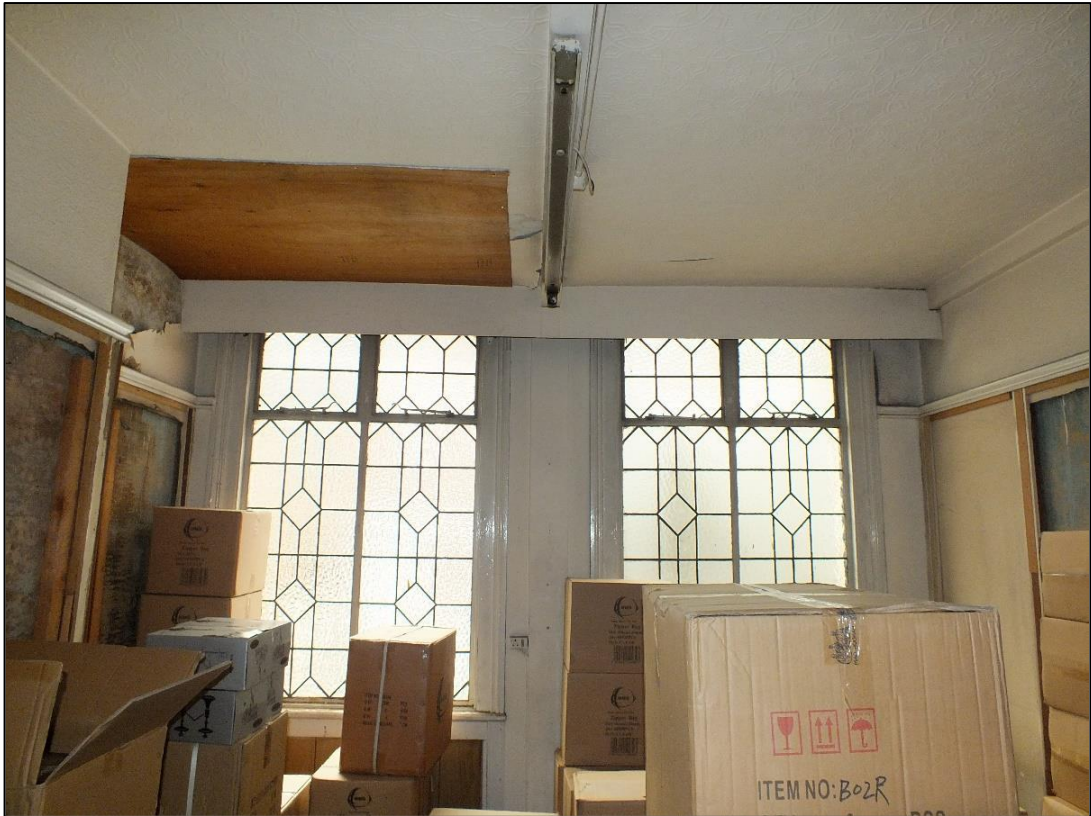
Photo 39 View of windows overlooking Great Hampton Street in No.28

- 4.41. The first floor of the building has been subject to later subdivision and lateral conversion, presumably when they became part of the site wide furniture works. Some historic details are still present, for example door joinery and cornice as seen in Photo 39, however much of this has been obscured or removed by later work. The second floor however remains largely intact in plan form and experience, as seen in Photos 40-42.

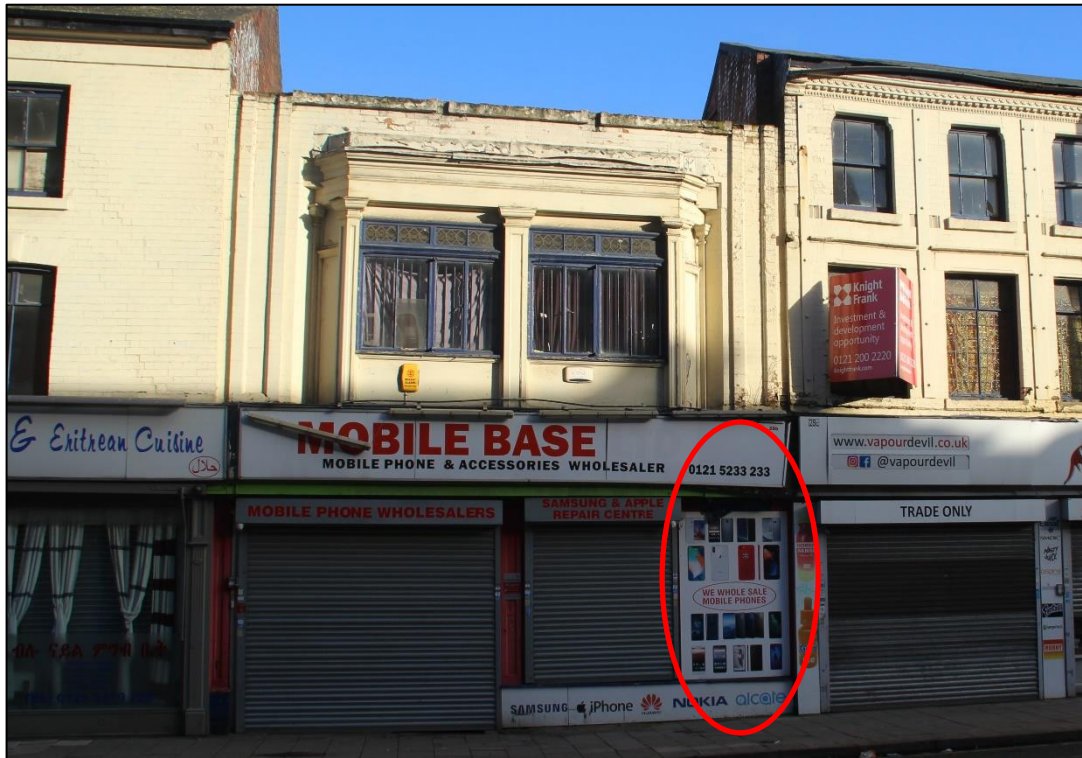
4.43. This is a much altered two-storey building that appears at one time to have been a three-storey building. As indicated on historic cartography, it was constructed between 1855 and 1890. The front (east) elevation is formed of a painted brick façade featuring a wide shopfront with deep fascia to ground floor, and a double oriel window to the first floor supported on moulded pilasters and capitals (Photo 43). The window features lead light detailing, as with Nos.28 and 27. Remnants of the original timber shop front and stall riser are seen abutting that of No.30 (Photo 44). However, evidence of movement and alteration have affected the building, and there is evidence of a second floor having been removed. This is indicated by the remnants of three window sills seen as part of the crude parapet, and the flat roof arrangement of the roofscape.

Photo 43 View of No.29 Great Hampton Street, the former passageway through this building is circled

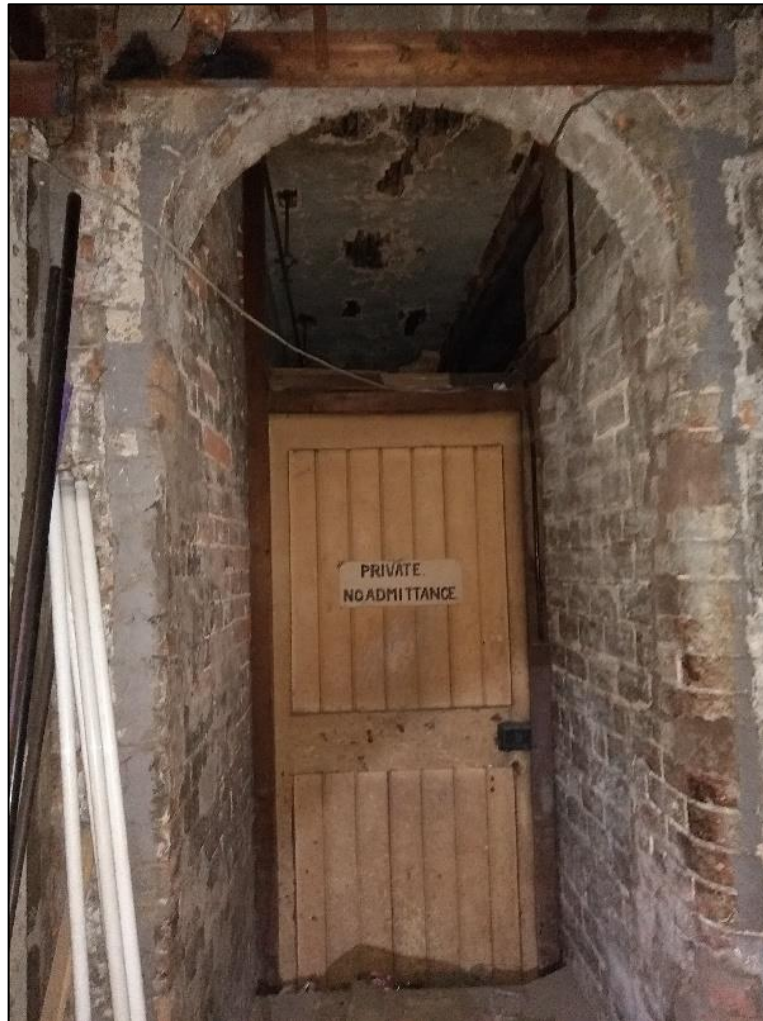
Photo 45 View from inside Building 3 of the former passageway leading from No.29 Great Hampton Street

4.44. The recording has uncovered a right-hand passageway (seen in cartography) to the rear which has now been sealed; it is only visible from Building 5 to the rear as seen in Photo 45 (and its location on Great Hampton Street is shown on Photo 43). It is in this area of the site (Building 5) that access to the basement of this building is available. The passageway would have exited the building in the area defined by the circle in the above. An original brick cobbled surface was also seen in this

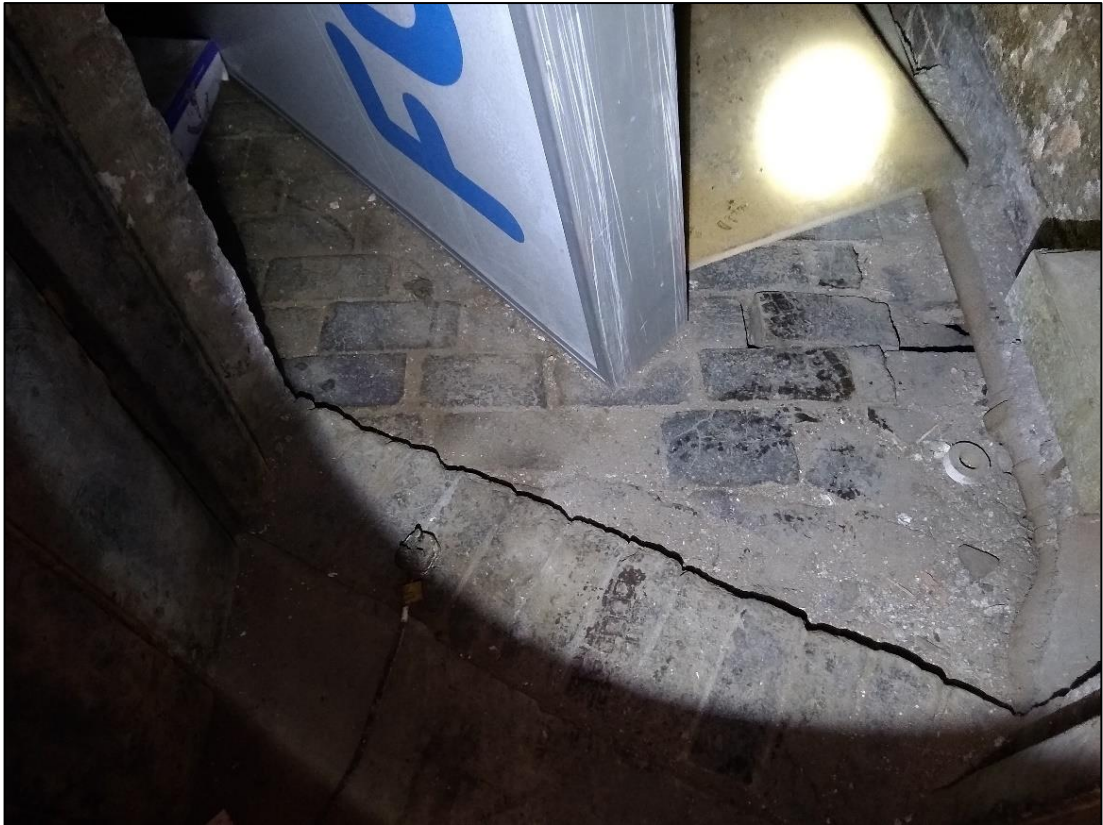
Photo 46 Floor with setts within the former yard (now interior of Building 3) connected to No.29 Great Hampton Street

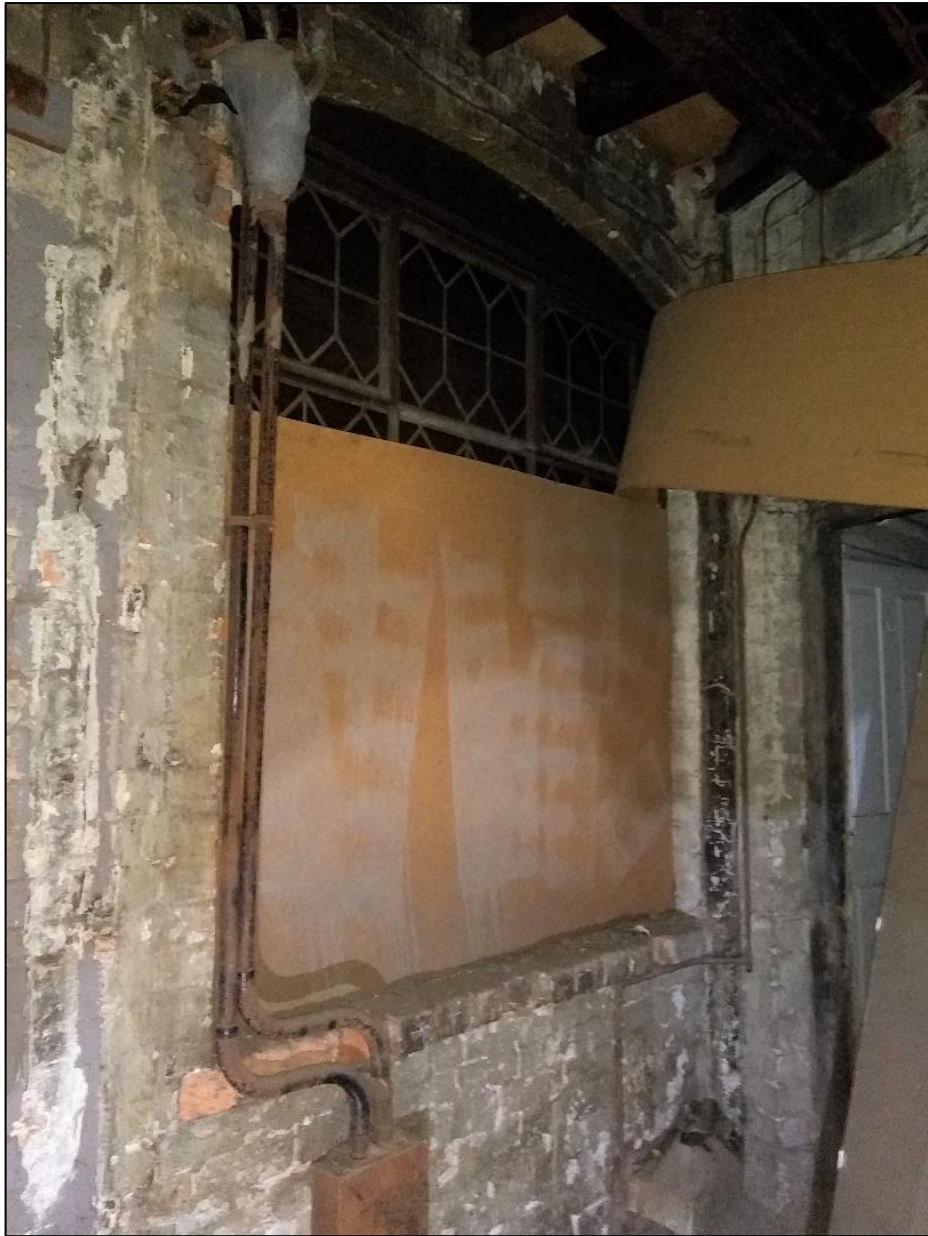
Photo 47 View of partially blocked window overlooking a former external area in No.29 Great Hampton Street (now seen internally in Building 3)

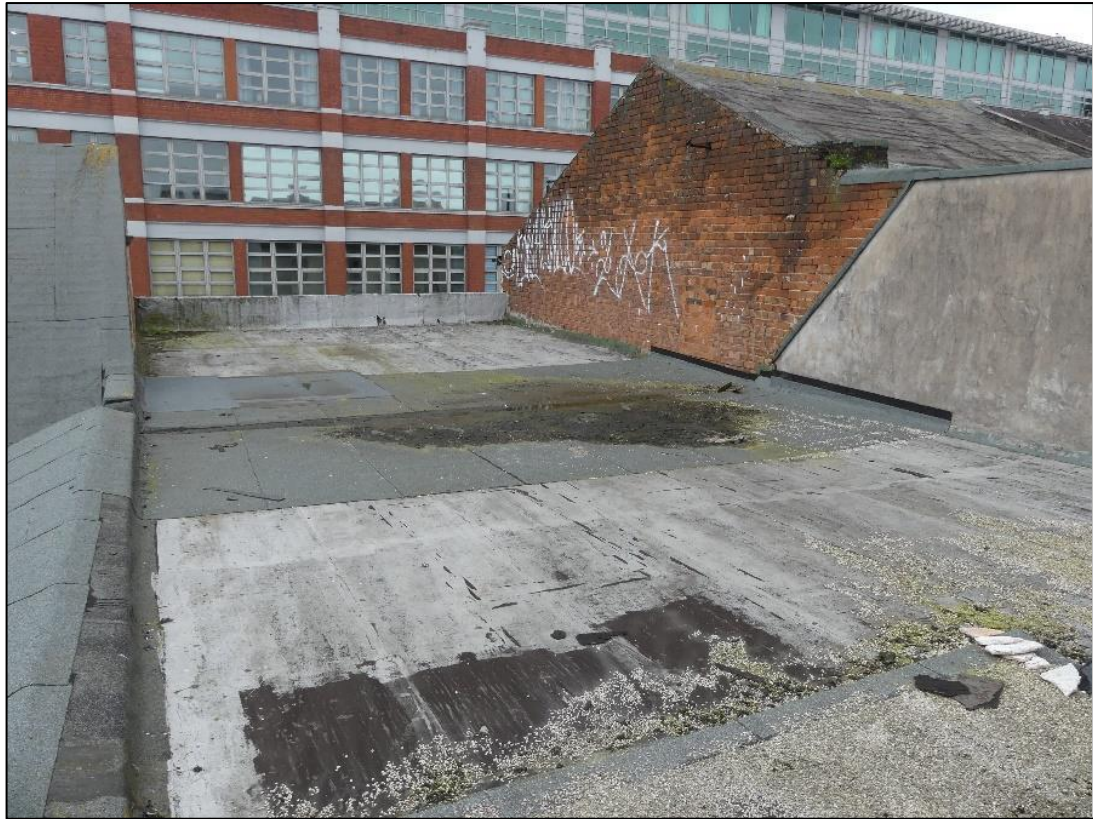
- 4.46. The rear yard has now been covered over with a series of flat roof two storey structures, which is evidenced by the ad hoc nature of this flat roof illustrated in Photo 48. The gable end of the former upper roof storey can also be seen in this image on the right-hand side.

Photo 48 Flat roof of No.29 Great Hampton Street, looking east

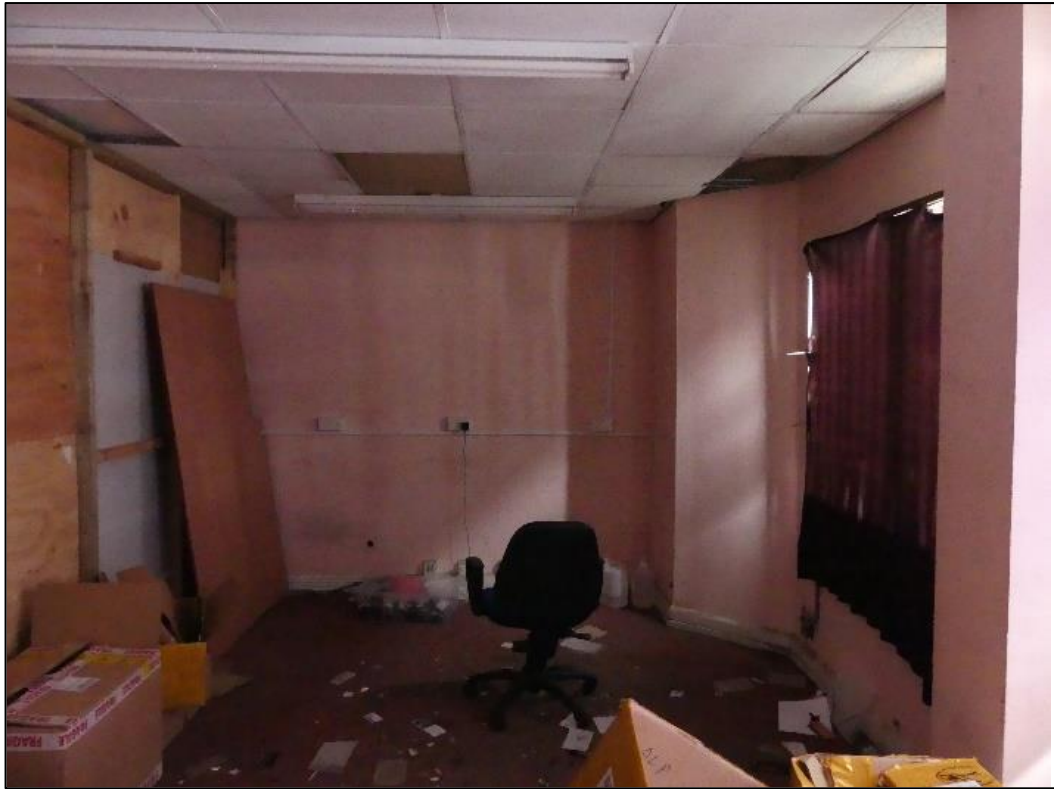
Photo 50 Interior view of No.29 Great Hampton Street, looking south

4.47. Internally the building features a modern retail space to the ground floor. The first floor is accessed via an original staircase as seen in Photo 49 that retains some detailing. The first floor has been partitioned and a false ceiling installed illustrated in Photo 50.

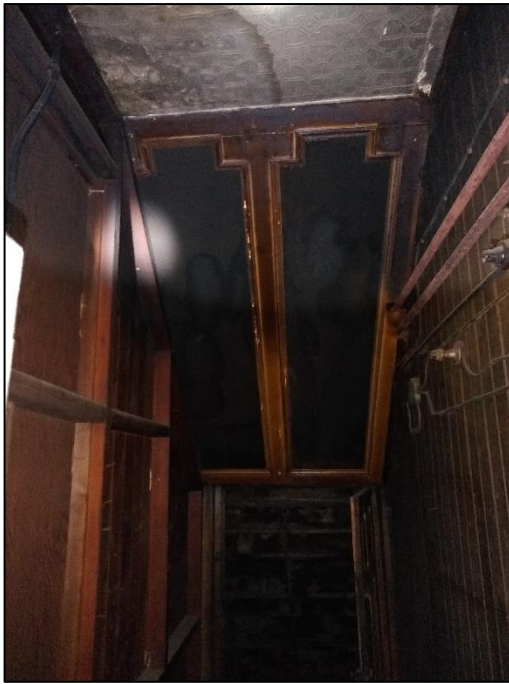
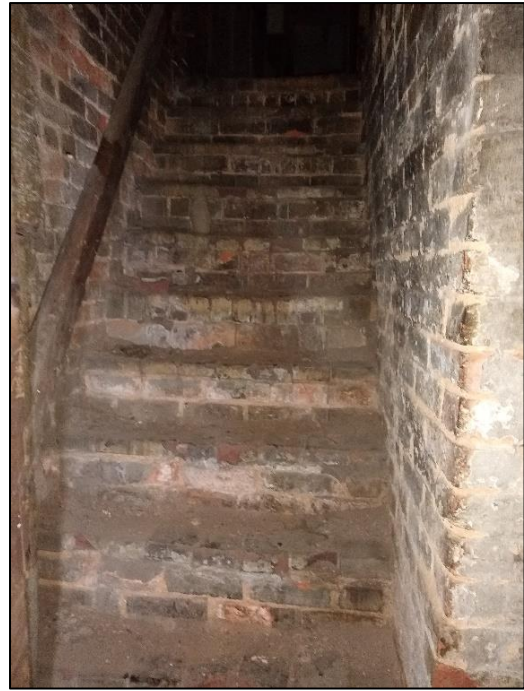
Photo 51 (left) Joinery on the ground floor stair as it starts to descend to the basement
Photo 52 (right) the basement stairs viewed from below

- 4.48. Of particular note in this building is the presence of the original basement area, which is accessed from the rear of Building 5. The basement staircase retains joinery detailing, whilst the basement, which has been altered over time with the insertion of services, is supported on regularly placed thick timber piers supporting substantial timber joists. Metal beams have also been inserted to assist in structural support though this is likely to be a later intrusion. Work benches, detritus and remnants of machinery indicate this was a working area. The floor is surfaced in clay tiles (Photos 51 – 54).

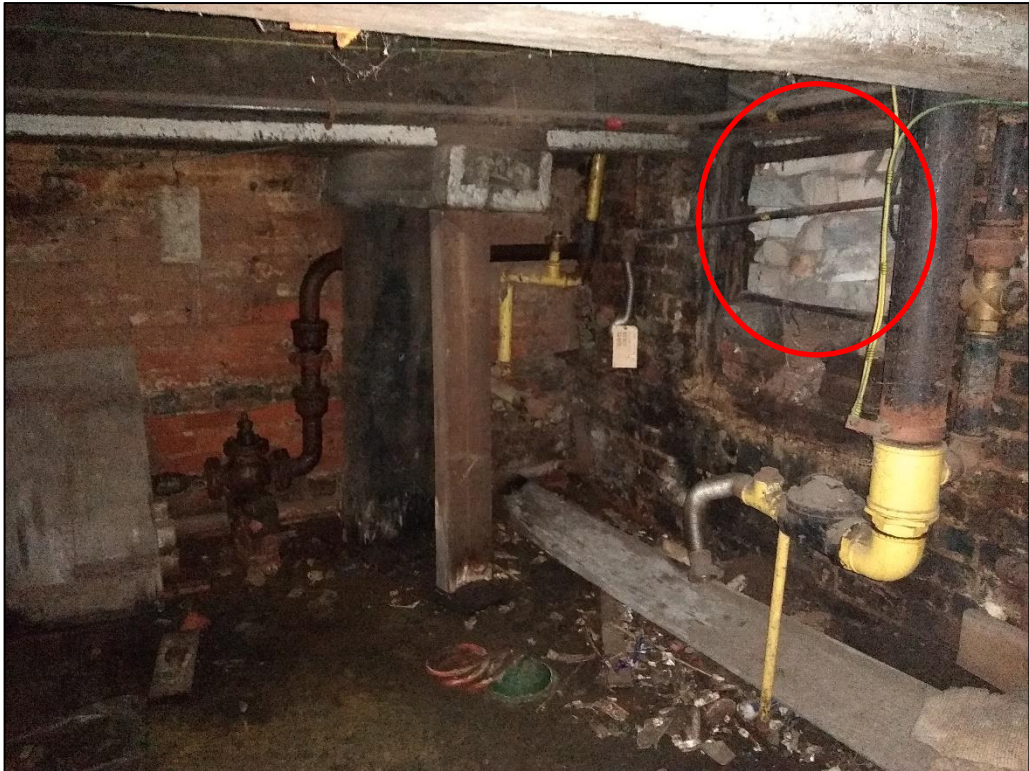
4.49. A blocked coal hole to the pavement is seen in the western wall of the basement room, soot staining on the brick work around suggests that coal may have been delivered here (Photo 55). To the rear of the basement area (i.e., eastwards) is another smaller subterranean room reached by two brick steps (Photo 56) which features three arched openings which look to be ovens or furnaces, indicating one function at least of the earlier manufacturing activity on the site remains interpretable (Photo 57). It is possible the heat from these ovens was channelled to help with processes within the varnish works within the rear courtyard area. A blocked staircase is seen in the south-east corner of the room (Photo 58).

Photo 55 View of the west wall of the basement with blocked light well (circled)

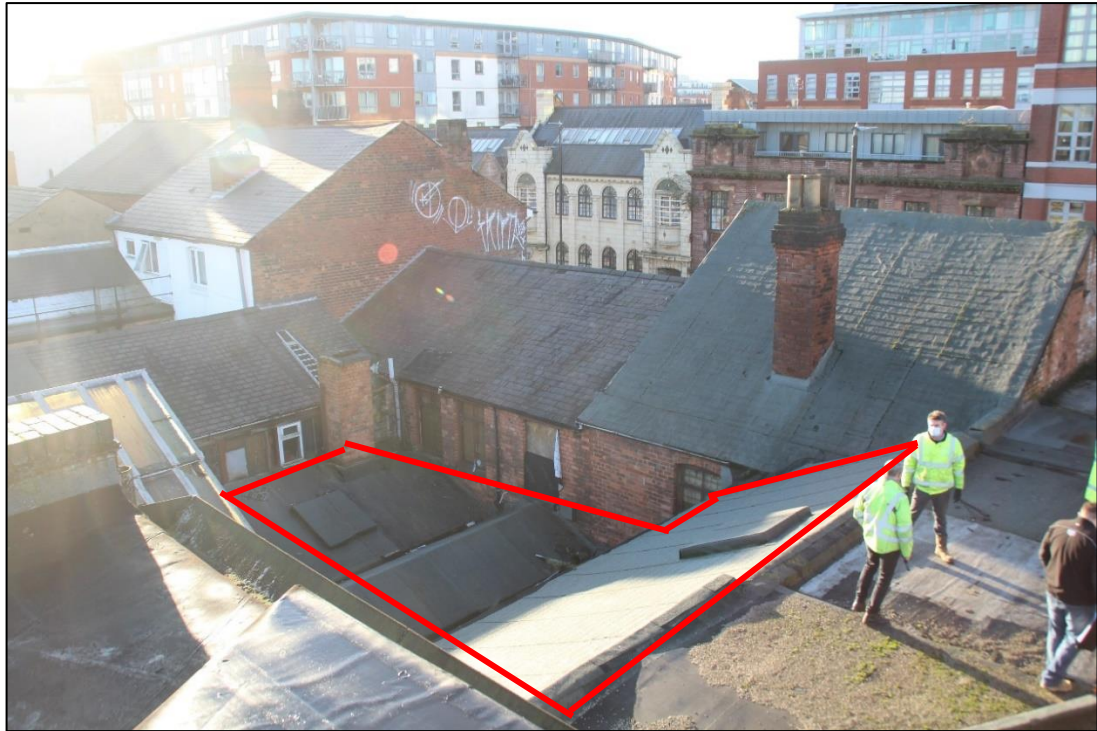
- 4.53. Building 5 comprises, the rear factory range to the east of Building 4. Cartographically it is presented as seen in Fig.21 as a series of linear and block shaped workshops addressing an internal courtyard accessed via the wide opening in No.30. These ad hoc buildings appear to have been entirely swept away when the current structure was constructed. Like the other larger factory buildings, it was constructed post 1927 as it does not appear on the OS map of 1917-27.
- 4.54. It has no external elevations as it is bound within the built form of the Site, though a timber clad gable end with windows below is visible on the roof image shown in Fig.21. At its western extent there is a series of connected but ad hoc roof forms, the central element being a simple pitched roof, which cover the former rear yard of Nos.27 and 28. These are seen in Photo 59 below.

Photo 59 The ad hoc roof coverings of Building 5 at its western end, which comprise the former yards of No.27 and 28 Great Hampton Street

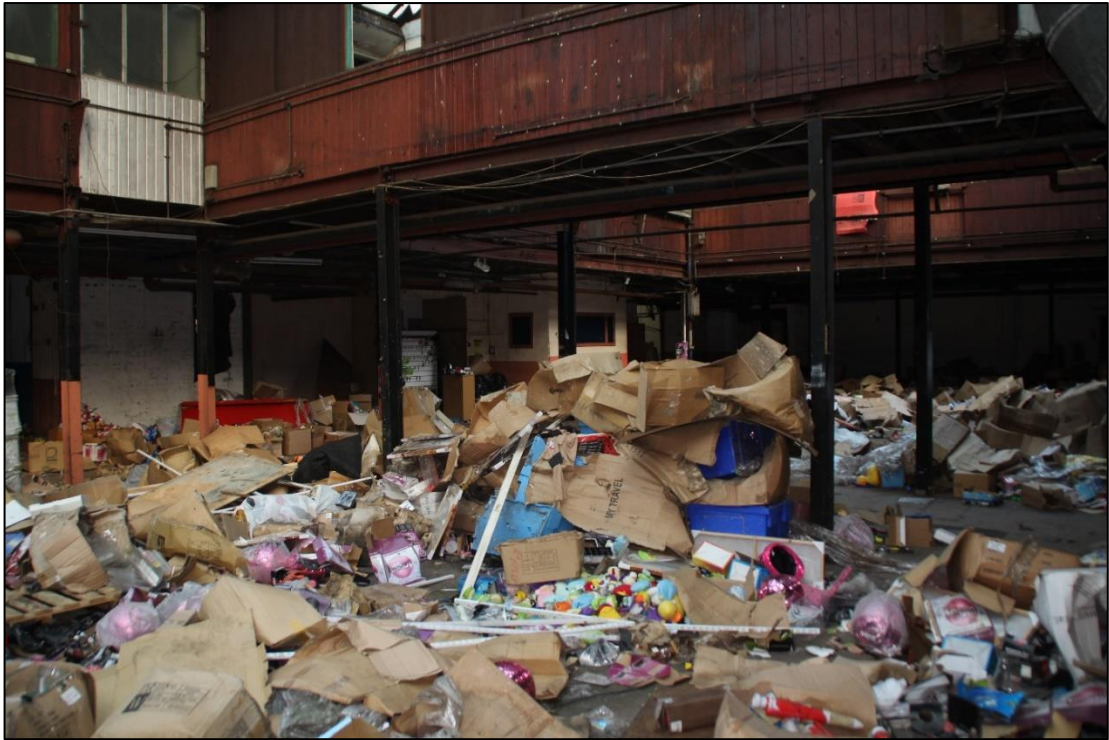
4.55. The building is a two-storey steel framed structure with brick flank walls and a mezzanine first floor encircling a double central atrium lit by a glazed lantern light. Internally the upper floors are suspended on the steel frame and are clad in tongue and groove timber cladding, with frost glazed windows above (Photo 60 and 61). The glazed roof truss is of steel double king post style braces bolted together (Photo 62). The flank walls are brick with regular piers carrying the steel beams. The walls have been punctured with large openings carrying shutter blinds and double doors at intervals. At the western end, under the covered yard area described above, new walls of CMU's have been constructed, presumably to support modern roof additions. There is no evidence in the brickwork of these flank walls that they contain remnants of the former workshops seen in cartography, this is evidenced in Photo 63 which illustrates that they were clearly made to suit the building frame.

Photo 60 Internal view of Building 5, looking west

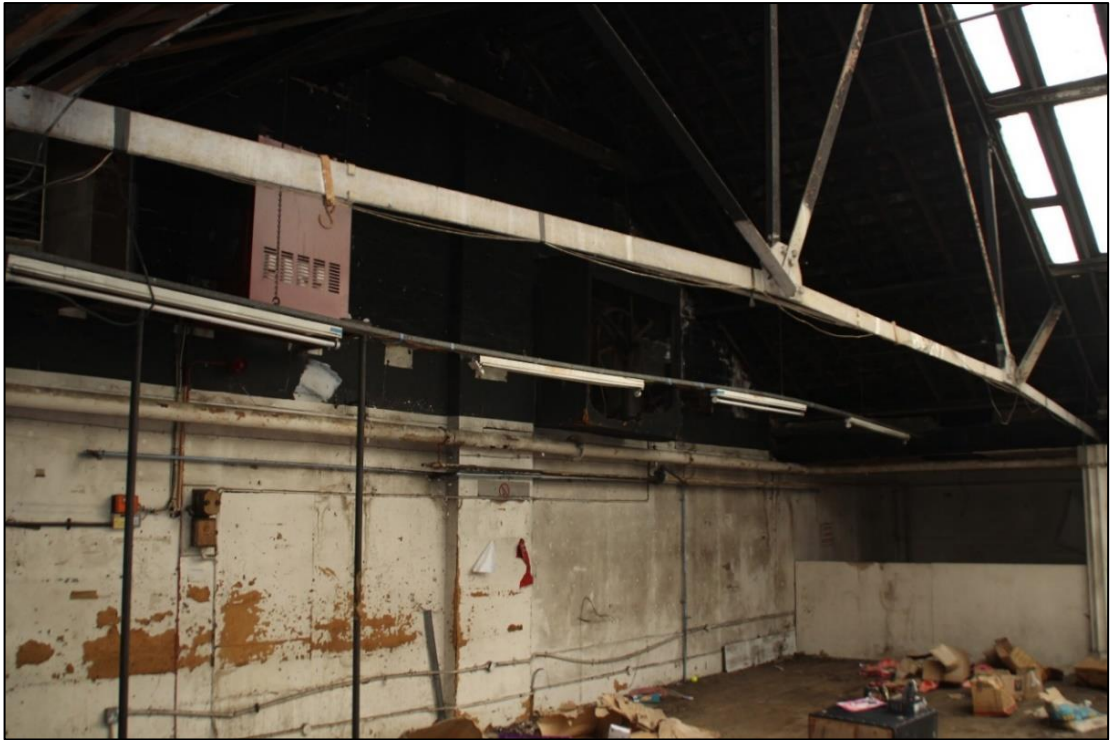
Photo 62 Internal view of roof truss on first floor of Building 5

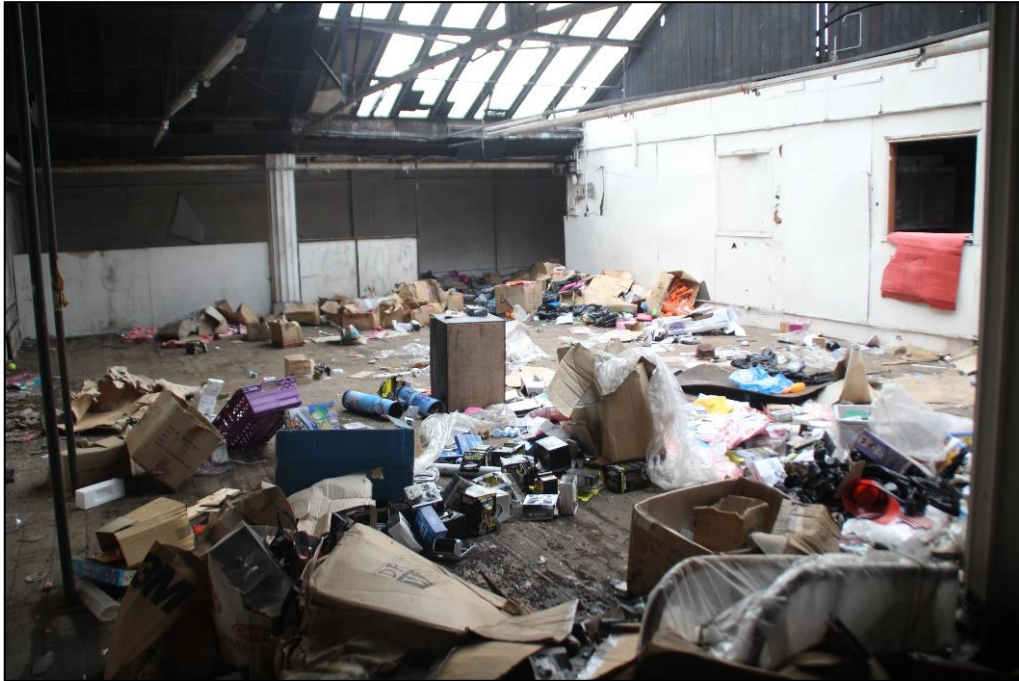
Photo 64 View of first floor in Building 5, looking west

4.56. The first floor, which circumnavigates the open floor below, is a series of corridors with timber floors, containing a large open plan space at the eastern end as it accesses Building 6 (as seen in Photo 64 and 65 below). Above these first-floor spaces are the lean-to felted roofs of the roofscape which encircles the glazed lantern.

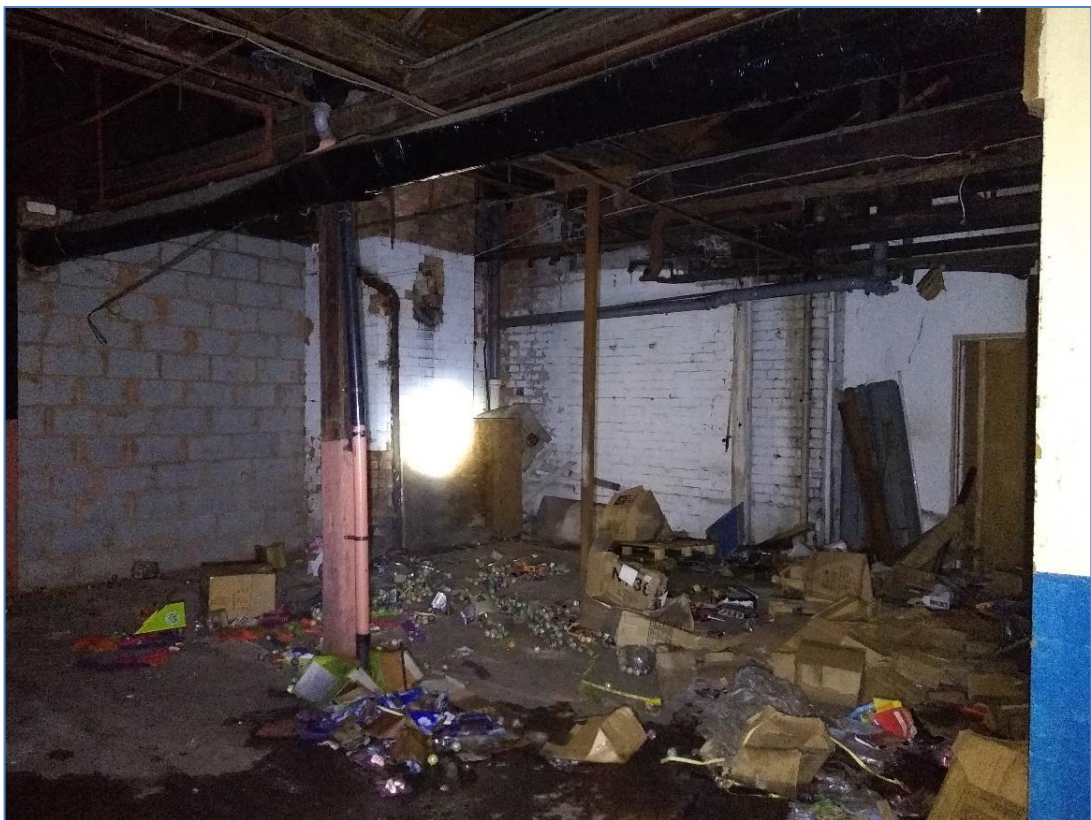
Photo 66 View of the rear (west) of Building 5 where the former yards to No.27-29 Great Hampton Street were located

-
- 4.57. At the western end of the ground floor, the space is open plan to the rear of No.27 and 28 Great Hampton Street, which essentially means that the rear yards of these buildings have been incorporated into the factory floor (Photo 66). The ad hoc roofs described above are seen from below as in Photo 67. Part of this area has been subdivided to provide a kitchenette and lavatories. Details such as a small rear window of No.28 is evident (Photo 68).
- 4.58. A small room to the rear of No.28 (now subsumed into Building 5) has a large, pressurised boiler pipe with metal steps to a lower area, it is possible this was connected to boilers within the basement area, initially this may have been part of the furnace system seen in Building 4 (Photo 69).

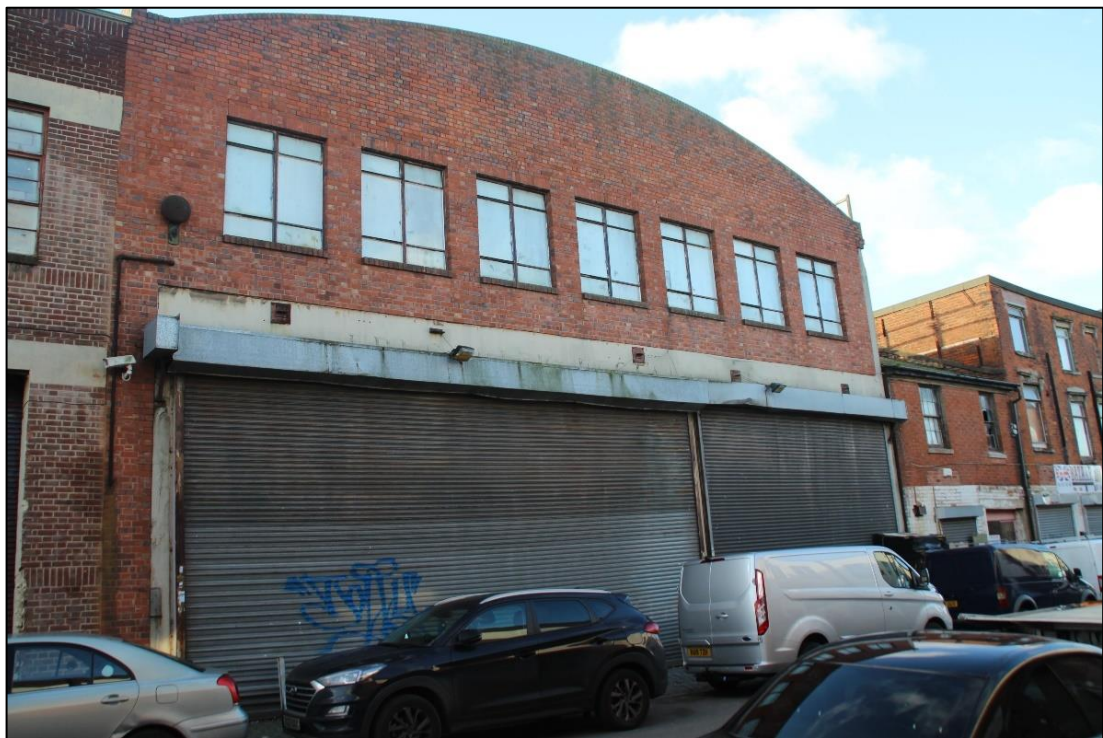
- 4.61. From Barr Street (Photo 70), the building is formed of a large double height brick factory building with a part glazed barrel roof form and high-level metal windows over a double set of large roller shutter doors.

Photo 70 View of the Barr Street frontage of Building 6
