The Lampworks Jewellery Quarter, Birmingham

Historic Building Recording (Level 3)

CA Project: CR0549

January 2021

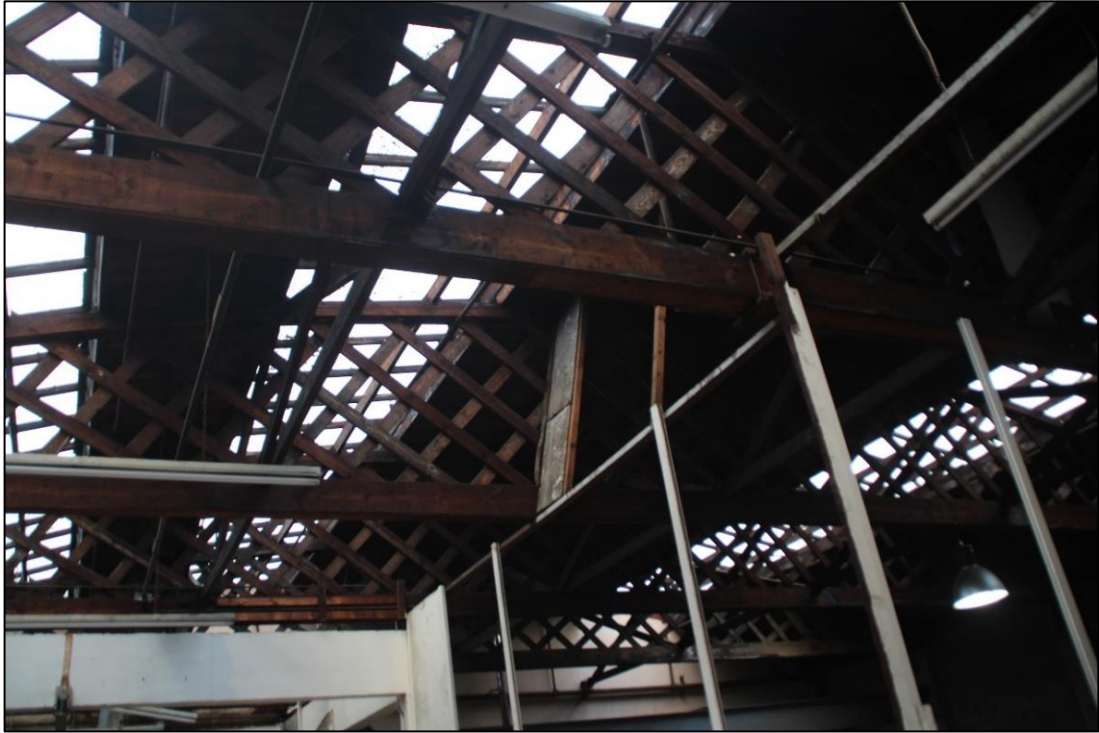
Photo 71 Internal view of the roof truss in Building 6

- 4.62. Internally the building is subdivided, with the Belfast truss roof forming the main structural roof element (Photo 71). The subdivisions internally appear to have been a later alteration as they feature newer steel beams. Part of the subdivision has

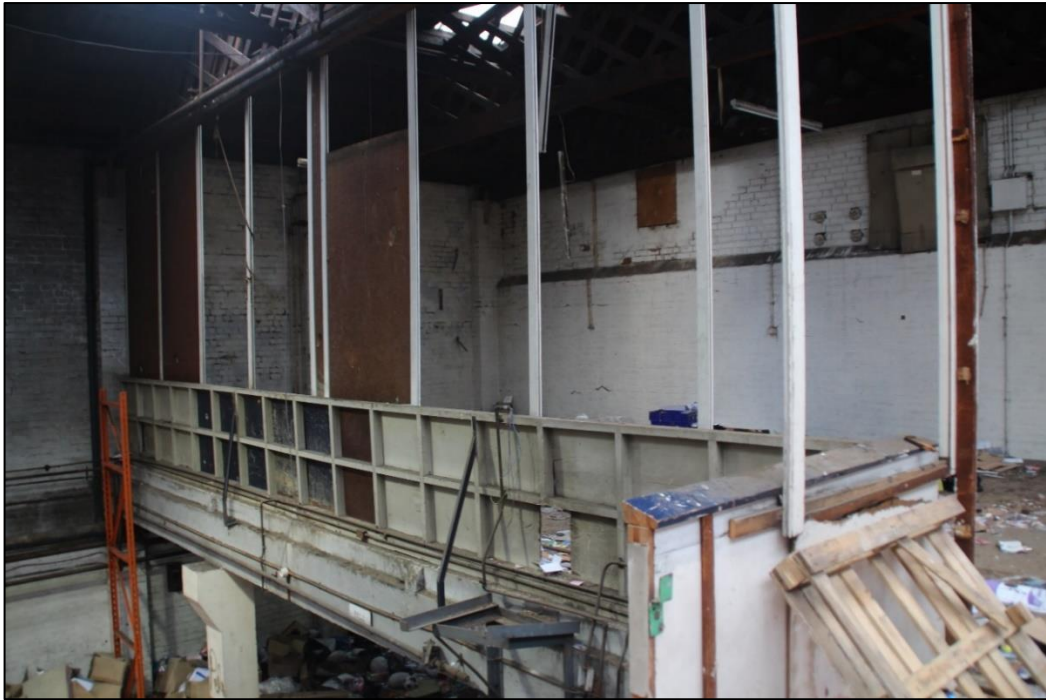
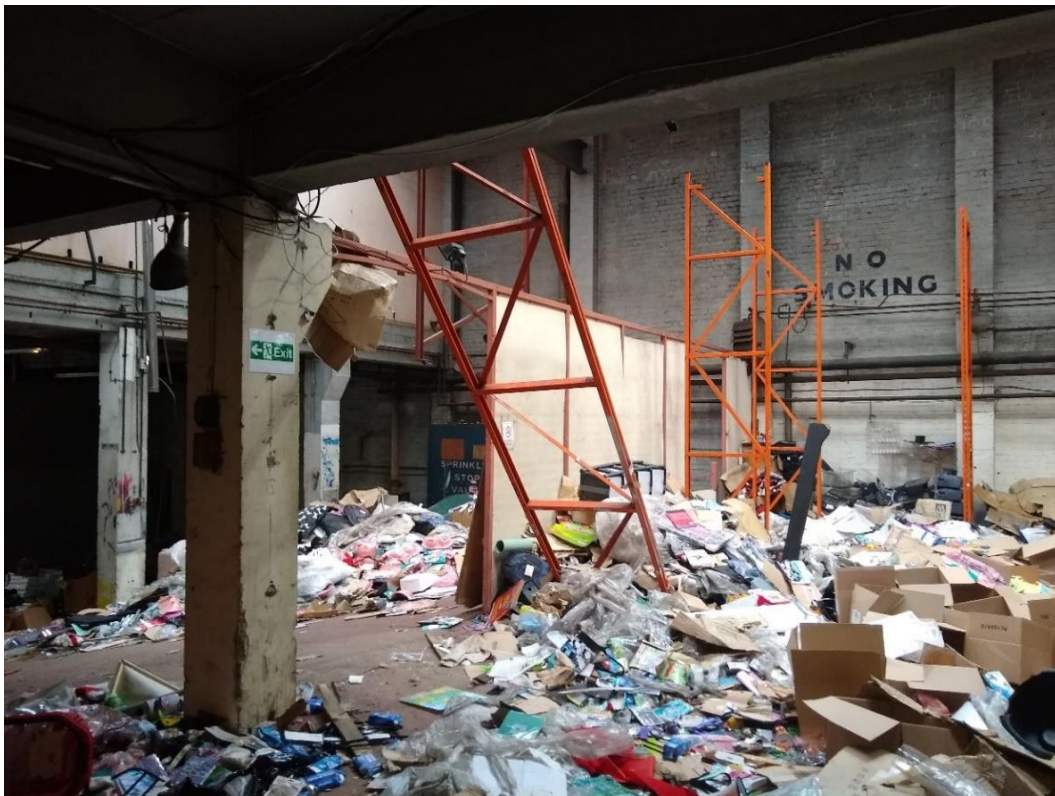
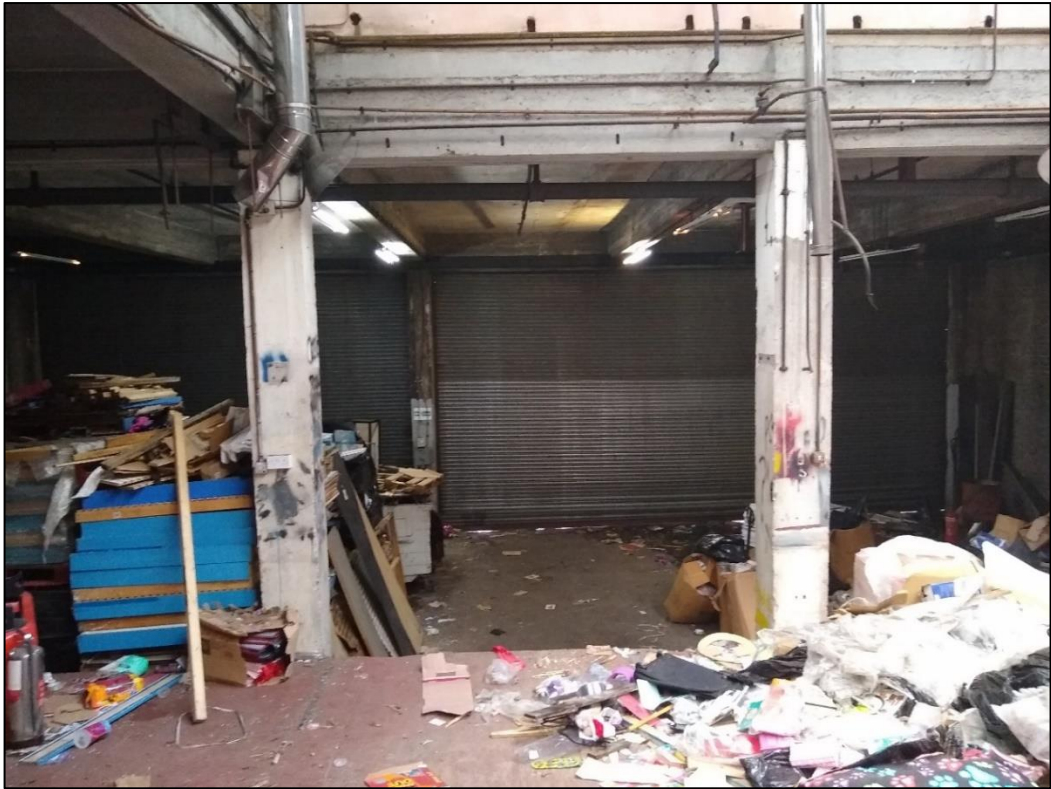
occurred to create an eastern loading bay into which vehicles could reverse park from Barr Street to be loaded up (Photos 72-74).

- 4.63. The loading bay takes account of the topography of the site with a sharp drop in the concrete floor to create a lower and upper area within the bay (Photos 72-74). Above the loading bay is a first-floor area accessed via a staircase with a glazed atrium which overlooks the loading bay area. Off from this mezzanine, at its eastern extent a large room addresses the street, with the factory windows seen externally currently blocked up as seen in Photo 75. The upper floor is supported on concrete piers with steels and concrete beams above.

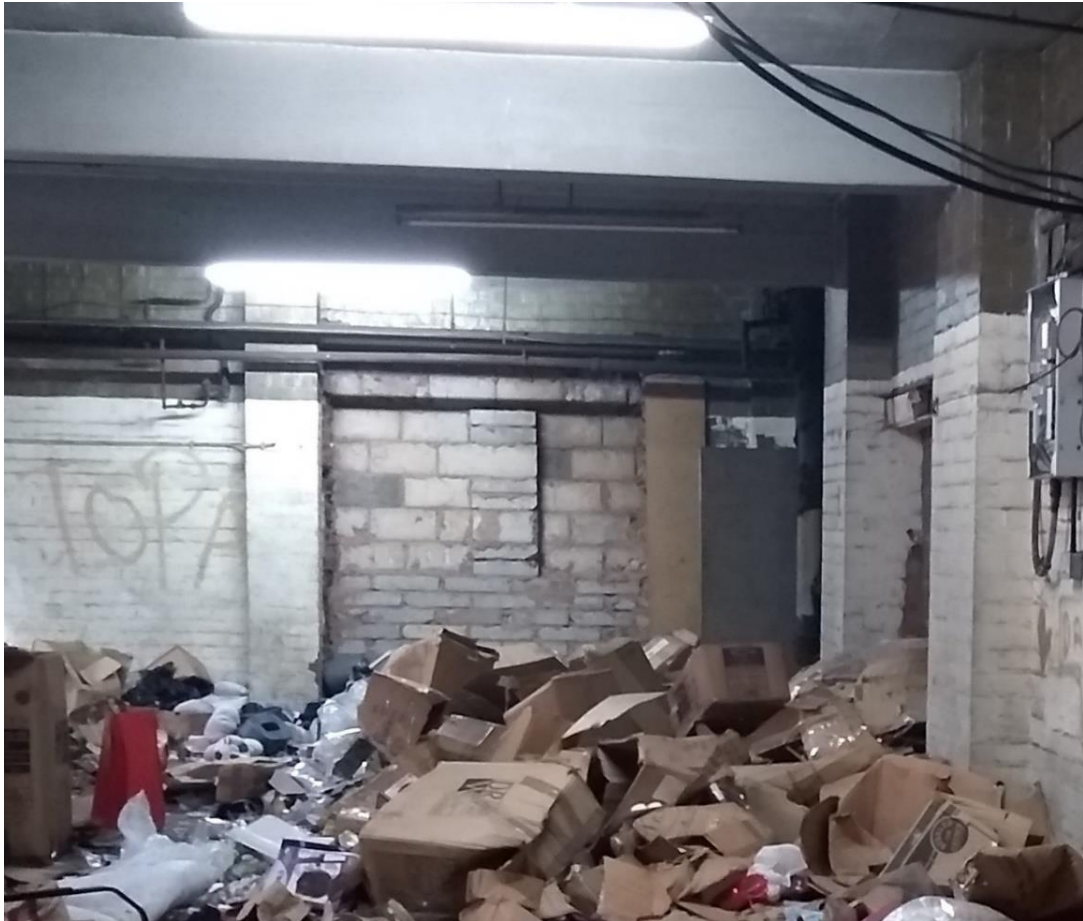
Photo 76 **View of wall section in Building 6**

- 4.64. To the rear (west) of the loading bay area is a small section of wall which may be constructed of coursed stone as opposed to the rest of the building which is of brick construction (Photo 76). This may be a remnant of the former buildings on the site. Close examination was not possible as access to the area of the section of wall was impeded. Equally this could have been an opening to the building adjacent (Building 7) at a time when the whole site formed one factory complex. The blockwork has an irregular appearance not commensurate with concrete blocks.

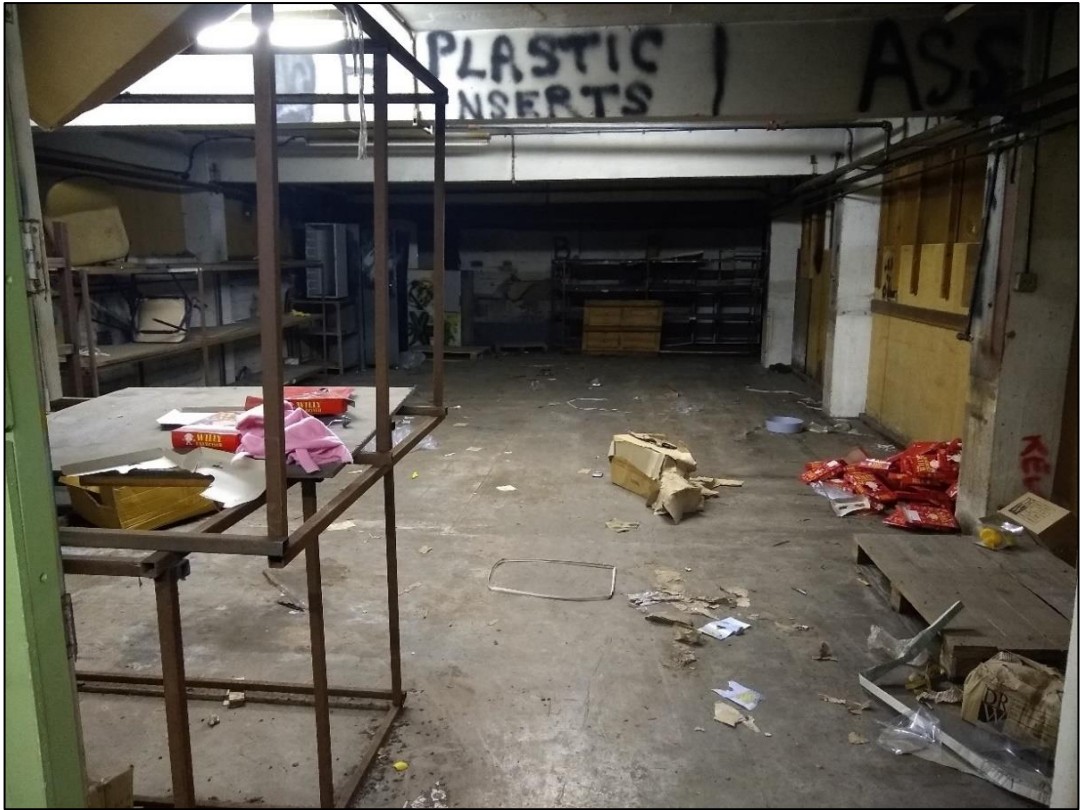
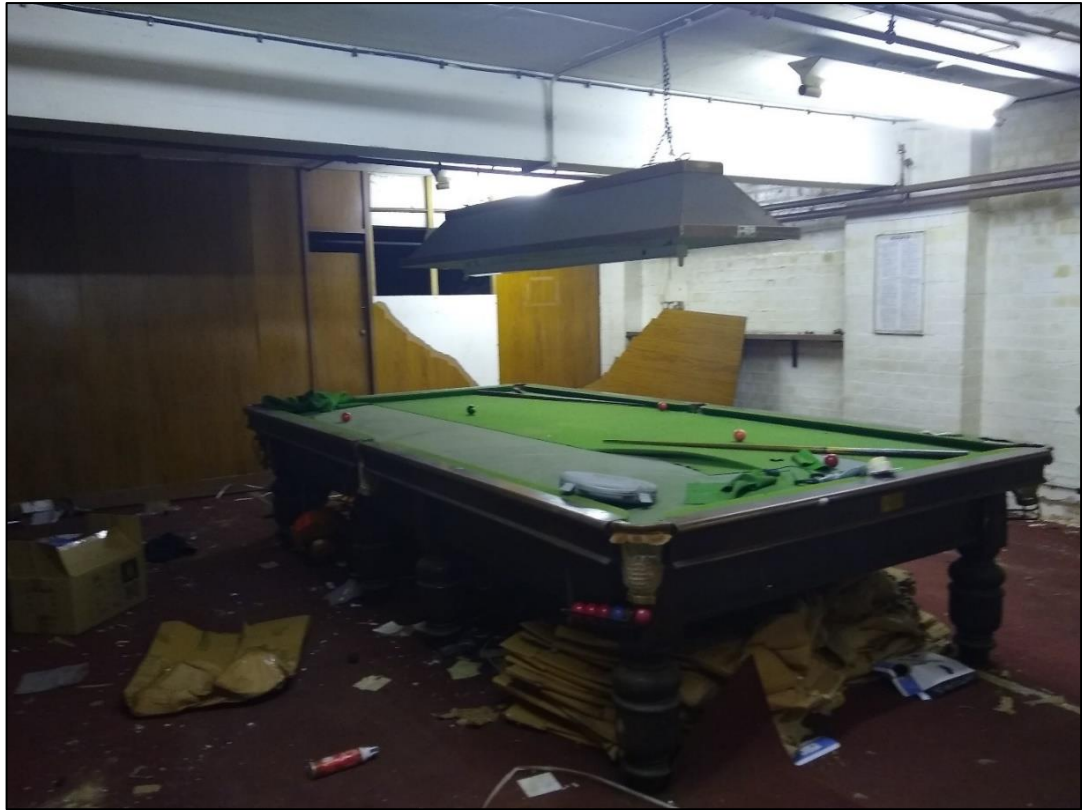
- 4.65. A staircase within the loading bay area leads down to a basement level, which is formed under the upper level of the bay before it drops to street level. Within the basement is a series of four rooms, one of which contains a pool table and kitchenette and may have formed an informal 'social club' of the Restall factory (Photos 77-79)

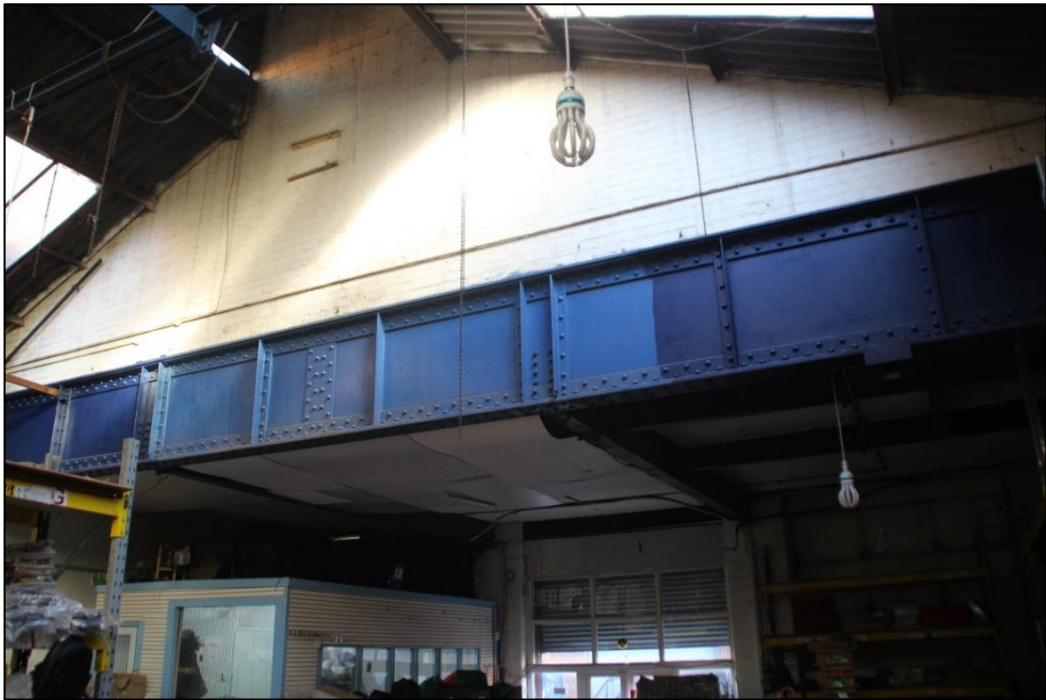
Photo 81 **View of mezzanine structure from ground floor of Building 7**

4.68. Internally the Building is accessed from Barr Street. The frontage building has effectively been amalgamated with the rear warehouse building via a complete opening out at ground floor. The first floor of the frontage building now forms a mezzanine over the eastern ground floor warehouse space, accessed via steps at

the northern side as seen in Photo 81. The steels used to create this arrangement are substantial and modern in appearance.

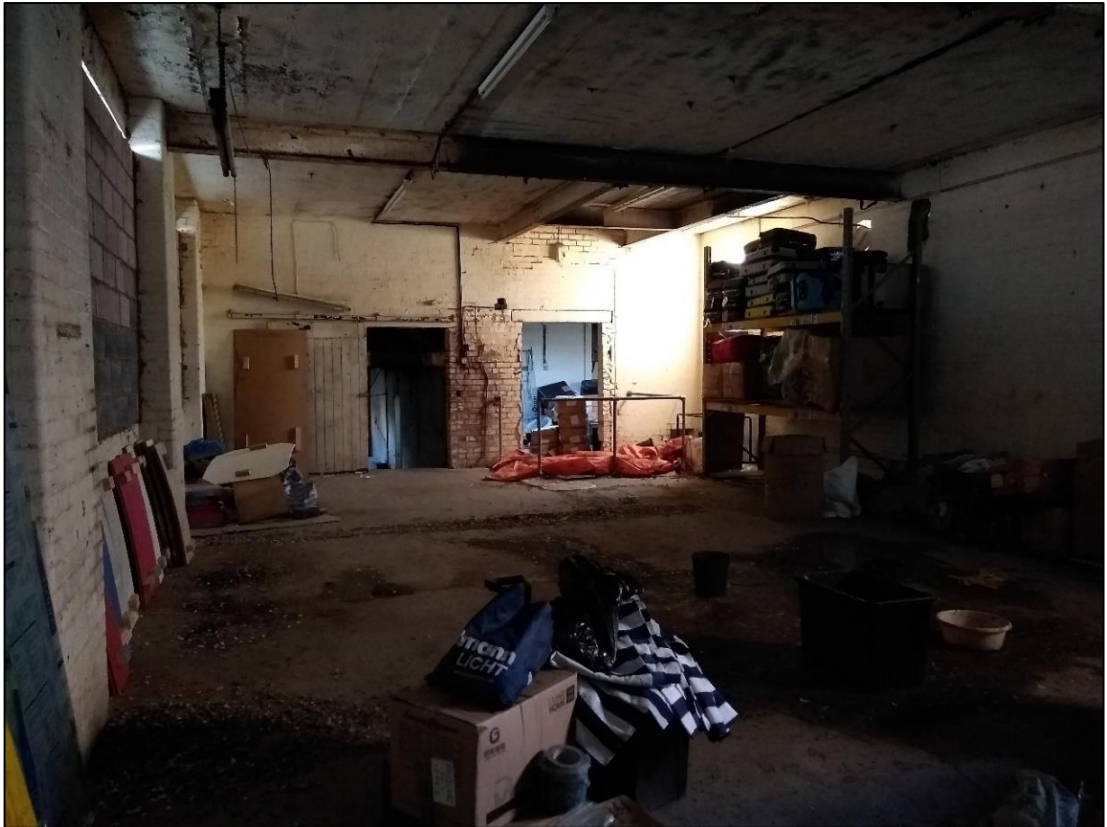
Photo 83 View of first floor of Building 7, looking south

- 4.70. The upper floor of Building 7 comprises a large open plan room. The walls are of brick with steel beams (likely inserted as part of the conversion when the warehouse was created in the 1950's). The industrial frontage windows have been blocked up as seen in Photo 83 and 84. The floor has been coated in a black surface but is likely timber or boarding under this. Two openings are seen in the southern flank wall which lead to Building 8.

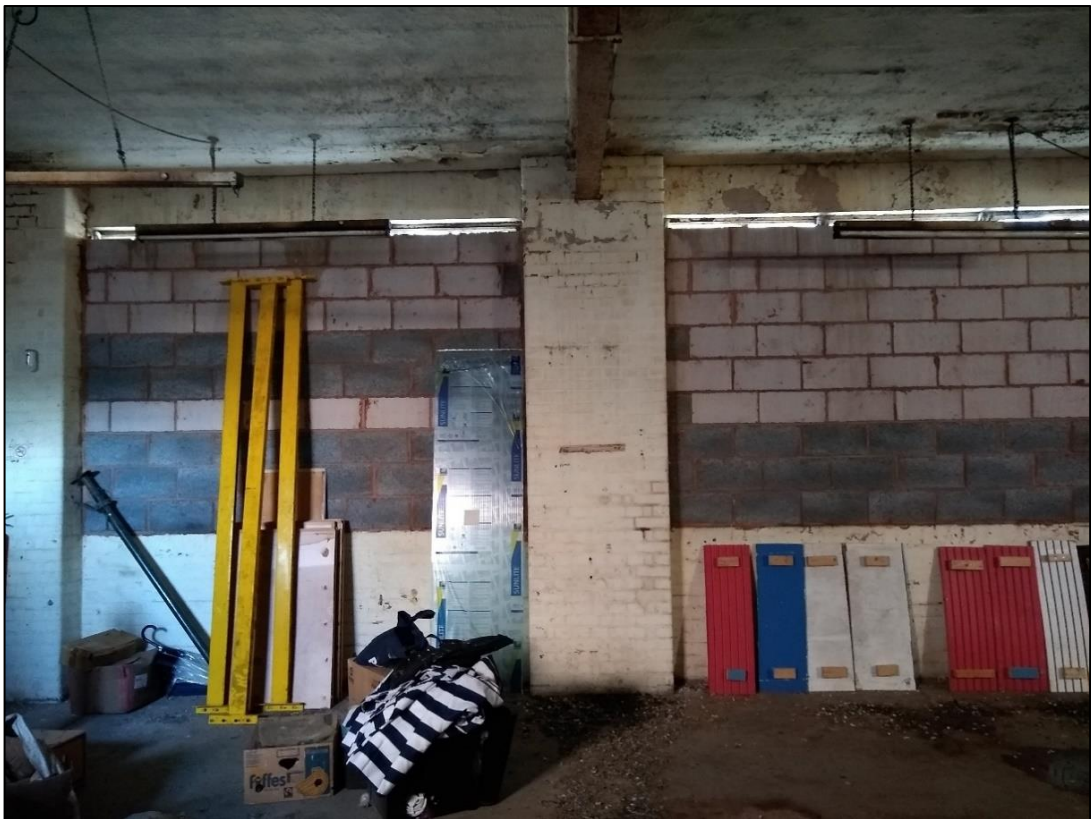
Photo 84 View of blocked windows to the front of Building 7

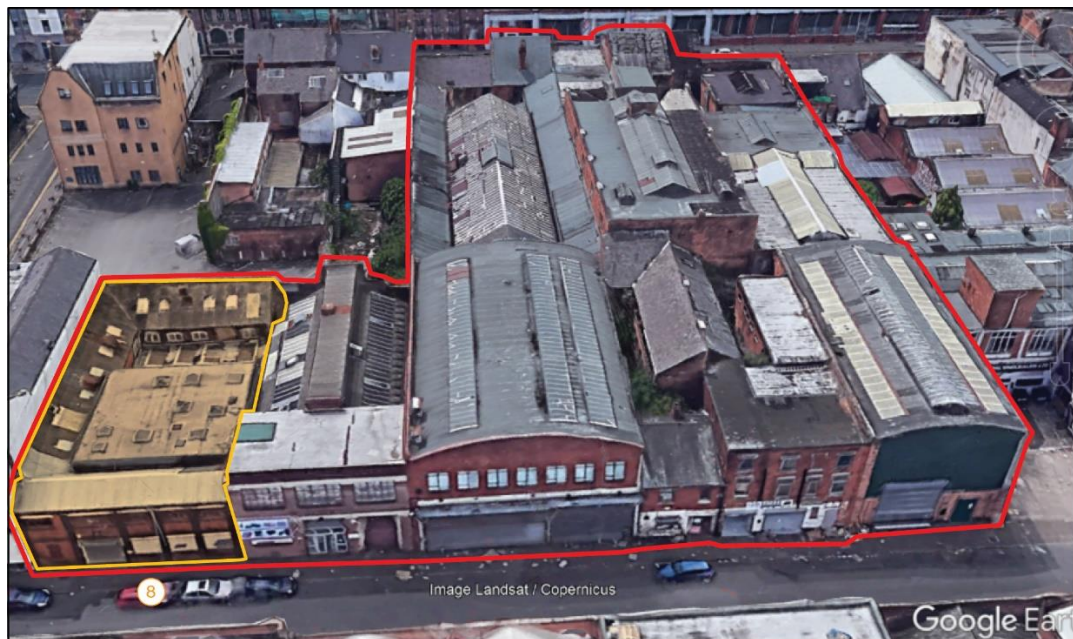
Fig.26 Aerial view of Building 8

4.72. Building 8 is formed of several ad hoc structures as can be seen from the view of the roofscape (Fig.26), and is known as 46-54A Barr Street. Some of these structures are seen on the 1890 OS map and are therefore historic elements. The mapping shows a rectangular courtyard arrangement where the courtyard is encircled by linear ranges, with several differently shaped structures within the courtyard itself. The northern range has been lost to the construction of the warehouse element of Building 7, but those on the west, east and southern walls of the rectangular plot have survived. The mapping (Fig.27) shows an X for a carriage opening, which corresponds with a roller shutter opening in the front façade on the fourth bay. The courtyard arrangement remained until the 1950's when it was gradually filled in and is now covered in flat roofs, as per Fig.26 The building is now accessible from Building 7, with lateral openings at both ground and first floor level. Though at first floor level there is a c.1m drop in floor level between the first floor of Building 7 to 8.

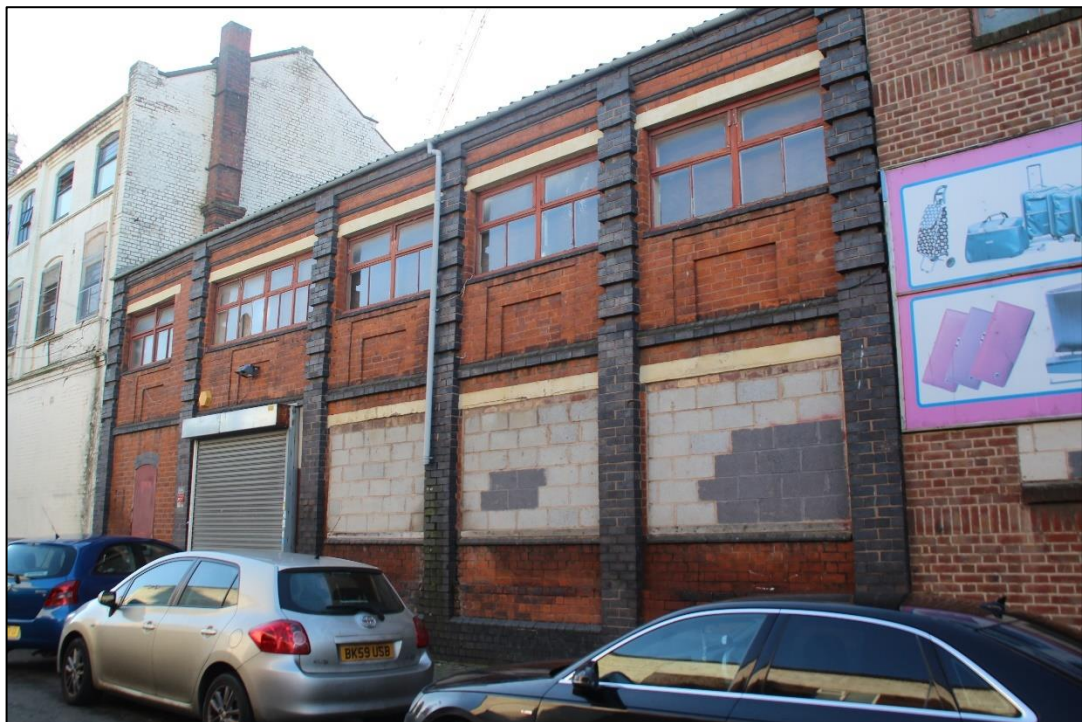
Photo 85 **View of the Barr Street frontage of Building 8**

4.73. The street frontage façade is polite 19th century industrial in character, with five bays divided by blue brick piers and string courses with additional limestone detailing to window headers. Both the blue and red brick is detailed with panel mouldings and inset detailing. In his report Graeme Ives asserts this façade is later in age, however it certainly has a 19th century character, therefore it is likely to be original. The windows on both storeys are large industrial size units, though the ground floor windows have been blocked (with the carriage entrance roller shuttered, and the upper floor appear to be the original metal versions). An original brick chimney with detailing is seen running up the gable wall of the adjacent property (Photo 85).

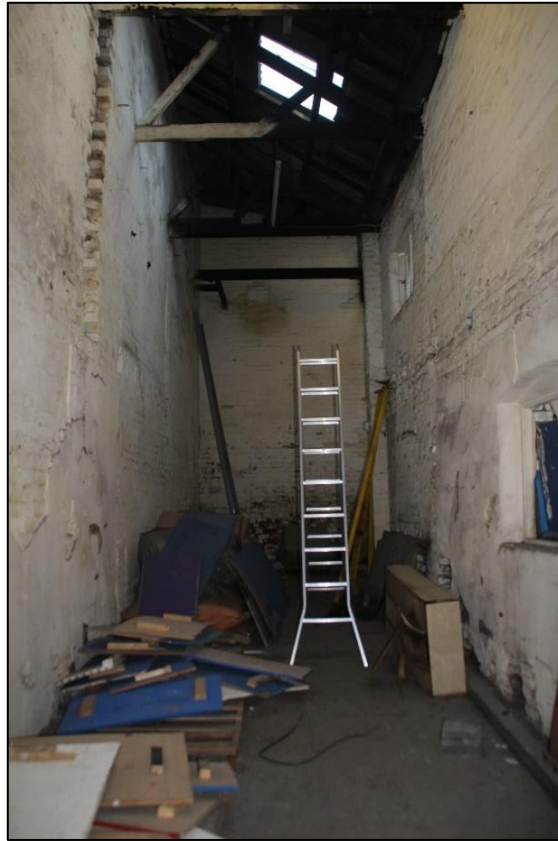
Photo 86 View of the southernmost linear former range in Building 8, looking west

4.74. Internally the courtyard plan, lined by linear ranges is discernible within the building fabric of the south and west sides, though the first floors and internal spine walls of the linear buildings have been removed and they are now essentially open plan from the ground floor to the lean-to roofscape (Photo 86). Scars and holes within the brickwork denote where floor, ceiling and wall fabric has been removed. This is seen best in Photos 86 and 87. The inward courtyard facing walls of the linear workshop ranges are still intact with windows at first floor height, though at ground floor ceiling height the external wall has been removed and supported with steel beams, this is best seen in Photos 88 and 89. Also seen in Photo 89 is part of the

courtyard area which has been covered over in an ad hoc fashion (the section containing lightwells). The roof materials for these areas are all replacements, either metal, asbestos or plastic corrugated sheets.

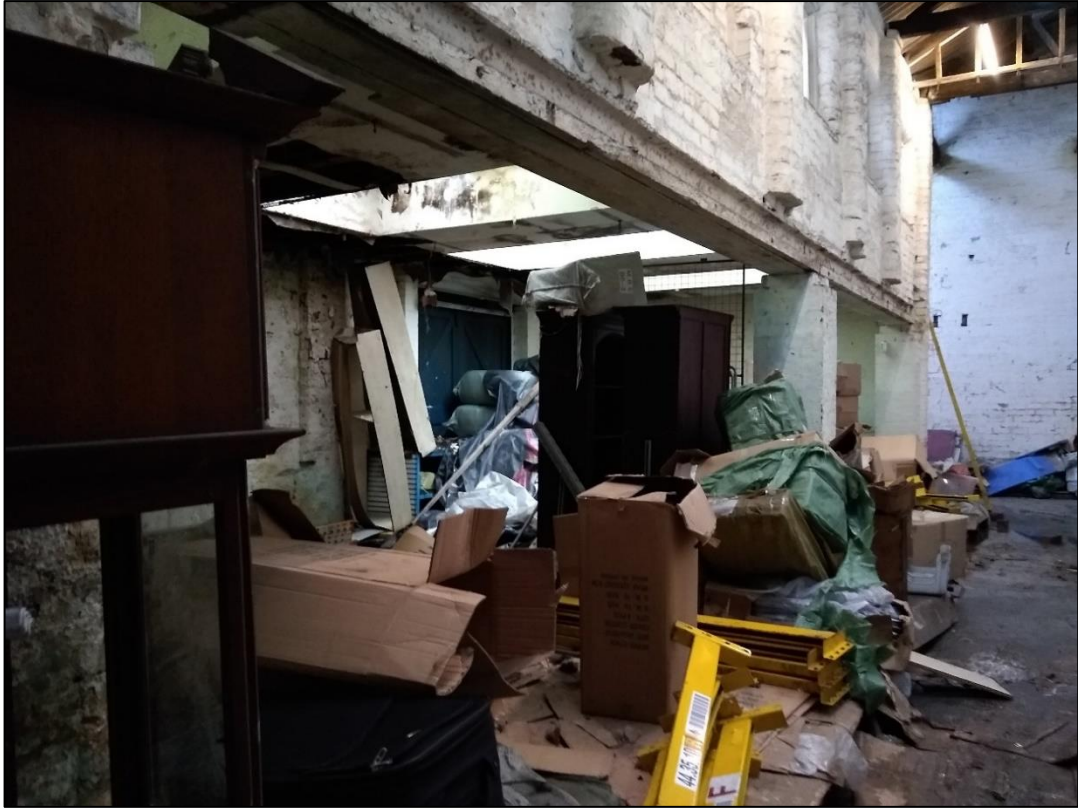
Photo 89 View of the steels supporting the eastern wall of the western linear range, plus the lightwells of the infilled courtyard

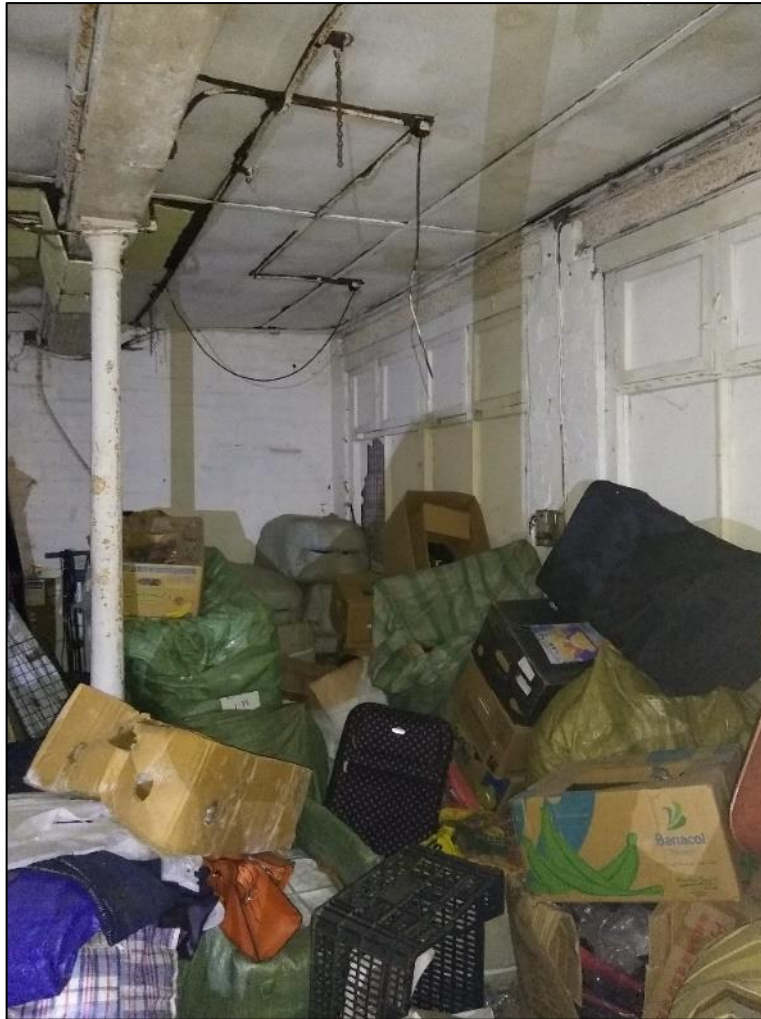
**Photo 90
windows**

- 4.75. The ground floor of the linear frontage range was accessible, which contained three of the five ground floor window openings (Photos 90 and 91), and in an adjacent space the wide carriage opening with arch was seen, as in Photo 92. The metal window frames have been painted but are extant behind the cement blocks that are seen externally. Also, of note in this space is a series of three or four metal columns with moulded capitals which support a large timber beam.

View of the ground floor interior frontage building of Building 8 with extant

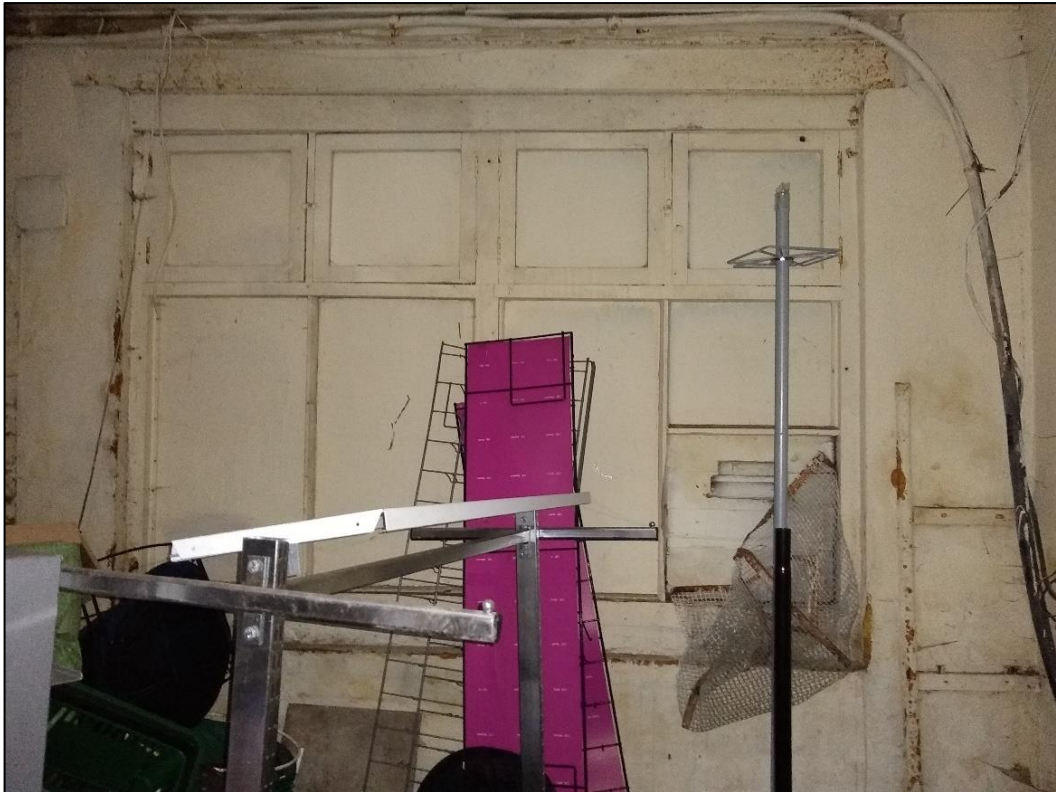
Photo 91 **View of the blocked ground floor frontage windows of Building 8**

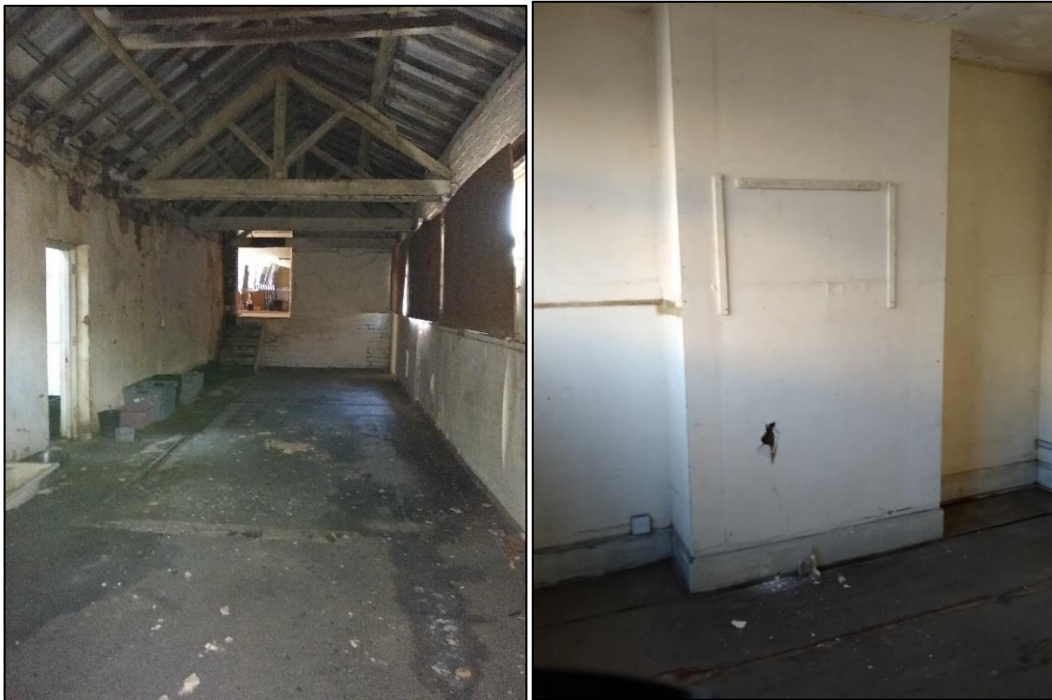
Photo 93 (left) View of the first floor of the frontage range of Building 8
Photo 94 (right) View of the chimney breast of first floor room in Building 8

4.76. At first floor level, the frontage range spaces are intact, as seen in Photo 93, though the windows have been boarded up. The pitched king post roof truss is visible (likely original), and the floor has been asphalted to allow for the metal working processes that were present within the Building. At the far southern end of the Building, below the chimney mentioned above is a small domestic room with chimney breast, potentially a rest and cooking area (Photo 94).

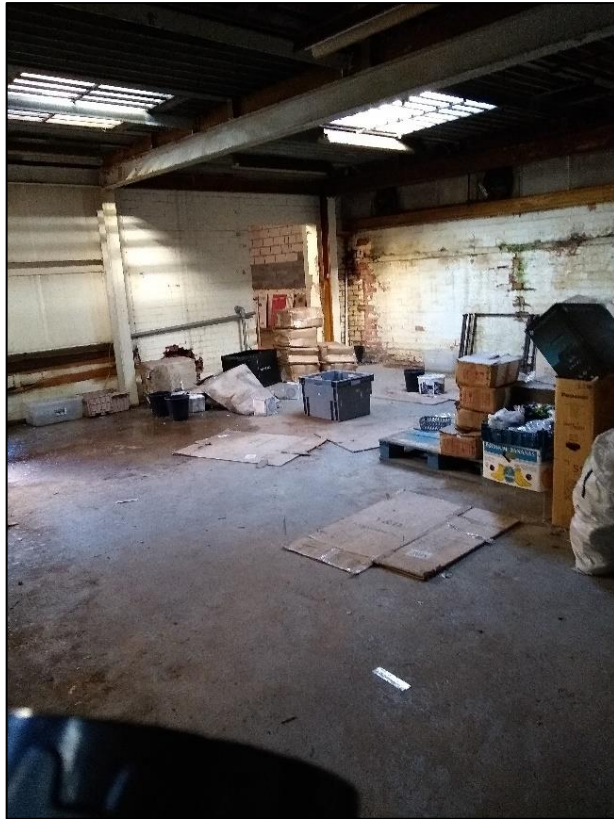
Photo 95 View of room in courtyard infill of Building 8

4.77. The rooms behind this frontage area are formed of the flat roofed courtyard building as seen in the roof image, these are open plan rooms with no remarkable features (Photo 95). They are accessed from the ground floor via a steep staircase. An office style room at the rear overlooks the filled in courtyard, with the windows of the linear ranges (seen in Photos 96 and 97) visible over the infill section.

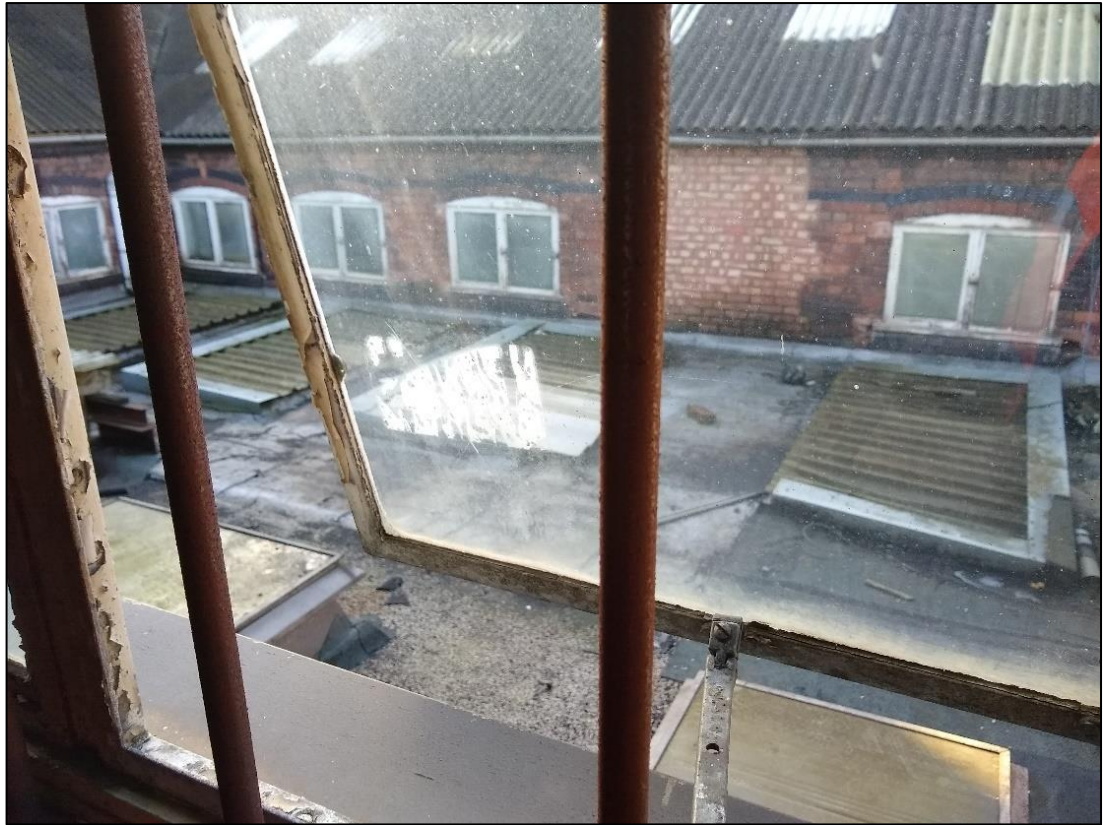
Photo 97 View of the first-floor windows of the linear ranges encircling the former (now covered) courtyard in Building 8

- 4.78. Building 8 retains some historic structures which are legible, including the structural wall and window fabric of the linear ranges which lined the internal courtyard as seen in Fig.27. Of particular interest is the survival of the frontage range without major alteration, which includes the internal structural metal columns, the carriageway entrance and the internal spaces of the first floor. Internally, ad hoc additions and infill to the courtyard has obscured the legibility of these areas from the ground, though their plan form is visible from windows overlooking it at first floor level.

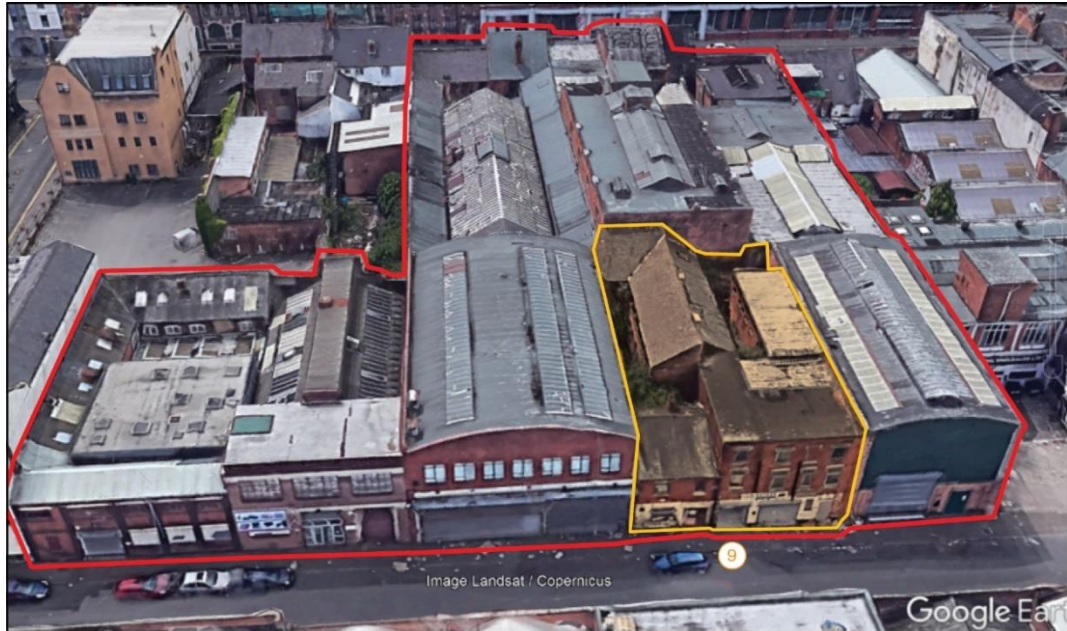
Fig.28 Aerial image of Building 9

-
- 4.79. Building 9 is formed of the buildings known as 54A and 54B, 56A and 56B Barr Street; essentially 54A and 56A being the frontage buildings and 54B and 56B being the rear buildings. As shown in the cartography above (Fig.29), 54 Barr Street was, by 1890, formed of a domestic frontage building with a linear rear range. 56 Barr Street was formed of a larger domestic property with a rear linear range that wrapped around both the plot of Building 6 and Building 2 adjacent to the north, with a building located centrally within the area creating a wraparound courtyard. The buildings were amalgamated with the Restall Furniture company in the mid-20th century.

- 4.80. Unfortunately, both buildings forming Building 9 were found to be heavily contaminated with asbestos therefore access was severely limited by this and by the dilapidation of the buildings with access to much of the interior unsafe. However, some first-floor areas were accessed via Building 3 though inspection was cursory due to safety concerns. Some record of the structures of the site was therefore possible.

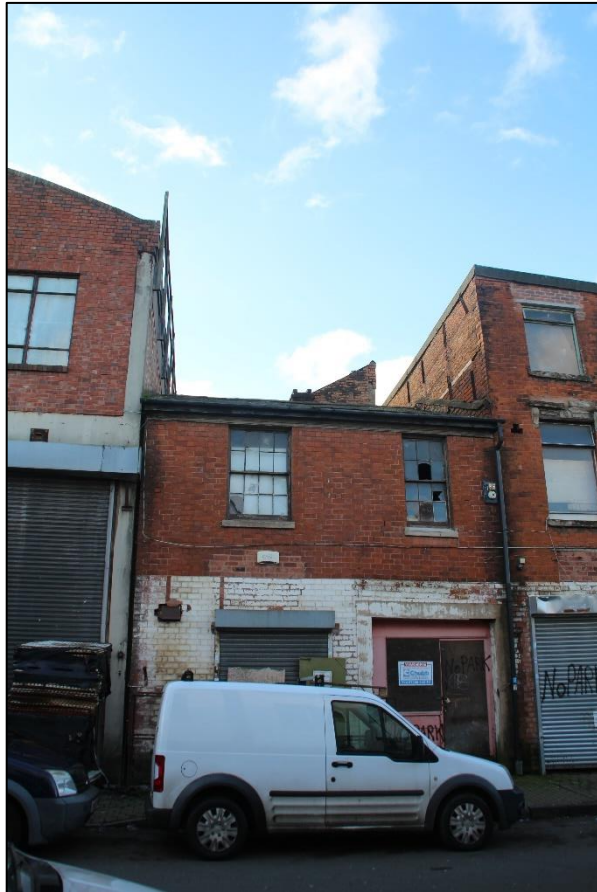
Photo 98 **View of No.54A Barr Street**

- 4.81. 54 Barr Street is a small domestic scale building, essentially a two up two down brick dwelling (Photo 98). It has been heavily altered and its construction is thought to be circa 1860's (Graeme Ives 2019). The brickwork is Flemish bond, and it has a double pitched roof with an L shape workshop range at the rear. Much of the building was inaccessible but what follows is a rapid record of those areas that were seen. Orientation within the spaces was difficult without light and floorplans. Of note here is the topography of the site, which slopes down from west to east, meaning the ground floor of Barr Street is significantly lower than that of Great Hampton Street (this is why the loading bay in Building 6 works well with an upper loading level and a lower vehicle parking level). Access to Building 9 therefore, was achieved via a set of stairs from Building 3 within a modern factory opening.

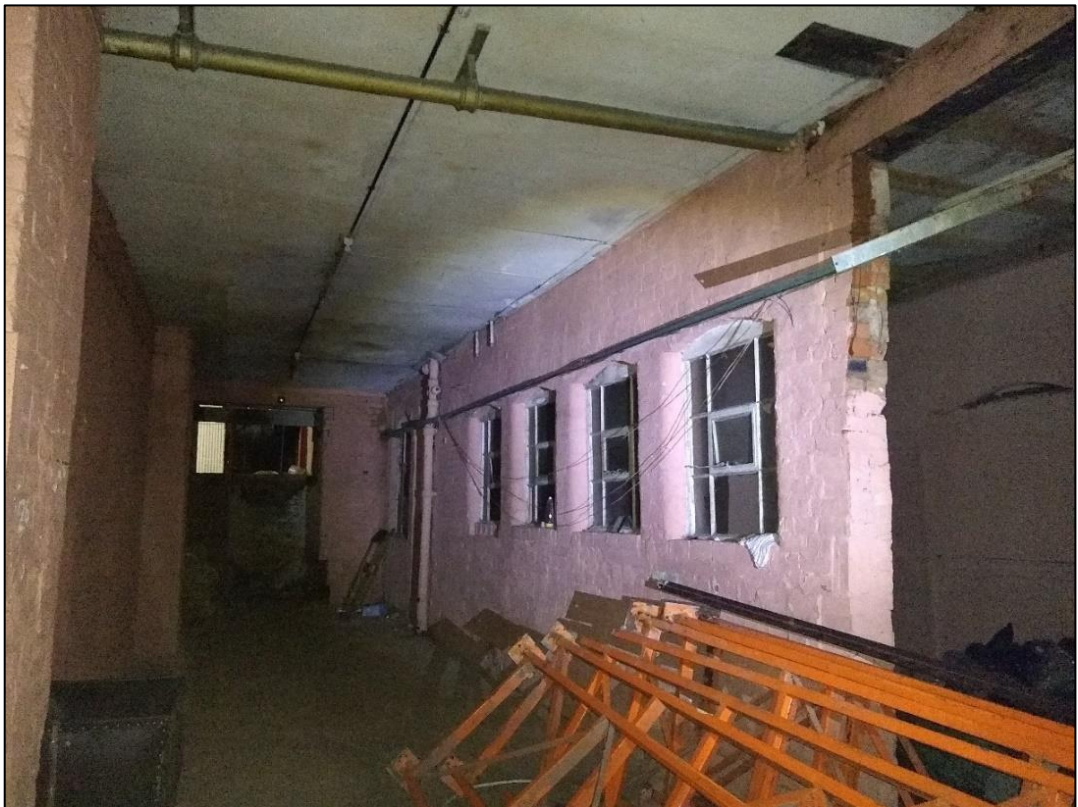
Photo 100 **View of interior passageway, ground floor Building 9**

4.84. This passageway was accessible internally from Building 3 and is seen in Photos 100 to 101. To note in Photo 100 is the windows along the passageway that are formed in the southern flank wall of No.56, which evidences that No.56 precedes that of No.54, or that the passageway was covered over at some point with an upper floor to No.54. Turning at a right angle is the rear passageway which

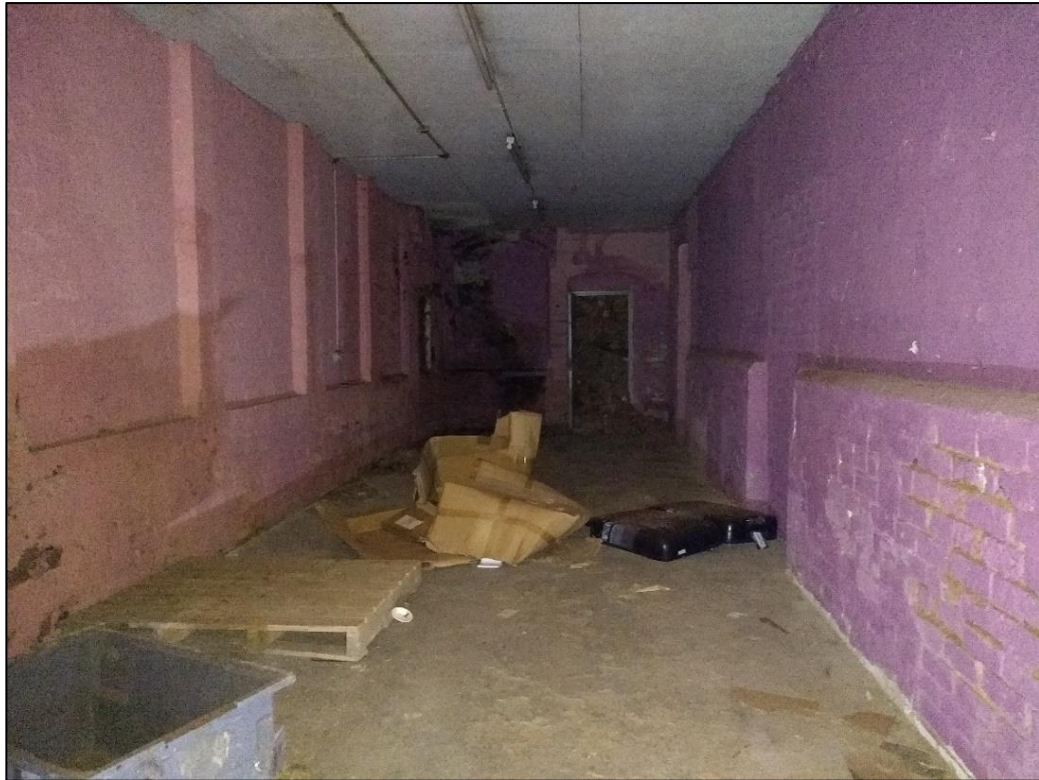
Photo 101 View of interior ground floor passageway, Building 9

circumnavigates the rear range as see in Fig.29 and in Fig.30 below annotated on an aerial image. This is seen in Photo 101 this one with a blocked doorway into the rear range.

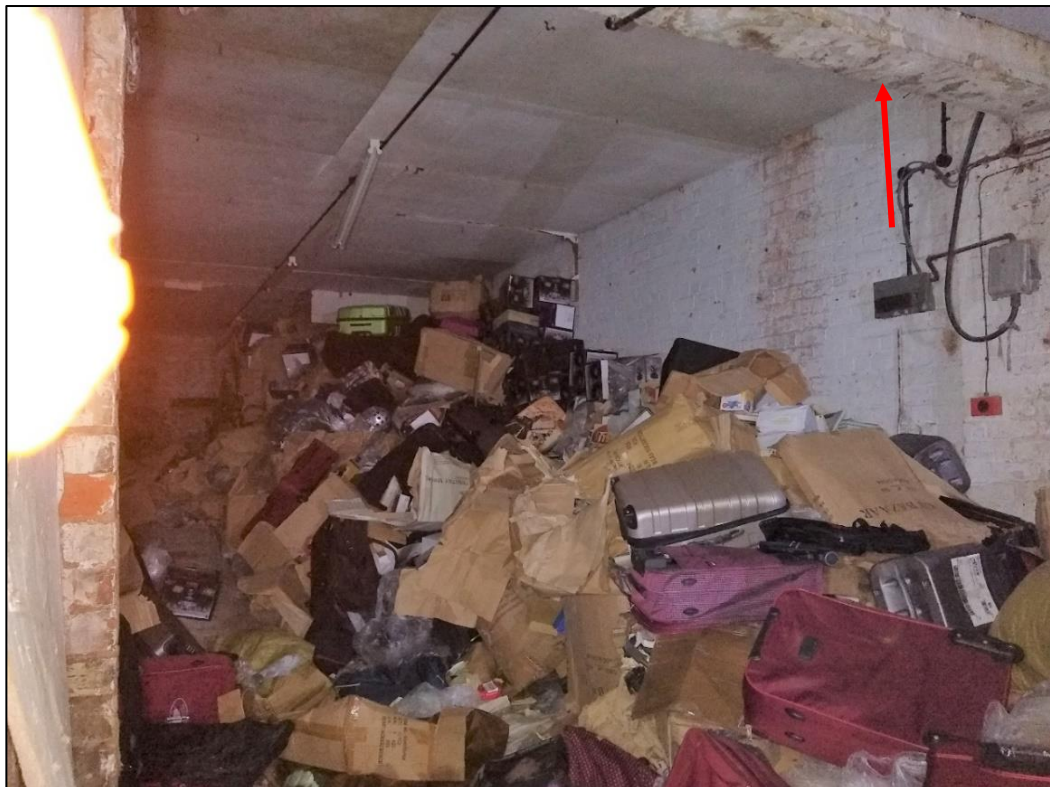
Photo 102 View of interior room of No.56A Barr Street viewed from passageway (chamfered beam arrowed)

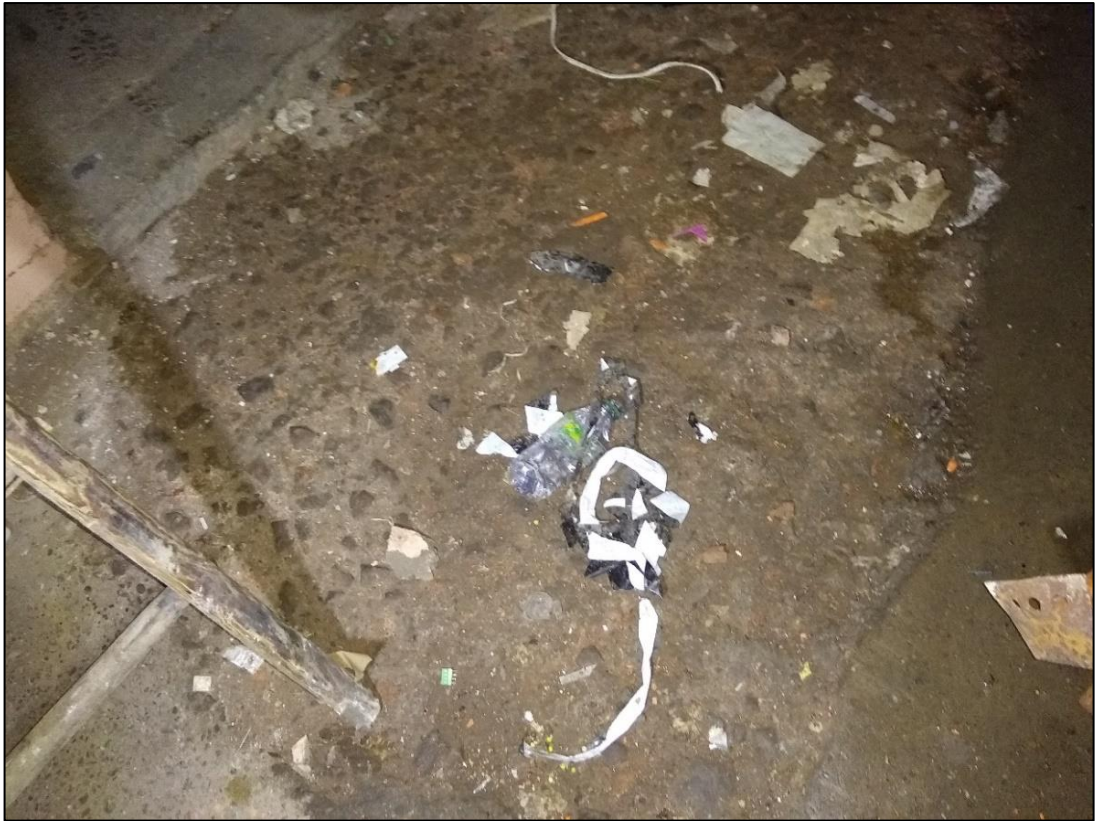
Photo 103 **View of metalled stone floor in passageway of Building 9**
