The Lampworks Jewellery Quarter, Birmingham

Historic Building Recording (Level 3)

CA Project: CR0549

January 2021

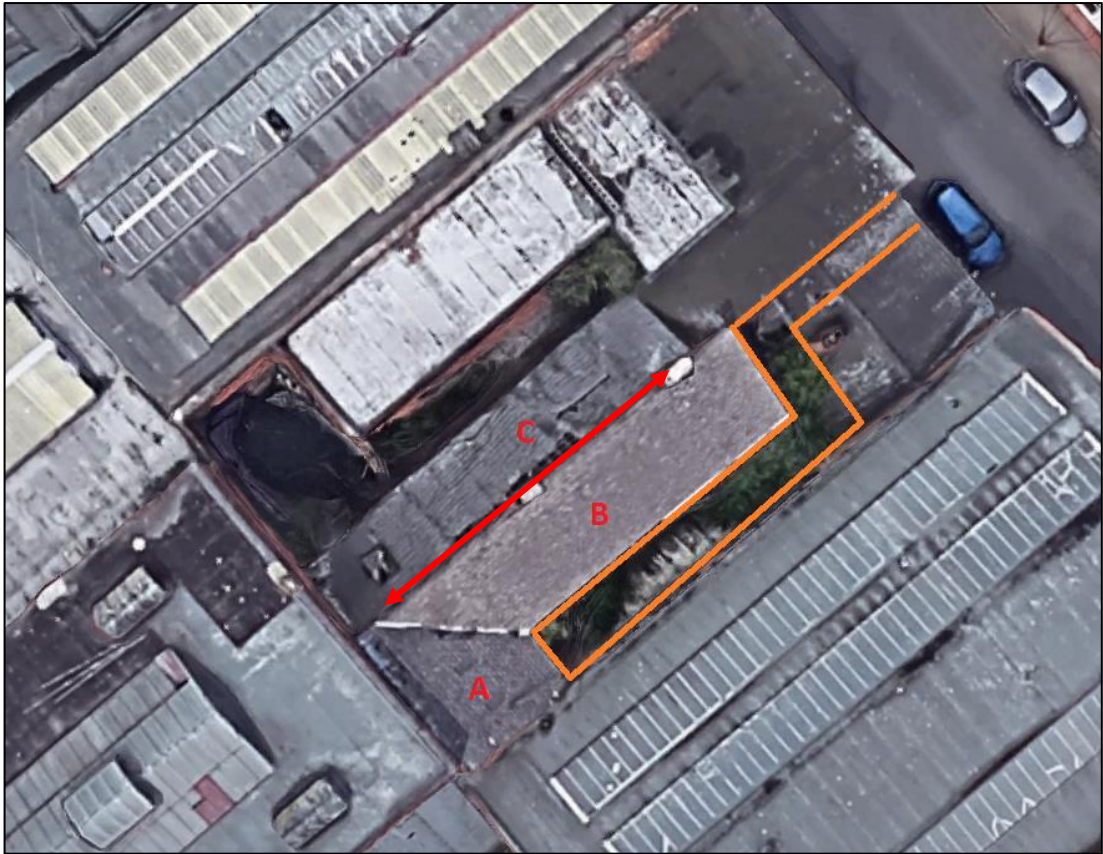
- 4.86. The upper floors of the eastern street frontage buildings of No.54 and 56 were inaccessible for safety reasons. There was more access available to the upper floors of the rear linear ranges of these two buildings from the western end of Building 3 at first floor level, though condition was still parlous, so inspection was rapid.
- 4.87. The block building (Fig.30 A), linear range (Fig 30. B) and its side-by-side linear range (Fig.30 C) to the rear of No.54 as seen in the 1904 map was accessed from Building 3 via domestic doorway. The block building A acts as an entrance area for accessing B and C and this arrangement is best seen in Fig.30 of the roofscape.

Fig.30 Annotated aerial map showing passageways and linear ranges of Building 9

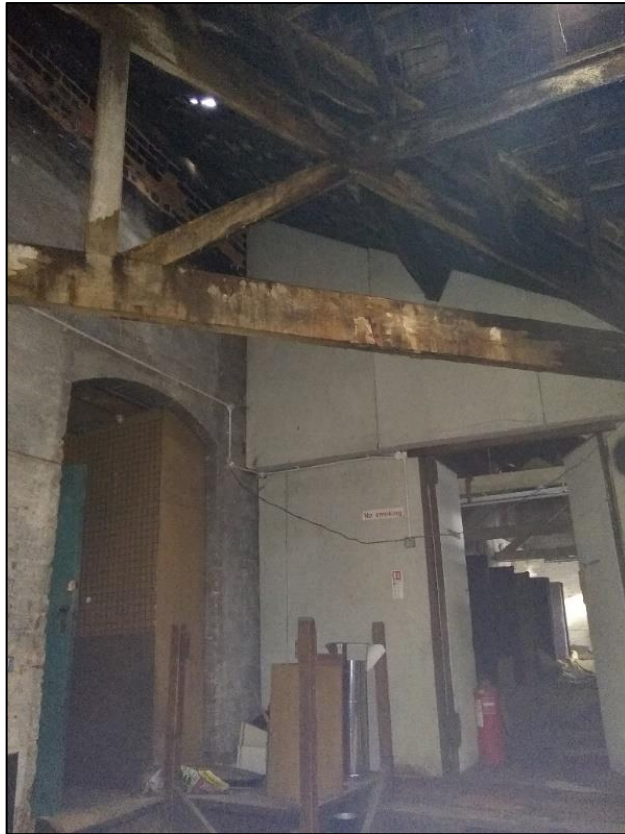
Photo 104 View of building A in rear range of Building 9

- 4.88. Building A is open to the corner hipped roof truss above (Photo 104). It is formed of brick and has a blocked window looking east towards No.54A over the former passageway which is now covered and seen in Photo 104.
- 4.89. A tall arched opening to range C with a small set of stairs is seen within the north wall abutting range C. The floor level of this building is c.75cm below that of both ranges B and C. Access to range B is through the eastern wall and again up a set of stairs. Range B is a long room with simple triangular roof truss, though the roof is actually leaning against that of range C. The room is subdivided into stalls which may once have held metal trade workbenches (Photo 105 and 106). Regular window openings to the south have been blocked up. These were seen from within Building 6 externally as seen in Photo 107 and were large multi-pane metal factory windows.

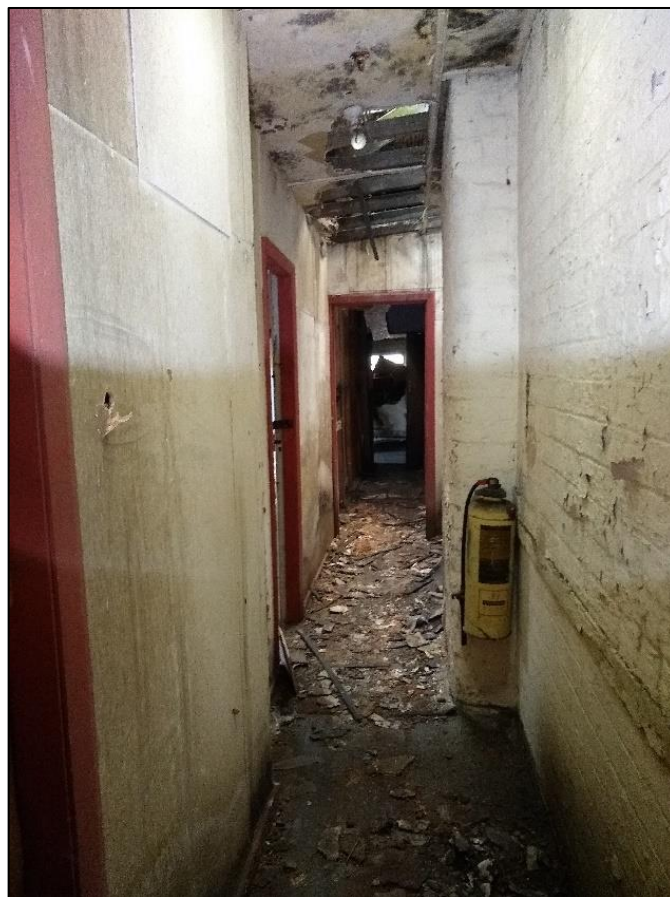
Photo108 View of the upper floor hallway in building C of Building 9

4.90. On entering range C through the brick arched opening, there is a long corridor with small rooms accessed off the corridor to the north. These rooms have been created with studwork which is visible, suggesting that the subdivision of the linear range at this level is a later alteration and that at first it was open plan as seen in range B. The corridor itself has a lathe and plaster ceiling (Photos 108 and 109). A linear room is reached at the end of the corridor, this has a lean-to roof, with brick walls and a timber floor (Photo 110). Two multi-pane metal factory windows are seen on the northern wall and a large window at the end of the room looks east towards the rear of No.54A (Photo 111). This roof is seen externally as being asphalt that has slipped as in Photo 112. The brick wall (arrowed in Photo 112) forms the spine between the roof of No. 54B and 56C or ranges B and C as annotated in Fig.30 above.

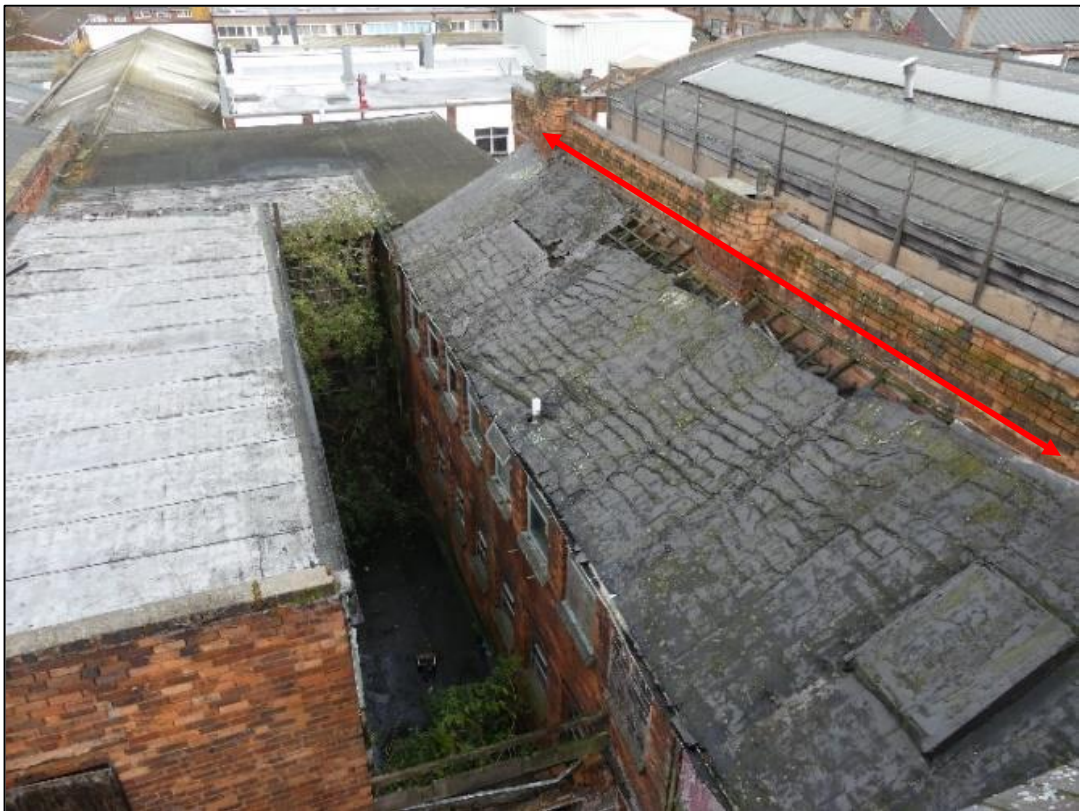
Photo 112 View of the slipped tarmac roof of building C of Building 9, with original spine wall arrowed
